## Carolina Crossroads - Video Inspection Summary - Phase 2 - 04/09/2021

# I-20/I-26/I-126 Corridor Improvement Project

Structure EC-4201

4' x 4' RCBC

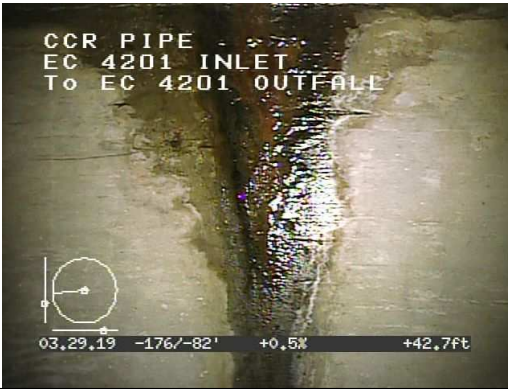
Distance	Fault Observation	Time	Picture
42.7	<p style="text-align: center;"><b>Infil Weeper</b>  <b>Position: 7 To 10</b>  <b>Severity: None</b>  <b>Joint</b>  <b>Maint Weight: 2</b></p>	10:43

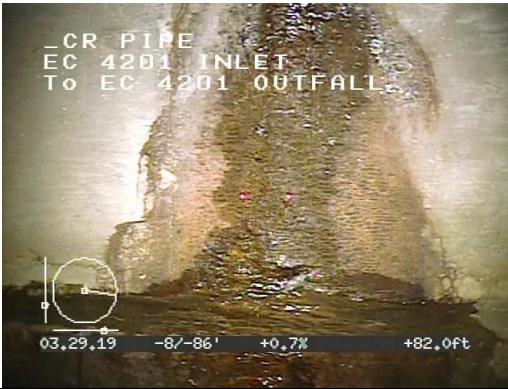
Distance	Fault Observation	Time	Picture
82.0	<b>Roots Fine Barrel</b> <b>Position: 3 To 4</b> <b>Severity: None</b> <b>Maint Weight: 2</b>	20:06

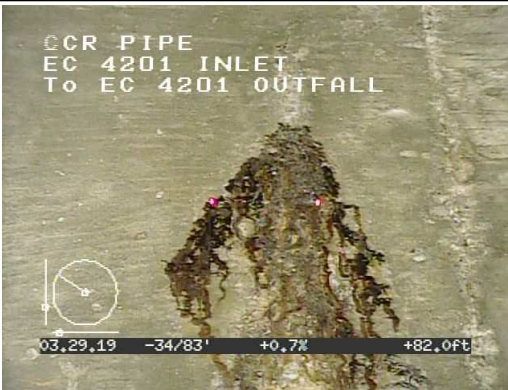
82.0	<b>Roots Fine Barrel</b> <b>Position: 10</b> <b>Severity: None</b> <b>Maint Weight: 2</b>	20:17

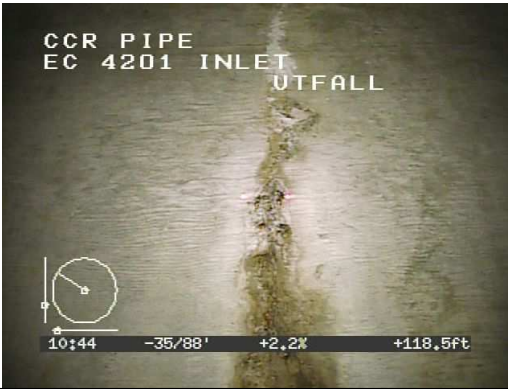
Distance	Fault Observation	Time	Picture
118.5	<b>Infil Weeper</b> <b>Position: 7 To 9</b> <b>Severity: None</b> <b>Maint Weight: 2</b>	32:21

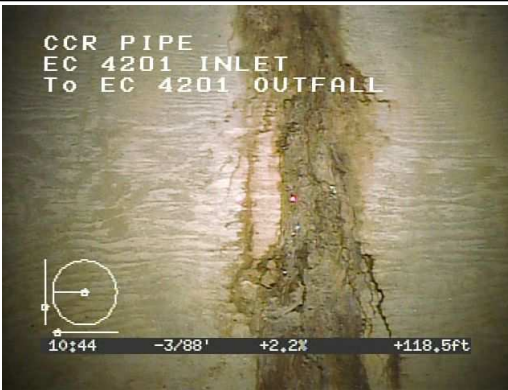
118.5	<b>Picture Number: 2</b> <b>Infil Weeper</b> <b>Position: 7 To 9</b>	0

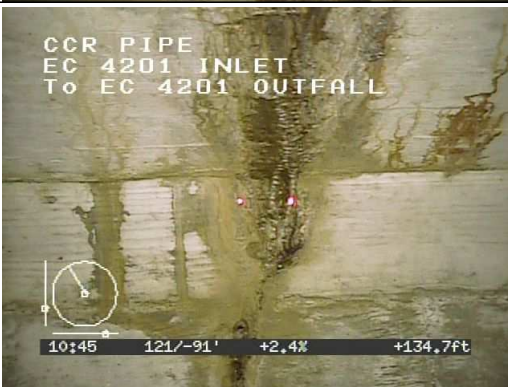
134.8	<b>Roots Fine Barrel</b> <b>Position: 7 To 4</b> <b>Severity: None</b> <b>Maint Weight: 2</b>	33:59

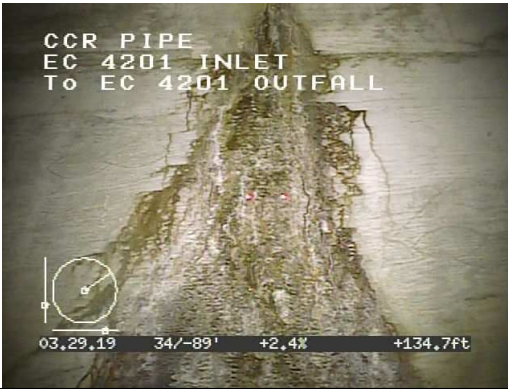
Distance	Fault Observation	Time	Picture
134.8	<b>Infil Weeper</b> <b>Position: 7 To 5</b> <b>Severity: None</b> <b>Maint Weight: 2</b>	36:22

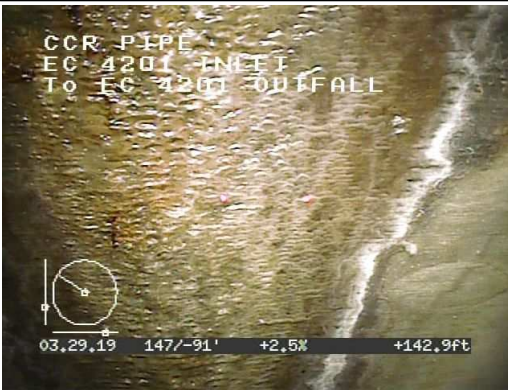
<p>CCR PIPE EC 4201 INLET TO EC 4201 OUTFALL</p> <p>03,29,19 34/-89' +2.4% +134.7ft</p>
142.9	<b>Infil Weeper</b> <b>Position: 7 To 10</b> <b>Severity: None</b> <b>Maint Weight: 2</b>	38:21

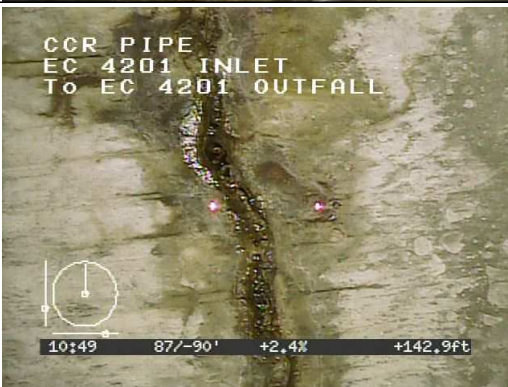
<p>CCR PIPE EC 4201 INLET TO EC 4201 OUTFALL</p> <p>03,29,19 147/-91' +2.5% +142.9ft</p>
142.9	<b>Infil Dripper</b> <b>Position: 12</b> <b>Severity: None</b> <b>Maint Weight: 3</b>	37:21

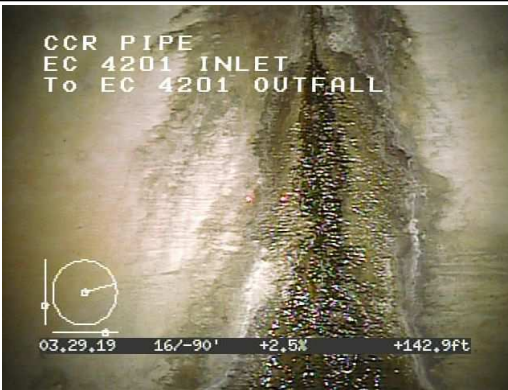
142.9	<p align="center"><b>Infil Weeper</b>  <b>Position: 2 To 4</b>  <b>Severity: None</b>  <b>Maint Weight: 2</b></p>	38:14

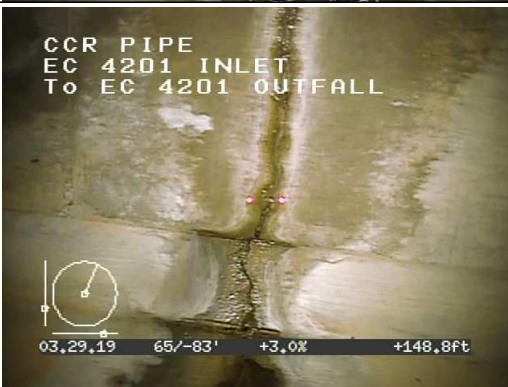
148.8	<p align="center"><b>Infil Dripper</b>  <b>Position: 1</b>  <b>Severity: None</b>  <b>Maint Weight: 3</b></p>	39:51

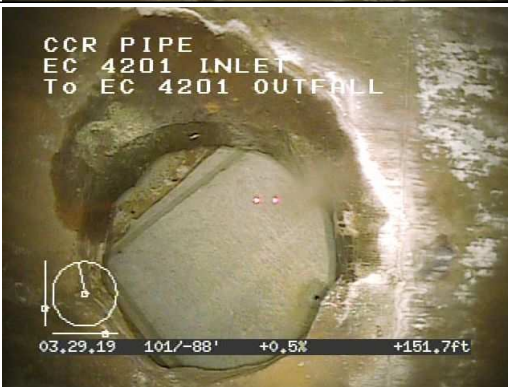
<p>CCR PIPE EC 4201 INLET To EC 4201 OUTFALL</p> <p>10:53 -87/85' +3.1% +148.8ft</p>
151.8	<p style="text-align: center;"><b>General Observation</b>  <b>Severity: None</b>  <b>Remarks: JUNCTION</b>  <b>BUILT OVER PIPE</b></p>	44:56

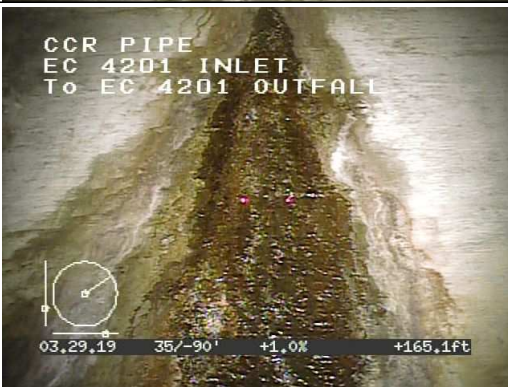
- 14) 159.2 feet – Transverse crack and infiltration weeping on top of culvert.
  - 15) 165.2 feet – Transverse crack and infiltration weeping on top of culvert.

<p>CCR PIPE EC 4201 INLET TO EC 4201 OUTFALL</p> <p>11:04 123/-89' +1.0% +165.1ft</p>
165.2	<p style="text-align: center;"><b>Infil Weeper</b>  <b>Position: 1 To 5</b>  <b>Severity: None</b>  <b>Maint Weight: 2</b></p>	51:26

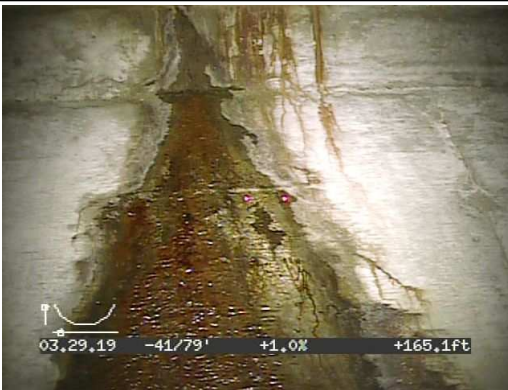
Distance	Fault Observation	Time	Picture
165.2	<p>Infil Dropper            Position: 4            Severity: None            Maint Weight: 3</p>	51:46	  <p>CCR PIPE            EC 4201 INLET            To EC 4201 OUTFALL</p> <p>Infil Dropper</p> <p>11:04 -11/-88' +1.0% +165.1ft</p>
165.2	<p>Infil Weeper            Position: 7 To 10            Severity: None            Maint Weight: 2</p>	52:29

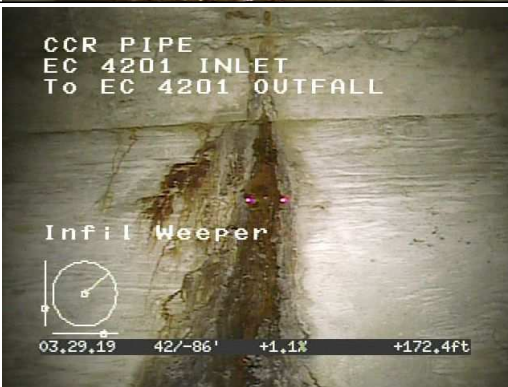
<p>Infil Weeper</p> <p>03:29.19 -41/79' +1.0% +165.1ft</p>
172.4	<p>Infil Weeper            Position: 1 To 5            Severity: None            Maint Weight: 2</p>	53:49

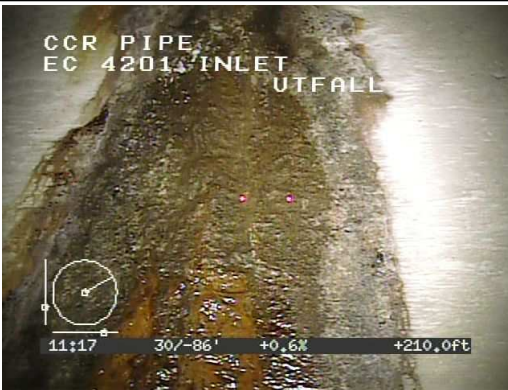
210.1	<p align="center"><b>Infil Weeper</b>  <b>Position: 1 To 5</b>  <b>Severity: None</b>  <b>Maint Weight: 2</b></p>	1:03:57

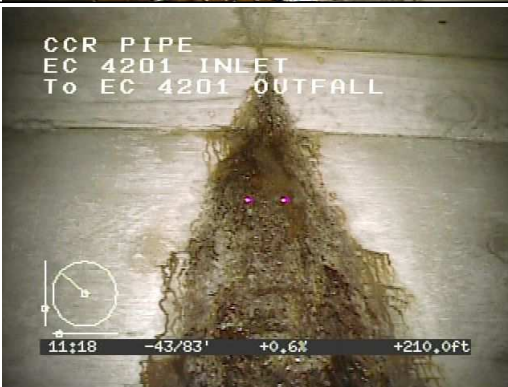
210.1	<p align="center"><b>Infil Weeper</b>  <b>Position: 7 To 10</b>  <b>Severity: None</b>  <b>Maint Weight: 2</b></p>	1:04:34

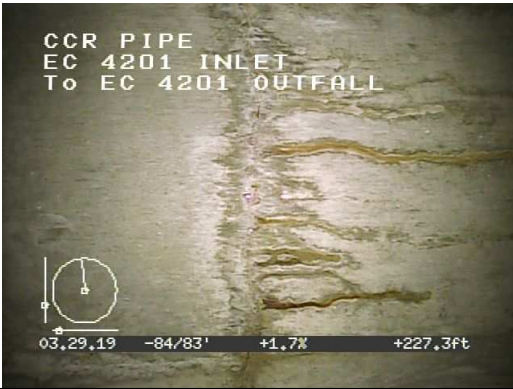
Distance	Fault Observation	Time	Picture
227.4	<b>Roots Fine Barrel</b> <b>Position: 7 To 12</b> <b>Severity: None</b> <b>Maint Weight: 2</b>	1:11:43

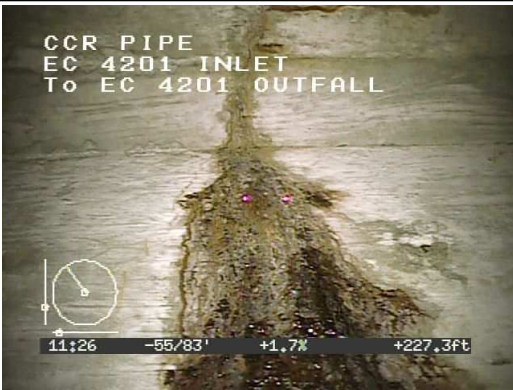
227.4	<b>Picture Number: 2</b> <b>Roots Fine Barrel</b> <b>Position: 7 To 12</b>	0

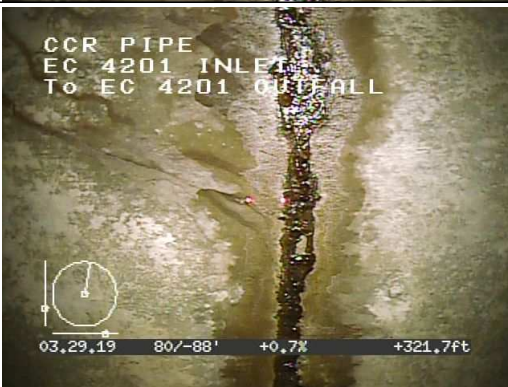
321.8	<p style="text-align: center;"><b>Infil Dripper</b>  <b>Position: 12</b>  <b>Severity: None</b>  <b>Maint Weight: 3</b></p>	1:43:27

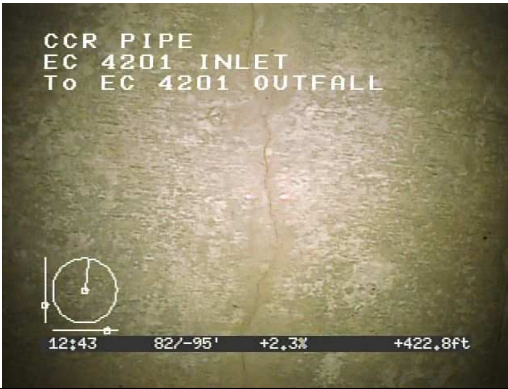
Distance	Fault Observation	Time	Picture
422.9	<p align="center"><b>Crack</b>  <b>Circumferential</b>  <b>Position: 10 To 1</b>  <b>Severity: None</b>  <b>Struct Weight: 1</b></p>	2:23:23

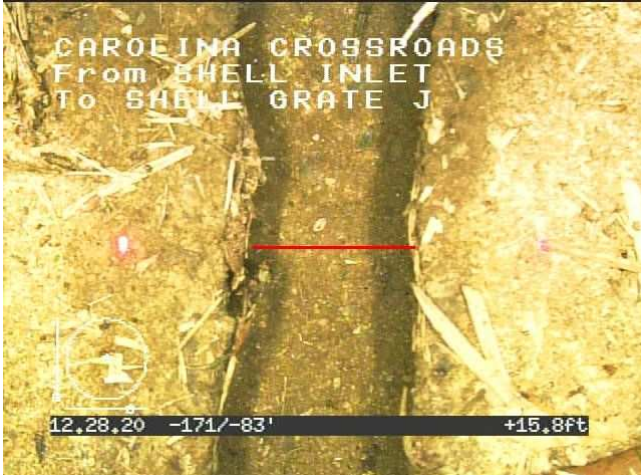
15.9	<p><b>Miscellaneous General Observation</b> Severity: None Remarks: GAP OBSERVATION 0.961</p>	04:11

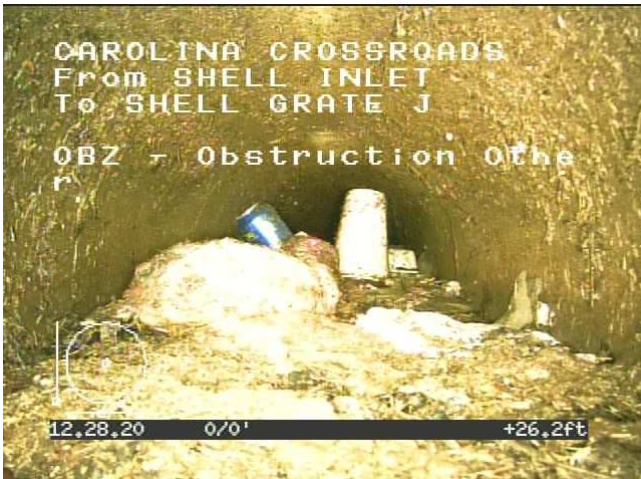
Distance	Fault Observation	Time	Picture
26.3	<p><b>Obstruction Other</b>  <b>Position: 4 To 8</b>  <b>Severity: None</b>  <b>Percent: 40</b>  <b>Remarks: DIRT AND DEBRIS IN PIPE</b>  <b>Maint Weight: 5</b></p>	06:28

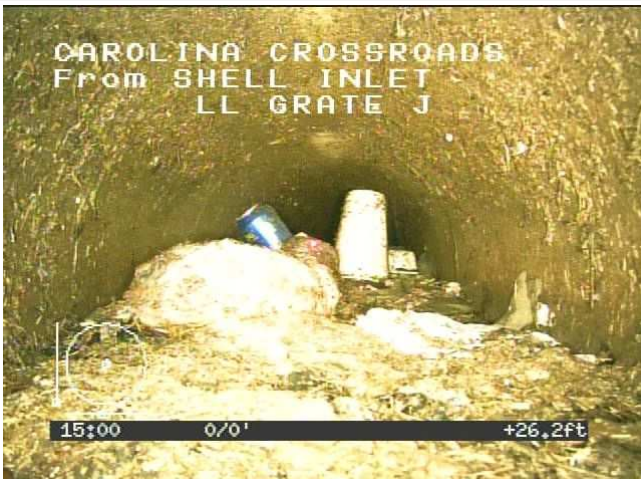
26.3	<p><b>Miscellaneous</b>  <b>Abandoned Survey</b>  <b>Severity: None</b>  <b>Remarks: DEBRIS IN PIPE</b></p>	06:49

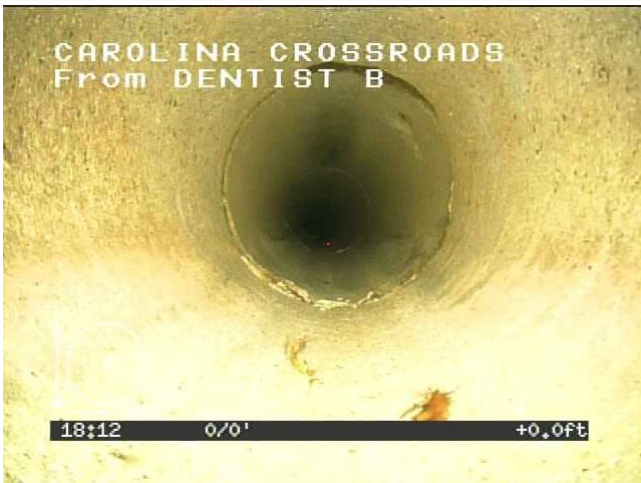
Distance	Fault Observation	Time	Picture
0.0	<p>EP-4240</p> <p>Access Point Catch Basin Severity: None Remarks: DENTIST B</p>	24

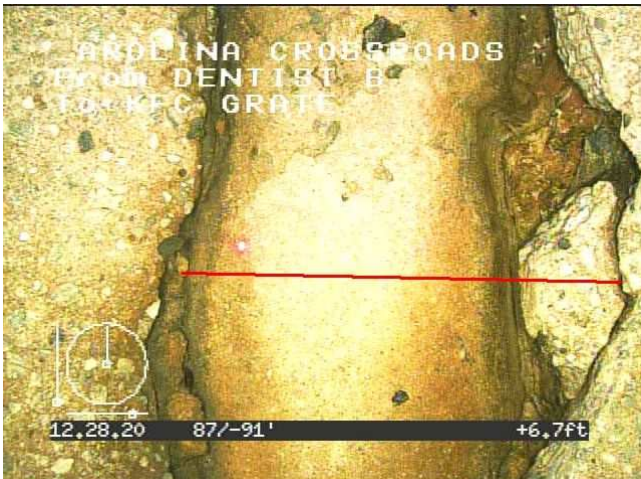
6.7	<p>Broken Position: 12 Severity: None Joint Remarks: BROKEN SPIGOT 6.208 Struct Weight: 4</p>	02:57

(6.7) B - Broken - Position: 12 Remark: BROKEN SPIGOT 6.208

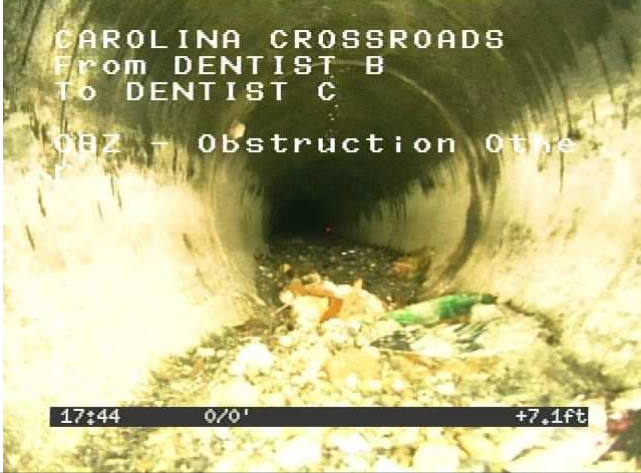
<p>CAROLINA CROSSROADS</p> <p>17:43 0/0' +0.0ft</p>
7.1	<p><b>Obstruction Other</b> Position: 5 To 7 Severity: None Cont Defect: S01 Percent: 15 Remarks: GRAVEL DIRT ETC IN PIPE Maint Weight: 3</p>	01:57

<p>CAROLINA CROSSROADS From DENTIST B To DENTIST C</p> <p>082 - Obstruction Other</p> <p>17:44 0/0' +7.1ft</p>

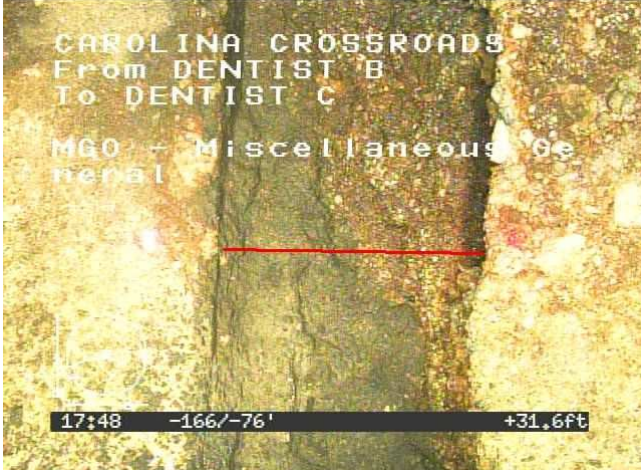
Distance	Fault Observation	Time	Picture
31.6	<p style="text-align: center;"><b>EP-4242</b></p> <p><b>Miscellaneous General Observation</b>  Severity: None  Remarks: GAP  <b>OBSERVATION 1.729</b></p>	06:12

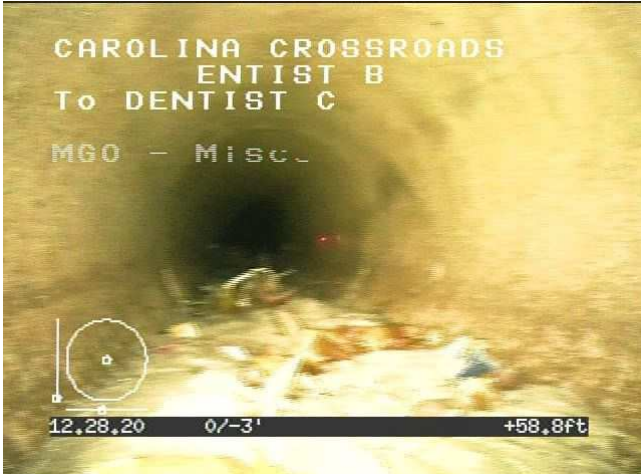
58.9	<p><b>Miscellaneous General Observation</b>  Severity: None  Remarks: HIDDEN  <b>JUNCTION</b></p>	10:41

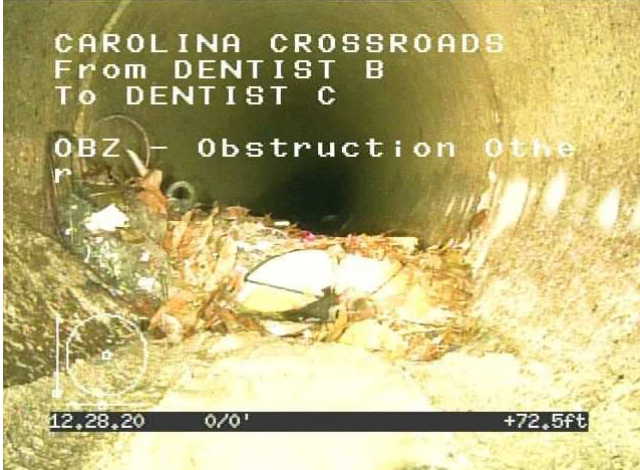
Distance	Fault Observation	Time	Picture
72.5	<p data-bbox="339 98 523 147"><b>EP-4242</b></p> <p data-bbox="308 181 584 495"><b>Obstruction Other</b>  <b>Position: 5 To 7</b>  <b>Severity: None</b>  <b>Cont Defect: F01</b>  <b>Percent: 15</b>  <b>Remarks: GRAVEL DIRT</b>  <b>ETC IN PIPE</b>  <b>Maint Weight: 3</b></p>	15:45

<p data-bbox="906 129 1366 208">CAROLINA CROSSROADS From DENTIST B To DENTIST C</p> <p data-bbox="906 232 1433 286">OBZ - Obstruction Other</p> <p data-bbox="906 510 1449 533">12:28:20 0/0' +72.5ft</p>

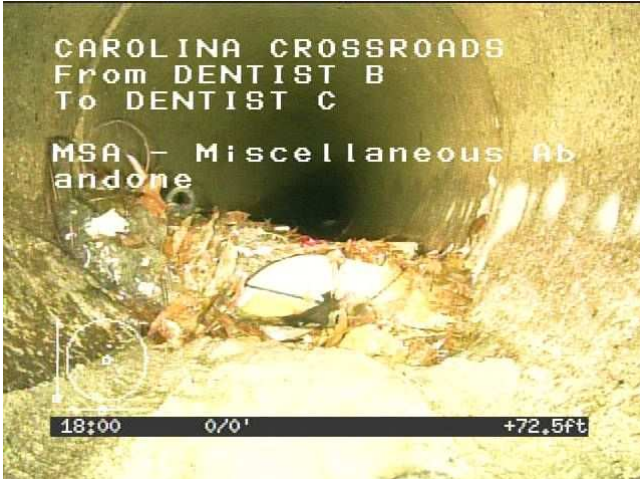
72.5	<p data-bbox="276 725 616 920"><b>Miscellaneous</b>  <b>Abandoned Survey</b>  <b>Severity: None</b>  <b>Remarks: OBSTACLE</b>  <b>CAN TRAP CAMERA</b></p>	17:27

<p data-bbox="906 611 1366 689">CAROLINA CROSSROADS From DENTIST B To DENTIST C</p> <p data-bbox="906 714 1433 768">MSA - Miscellaneous Abandoned</p> <p data-bbox="906 992 1449 1014">18:00 0/0' +72.5ft</p>

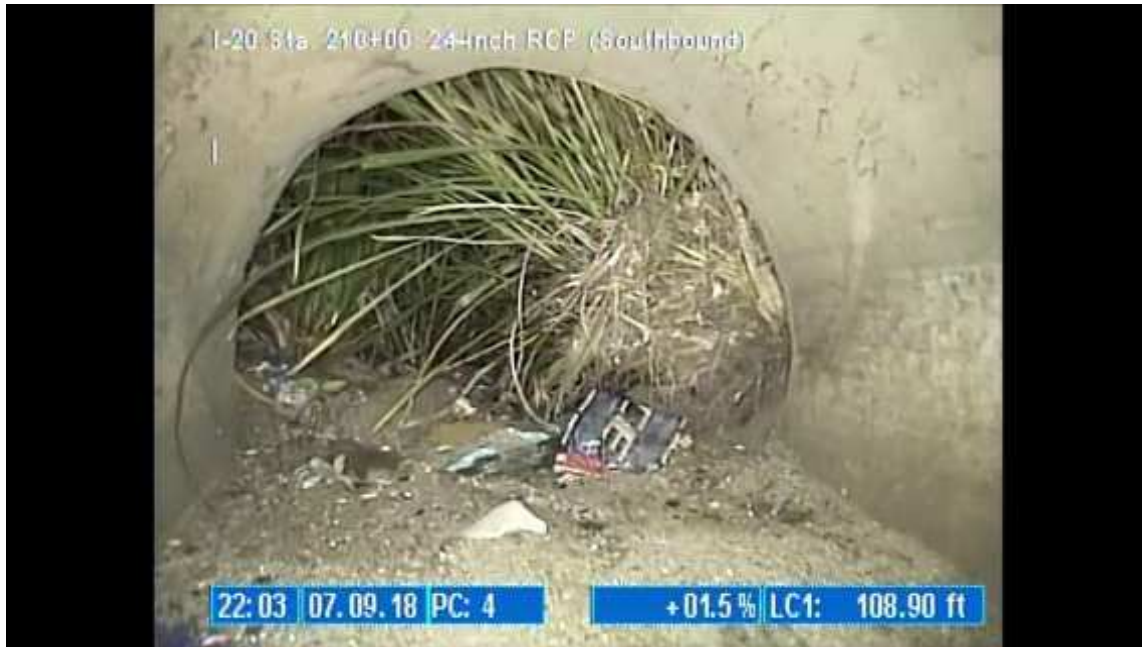
- Dimensions: Verified 24-inch RCP, Approximately 200 LF
- Observations
  1. South entrance is blocked by vegetation.
  2. Both directions need to be cleaned.
- Recommendations
  1. Clean both directions.

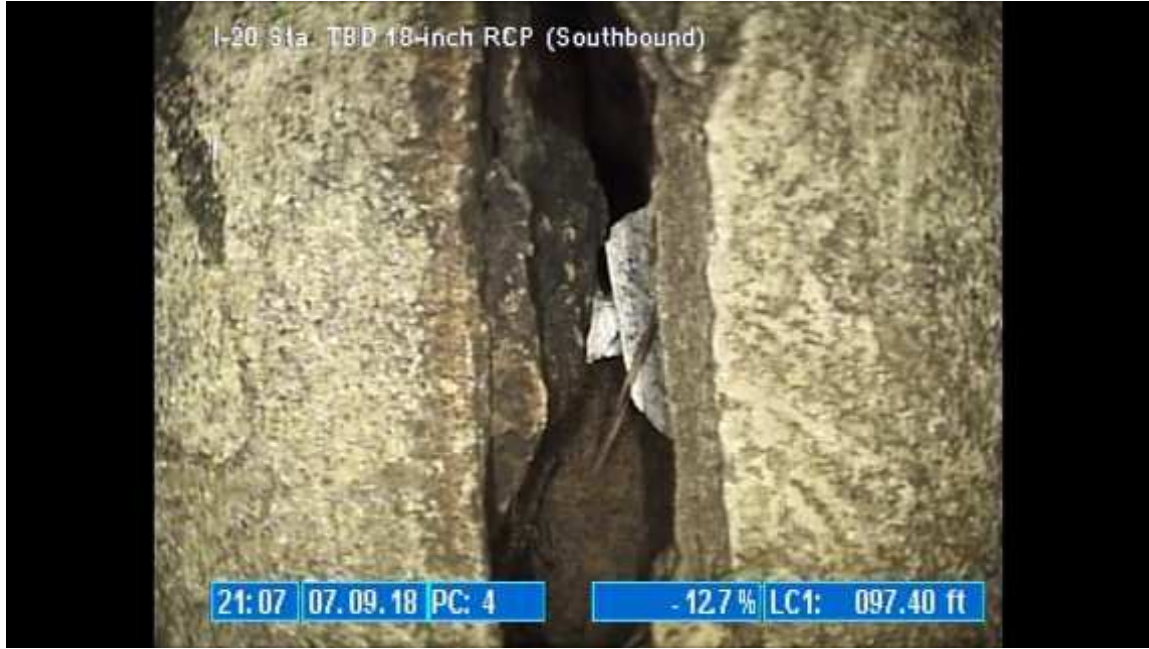
- Dimensions: Verified 18-inch RCP, Approximately 225 LF
- Observations
  1. Joint at approximately 98-feet (South of entry)-severe joint separation, soil is visible, unable to continue inspecting.
  2. Joint at approximately 82-feet and 86-feet (South of entry)-roots growing through the joint, not properly sealed.
  3. Joint at approximately 5-feet (South of entry)-moderate joint separation, appears to be groundwater entering/exiting at the bottom of the joint.
  4. Joint at approximately 9-feet (South of entry)-roots growing through the joint, not properly sealed.
- Recommendations
  1. Slipline or replace existing pipe.
  2. Determine if new backfill is needed under pipe where water is exiting through joint.

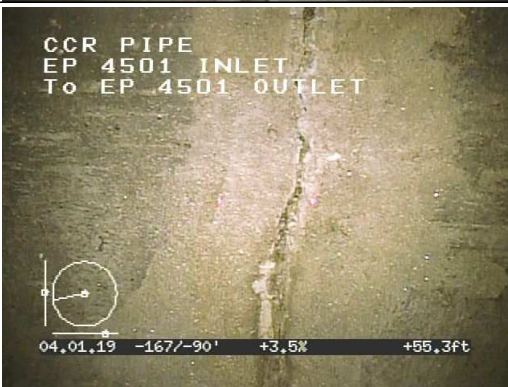
- 6) 43.3 feet – Longitudinal crack in pipe.
  - 7) 55.3 feet – 0.99" gap in joint; longitudinal crack in pipe; intrusion weeping; fine root intrusion in joint.

<p>CCR PIPE EP 4501 INLET To EP 4501 OUTLET</p> <p>04,01,19 93/-91' +3.5% +55.3ft</p>
55.3	<b>Infil Stain</b> <b>Position: 7 To 9</b> <b>Severity: None</b> <b>Joint</b>	20:40

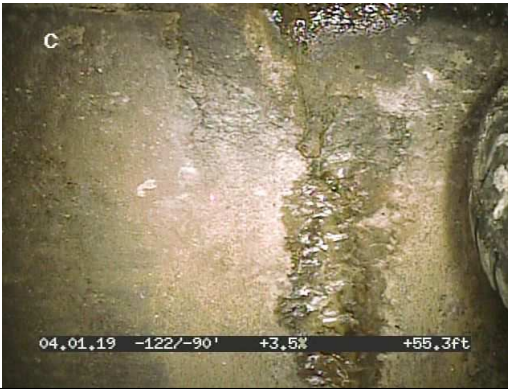
Distance	Fault Observation	Time	Picture
55.3	<b>Roots Fine Joint</b> <b>Position: 7</b> <b>Severity: None</b> <b>Joint</b> <b>Maint Weight: 1</b>	20:53

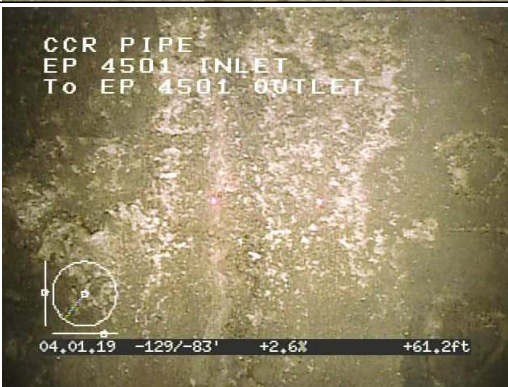
61.2	<b>Infil Stain</b> <b>Position: 7 To 9</b> <b>Severity: None</b> <b>Joint</b> <b>Remarks: STAIN NOT WEEPER</b>	23:36

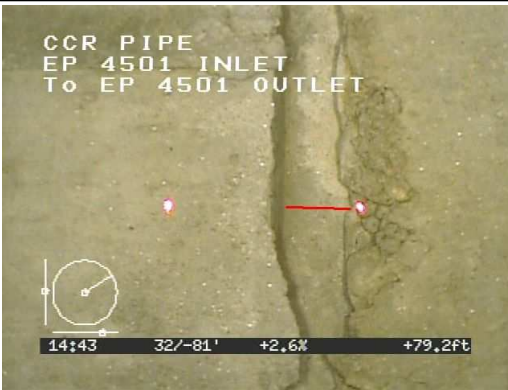
<p>CCR PIPE EP 4501 INLET To EP 4501 OUTLET</p> <p>14:42 -11/-81' +2.6% +79.2ft</p>
79.2	<p style="text-align: center;"><b>General Observation</b>  <b>Severity: None</b>  <b>Remarks: 0.82</b></p>	32:38

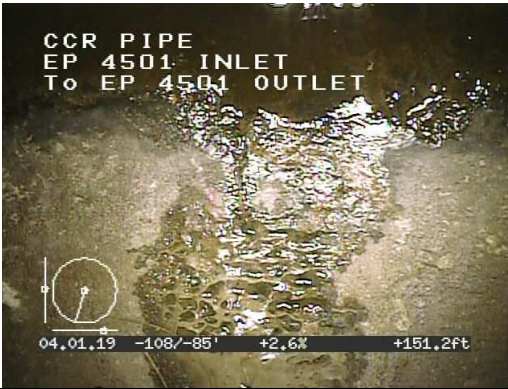
Distance	Fault Observation	Time	Picture
151.3	<b>Roots Fine Joint</b> <b>Position: 7</b> <b>Severity: None</b> <b>Joint</b> <b>Maint Weight: 1</b>	53:39

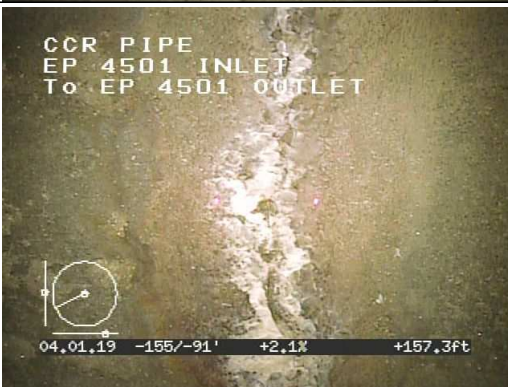
<p>CCR PIPE EP 4501 INLET To EP 4501 OUTLET</p> <p>04,01,19 81/-74' +2,1% +157,3ft</p>
157.3	<b>Infil Stain</b> <b>Position: 7 To 9</b> <b>Severity: None</b> <b>Joint</b>	56:01

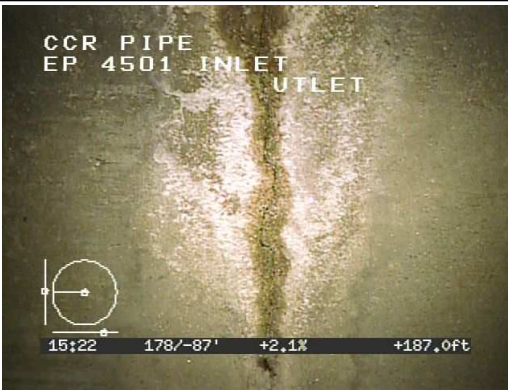
<p>CCR PIPE EP 4501 INLET UTLET</p> <p>04,01,19 -92/117' +1.8% +182.7ft</p>
187.1	<p><b>Roots Fine Joint</b>  <b>Position: 7 To 9</b>  <b>Severity: None</b>  <b>Joint</b>  <b>Maint Weight: 1</b></p>	1:09:30

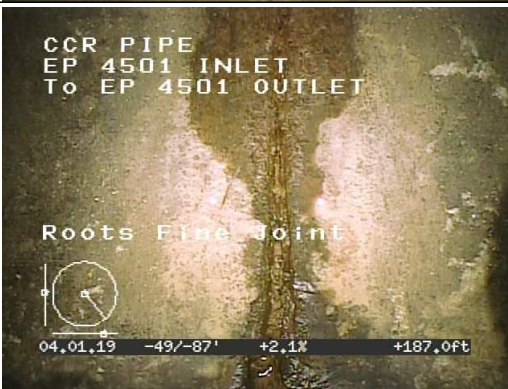
<p>CCR PIPE EP 4501 INLET UTLET</p> <p>15:22 178/-87' +2.1% +187.0ft</p>
187.1	<p><b>Roots Fine Joint</b>  <b>Position: 4 To 5</b>  <b>Severity: None</b>  <b>Joint</b>  <b>Maint Weight: 1</b></p>	1:09:54

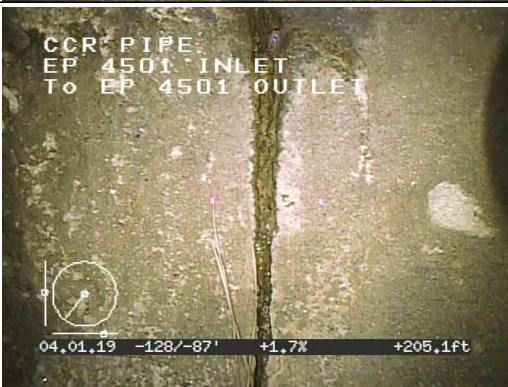
<p>CCR PIPE EP 4501 INLET To EP 4501 OUTLET</p> <p>15:27 -154/-80' +0.9% +198.8ft</p>
205.2	<p align="center"><b>Roots Fine Joint</b>  <b>Position: 7</b>  <b>Severity: None</b>  <b>Joint</b>  <b>Maint Weight: 1</b></p>	1:15:37

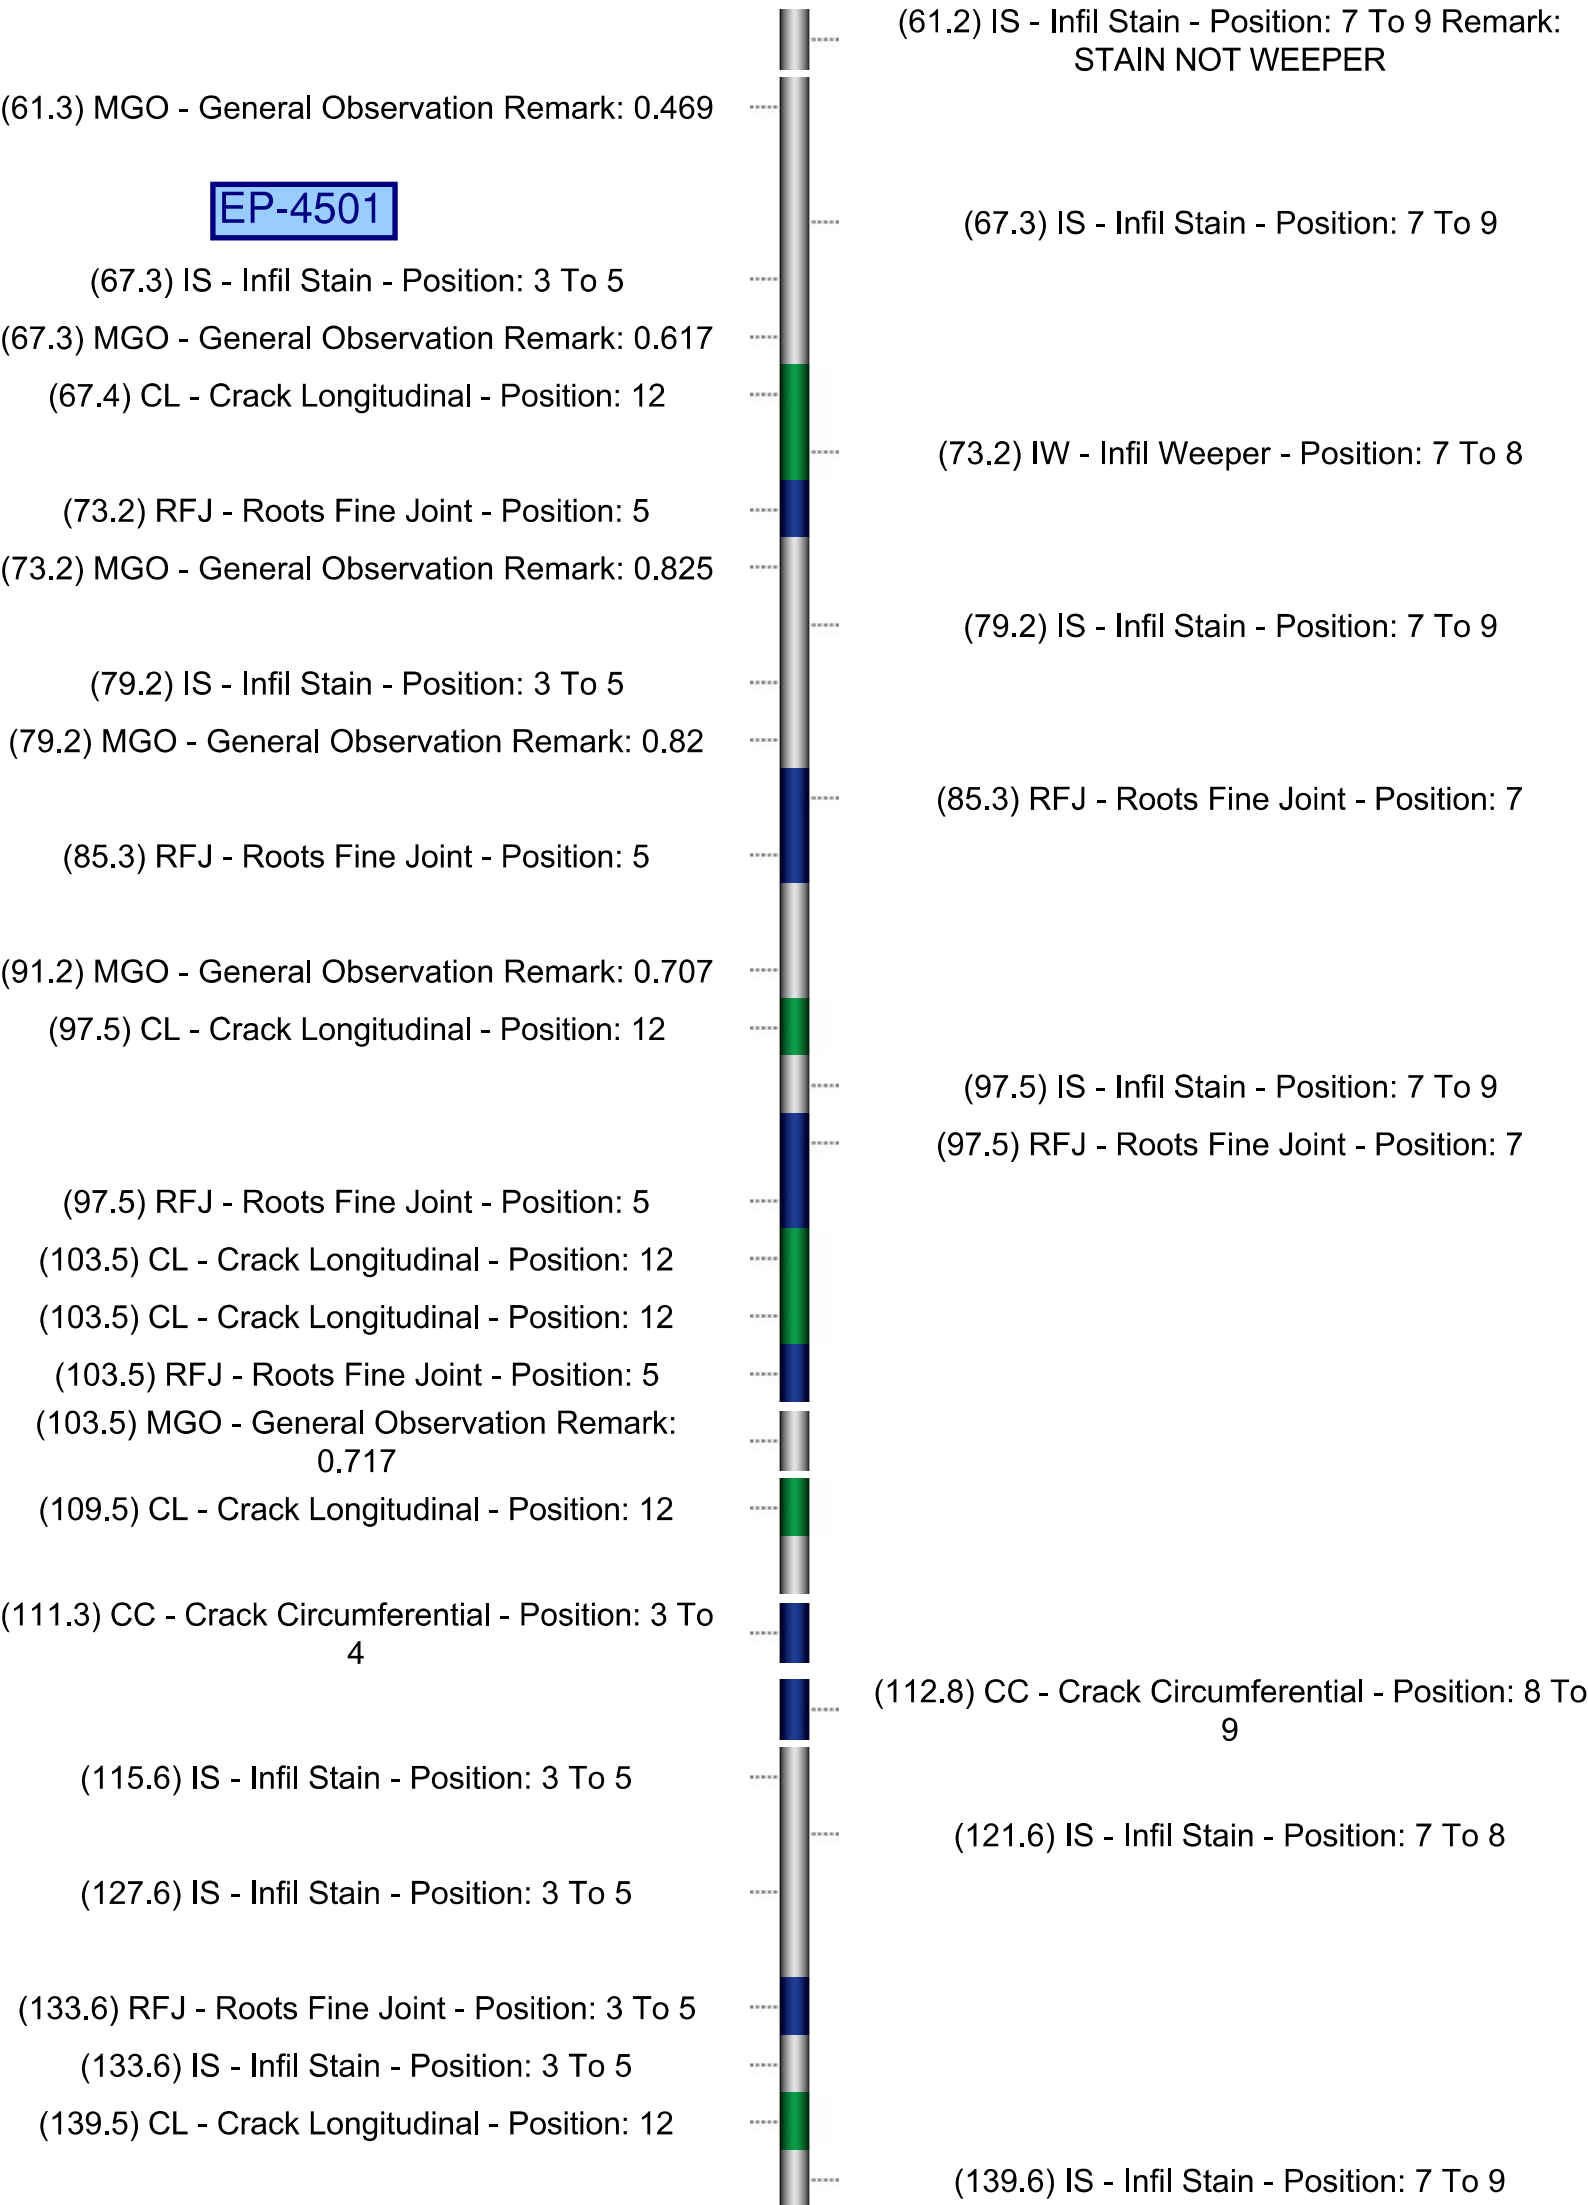
EP-4501

(145.2) CL - Crack Longitudinal - Position: 12  
Photo Num: 2 (145.2) CL - Crack Longitudinal - Position: 12

(145.3) IS - Infil Stain - Position: 1 To 5

(145.2) IS - Infil Stain - Position: 7 To 8
