LEAD-BASED PAINT INVESTIGATION REPORT

**S-40-234 BRIDGE OVER I-26
SCDOT #407023400100
RICHLAND COUNTY, SOUTH CAROLINA**

Re.: Lead-Based Paint Investigation Report
S-40-234 Bridge over I-26
SCDOT #407023400100
Richland County, South Carolina
F&ME Project No.: E5350.02

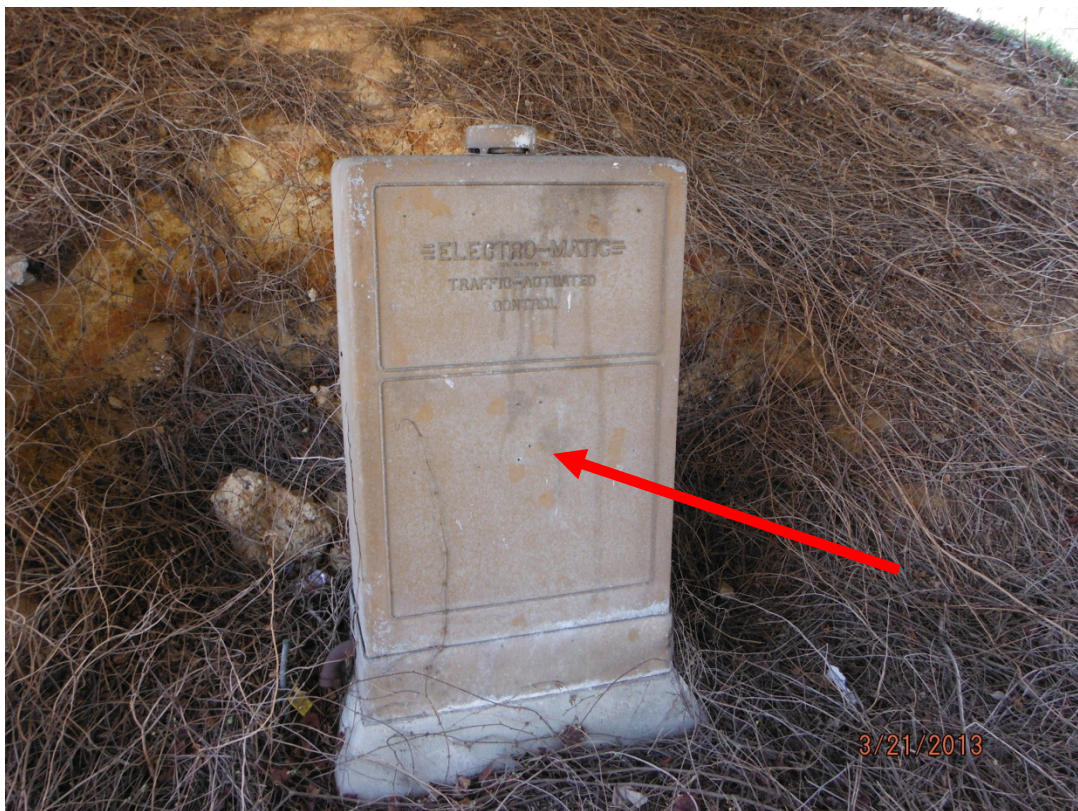
During the investigation, two (2) suspect paints/coatings were noted. The first is a suspect tan paint observed on the traffic control box that is positioned underneath the south end of the bridge. The second suspect paint is the black striping on the center drilled shafts. The XRF data indicated that the tan paint/ coating tested positive for lead content $\geq 0.7 \text{ mg/cm}^2$, while the black paint was negative for lead at this action level. See Appendix A for the XRF data (Table I) and photographs of the item that tested positive for lead content.

Tan Painted Traffic Control Box

Lead-based paint solid waste such as paint chips, blasting debris, dust, soil or sludge with a TCLP greater than 5mg/l are to be disposed of in compliance with applicable guidelines for hazardous waste disposal.
