MEMORANDUM | August 17, 2023

I-20 / I-26 / I-126 Corridor Improvement (Carolina Crossroads)
Asset IDs 7272, 7586, and 7937 - Laboratory Studies of Concrete Cores

WJE PROJECT NO. 2023.1990

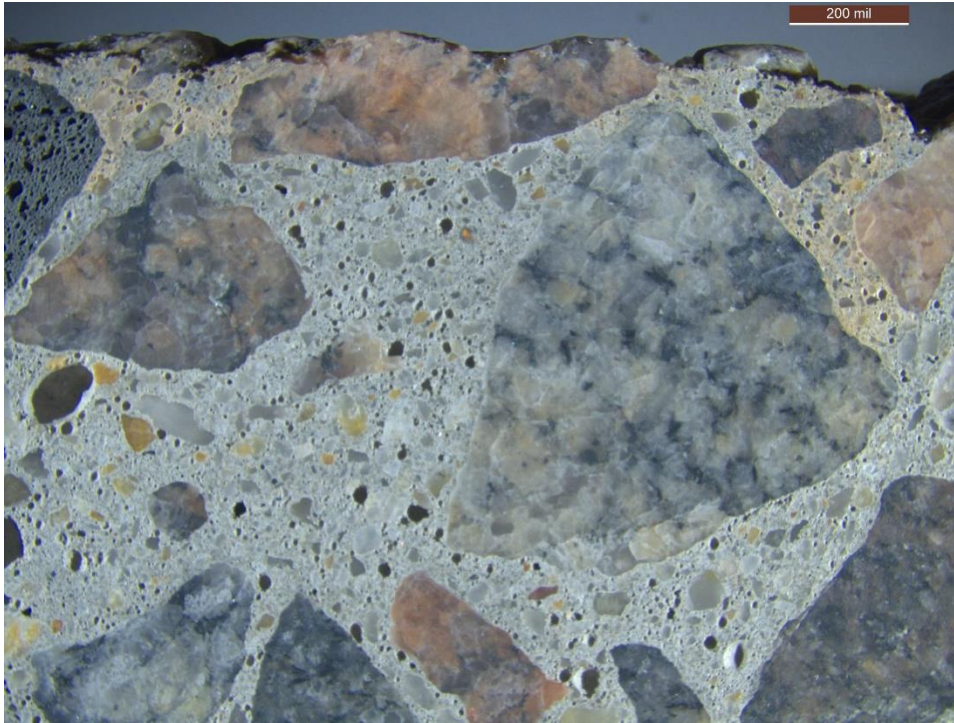
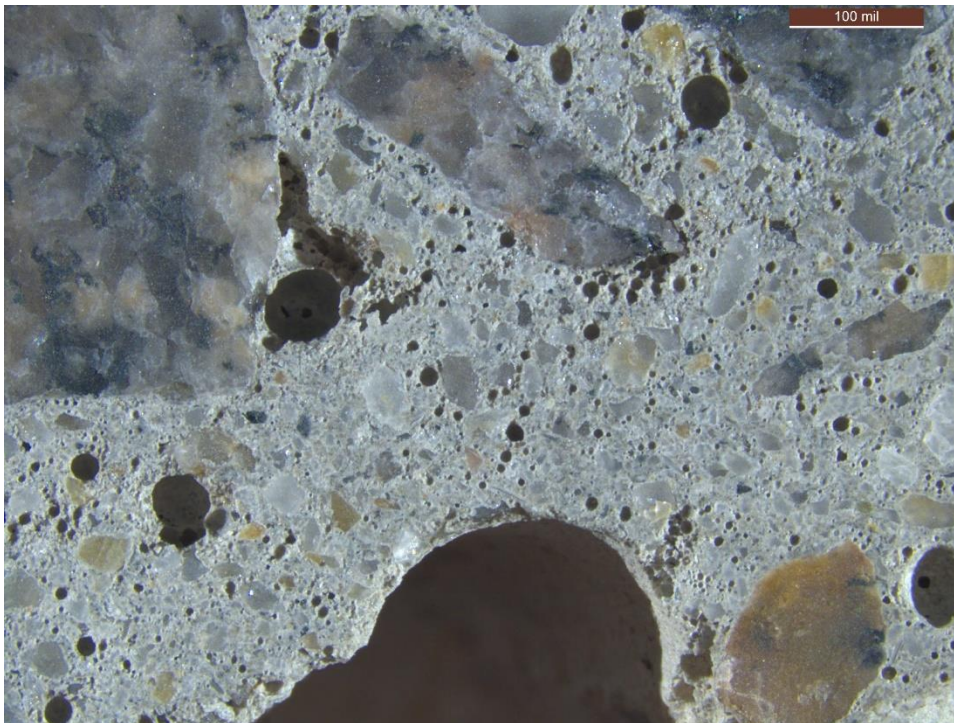
Figure 14. 7272-C2. Closeup views of the top region (top photo) and bottom region (bottom photo) of the core show paste, air voids, and aggregate of the concrete.

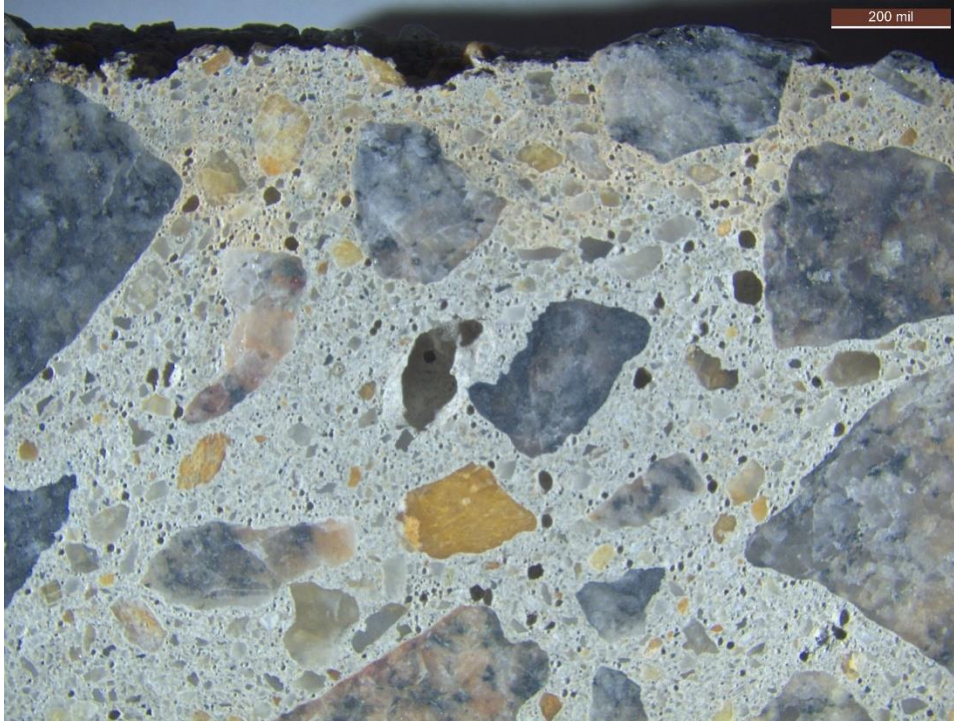
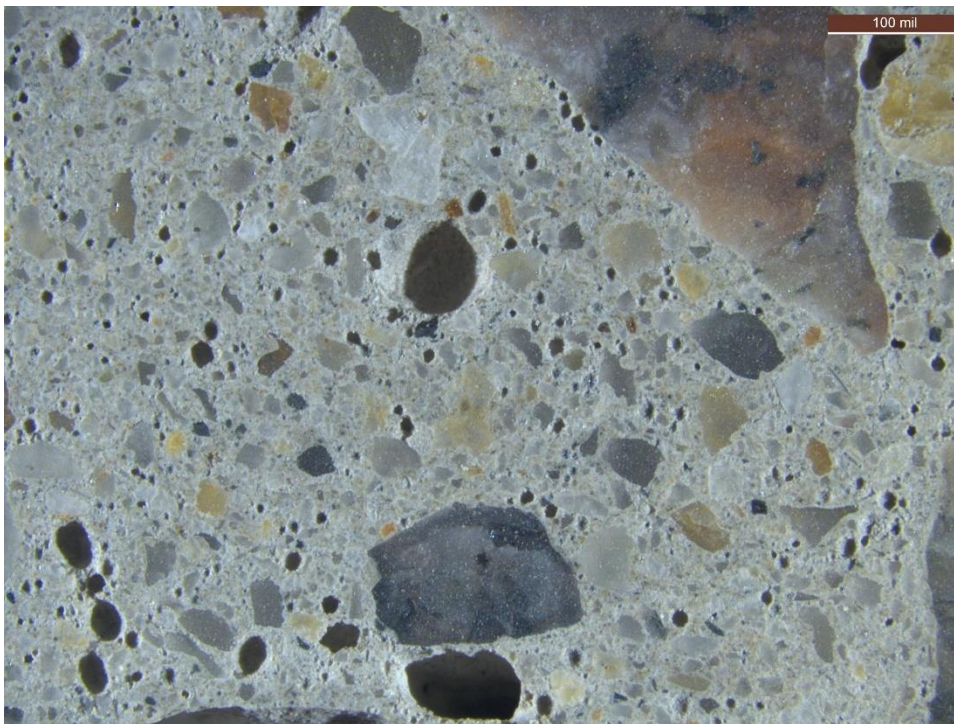
Figure 18. 7272-C13. Closeup views of the top region (top photo) and bottom region (bottom photo) of the core show paste, air voids, and aggregate of the concrete.

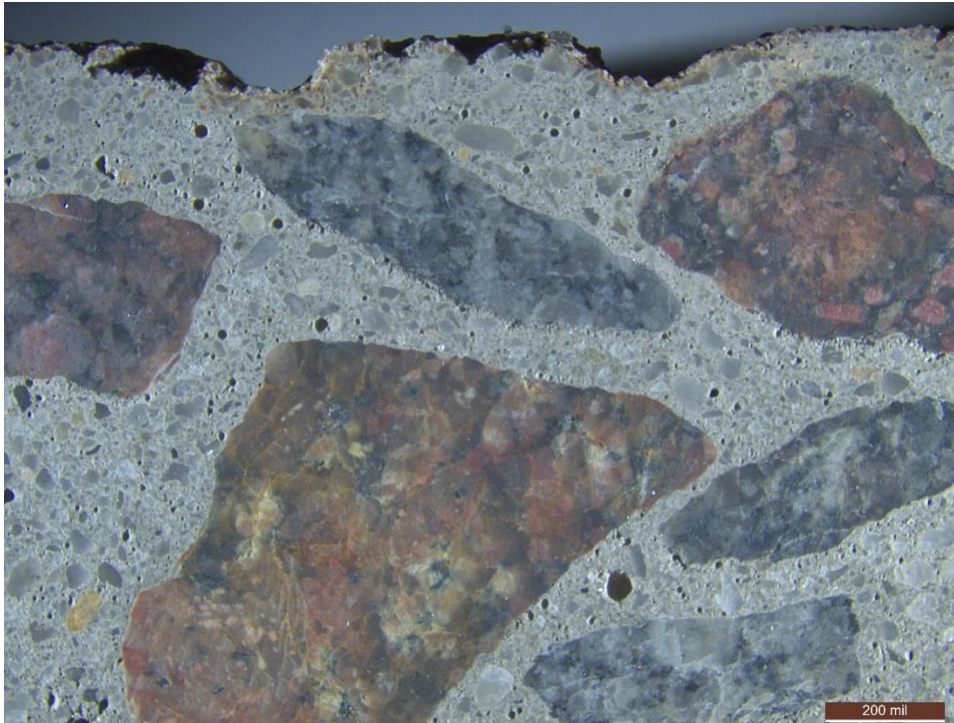
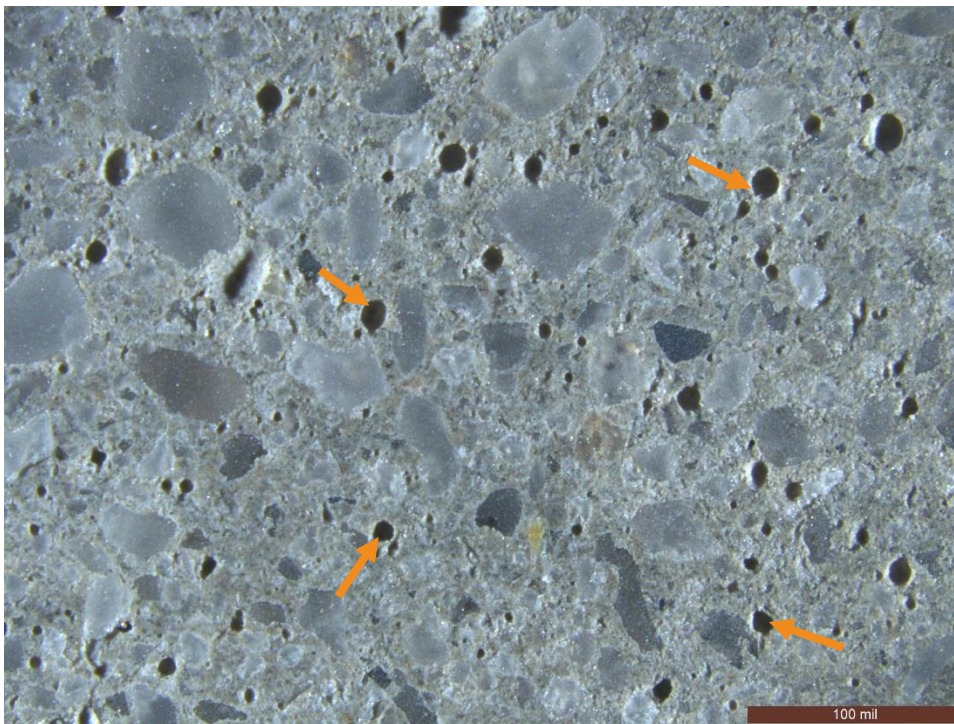
Figure 30. 7937-C16. Closeup views of the top region (top photo) and a region roughly 2.5 inch deep (bottom photo) of the core show paste, air voids, and aggregate of the concrete. Orange arrows indicate air voids.
