Submitted By: Maddy Barb	ian, PE		Date: 6/5/24
To: Michael Pitts, PE, As	ssoc. DBIA		
Program/Project Ma			
BASIS OF DESIGN EXCEPTION			
Request for Approval of Design	n Exceptions to AASHT	O Guidelines	
✓ Request for Approval of Design			es

•		
PROJECT CHARACTERISTICS			
County: Horry RD/Ro	ute: S-26-154		Const. Pin: P041158
From: Milepoint 0.64		To: Milepoint 0	0.69
Length: 275 feet		MPO/COG: GS	ATS
Work Type: Bridge Rehabili	tation including		
Functional Classification: Urban	Major Collecto	or	
	/3		
IS THIS A "PROJECT OF DIVISIONAL IN ☐ Yes ☐ No	TEREST", SUBJECT TO	FHWA/SCDOT STEWAR	RDSHIP AND OVERSIGHT PLAN?
CRASH ANALYSIS  (Attach additional sheets with accide  TOTAL PROJECT ESTIMATE (\$)	•		
		<b></b>	_
CHECK APPROPRIATE BOX(ES) FOR			T
☐ Design Speed ☐ Minimum Radii	Maximum Grade		▼ Travel Lane Width ✓ Shoulder Width
Stopping Sight Distance	<ul><li>☐ Vertical Clearance</li><li>☐ Bridge Width</li></ul>	.⊏	☐ Horizontal Clearance
☐ Vertical	Structural Capac	itv	☐ Cross Slope
☐ Horizontal	Superelevation F		☐ Travel Lanes
	<del>_</del> ·		☐ Shoulders

## ATTACHMENT A

### **DESCRIBE ELEMENTS FOR DESIGN EXCEPTION**

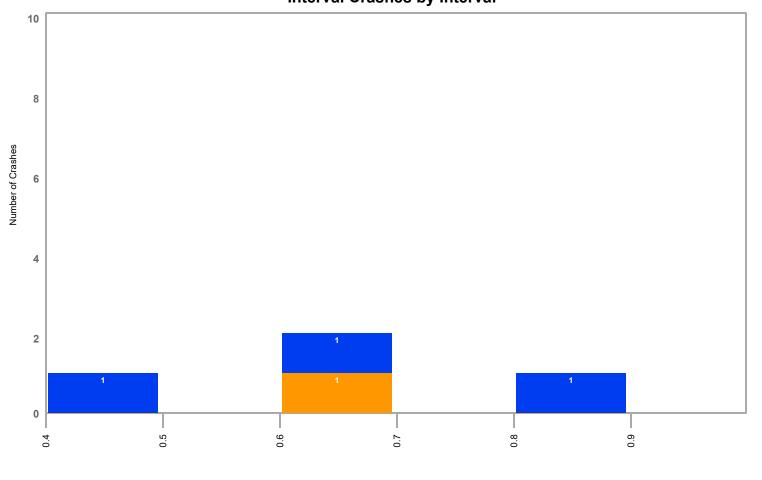
## **Interval Crashes by Interval**

Query Crash List HORRY S- 154 (CYPRESS AVE) MP 0.4 to 0.9 (Length = 0.5 miles)

AADT: 1750 Functional Class: Urban - Major Collector 01/01/2019 through 09/30/2022
