## APPENDIX T

Timber Bridge Inspection Guidance (TBIG)

Version 1.0, 2024

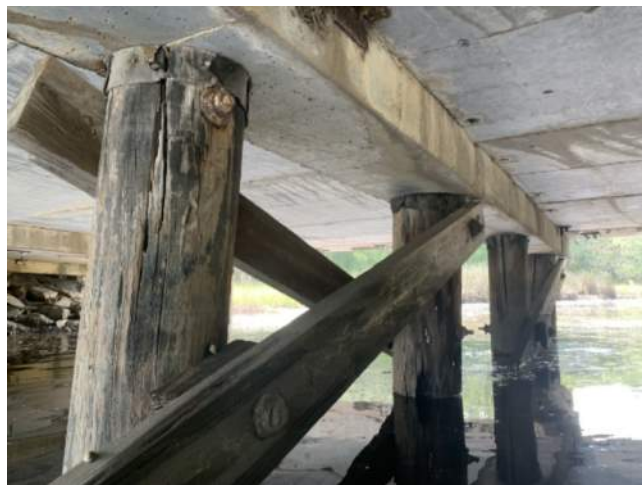
**Figure 1.0 Example of a Timber Pile Bridge (Timber Piles under Reinforced Concrete Cap)**

While the guidance in this appendix can be used for timber pile caps, decks, and superstructures, this specific guidance is focused mostly on timber pile bridges. A timber pile bridge is a bridge which contains at least one bent composed of exposed timber piles that are primary load carrying members. It may or may not have a timber bent cap. Bridge with timber piles concealed or buried at end bents or under footings are generally not considered a timber pile bridge unless determined to be one by a BITL. Other circumstances may require a structure to be considered a timber pile bridge and, thus, would subject that bridge to the requirements of this appendix as determined by a BITL.

Most timber substructures consist of southern yellow pine that has been treated with creosote. Pile end bents may have timber backwalls and wingwalls that retain the embankment material.

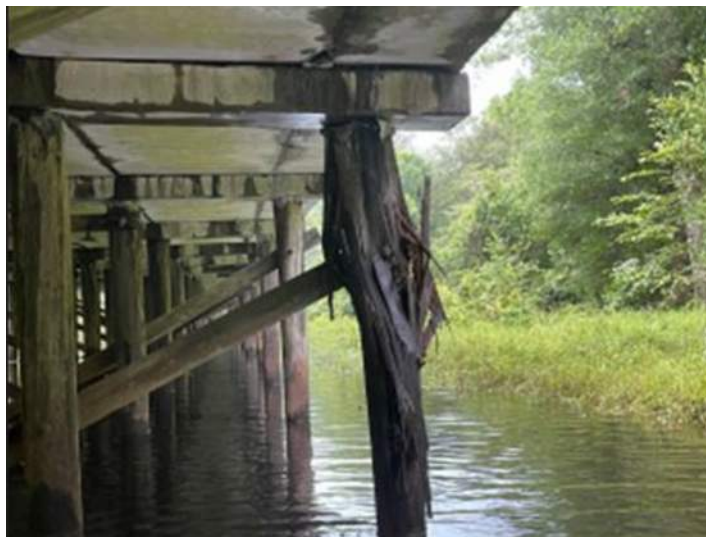
**Figure 3.1 Failed timber pile due to internal decay of the pile at a cross-frame through bolt.**

It is important to assess the presence of decay using hammers and resistance microdrills to determine the actual cross-section and location of both sound and deteriorated material. Decay or deterioration in timber substructures can potentially control the load rating of the bridge (see LRGD). Because of the variability of timber substructures, such as cap dimensions, pile diameter, and pile spacing, decay or deterioration can have a large impact on the capacity of the bridge depending on whether it occurs in an exterior or interior pile, the pile cap, or any combination therein. Special attention should be focused on any steel connections (such as cross bracing connections) and looking for evidence of decay in timber adjacent to the connections. Decay is further discussed in the remaining chapters of this appendix. Other possible defects that may impact timber bridge members are included below.

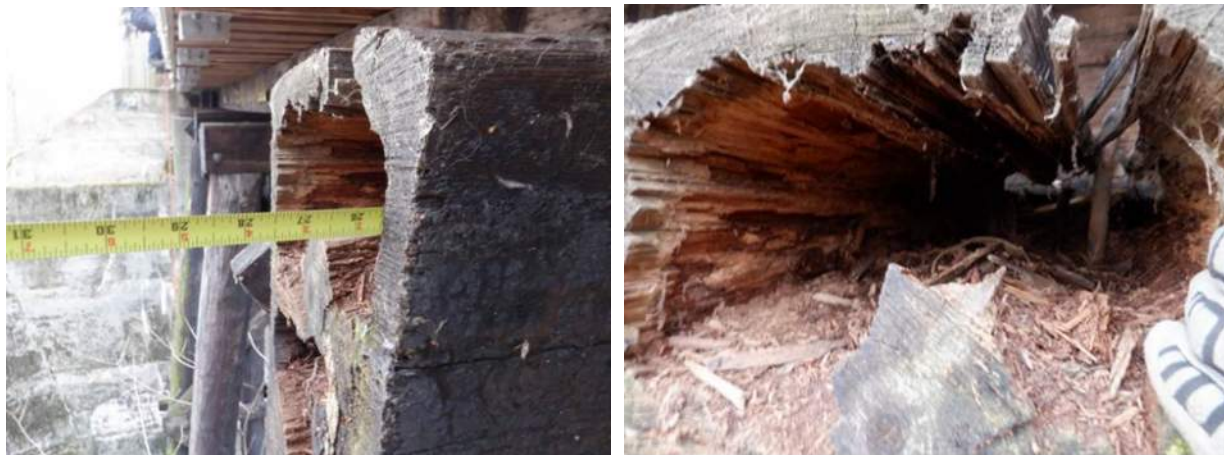
**Figure 3.3 Localized collapse of a timber bent cap.**

Sunken faces or localized surface depressions can indicate underlying decay. Decay voids or pockets may develop close to the surface of the member, leaving a relatively thin, depressed layer of intact or partially intact wood at the surface. Crushed wood can also be an indicator of decay.

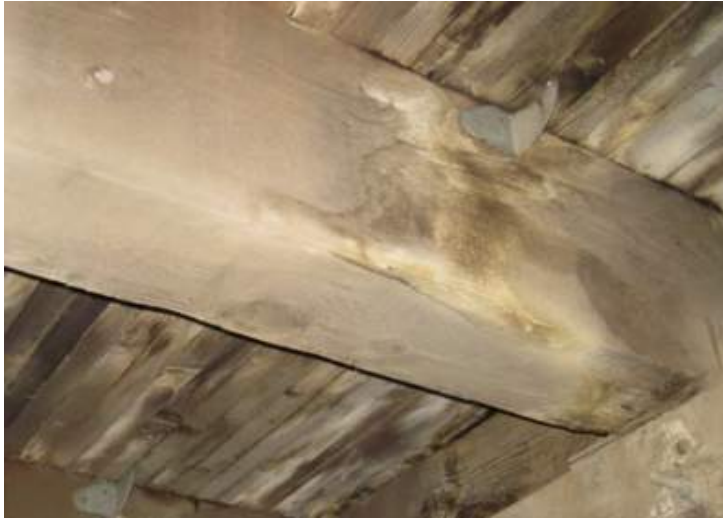
**Figure 3.4 Water staining and discoloration caused by water that infiltrated through the wearing surface.**

Staining or discoloration of wood indicates that the wood has been subjected to water and potentially has high moisture content, making it susceptible to decay. Rust stains from connection hardware are also an indication of areas of moisture exposure.

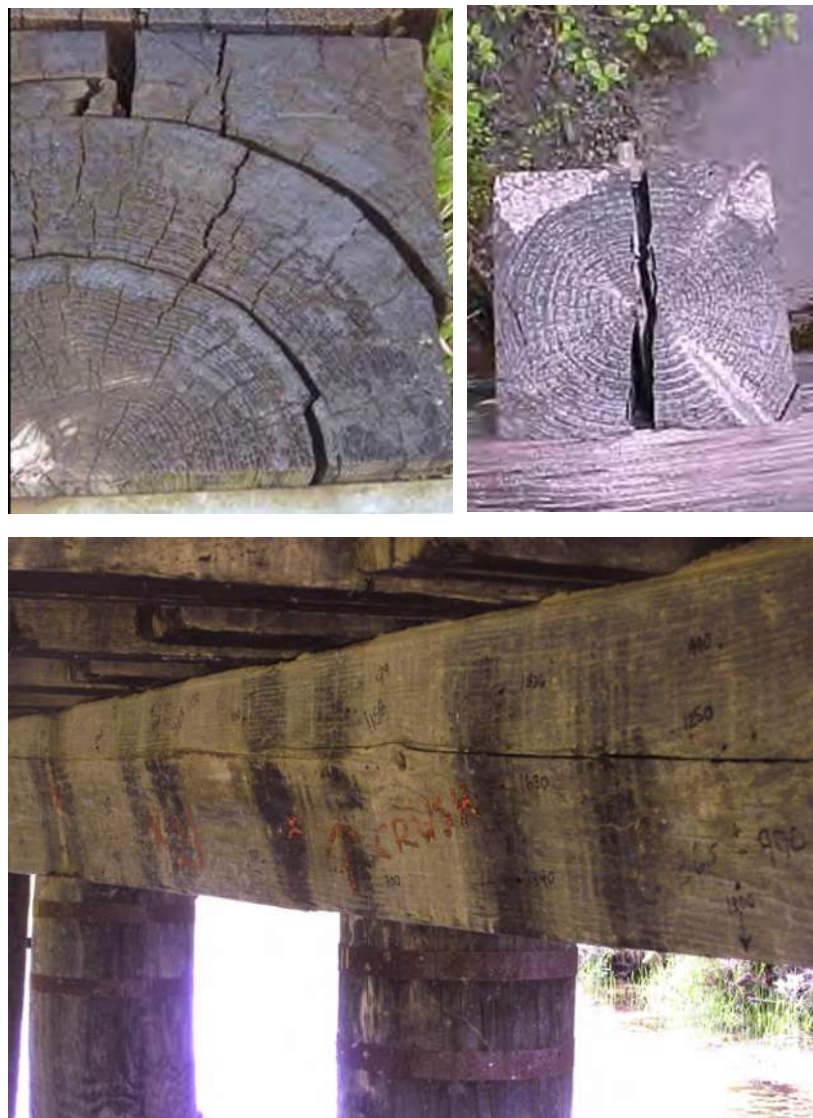
**Figure 3.7 Timber members showing various types of deterioration. Top left shows ring shake. Top right shows severe through splits. Bottom picture is of a long horizontal split provides an opportunity for moisture passing through the timber deck to enter the cap, leading to substantial decay.**

Timber members are susceptible to drying and weathering, which often result in surface and deep surface checks, ring shake, end checks, and through splits. Checks and splits in members can indicate a weakened member and create an entry for moisture to enter the element. If a check or split develops to a sufficient depth, the inner untreated wood is susceptible to moisture and decay fungi. This will create conditions that can result in severe decay and premature deterioration of a timber bridge element. Severe splits in timber end bent caps often lead to severe decay and should be thoroughly evaluated.

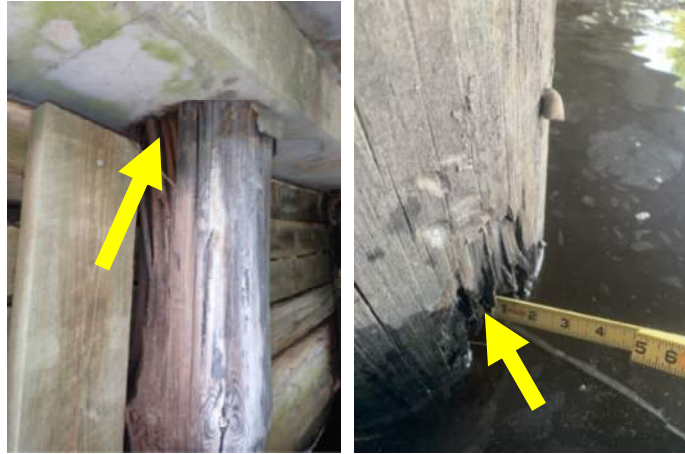
**Figure 3.8 Shell damage to timber piling at or near the water line or at the pile cap, often caused by construction damage (left photo) or debris floating down the waterway at the waterline (right photo).**

Other natural weathering damage occurs to timber piles exposed to water and materials flowing down the river or stream. This can affect the structural performance both through loss of cross-section and the removal of the preservative treatment.

Additional damage to timber bridge components can be caused by impact from vehicle or boat traffic. Flotsam such as trees and logs can also damage timber substructures during high flow rates associated with heavy rain events or seasons.

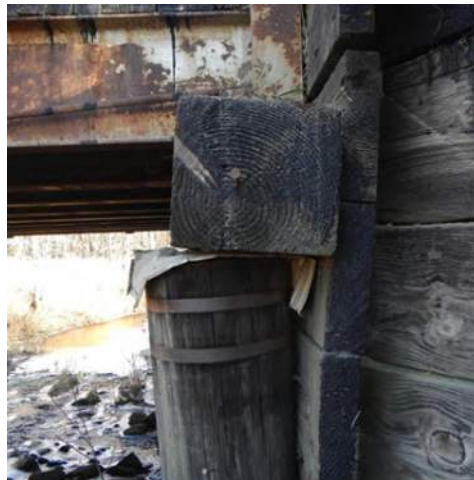
**Figure 3.9 Severe misalignment of the timber pile and timber pile cap.**

During inspections of timber bridge elements, there are other conditions that need to be further explored using the full combination of inspection and assessment techniques. These conditions can include the rotation or misalignment of timber bents and end bents caused by the loss of fill behind the end bent backwall or by some other mechanism. A second significant condition is the build-up of road materials like gravel or sand that hold moisture in contact with structural timber elements.

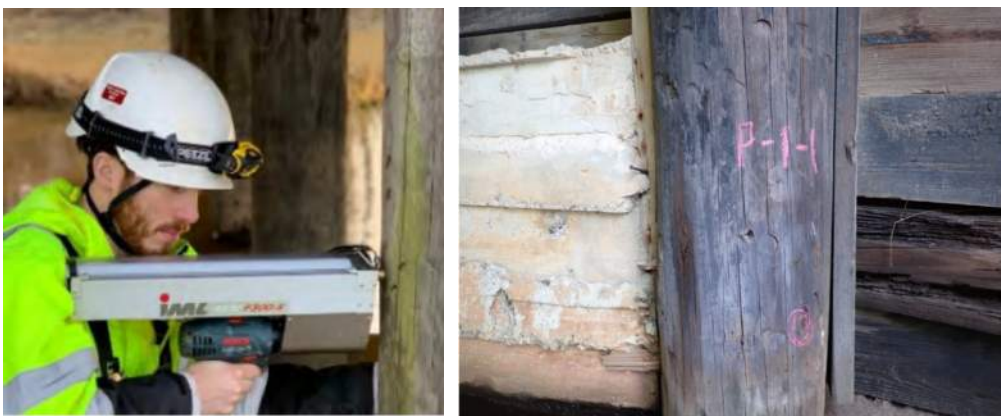
**Figure 7.1 In field use of a resistance drill (left photo) and the field marking of a timber pile that has been drilled (right photo).**

The resistance drill equipment measures the resistance of wood members to a drill bit that passes through them. This drill bit travels through the member at a defined movement rate and generates information that allows an inspector to determine the exact location and extent of the damaged area. While the unit is usually drilled into a member in a perpendicular direction to the surface, it is also possible to drill into members at an angle.

Resistance drills collect the data electronically or produce a chart or printout showing the relative resistance over its drilling path. Modern tools are also promoting the ability to view the data on a tablet, computer, or phone. Areas of sound wood have varying levels of resistance depending on the density of the species and voids show no resistance. The inspector can determine areas of low, mild, and high levels of decay with this tool, and quantify the level of decay in the cross-section. All holes shall be filled after drilling by injecting a small amount of silicone sealant or marine adhesive into the drill hole. The location of drilling shall be field marked and photographed.

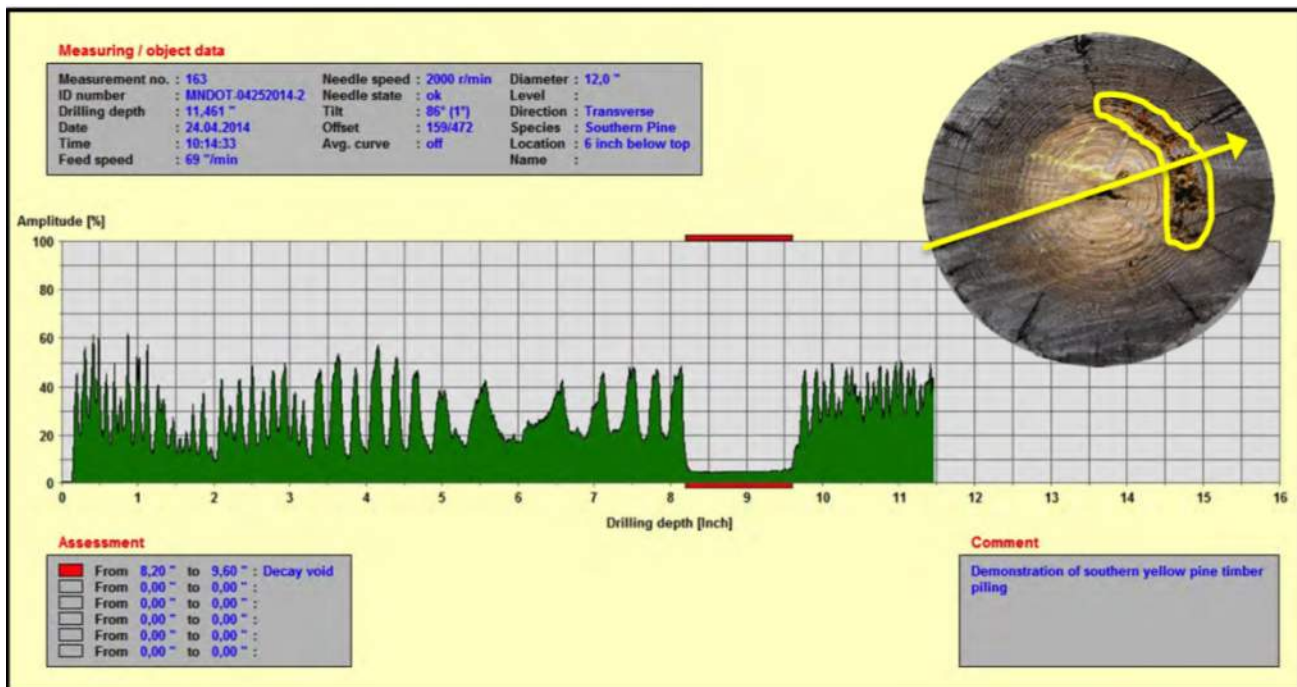
$$\text{Percent Decay} = \frac{\text{Length of Measured Decay}}{\text{Diameter of Decayed Pile}} \times 100\% = \frac{2 \text{ inches}}{12 \text{ inches}} \times 100\% = 17\%$$

Figure 8.2.1 Electronic view of a southern yellow pine timber piling showing a decay pocket between 8 and 10 inches of the drilling profile.

$$\text{Percent Decay} = \frac{\text{Length of Measured Decay}}{\text{Diameter of Decayed Pile}} \times 100\%$$

Bridge inspectors are to consider both moderate and severe decay (per Table 7.3) as decay when determining the percent decay. Load rating engineers may consider moderate (or partial) decay by engineering judgement to more accurately determine the remaining pile capacity when performing a load rating on a timber member.
