I-26 & I-95 INTERCHANGE IMPROVEMENTS

June 29, 2023

PIPE INSPECTION REPORT

This report contains the results of the video pipe inspection and assessment of the existing storm water drainage pipes within the project area in Orangeburg and Dorchester Counties.

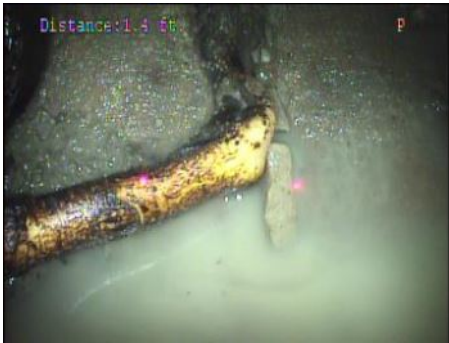
Distance	Dir.	Length	From/To	Code	Modifier/Severity	Rating	Comments
1.4 ft.	U		/	Root-in-Joint

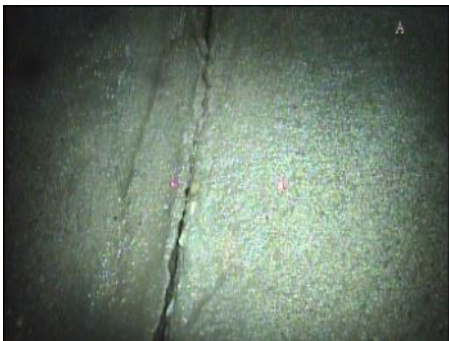
12.9 ft.	U		/	Joint Offset			
----------	---	--	---	--------------	--	--	--

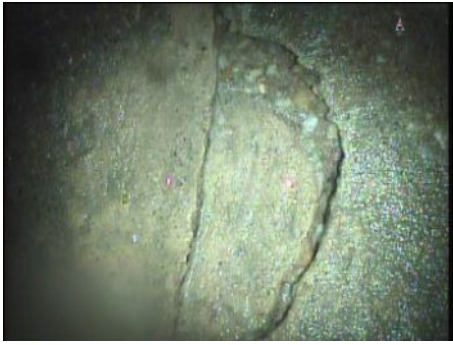
12.9 ft.	U		5 /	Broken			
----------	---	--	-----	--------	--	--	--

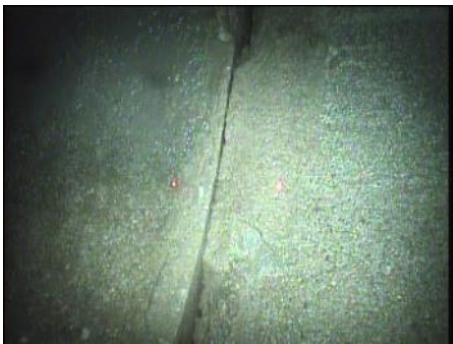
18.6 ft.	U		/	Joint Offset			
----------	---	--	---	--------------	--	--	--

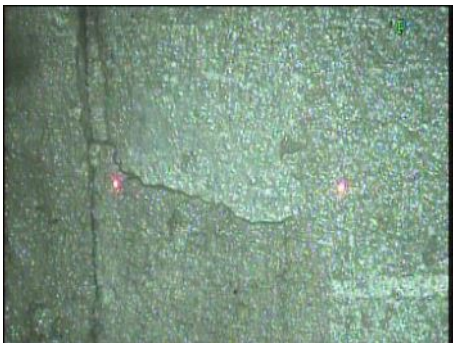
18.6 ft.	U		9 /	Crack			
----------	---	--	-----	-------	--	--	--

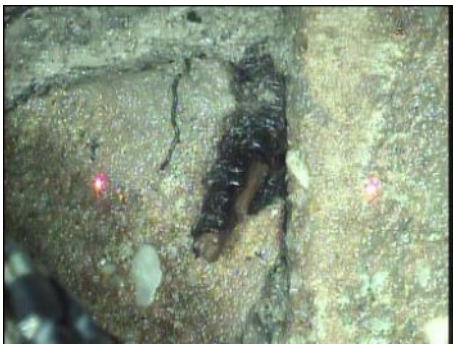
61.6 ft. U / Root-in-Joint

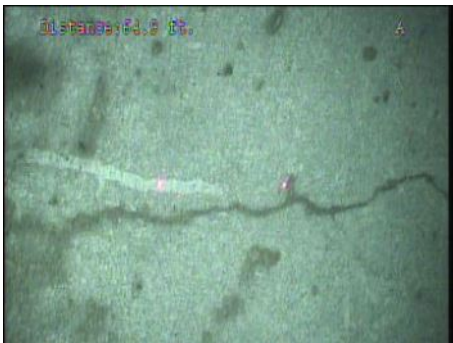
64.9 ft. U 12 / Crack

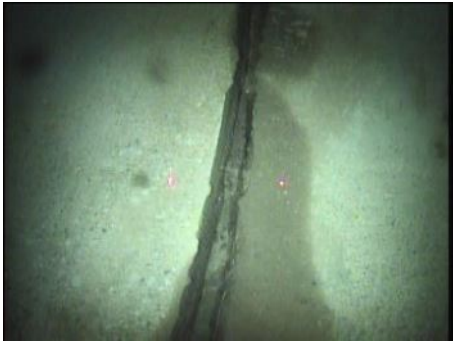
73.6 ft.	U		/	Joint Offset			
----------	---	--	---	--------------	--	--	--

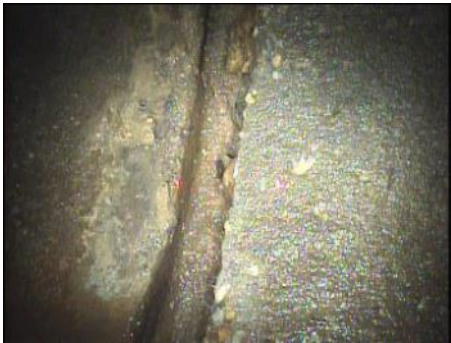
Distance	Dir.	Length	From/To	Code	Modifier/Severity	Rating	Comments
2.7 ft.	D		/	Joint Offset

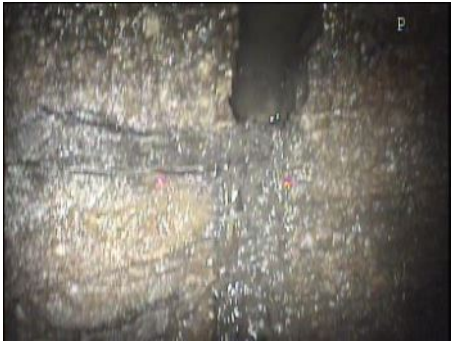
81.8 ft. D 6 / Root-in-Joint

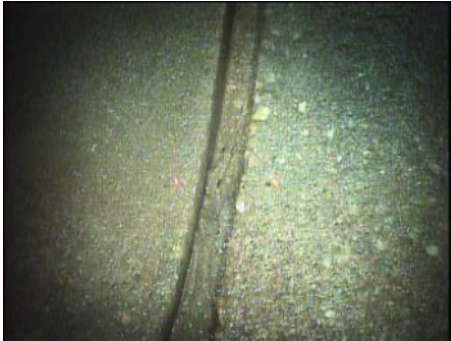
Distance	Dir.	Length	From/To	Code	Modifier/Severity	Rating	Comments
5.0 ft.	U		/	Joint Offset

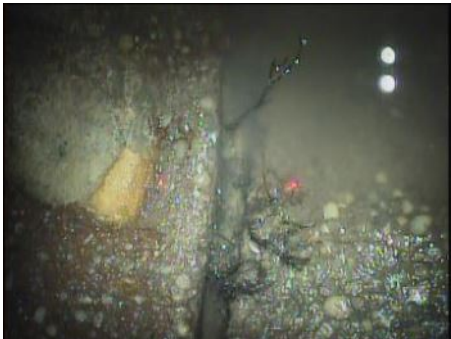
5.1 ft.	U		6 /	Root-in-Joint			
---------	---	--	-----	---------------	--	--	--

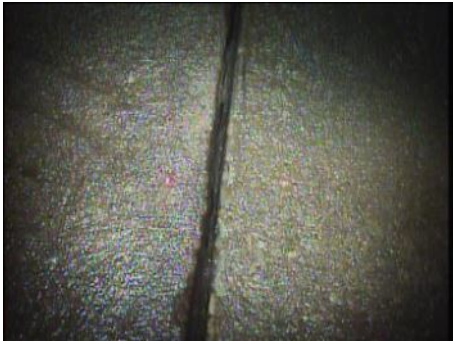
11.1 ft. U / Joint Offset

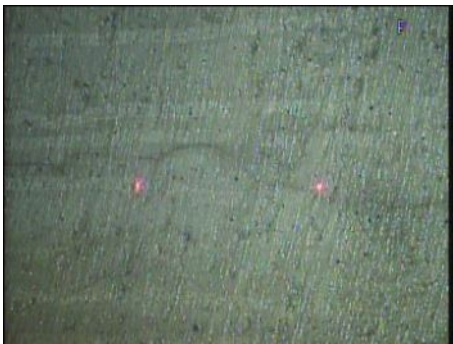
42.4 ft. U 19.3 ft. 12 / Crack

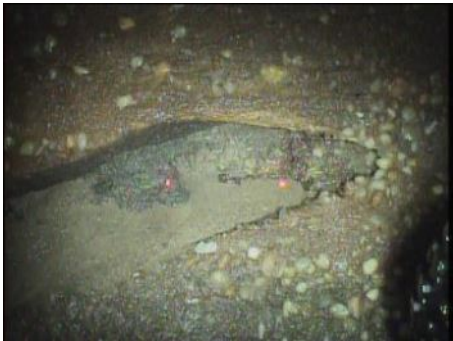
69.2 ft. U 5 / Chip

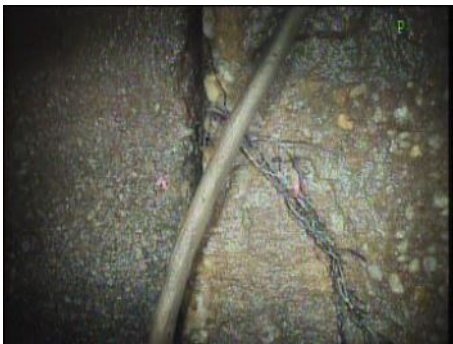
78.3 ft. U / Root-in-Joint

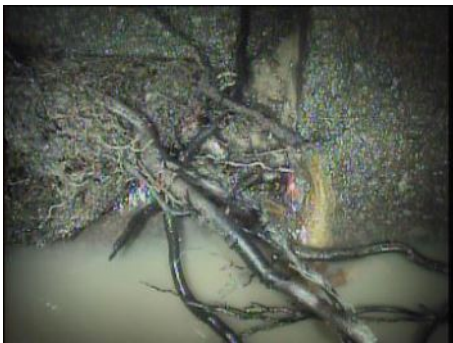
82.6 ft. U 7 / Root-in-Joint

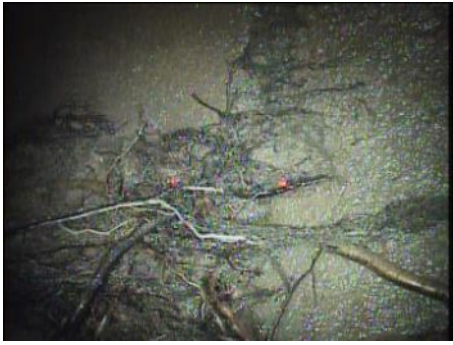
86.4 ft. U 5 / Root-in-Joint

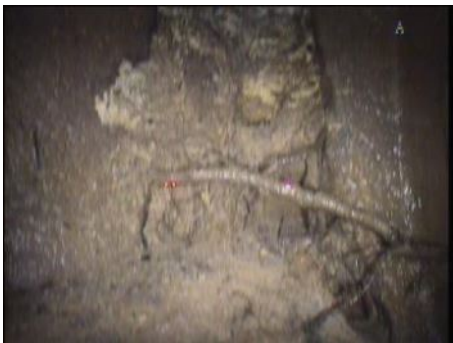
94.9 ft. U / Joint - Separated

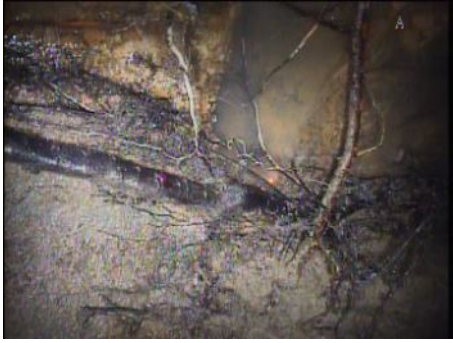
94.9 ft. U / Root-in-Joint

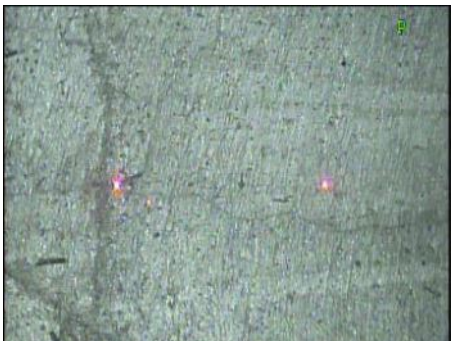
36.2 ft.	U	28.9 ft.	12 /	Crack			
----------	---	----------	------	-------	--	--	--

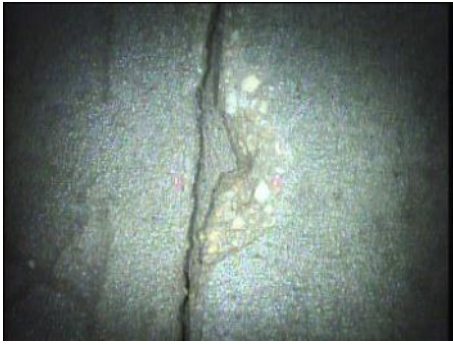
44.6 ft. U 2 / Broken

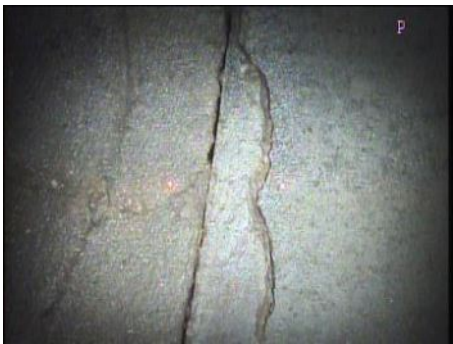
56.9 ft. U 1 / 6 Broken

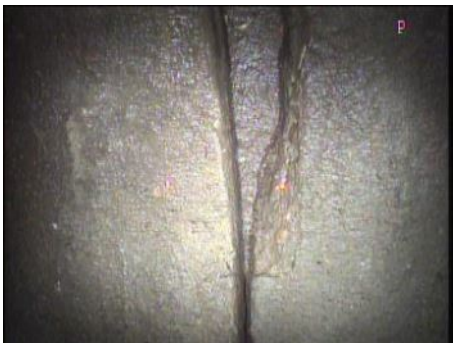
73.1 ft. U / Joint Offset

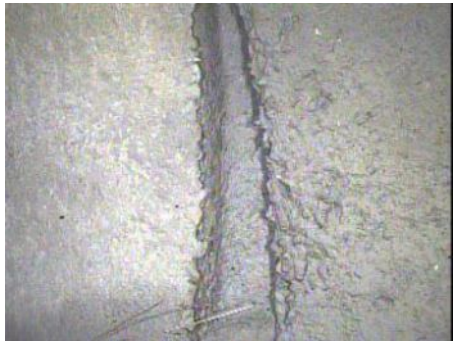
Distance	Dir.	Length	From/To	Code	Modifier/Severity	Rating	Comments
3.0 ft.	U		/	Joint Offset

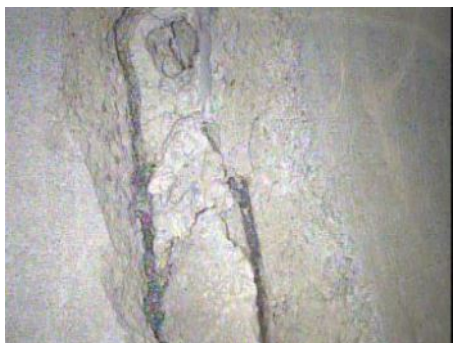
38.6 ft.	U		9 /	Broken			
----------	---	--	-----	--------	--	--	--

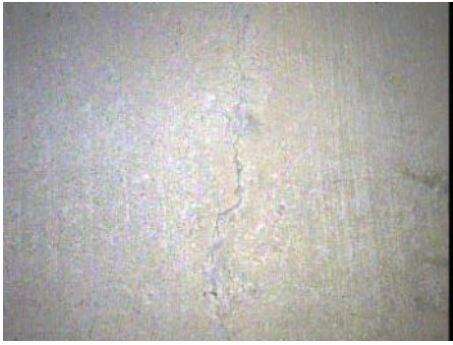
45.9 ft. U 9 / Crack

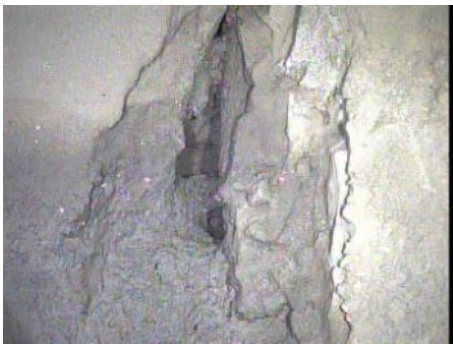
47.1 ft. U 9 / Broken

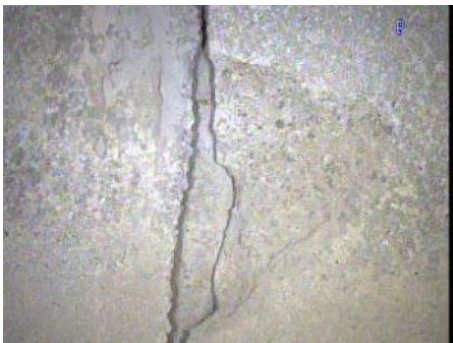
128.3 ft. U 3 / Broken

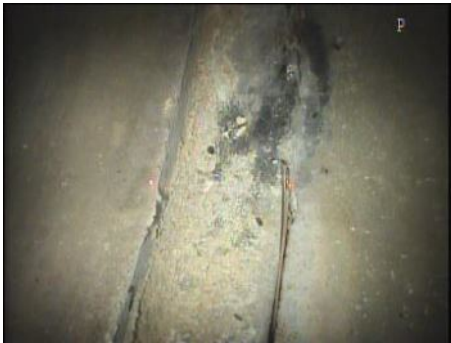
Distance	Dir.	Length	From/To Code	Modifier/Severity	Rating	Comments
6.8 ft.	D		/ Joint - Separated

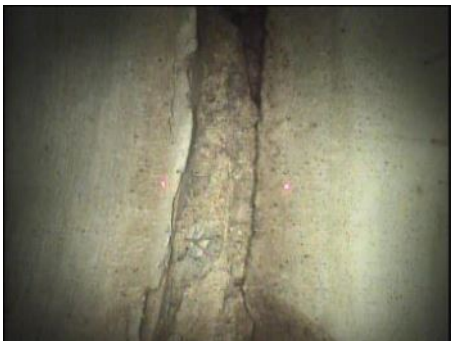
14.9 ft.	D		/ Joint Offset			
----------	---	--	----------------	--	--	--

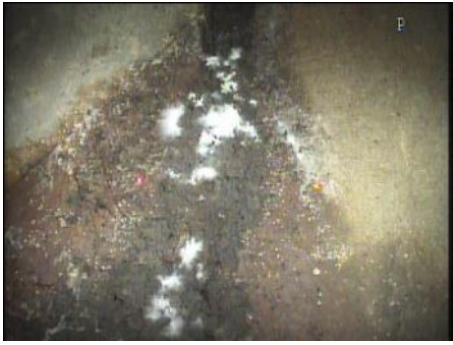
23.2 ft. D / Joint Offset

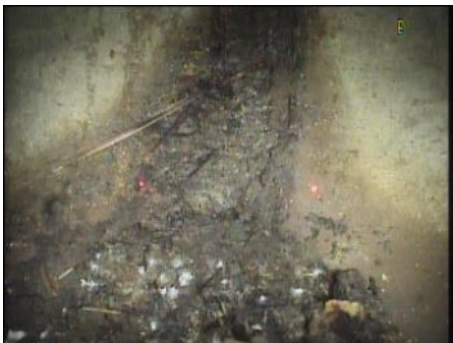
31.3 ft. D / Joint - Infiltration

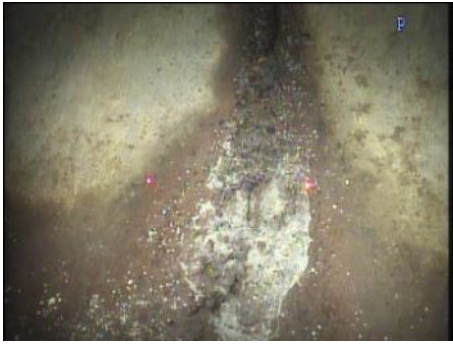
39.4 ft. D / Joint - Infiltration

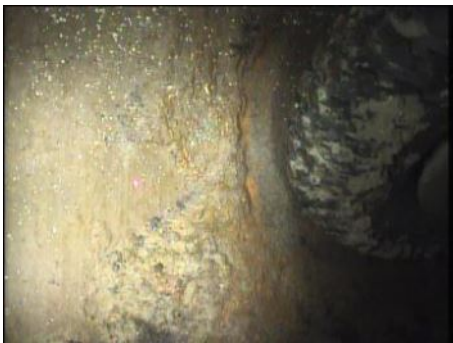
56.4 ft. D / Joint - Infiltration

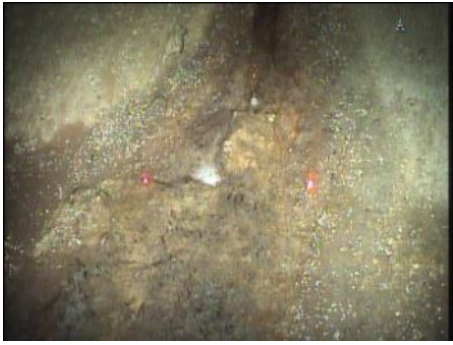
64.0 ft. D / Joint - Infiltration

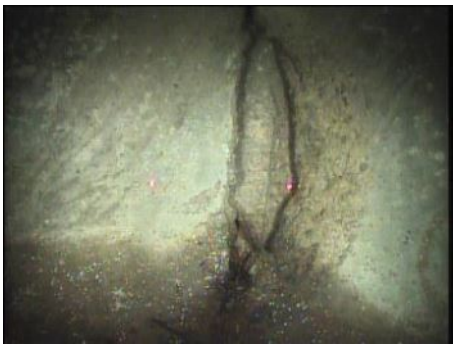
72.2 ft. D 4 / Chip

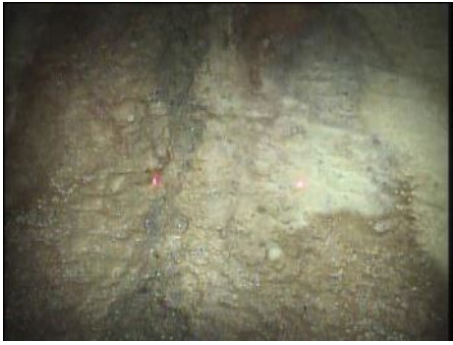
112.9 ft. D / Joint - Infiltration

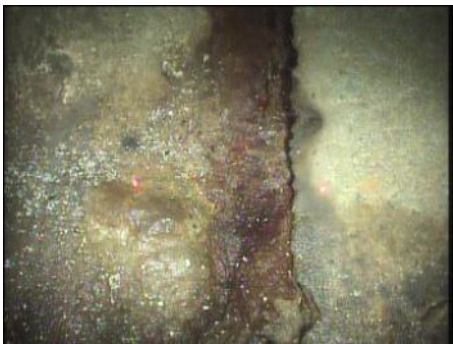
129.4 ft. D / Joint - Infiltration

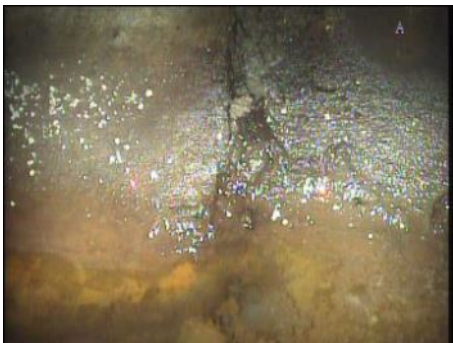
137.4 ft. D / Joint - Infiltration

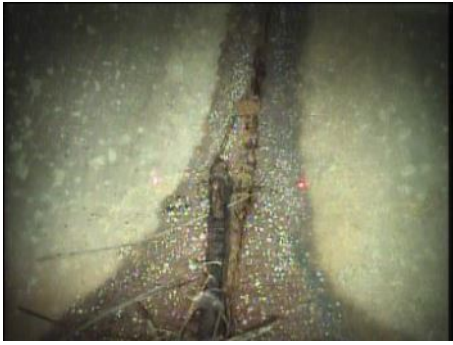
202.6 ft. D / Joint - Infiltration

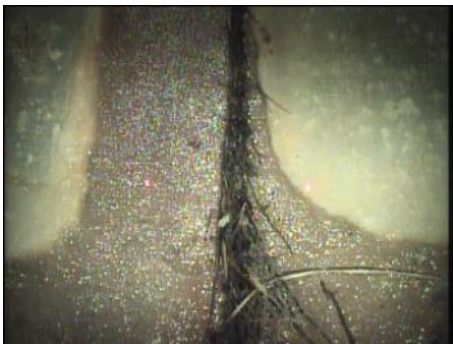
219.0 ft. D 9 / Root-in-Joint

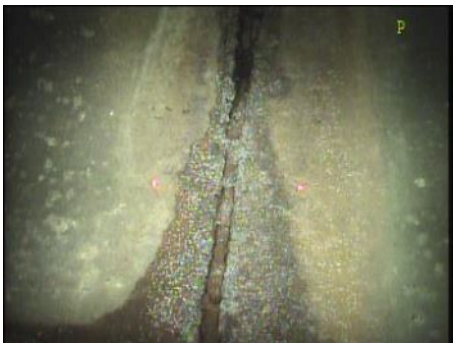
227.0 ft. D / Joint - Infiltration

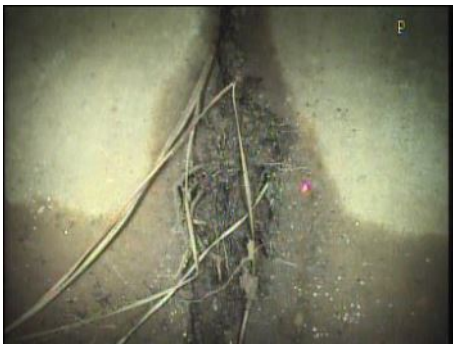
275.8 ft. D / Root-in-Joint

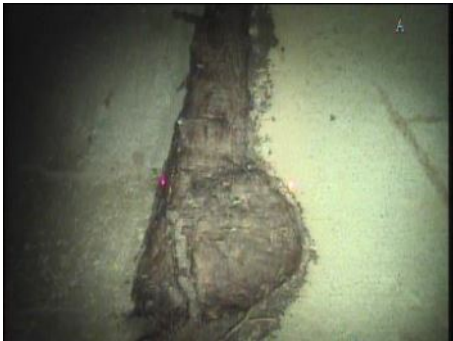
283.7 ft. D / Joint Offset

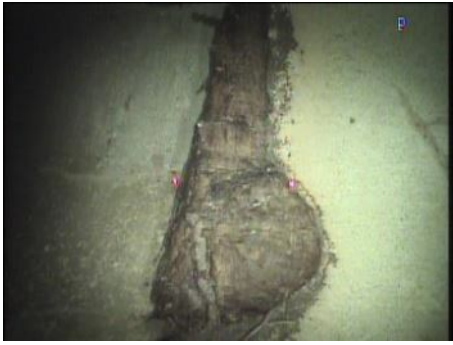
283.8 ft. D / Root-in-Joint

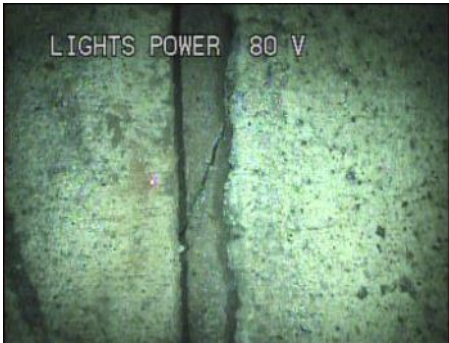
Distance	Dir.	Length	From/To Code	Modifier/Severity	Rating	Comments
23.9 ft.	D		/ Joint Offset

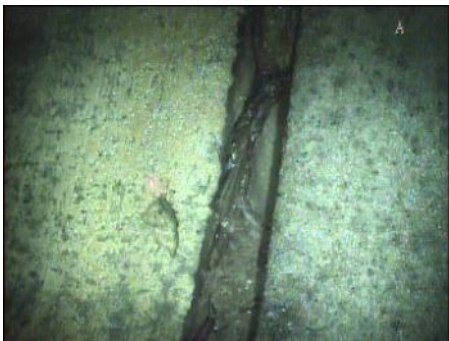
28.0 ft.	D		/ Joint Offset			
----------	---	--	----------------	--	--	--

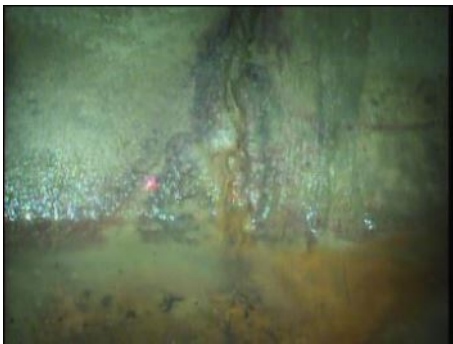
44.3 ft. D / Joint - Infiltration

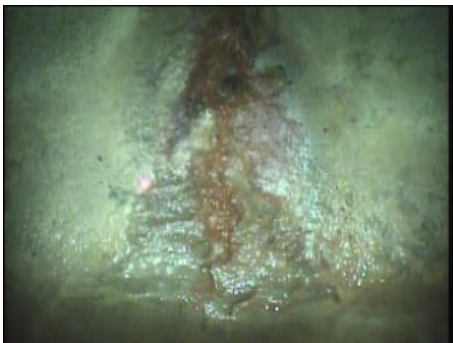
48.7 ft. D / Joint - Infiltration

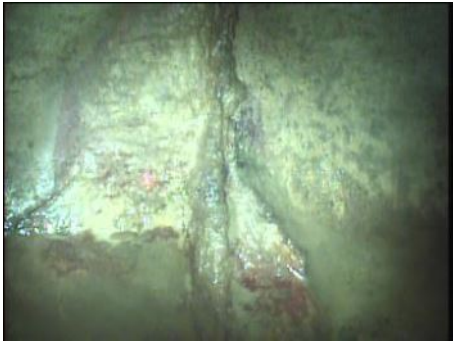
52.6 ft. D / Joint - Infiltration

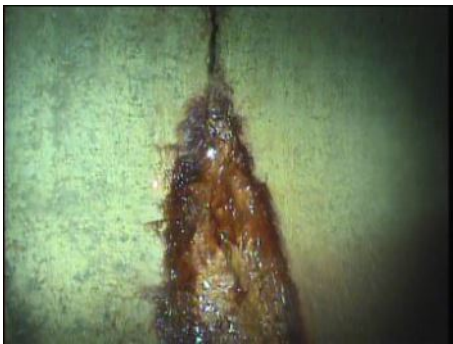
151.6 ft. D / Joint - Infiltration

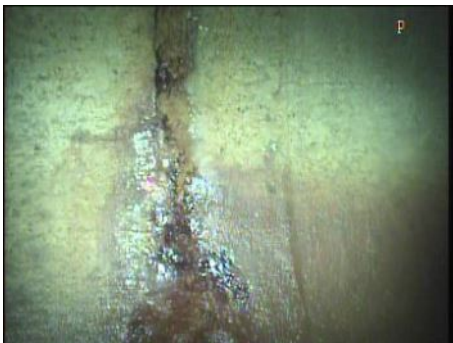
156.0 ft. D / Joint - Infiltration

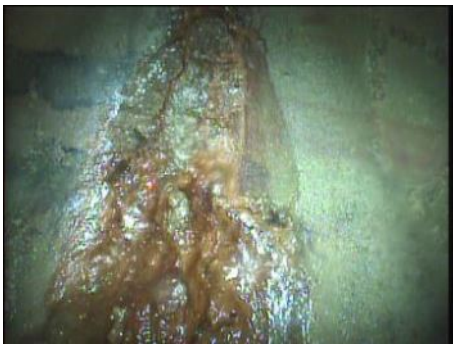
168.6 ft.	D		/	Joint - Infiltration			
-----------	---	--	---	----------------------	--	--	--

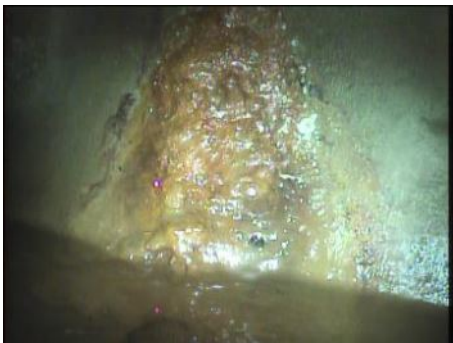
176.4 ft.	D		/	Joint - Infiltration			
-----------	---	--	---	----------------------	--	--	--

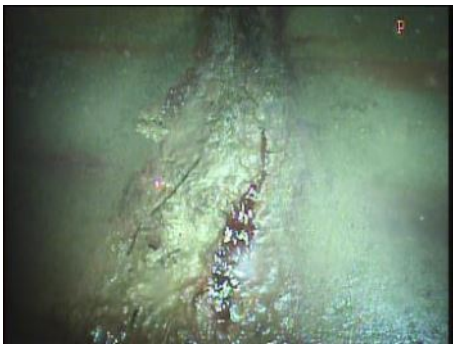
193.0 ft. D / Joint - Infiltration

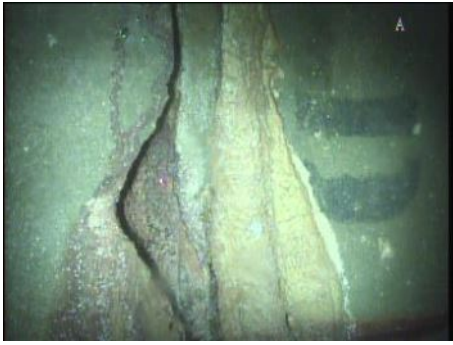
209.5 ft. D / Broken

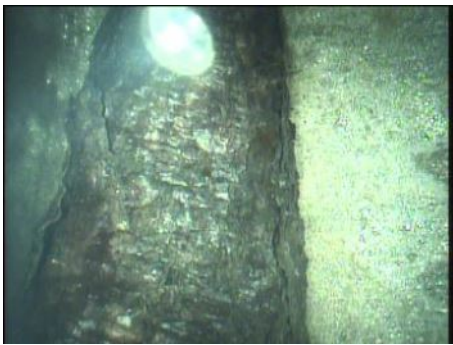
312.0 ft. D / Root-in-Joint

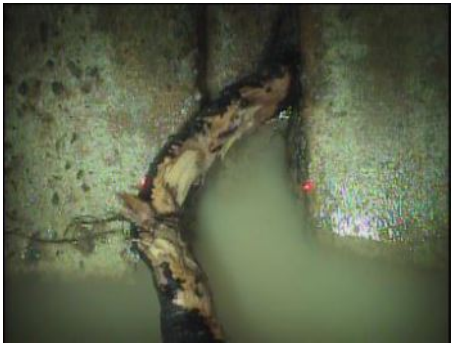
Distance	Dir.	Length	From/To	Code	Modifier/Severity	Rating	Comments
2.2 ft.	D		5 / 7	Root-in-Joint

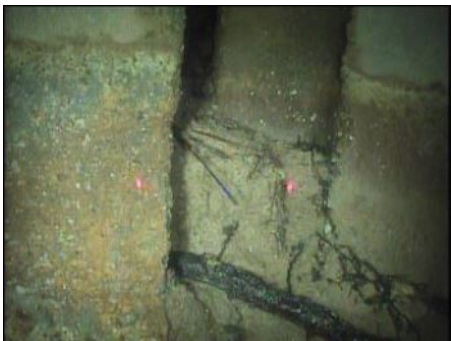
6.2 ft.	D		3 / 8	Root-in-Joint			
---------	---	--	-------	---------------	--	--	--

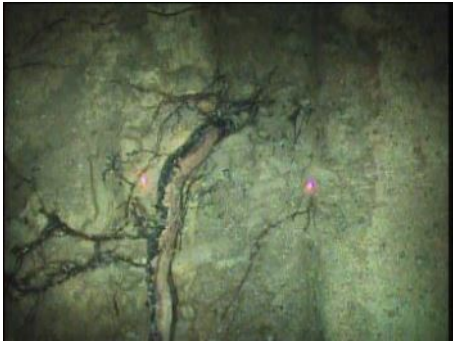
10.1 ft. D 4 / 8 Root-in-Joint

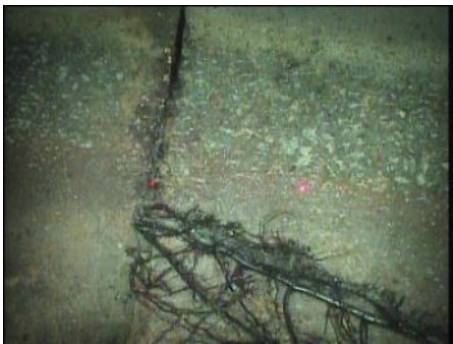
14.1 ft. D 4 / Root-in-Joint

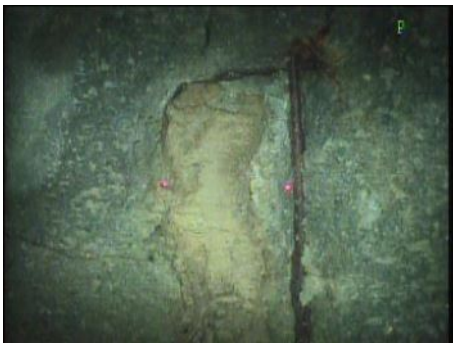
15.0 ft. D 8 / 10 Hole

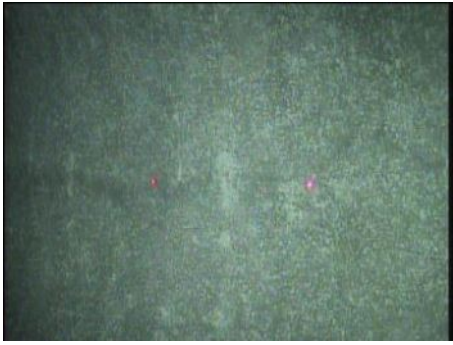
64.2 ft. D 40.3 ft. 12 / Crack

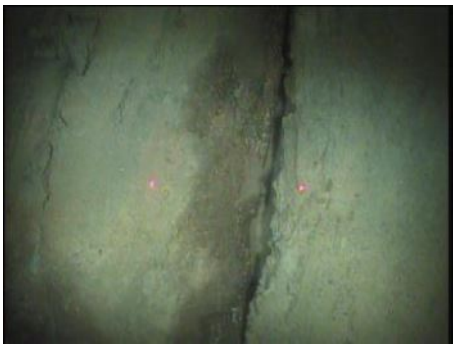
71.6 ft. D / Joint Offset

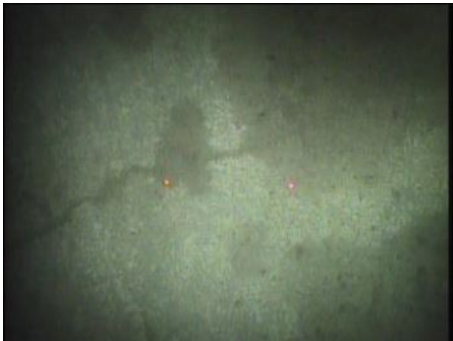
114.9 ft. D 12 / Crack

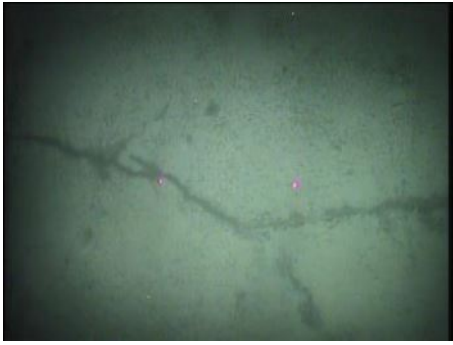
119.5 ft. D 1 / Crack

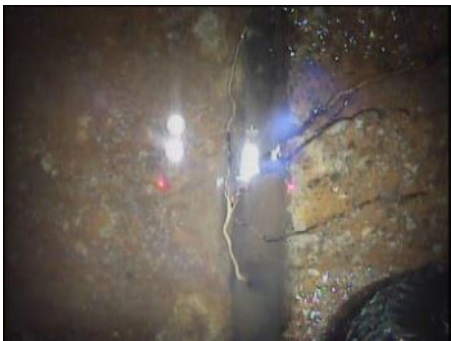
6.8 ft.	U		/	Root-in-Joint			
---------	---	--	---	---------------	--	--	--

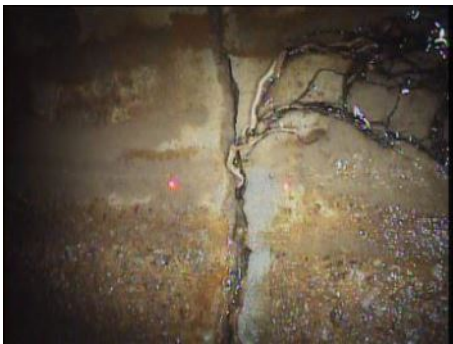
22.4 ft. U / Root-in-Joint

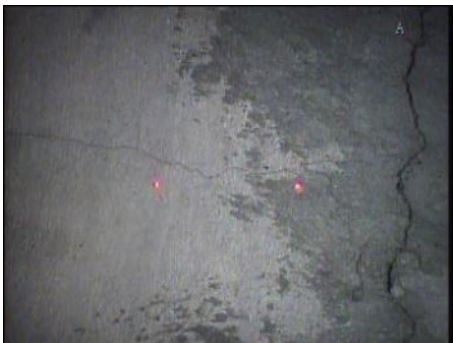
47.3 ft. U 36.8 ft. 12 / Crack

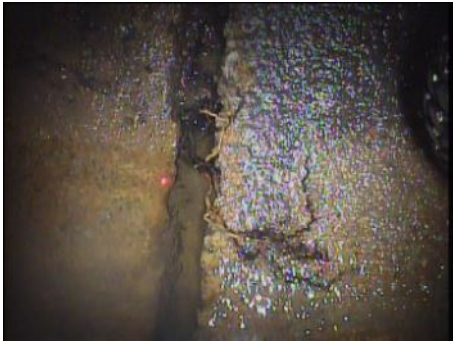
79.8 ft. U / Root-in-Joint

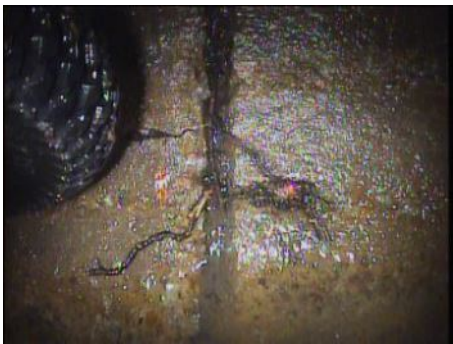
84.1 ft. U / Root-in-Joint

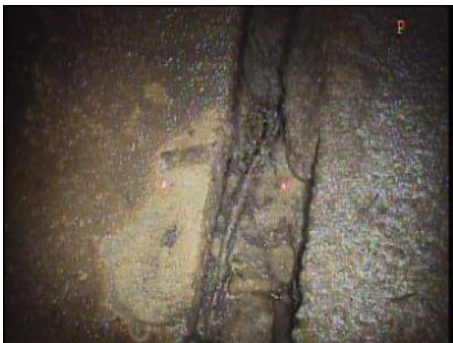
88.1 ft. U / Root-in-Joint

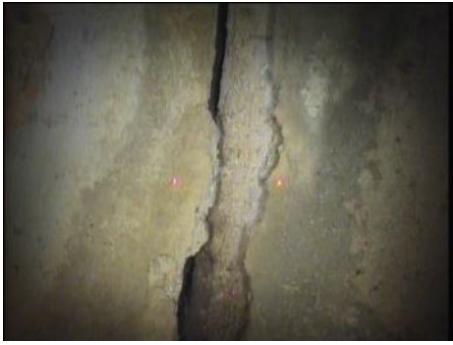
92.3 ft. U / Joint - Separated

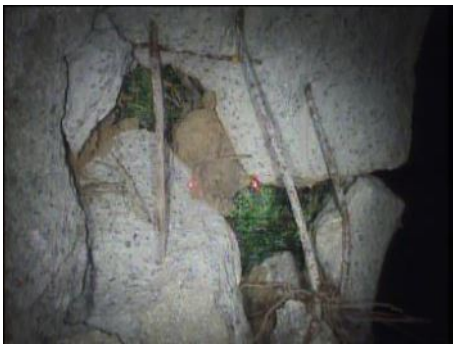
95.2 ft. U / Broken

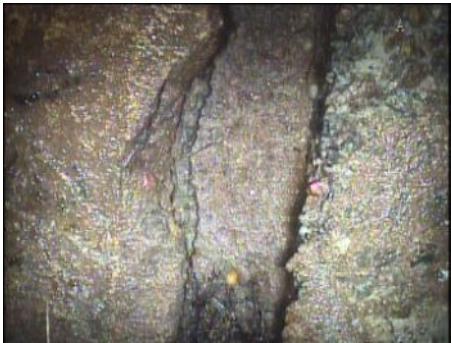
Distance	Dir.	Length	From/To	Code	Modifier/Severity	Rating	Comments
5.9 ft.	U		/	Joint Offset

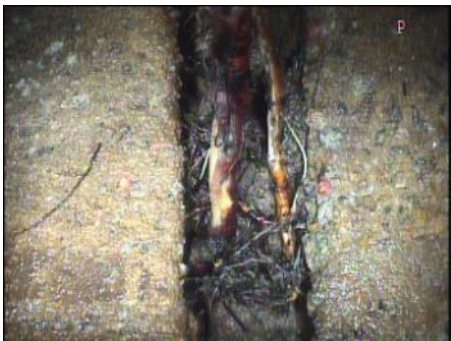
5.9 ft.	U		/	Root-in-Joint			
---------	---	--	---	---------------	--	--	--

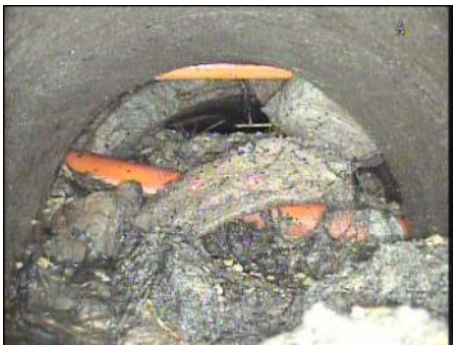
9.8 ft. U / Collapsed

2 Fiber Optic Cables Bored through side

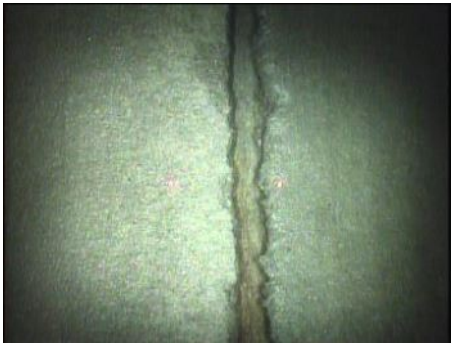
Distance	Dir.	Length	From/To	Code	Modifier/Severity	Rating	Comments
30.7 ft.	D		/	Joint Offset

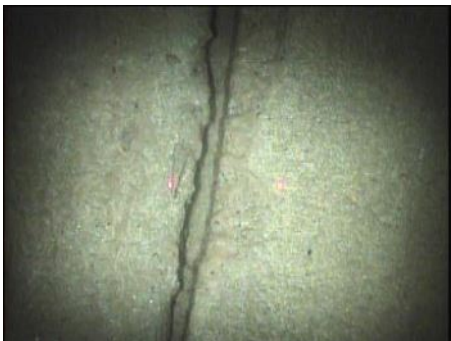
46.9 ft.	D		/	Joint Offset			
----------	---	--	---	--------------	--	--	--

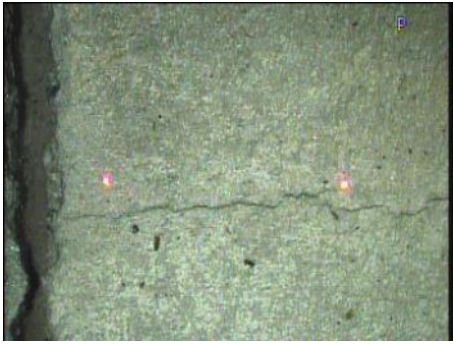
46.9 ft. D 10 / Crack

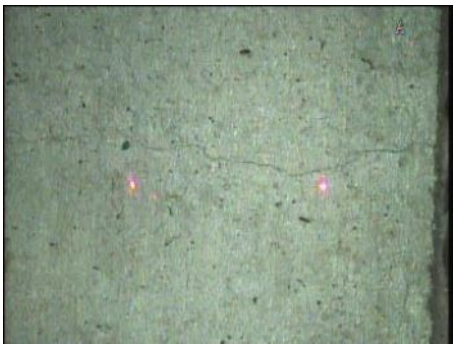
46.9 ft. D 16.8 ft. 12 / Crack

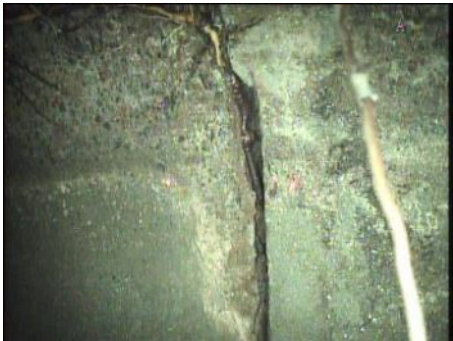
71.6 ft. D / Root-in-Joint

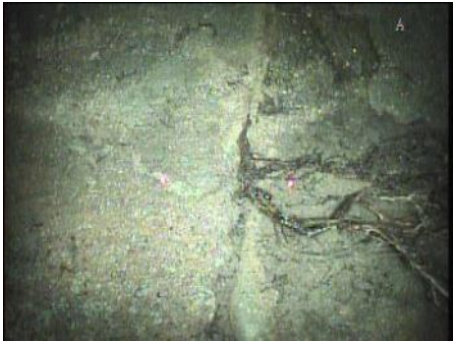
75.9 ft. D / Root-in-Joint

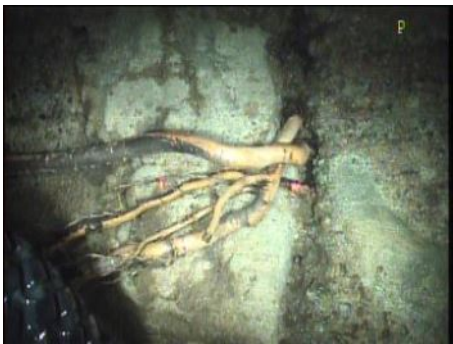
80.2 ft. D / Root-in-Joint

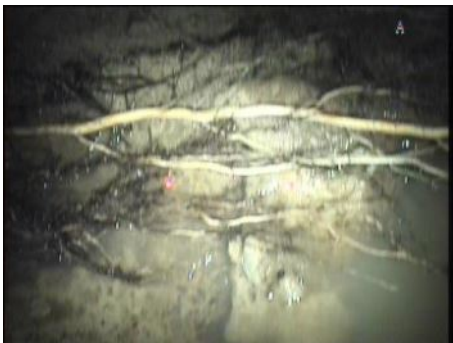
84.1 ft. D / Root-in-Joint

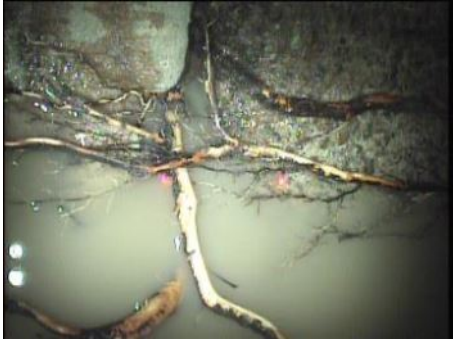
88.2 ft. D / Root-in-Joint

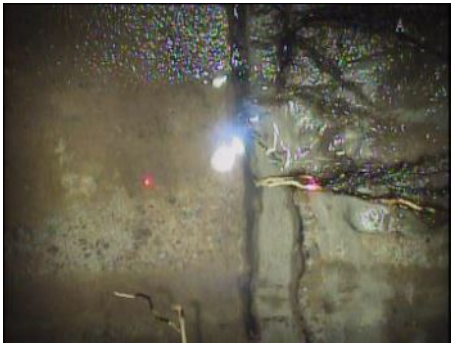
Distance	Dir.	Length	From/To	Code	Modifier/Severity	Rating	Comments
2.4 ft.	U		/	Root-in-Joint

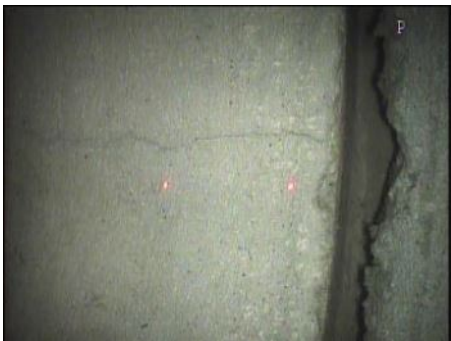
29.2 ft.	U	41.4 ft.	12 /	Crack			
----------	---	----------	------	-------	--	--	--

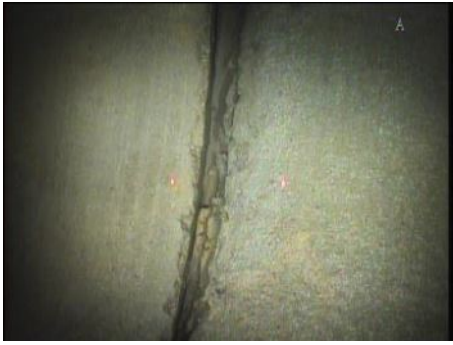
41.4 ft. U / Joint Offset

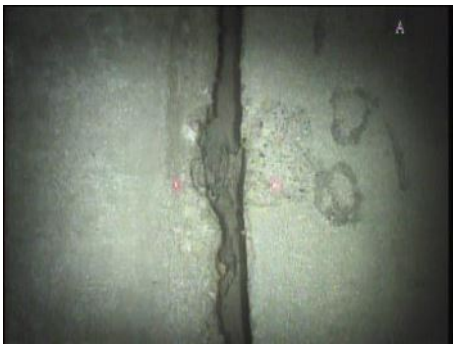
54.0 ft. U / Broken

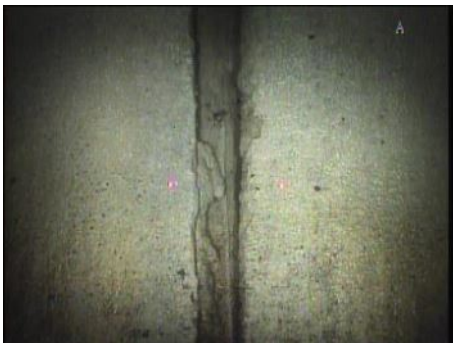
62.5 ft. U / Joint Offset

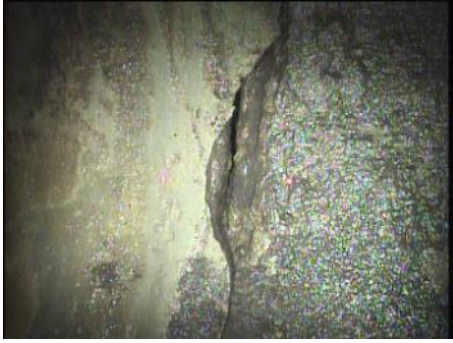
Distance	Dir.	Length	From/To Code	Modifier/Severity	Rating	Comments
70.6 ft.	U		3 /	Broken

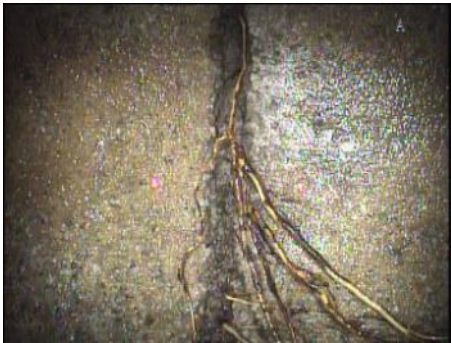
Distance	Dir.	Length	From/To	Code	Modifier/Severity	Rating	Comments
3.4 ft.	U		/	Root-in-Joint

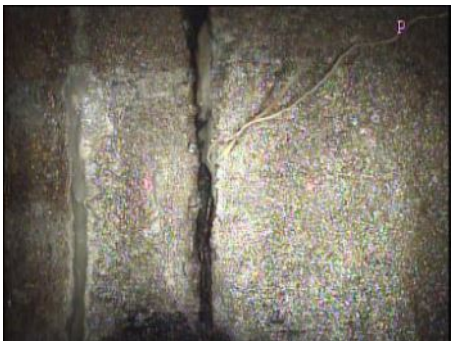
7.3 ft.	U		/	Root-in-Joint			
---------	---	--	---	---------------	--	--	--

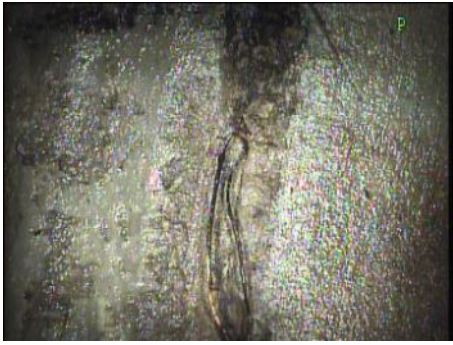
11.3 ft. U / Root-in-Joint

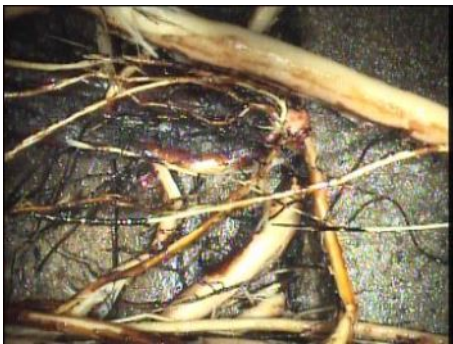
15.5 ft. U / Root-in-Joint

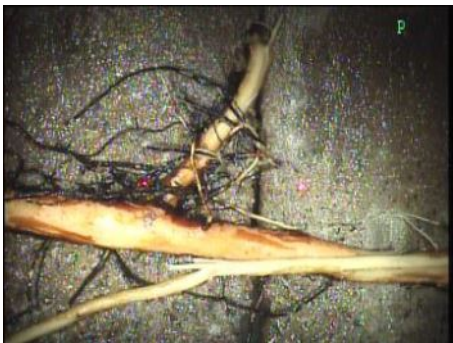
19.5 ft. U / Root-in-Joint

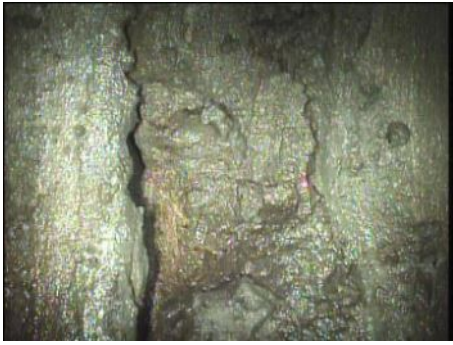
23.7 ft. U / Broken

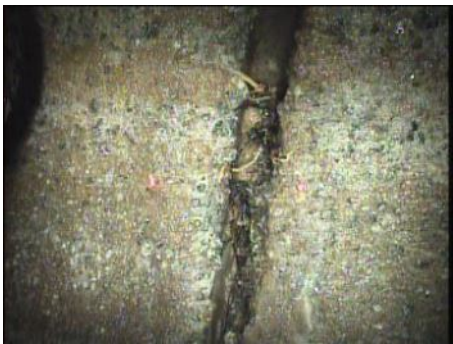
23.7 ft. U / Root-in-Joint

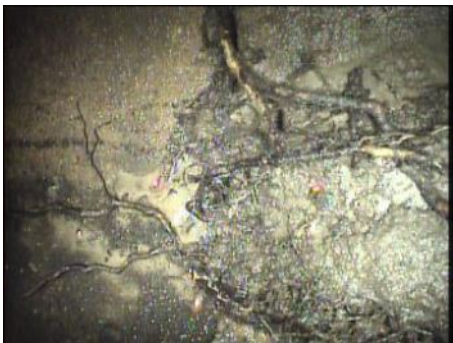
76.5 ft. U / Root-in-Joint

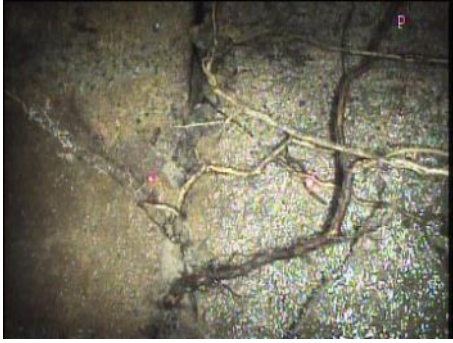
80.6 ft.	U		/	Root-in-Joint			
----------	---	--	---	---------------	--	--	--

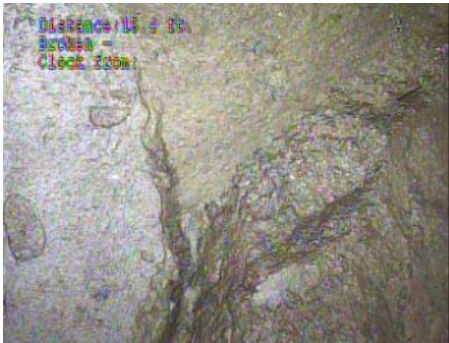
Distance	Dir.	Length	From/To Code	Modifier/Severity	Rating	Comments
15.4 ft.	U		/ Broken

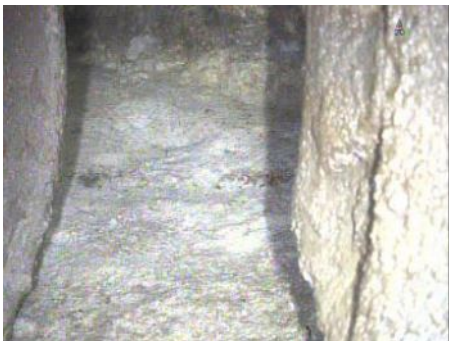
23.2 ft.	U		/ Joint - Separated			
----------	---	--	---------------------	--	--	--

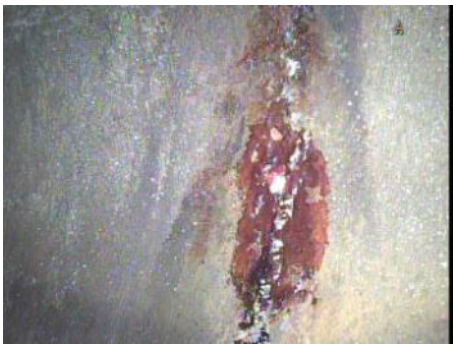
203.1 ft. U 12 / 3 Joint - Infiltration

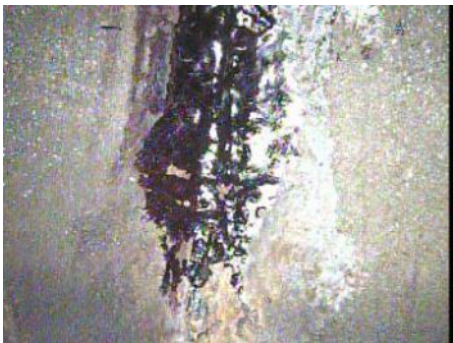
211.3 ft. U 10 / 2 Joint - Infiltration

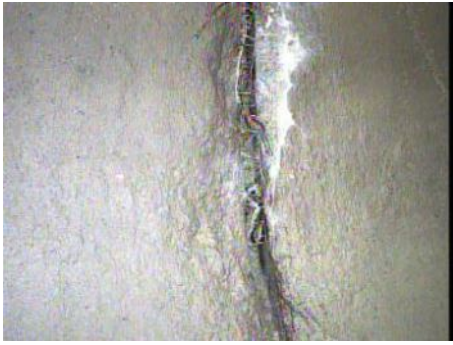
325.3 ft. U / Root-in-Joint

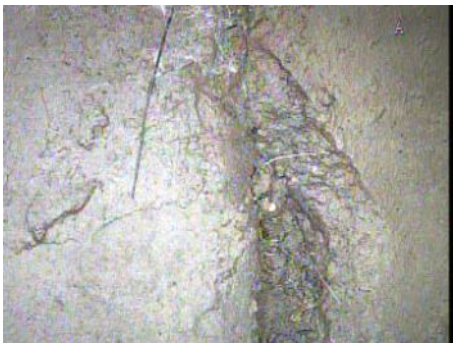
341.8 ft. U / Root-in-Joint

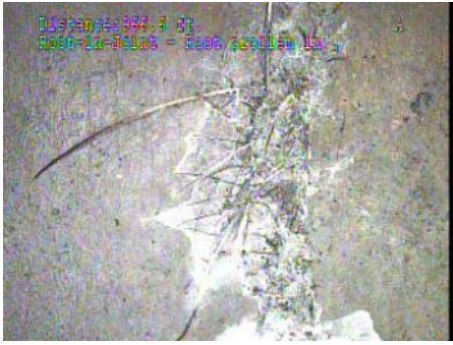
366.6 ft. U / Root-in-Joint

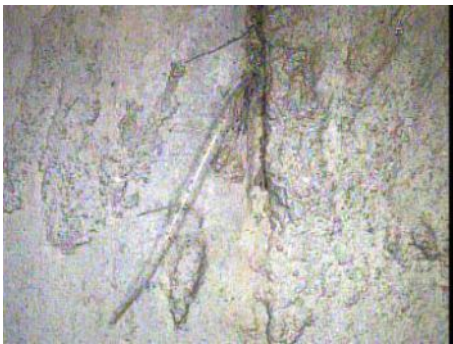
382.5 ft. U / Root-in-Joint

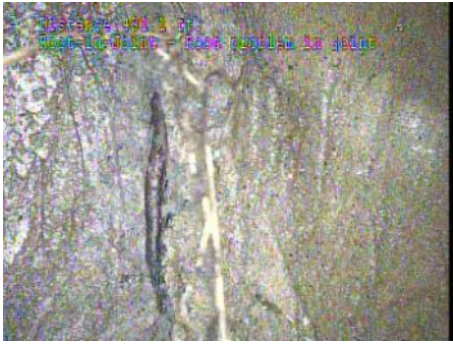
431.1 ft.	U		/	Root-in-Joint		
-----------	---	--	---	---------------	--	--

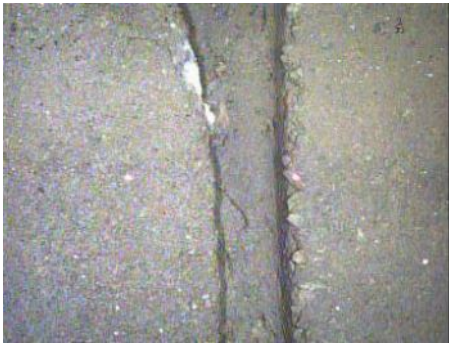
Distance	Dir.	Length	From/To Code	Modifier/Severity	Rating	Comments
7.2 ft.	D		/ Joint Offset

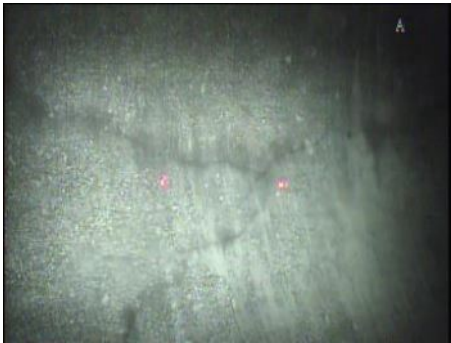
Distance	Dir.	Length	From/To	Code	Modifier/Severity	Rating	Comments
6.3 ft.	D	52.1 ft.	12 /	Crack

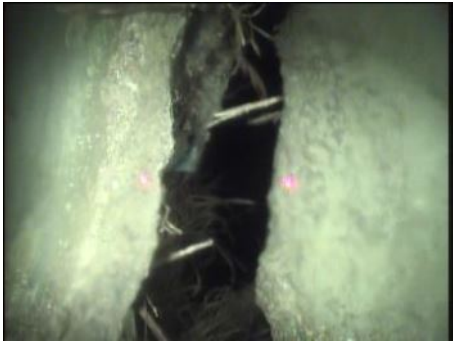
40.1 ft. D / Joint - Separated

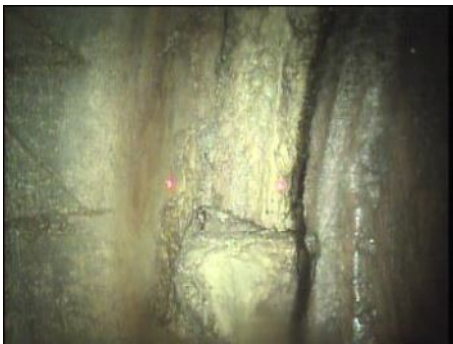
48.2 ft. D / Joint - Separated

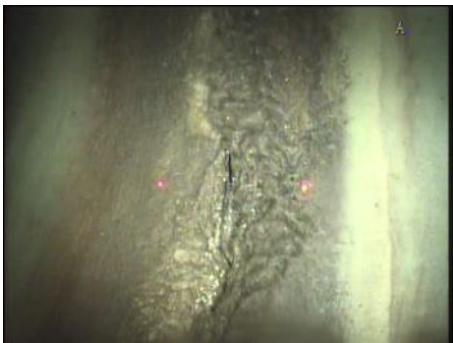
56.7 ft. D / Joint - Infiltration

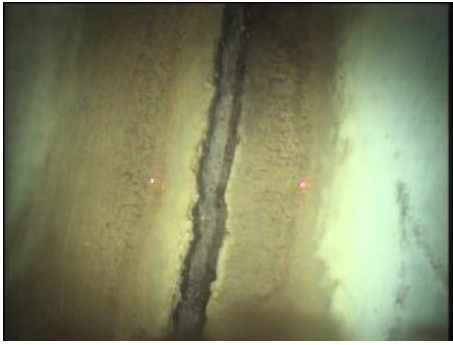
65.1 ft. D / Joint - Infiltration

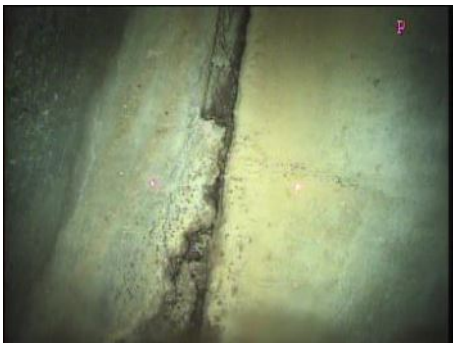
81.5 ft. D / Joint - Infiltration

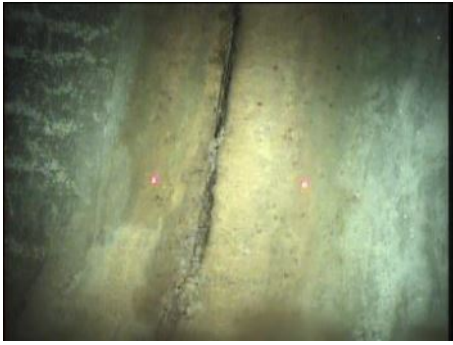
97.8 ft. D / Joint - Infiltration

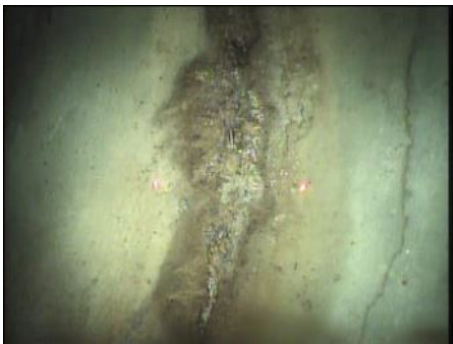
105.8 ft. D / Joint - Infiltration

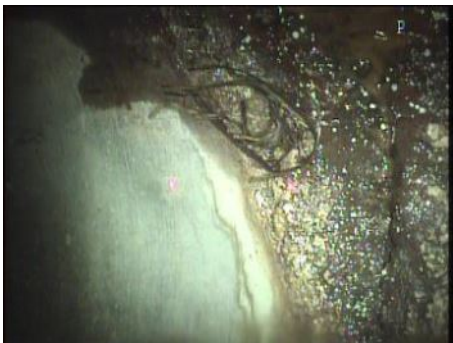
105.8 ft. D / Crack Circular - Narrow

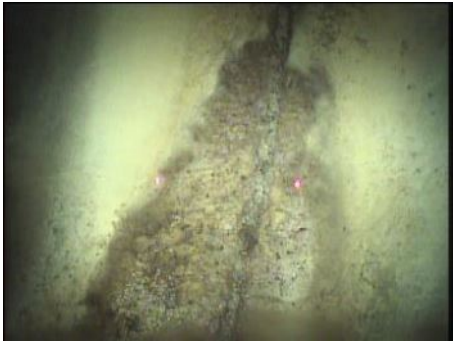
114.2 ft. D / Joint - Infiltration

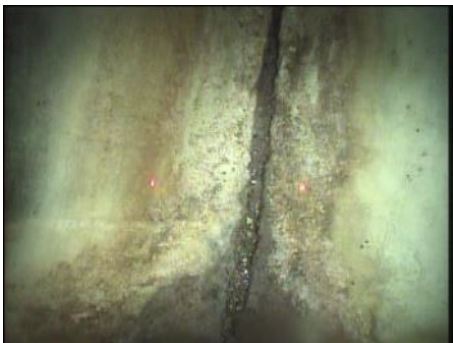
130.5 ft. D / Joint - Infiltration

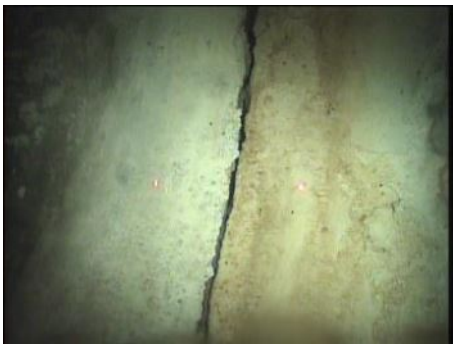
146.6 ft. D / Joint - Infiltration

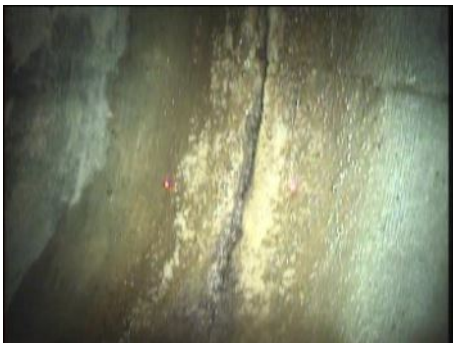
228.1 ft. D / Joint - Infiltration

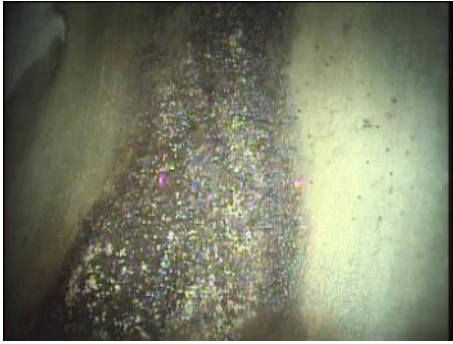
244.3 ft.	D	415.6 ft.	/	Joint - Infiltration			Every Joint Has Infiltration
-----------	---	-----------	---	----------------------	--	--	------------------------------

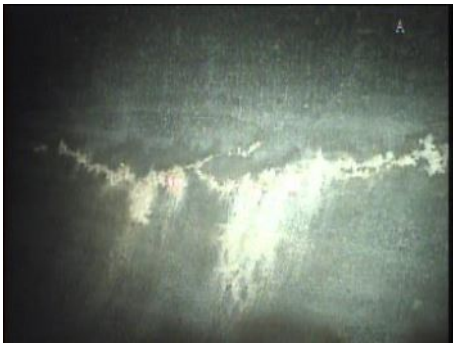
400.6 ft.	D		3 /	Crack			
-----------	---	--	-----	-------	--	--	--

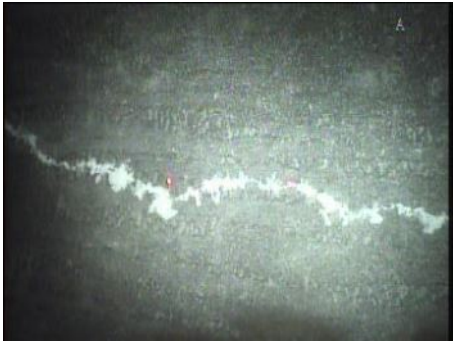
430.2 ft. D 3 / Crack

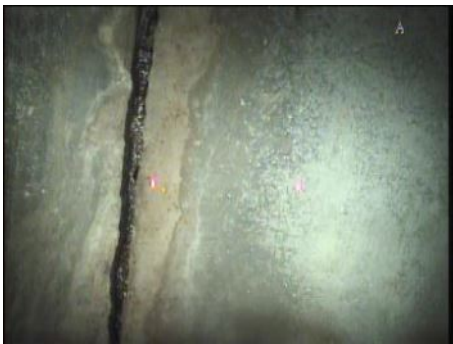
513.3 ft. D / Joint Offset

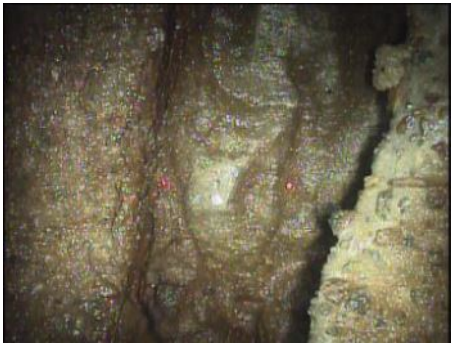
Distance	Dir.	Length	From/To	Code	Modifier/Severity	Rating	Comments
2.0 ft.	D		/	Joint Offset

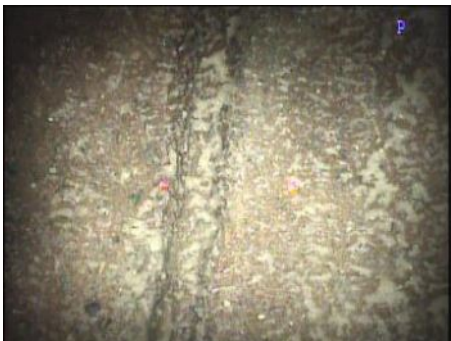
8.8 ft.	D		/	Joint Offset			
---------	---	--	---	--------------	--	--	--

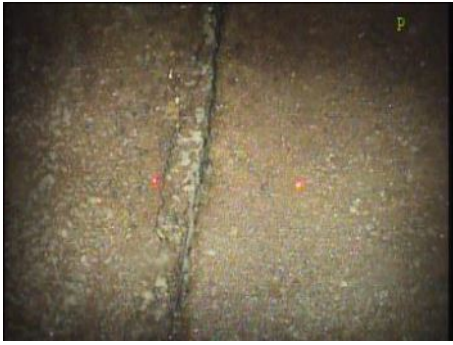
33.1 ft. D / Joint Offset

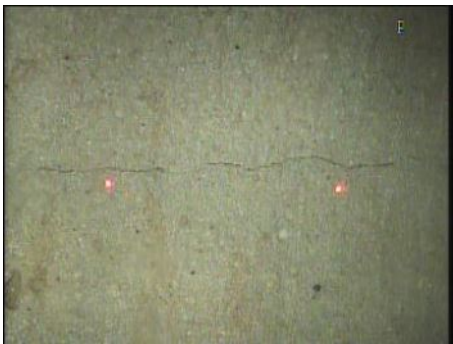
57.9 ft. D 12 / Crack

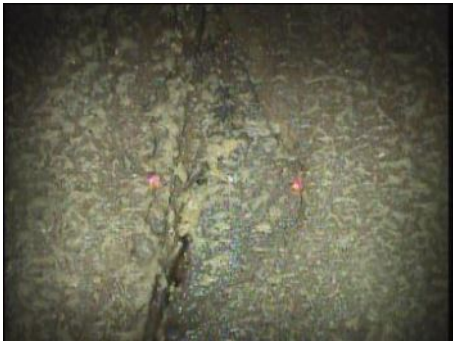
82.3 ft. D / Joint Offset

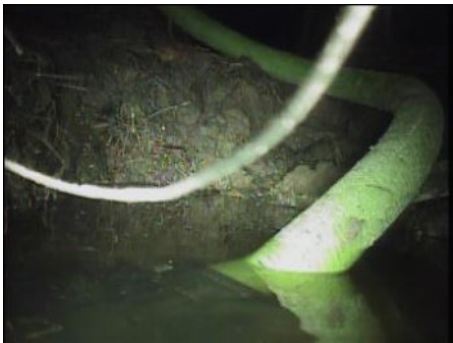
164.4 ft. D / End of Pipe

**PIPE UNABLE TO BE
CLEANED ALL THE
WAY THROUGH,
BECAUSE PIPE IS
LOWER THAN THE
GROUND AT
OUTFALL**

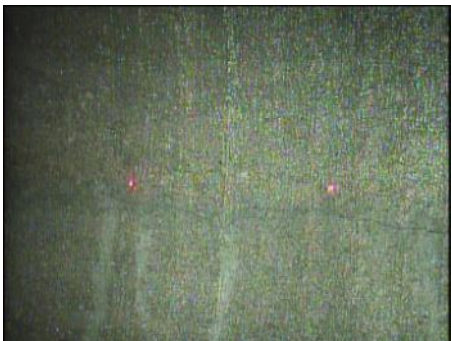
11.1 ft.	D		11 / Crack			
----------	---	--	------------	--	--	--

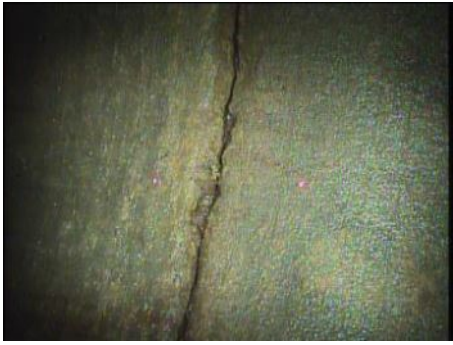
13.2 ft. D / Joint Offset
