I-26 & I-95 INTERCHANGE IMPROVEMENTS

June 29, 2023

PIPE INSPECTION REPORT

This report contains the results of the video pipe inspection and assessment of the existing storm water drainage pipes within the project area in Orangeburg and Dorchester Counties.

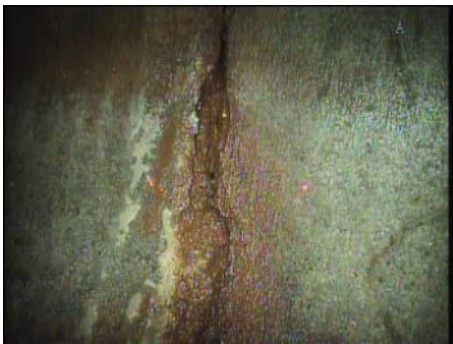
41.6 ft. D / Joint Offset

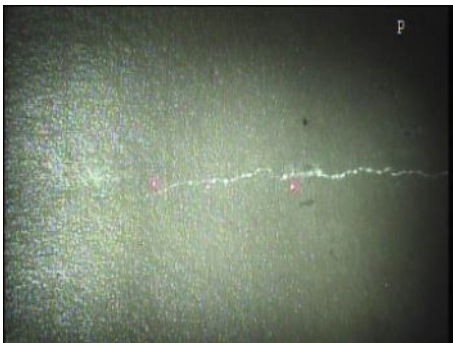
52.1 ft. D 12 / Crack

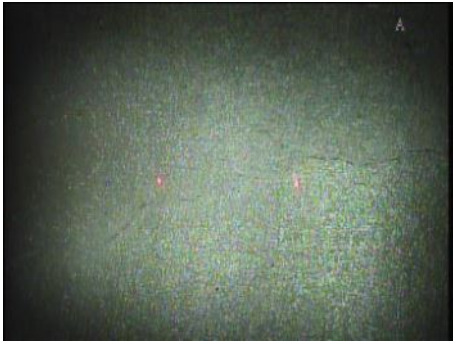
52.1 ft. D 2 / Crack

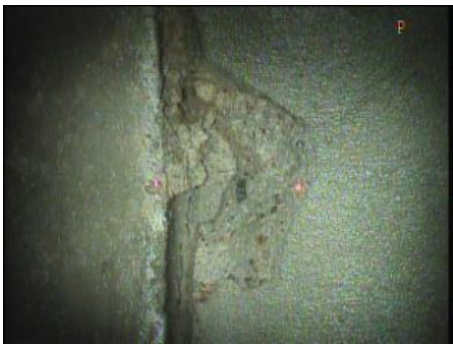
53.9 ft. D 1 / Broken

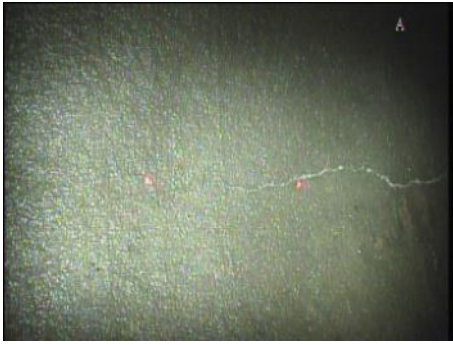
65.2 ft. D 9 / Crack

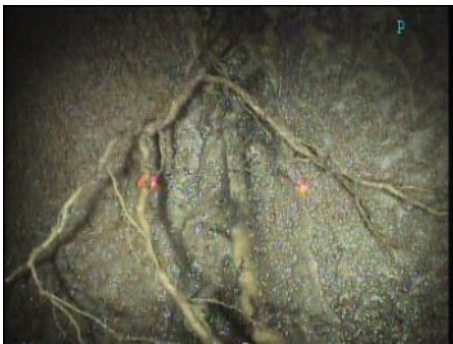
106.8 ft. D / Root-in-Joint

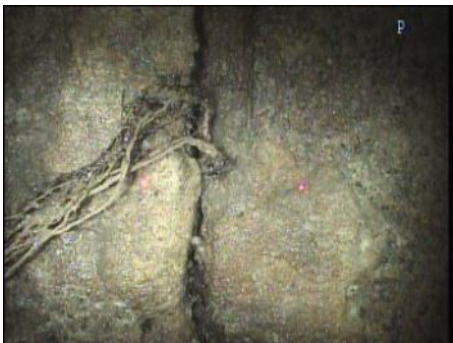
115.0 ft. D / Root-in-Joint

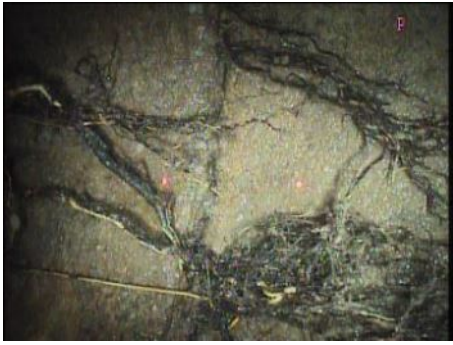
122.9 ft.	D		/	Root-in-Joint			
-----------	---	--	---	---------------	--	--	--

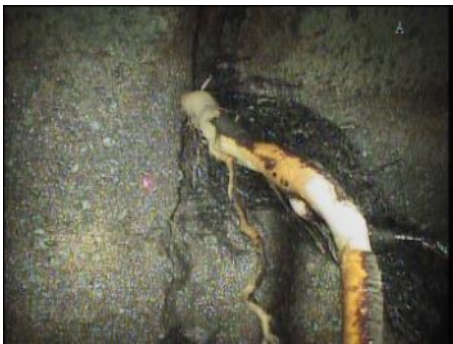
131.7 ft.	D		/	Root-in-Joint			
-----------	---	--	---	---------------	--	--	--

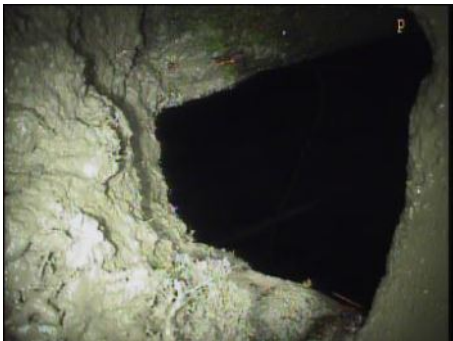
138.8 ft.	D		/	End of Pipe			
-----------	---	--	---	-------------	--	--	--

**Excessive Roots From
Trees at End of Pipe**

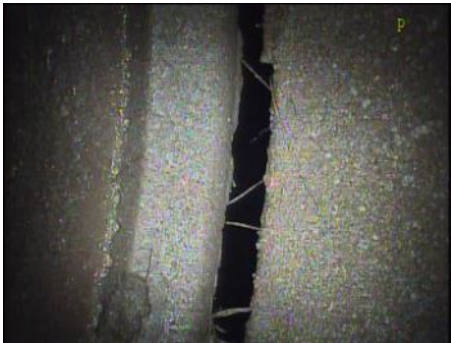
Distance	Dir.	Length	From/To	Code	Modifier/Severity	Rating	Comments
137.1 ft.	D		/	Joint - Separated

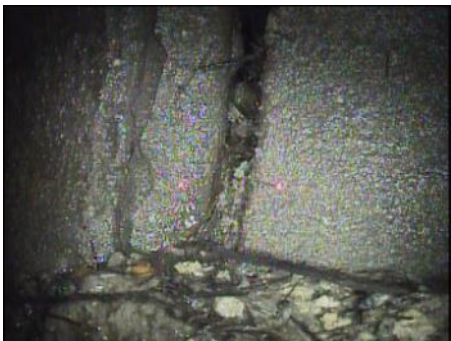
137.1 ft.	D		/	Joint - Infiltration			
-----------	---	--	---	----------------------	--	--	--

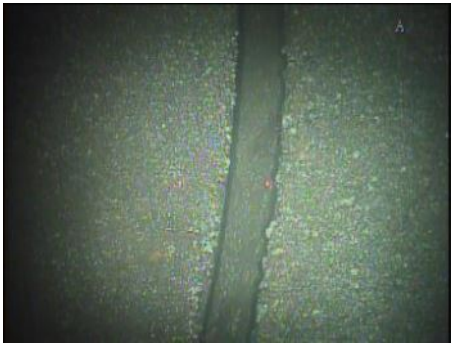
Distance	Dir.	Length	From/To	Code	Modifier/Severity	Rating	Comments
6.0 ft.	U		/	Joint Offset

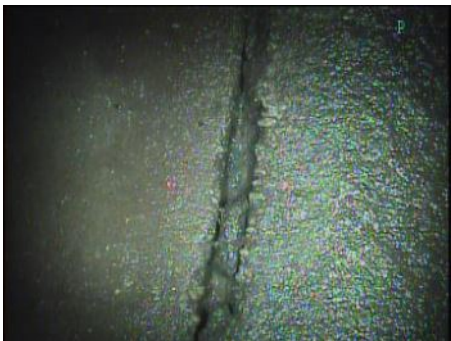
46.6 ft.	U		/	Joint Offset			
----------	---	--	---	--------------	--	--	--

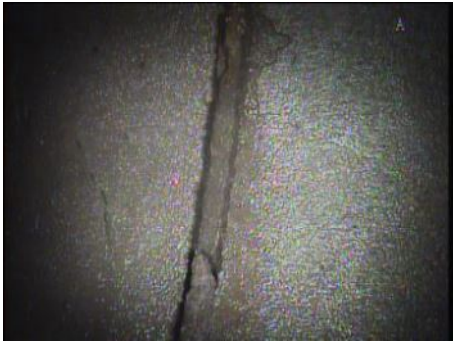
95.7 ft. U / Joint Offset

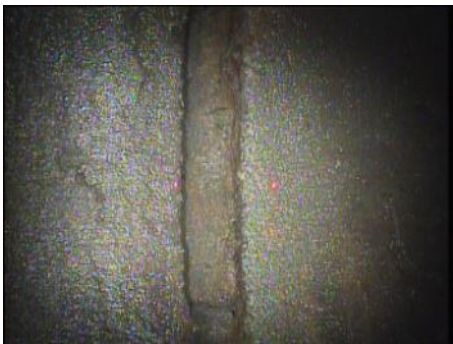
104.0 ft. U / Joint Offset

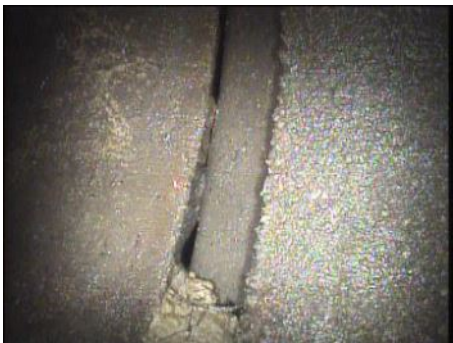
129.7 ft. U / Joint Offset

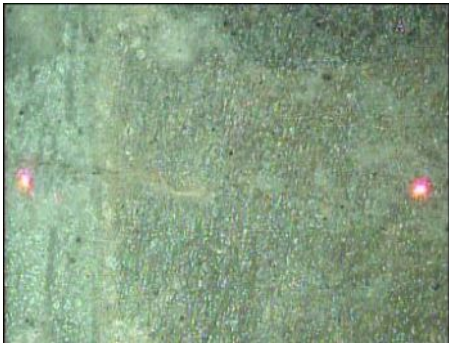
Distance	Dir.	Length	From/To	Code	Modifier/Severity	Rating	Comments
14.7 ft.	D		12 /	Crack

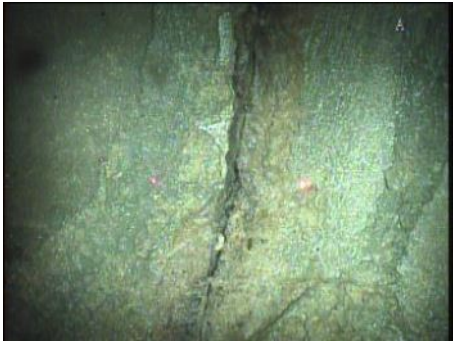
26.8 ft. D / Joint Offset

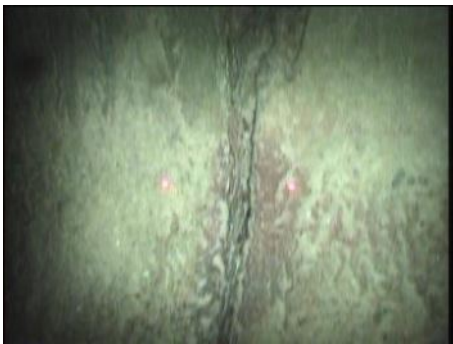
79.4 ft. D / Joint Offset

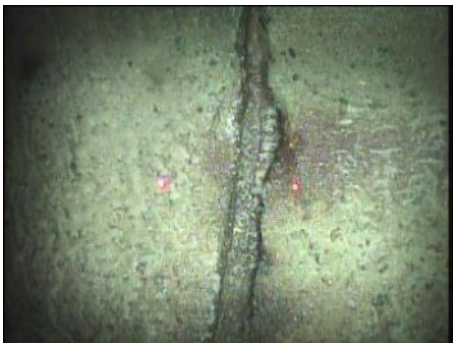
87.8 ft. D / Joint Offset

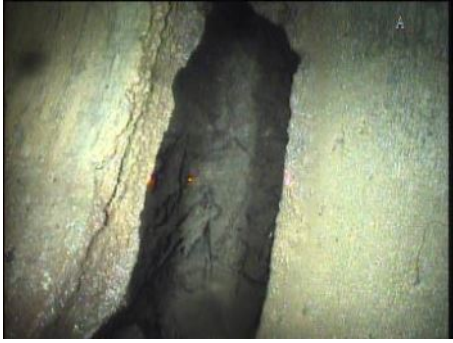
95.7 ft. D / Joint - Separated

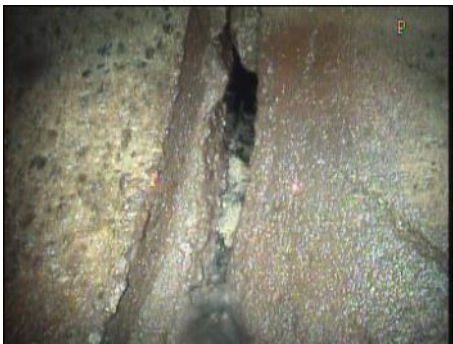
103.9 ft. D / Joint - Separated

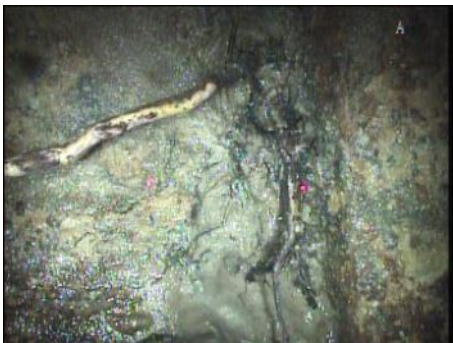
112.2 ft. D / Root-in-Joint

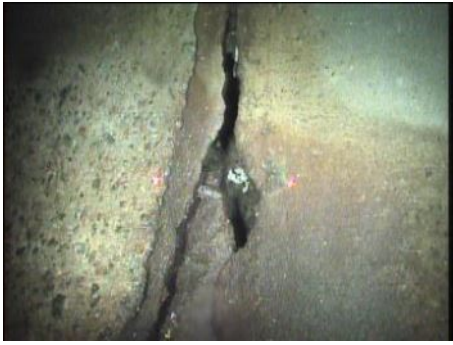
120.2 ft. D / Joint - Separated

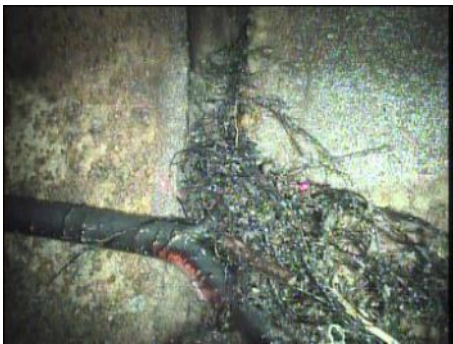
128.5 ft. D / Root-in-Joint

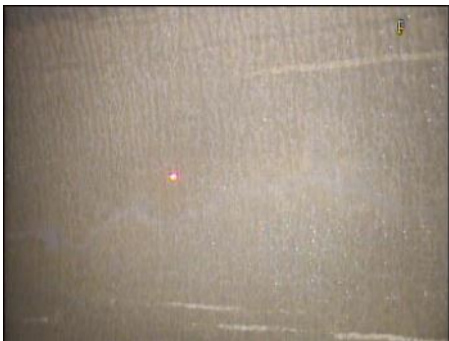
159.6 ft.	U	22.2 ft.	12 /	Crack			
-----------	---	----------	------	-------	--	--	--

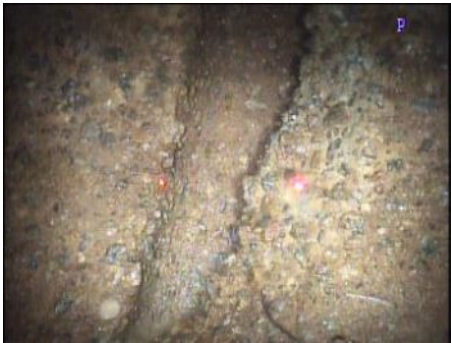
Distance	Dir.	Length	From/To	Code	Modifier/Severity	Rating	Comments
5.7 ft.	D		/	Joint Offset

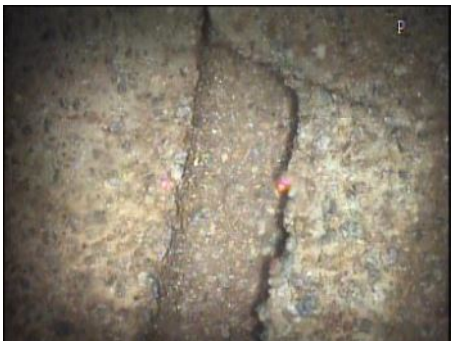
6.1 ft.	D		5 / 9	Broken			
---------	---	--	-------	--------	--	--	--

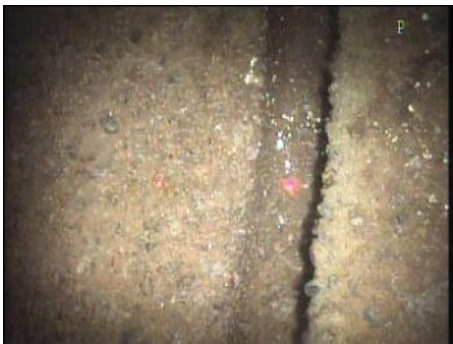
42.3 ft. D / Joint Offset

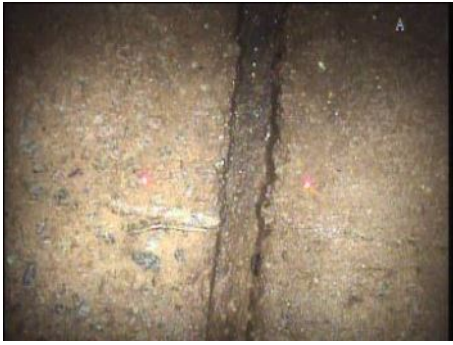
91.4 ft. D / Joint Offset

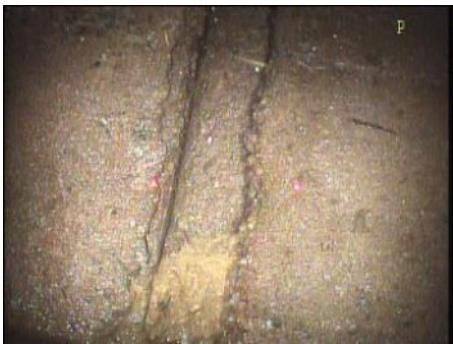
99.6 ft. D / Joint Offset

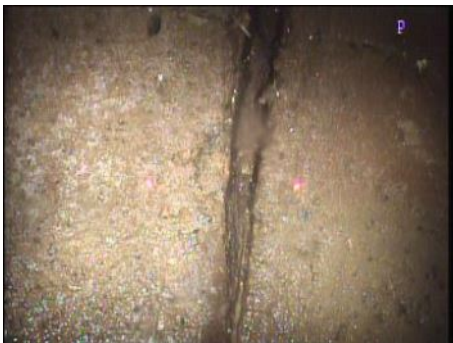
108.0 ft. D / Joint Offset

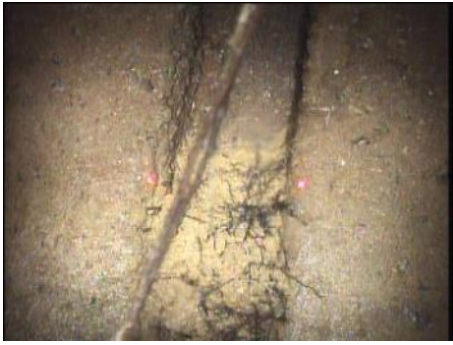
116.0 ft. D / Joint Offset

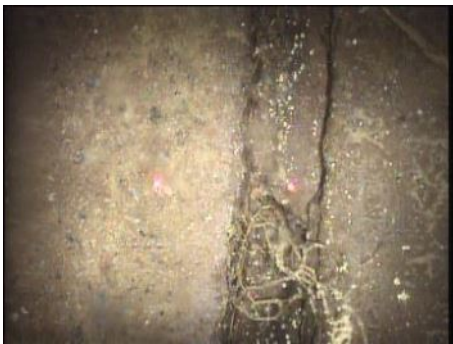
116.0 ft. D / Root

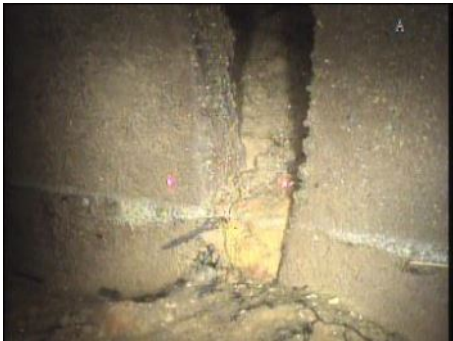
123.9 ft. D / Joint - Separated

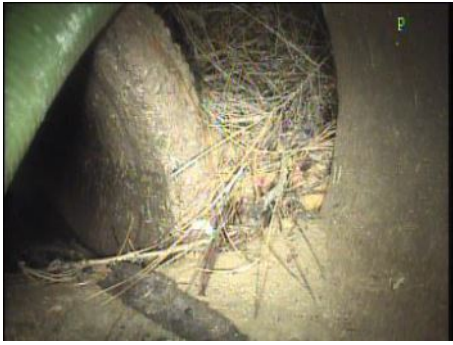
131.2 ft.	D		/	Joint - Separated			
-----------	---	--	---	-------------------	--	--	--

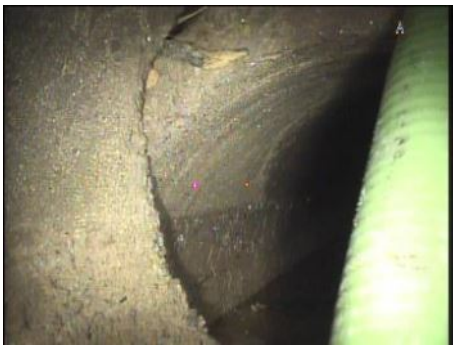
At 131.4 ft.
Abandoned Survey
Category: Miscellaneous
Comments: Last 2 Joints seperated -
Broken off

131.4 ft.	D		/	Abandoned Survey			
-----------	---	--	---	------------------	--	--	--

**Last 2 Joints
seperated - Broken off**

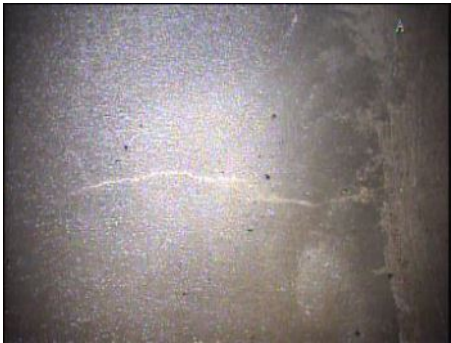
Distance	Dir.	Length	From/To	Code	Modifier/Severity	Rating	Comments
7.3 ft.	U		11 /	Crack

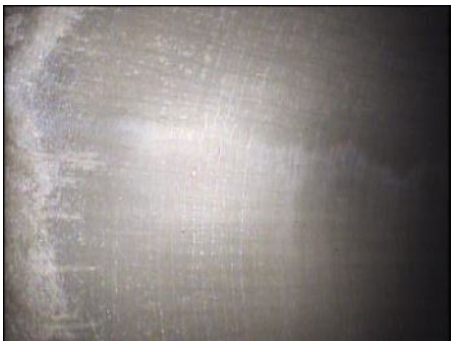
8.2 ft.	U	36.9 ft.	12 /	Crack			
---------	---	----------	------	-------	--	--	--

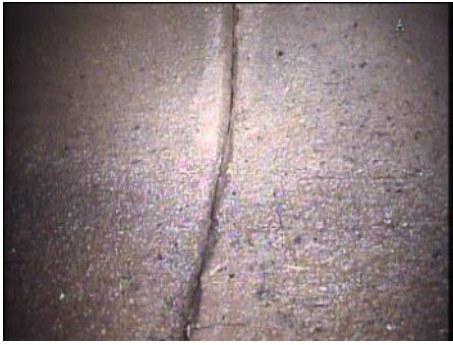
93.2 ft. U / Joint Offset

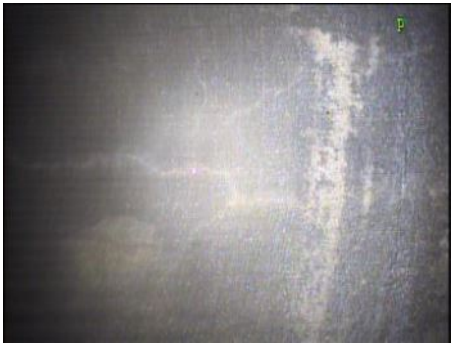
Distance	Dir.	Length	From/To	Code	Modifier/Severity	Rating	Comments
21.4 ft.	D	85.8 ft.	12 /	Crack

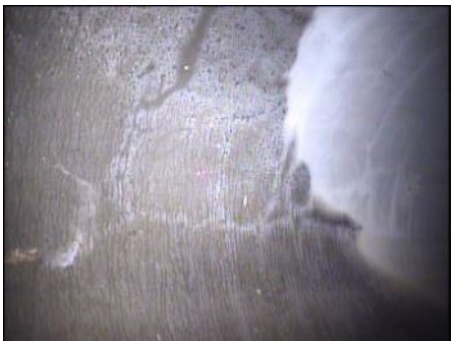
98.7 ft.	D		9 /	Crack			
----------	---	--	-----	-------	--	--	--

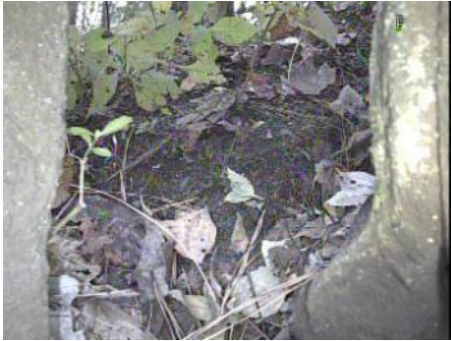
Distance	Dir.	Length	From/To	Code	Modifier/Severity	Rating	Comments
6.9 ft.	U		/	Joint - Separated

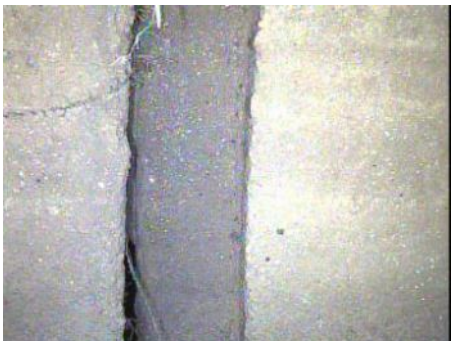
15.2 ft.	U		/	Joint - Separated			
----------	---	--	---	-------------------	--	--	--

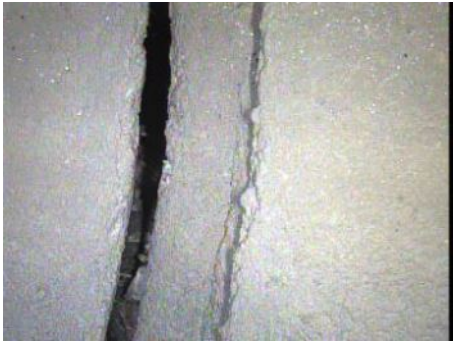
23.3 ft.	U		/	Joint - Separated			
----------	---	--	---	-------------------	--	--	--

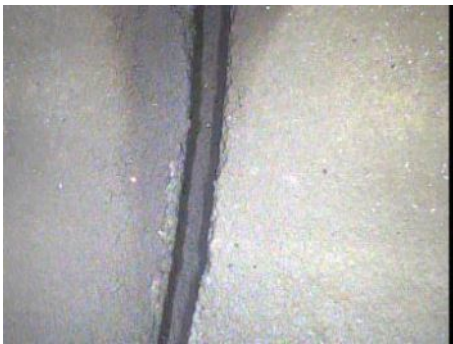
31.3 ft.	U		/	Joint Offset			
----------	---	--	---	--------------	--	--	--

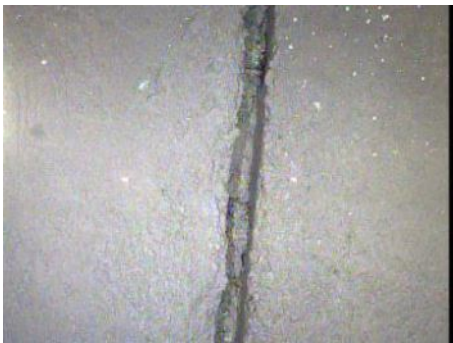
39.7 ft.	U		/	Joint Offset			
----------	---	--	---	--------------	--	--	--

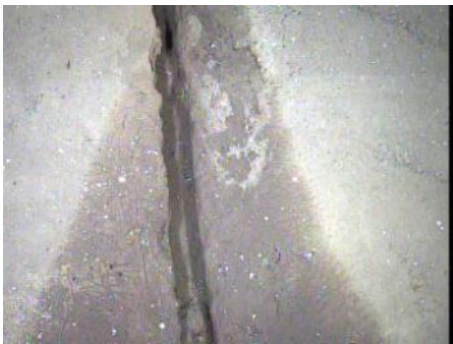
112.8 ft. U / Joint - Infiltration

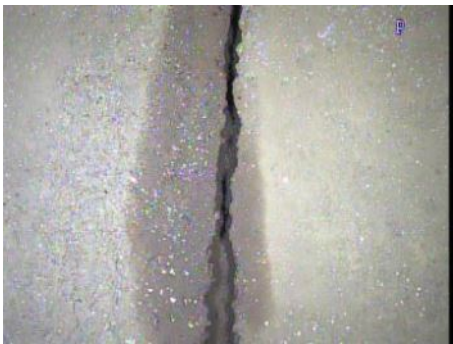
137.6 ft. U / Joint - Infiltration

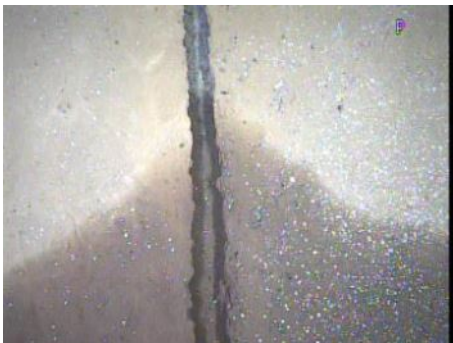
145.6 ft. U / Joint - Infiltration

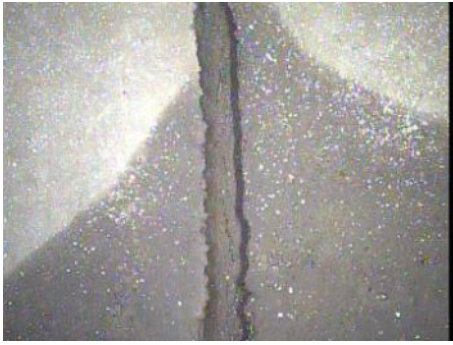
153.8 ft. U / Joint - Infiltration

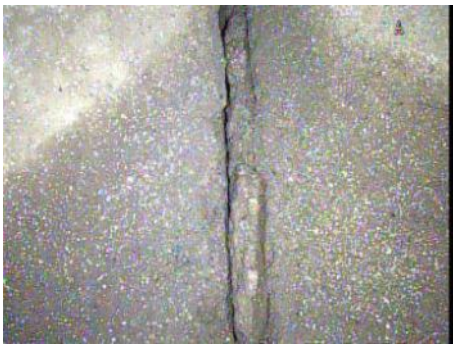
178.0 ft. U / Joint - Infiltration

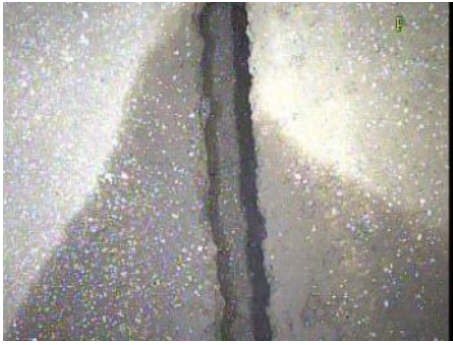
190.0 ft.	U		/	Joint - Infiltration			
-----------	---	--	---	----------------------	--	--	--

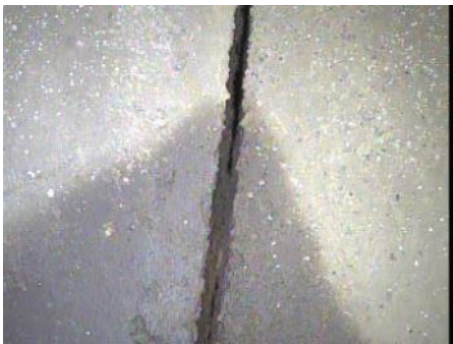
198.5 ft.	U		/	Joint - Infiltration			
-----------	---	--	---	----------------------	--	--	--

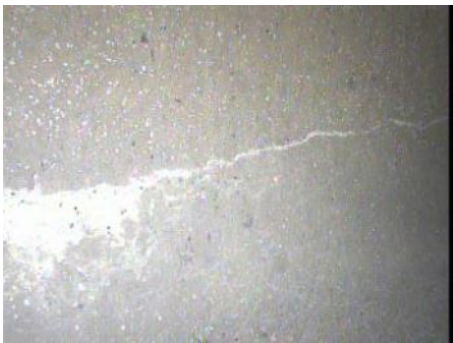
202.4 ft.	U		9 /	Crack			
-----------	---	--	-----	-------	--	--	--

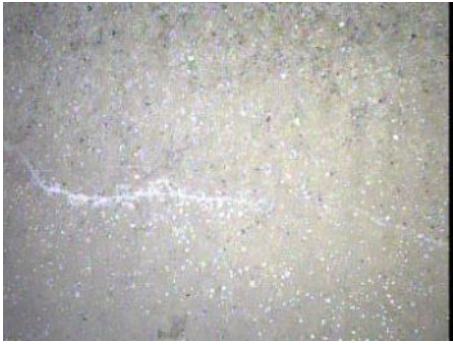
202.4 ft.	U		3 /	Crack			
-----------	---	--	-----	-------	--	--	--

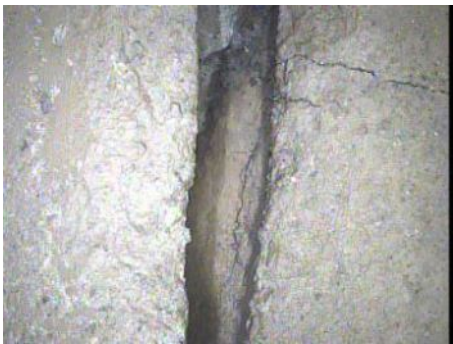
206.3 ft.	U		/	Joint - Separated			
-----------	---	--	---	-------------------	--	--	--

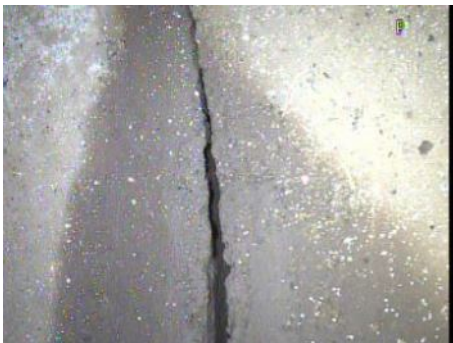
215.0 ft.	U		/	Joint - Infiltration			
-----------	---	--	---	----------------------	--	--	--

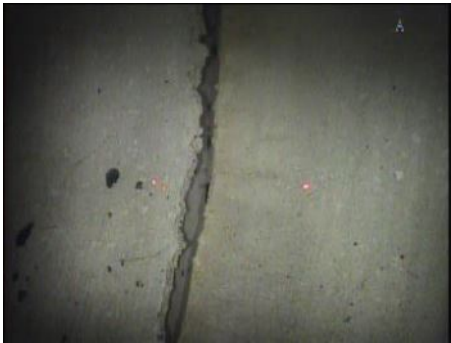
Distance	Dir.	Length	From/To Code	Modifier/Severity	Rating	Comments
3.5 ft.	D		/ Joint Offset

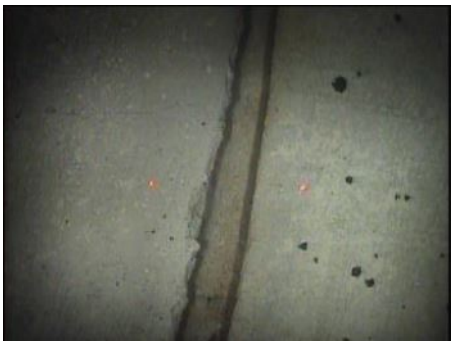
7.7 ft.	D		/ Joint Offset			
---------	---	--	----------------	--	--	--

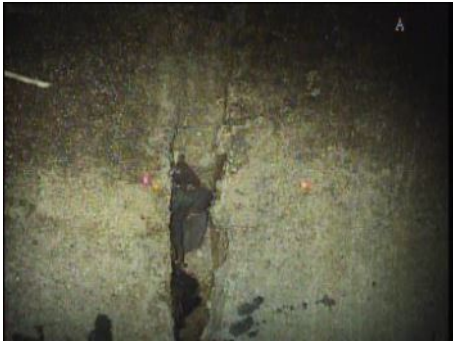
44.9 ft. D / Joint Offset

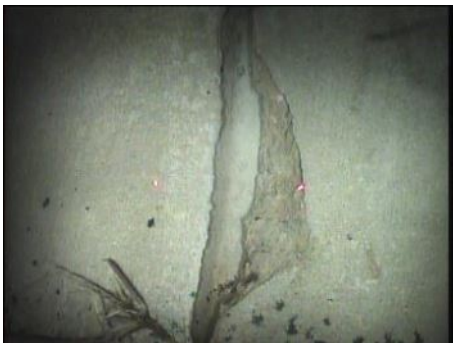
48.9 ft. D 3 / Broken

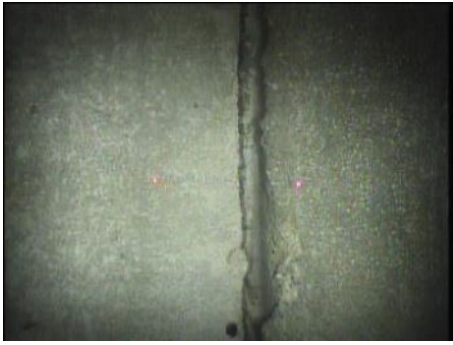
90.7 ft. D / Joint Offset Misaligned

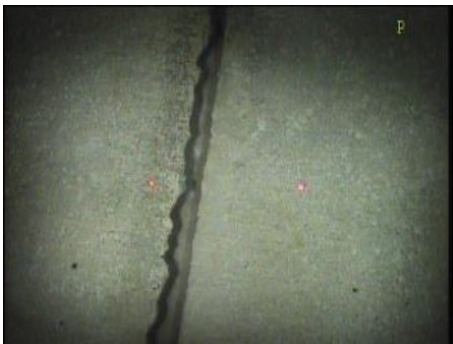
94.8 ft. D / Joint Offset

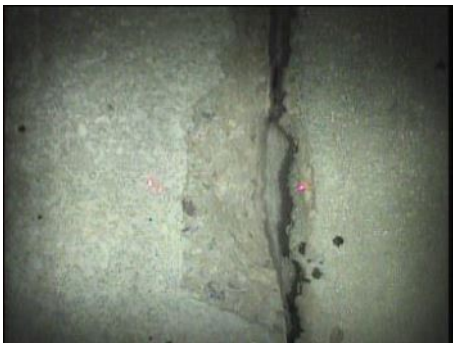
107.2 ft. D 9 / Broken

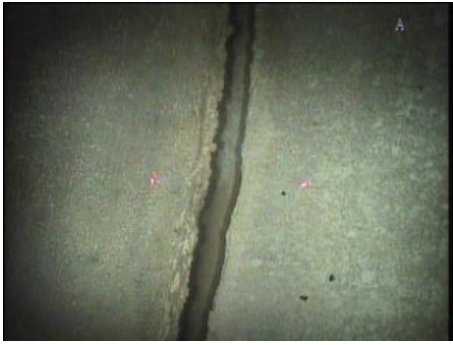
119.4 ft. D / Joint Offset Misaligned

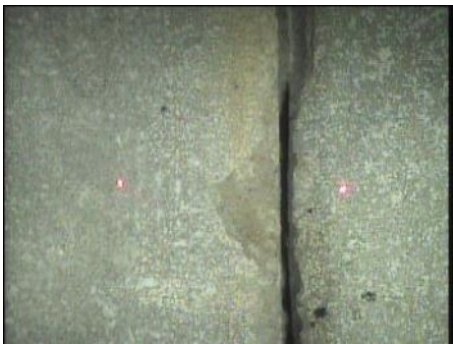
123.9 ft. D 9 / Chip

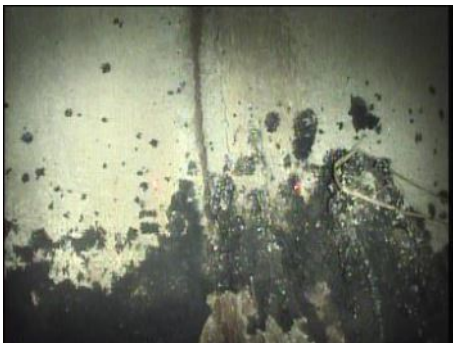
131.8 ft. D / Joint Offset

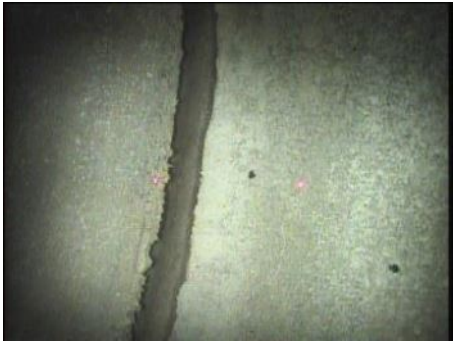
219.3 ft. D / Joint Offset Misaligned

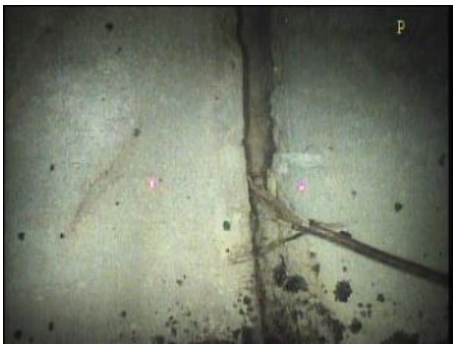
236.0 ft. D / Joint Offset

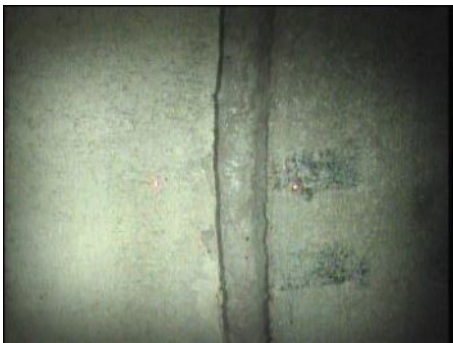
289.5 ft. D / Joint Offset Misaligned

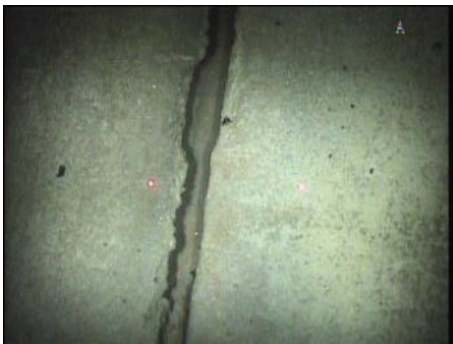
319.0 ft. D / Joint Offset

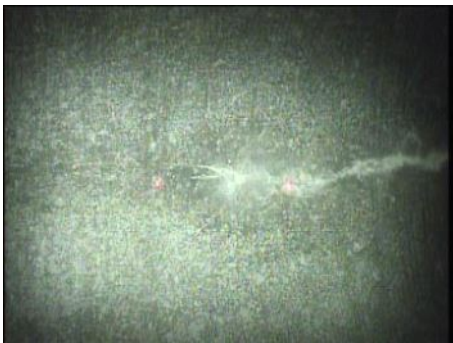
342.2 ft. D 9 / Crack

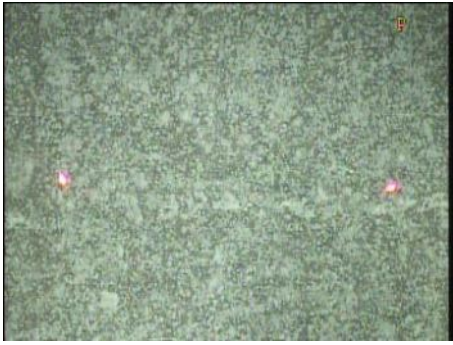
350.1 ft. D 9 / Crack

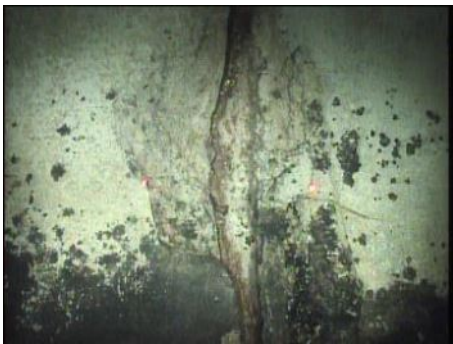
434.8 ft. D 9 / Broken

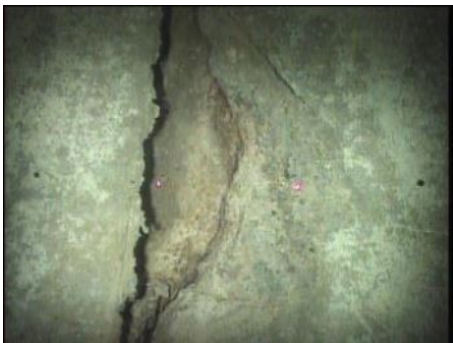
451.4 ft. D 3 / Broken

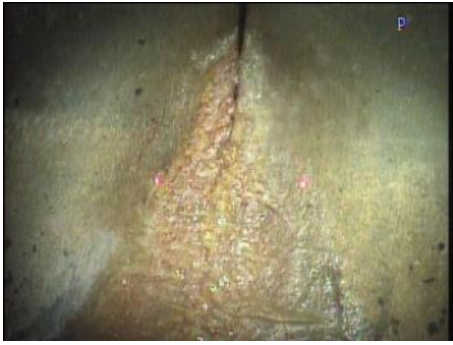
488.8 ft. D / Joint - Infiltration

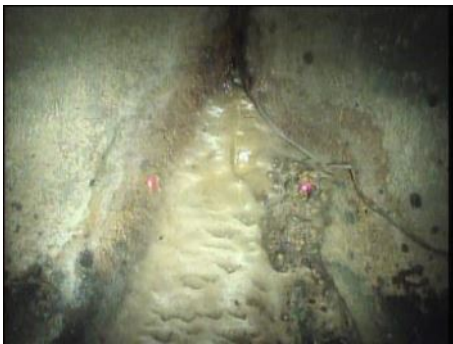
493.1 ft. D / Joint - Infiltration

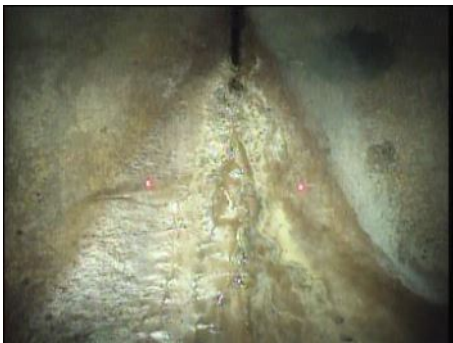
497.0 ft. D / Joint - Infiltration

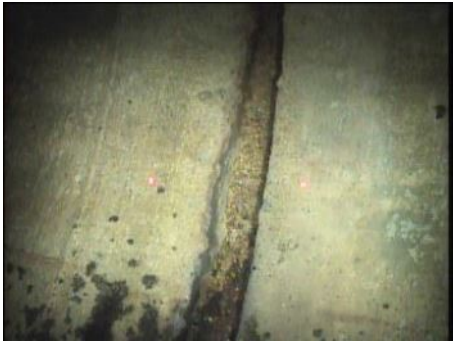
501.1 ft. D / Joint Offset

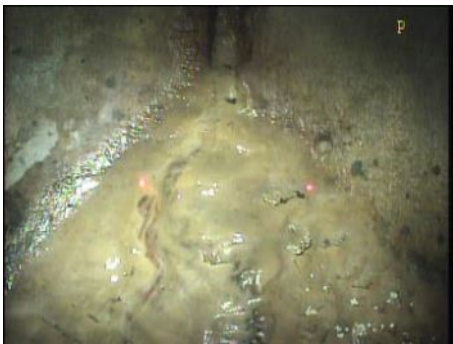
505.4 ft. D / Joint - Infiltration

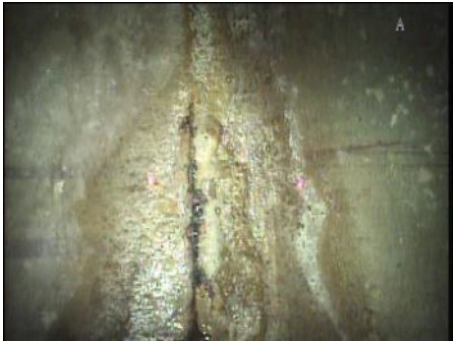
522.1 ft. D / Joint - Infiltration

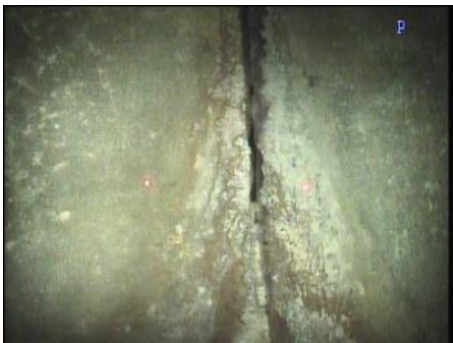
530.1 ft. D / Joint - Infiltration

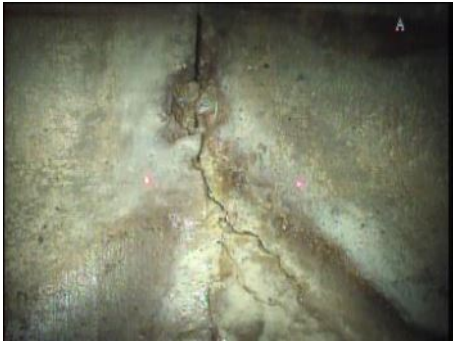
534.3 ft. D / Joint - Infiltration

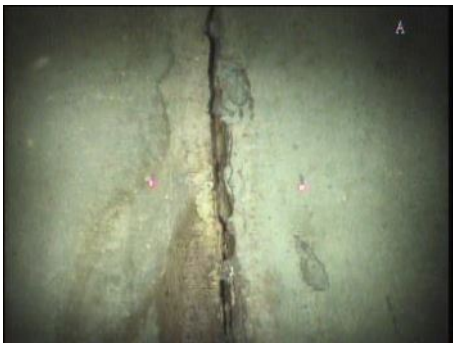
542.6 ft. D / Joint - Infiltration

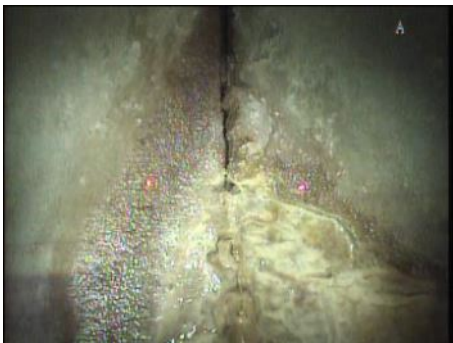
555.3 ft. D / Joint - Infiltration

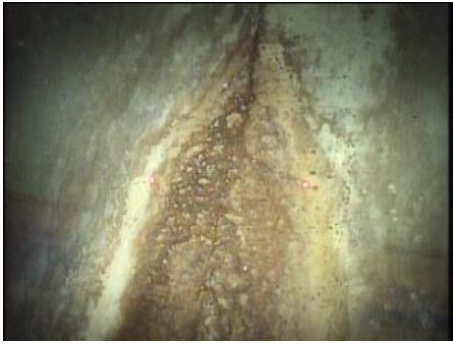
559.5 ft. D / Joint - Infiltration

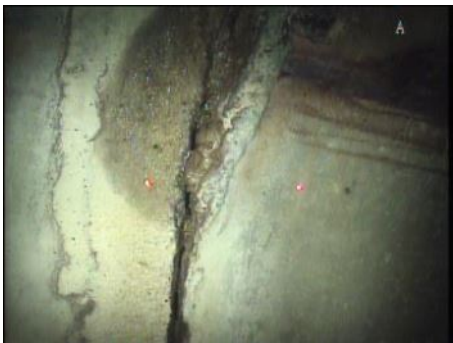
563.6 ft. D / Joint - Infiltration

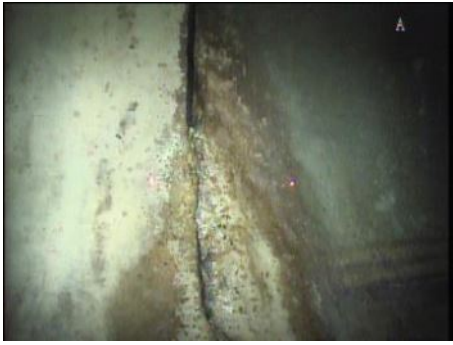
567.9 ft. D / Joint - Infiltration

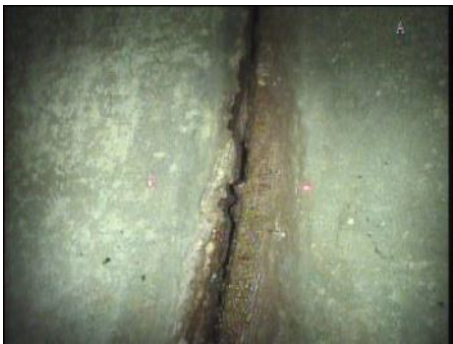
571.9 ft. D / Joint - Infiltration

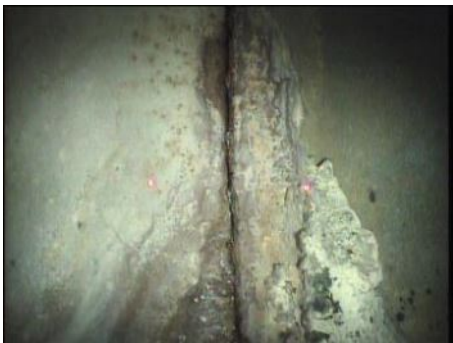
576.0 ft. D / Joint - Infiltration

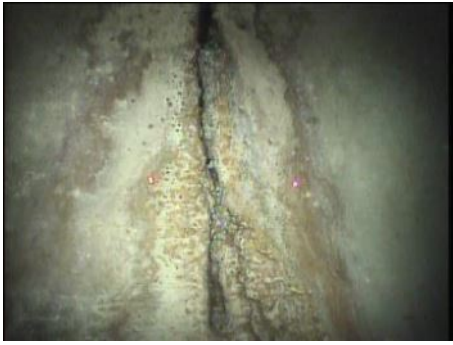
580.3 ft. D / Joint - Infiltration

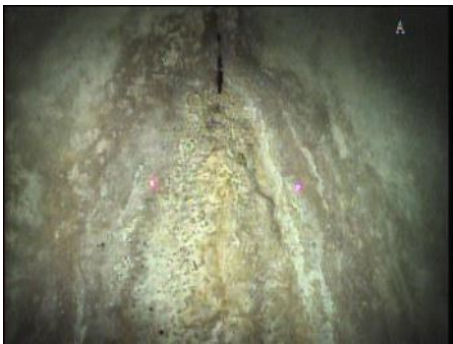
584.4 ft. D / Joint - Infiltration

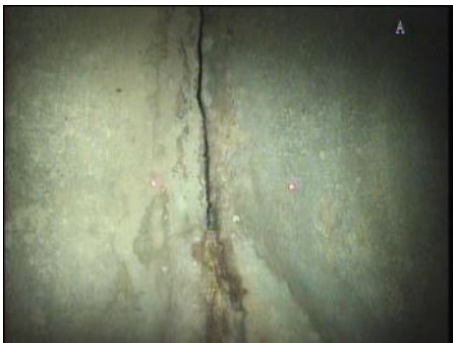
588.5 ft. D / Joint - Infiltration

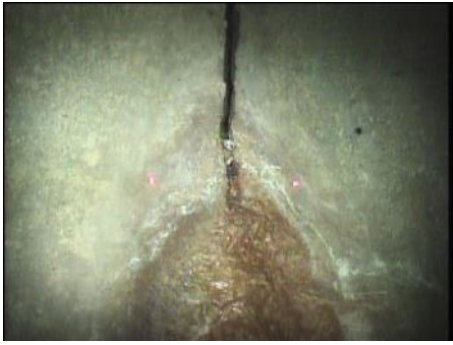
592.6 ft. D / Joint - Infiltration

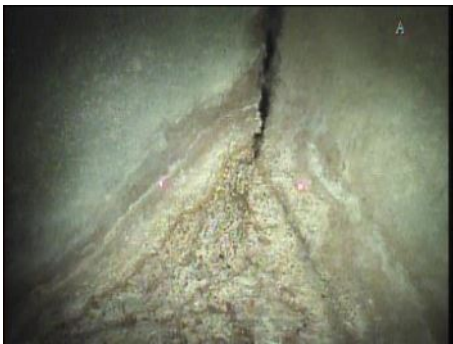
596.6 ft. D / Joint - Infiltration

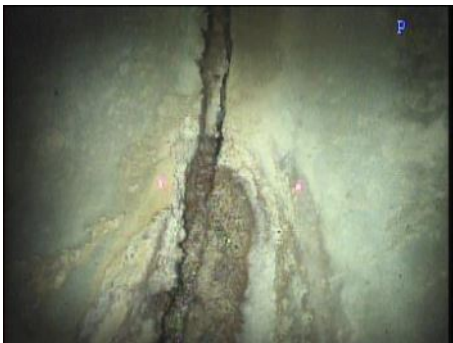
600.7 ft. D / Joint - Infiltration

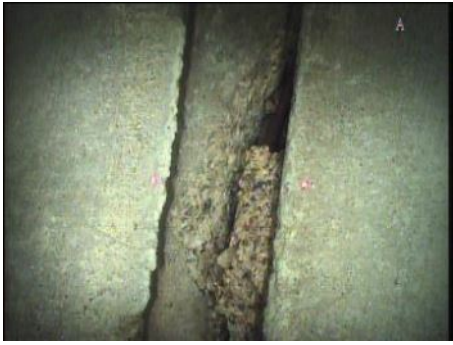
605.1 ft.	D		/	Joint Offset			
-----------	---	--	---	--------------	--	--	--

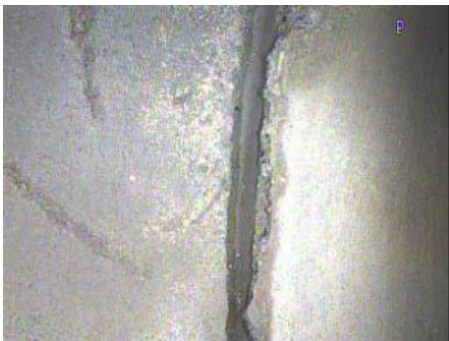
21.1 ft.	U		/	Joint Offset			
----------	---	--	---	--------------	--	--	--

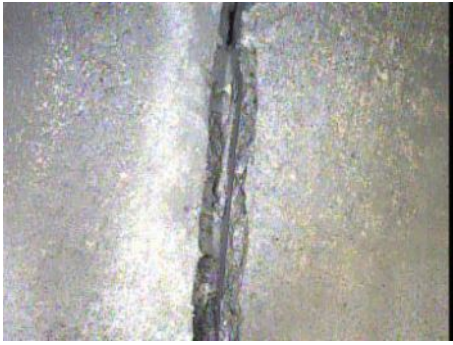
25.0 ft. U / Joint Offset

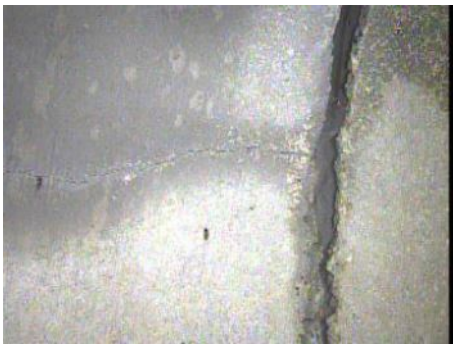
29.1 ft. U / Joint Offset

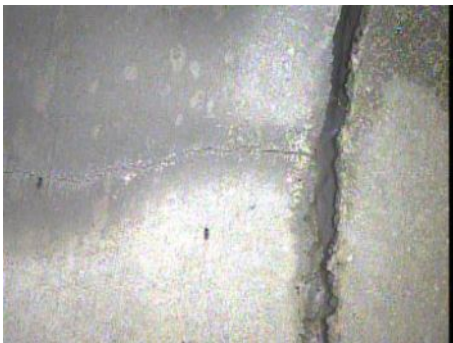
29.3 ft. U 3 / Crack

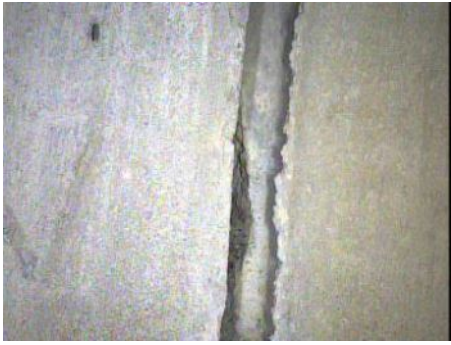
45.9 ft. U / Joint Offset

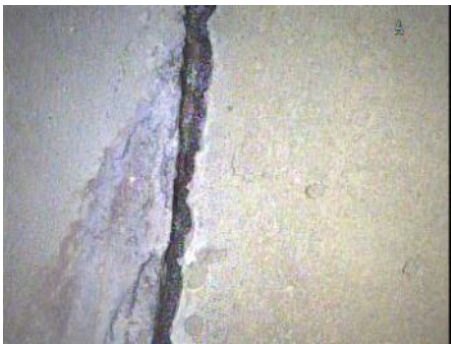
58.0 ft. U / Joint - Infiltration

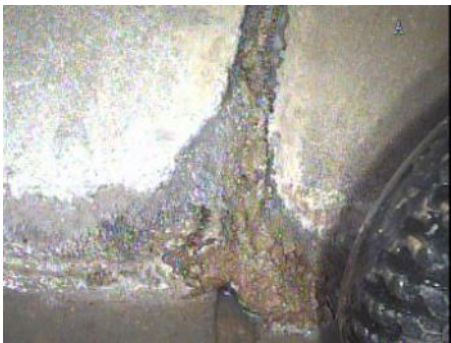
62.6 ft. U / Joint - Infiltration

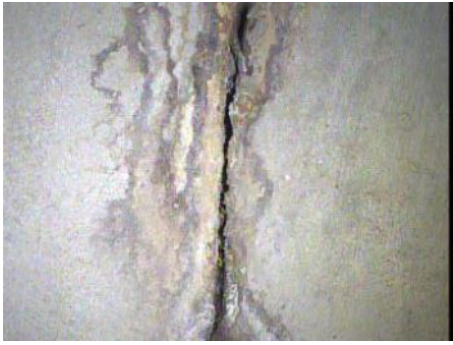
79.0 ft. U / Joint - Infiltration

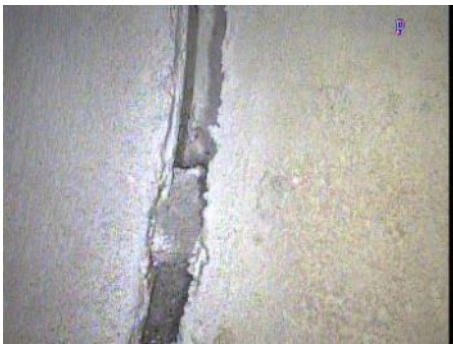
95.1 ft. U / Joint Offset

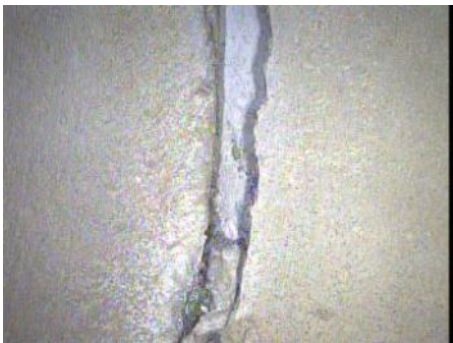
99.4 ft. U / Joint Offset

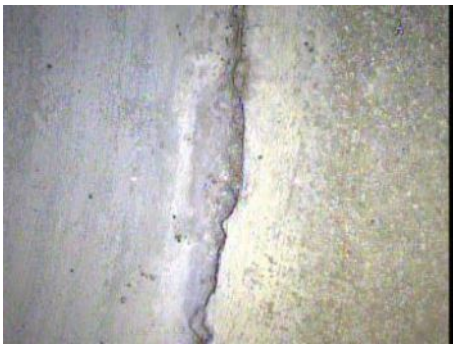
136.3 ft. U / Joint - Infiltration

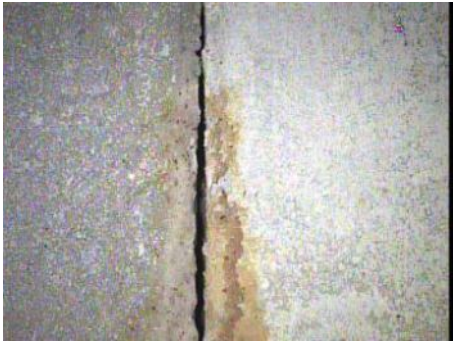
157.4 ft. U / Joint - Infiltration

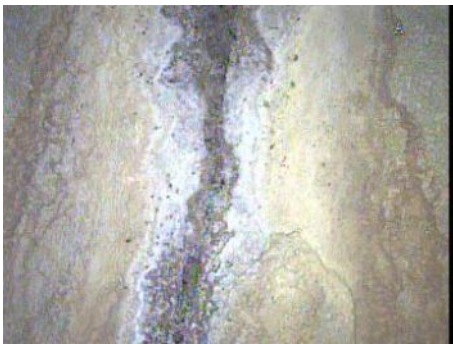
161.4 ft. U / Joint - Infiltration

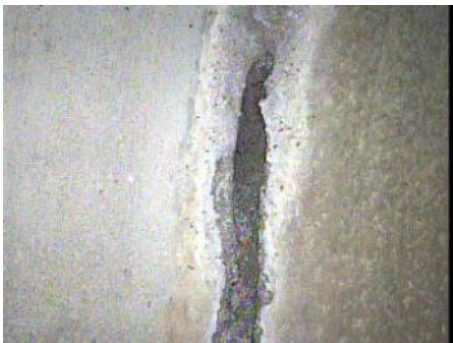
165.9 ft. U / Joint Offset

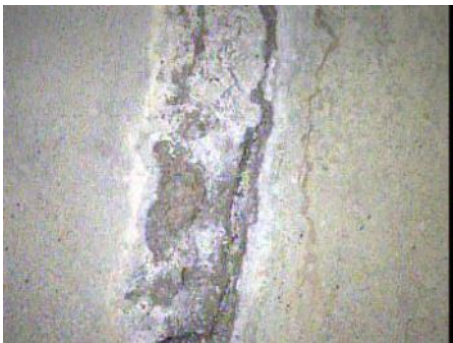
186.3 ft. U / Joint Offset

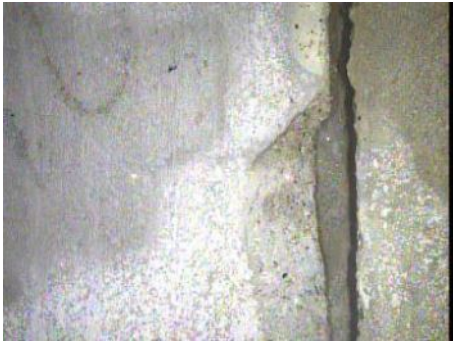
203.1 ft.	U		12 /	Crack			
-----------	---	--	------	-------	--	--	--

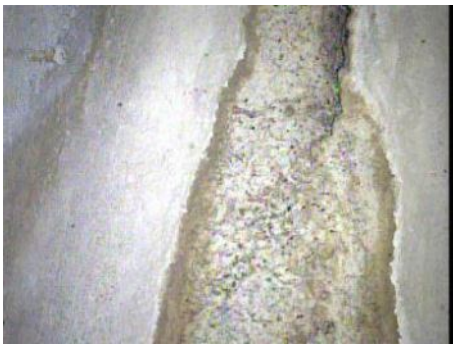
219.5 ft.	U		/	Joint - Infiltration			
-----------	---	--	---	----------------------	--	--	--

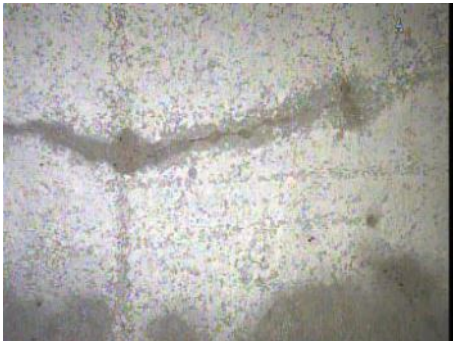
228.6 ft.	U	28.4 ft.	12 /	Crack			
-----------	---	----------	------	-------	--	--	--

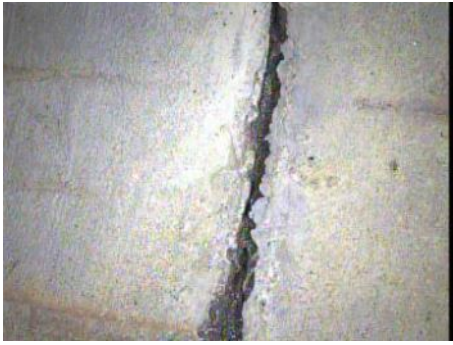
231.7 ft. U / Joint Offset

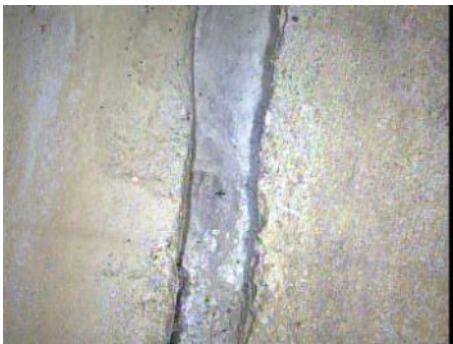
236.0 ft. U / Joint Offset

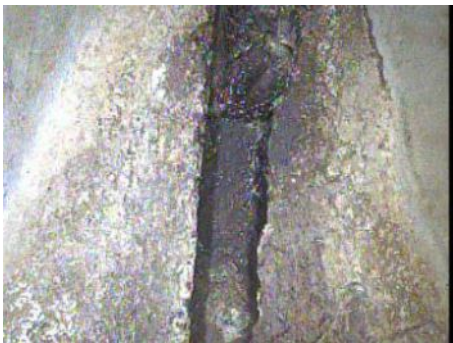
240.3 ft. U / Joint Offset

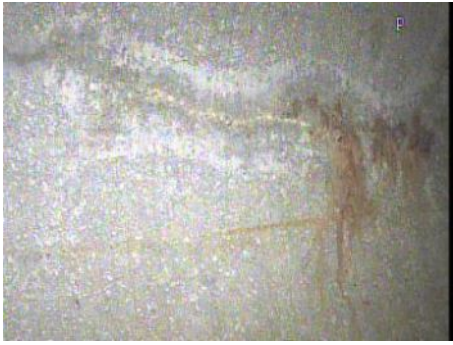
243.0 ft. U 10 / Crack

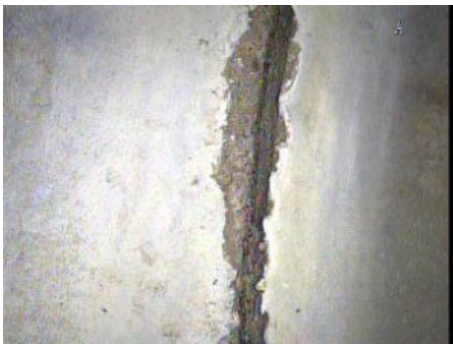
248.9 ft. U / Joint - Infiltration

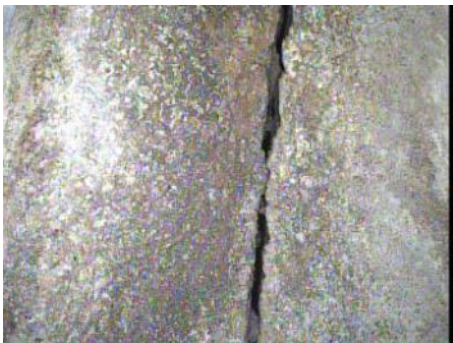
252.9 ft. U / Joint - Infiltration

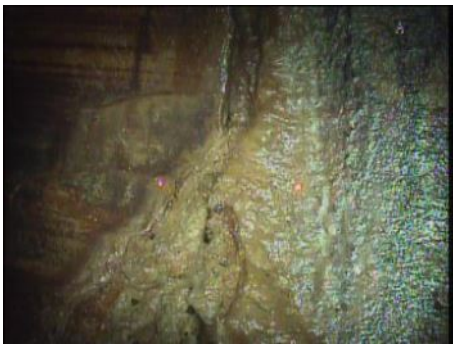
25.5 ft. D / Joint - Infiltration

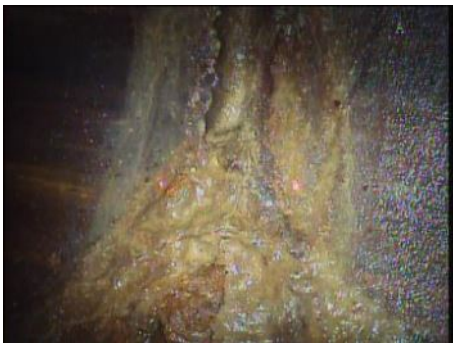
33.5 ft. D / Joint - Infiltration

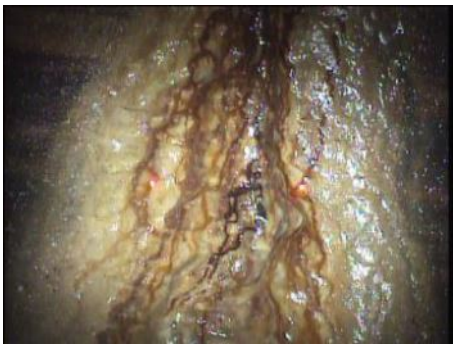
50.2 ft. D / Joint - Infiltration

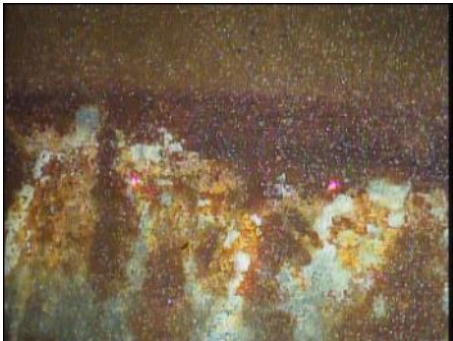
54.8 ft. D 3 / Crack

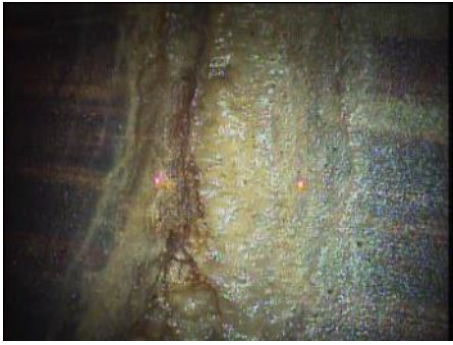
58.2 ft. D / Joint - Infiltration

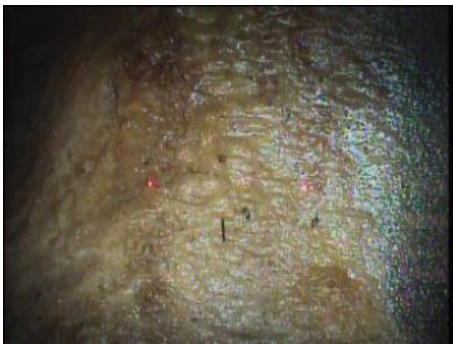
66.5 ft. D / Joint - Infiltration

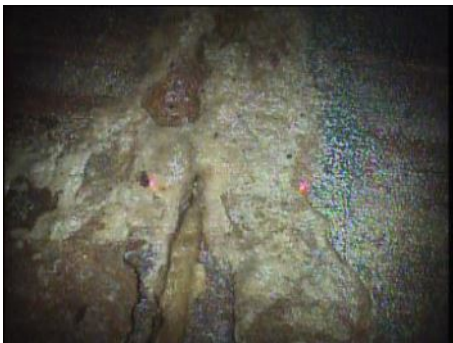
74.7 ft. D / Joint - Infiltration

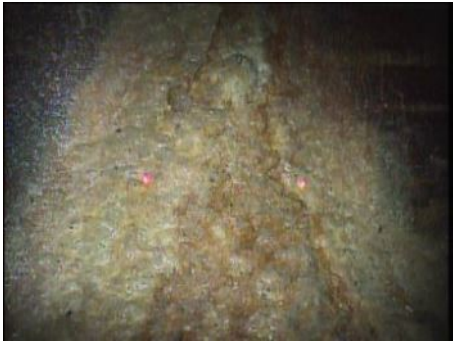
82.8 ft. D / Joint - Infiltration

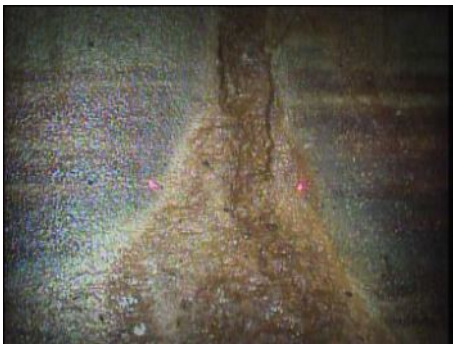
91.0 ft. D / Joint - Infiltration

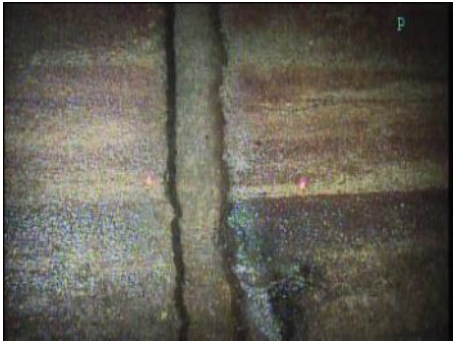
123.7 ft. D / Joint Offset

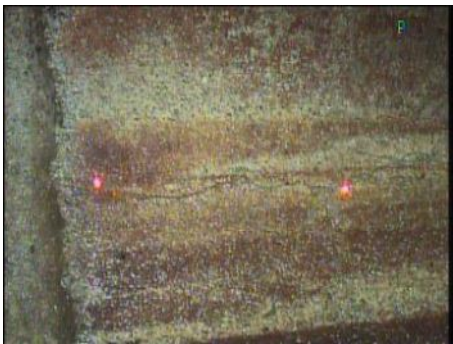
123.8 ft. D 9 / Crack

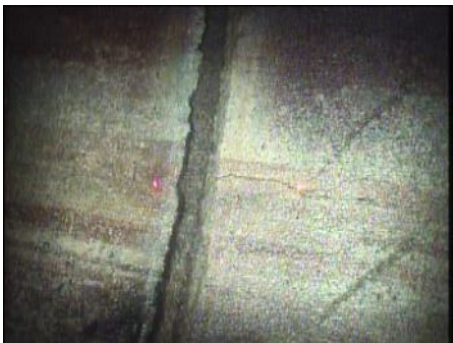
131.9 ft. D / Joint Offset

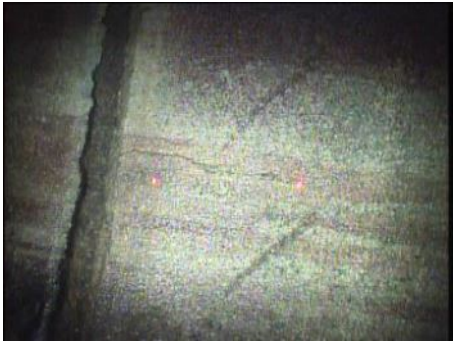
131.9 ft. D 3 / Crack

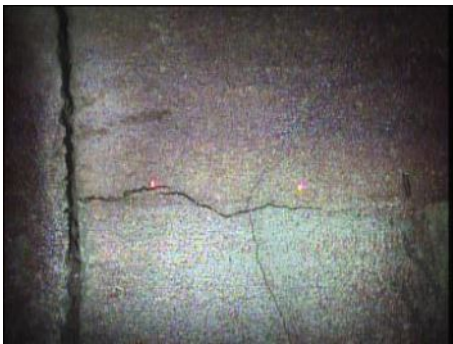
131.9 ft. D 12 / Crack
