I-26 & I-95 INTERCHANGE IMPROVEMENTS

June 29, 2023

PIPE INSPECTION REPORT

This report contains the results of the video pipe inspection and assessment of the existing storm water drainage pipes within the project area in Orangeburg and Dorchester Counties.

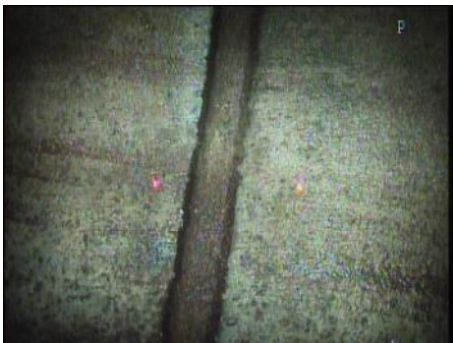
140.1 ft. D / Joint Offset

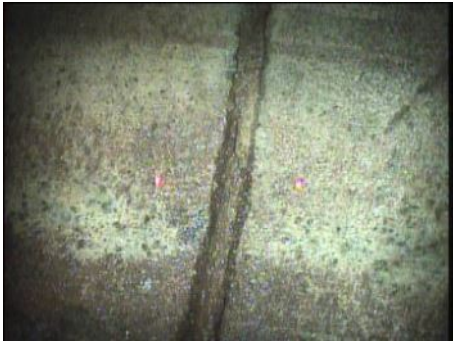
148.2 ft. D / Joint Offset

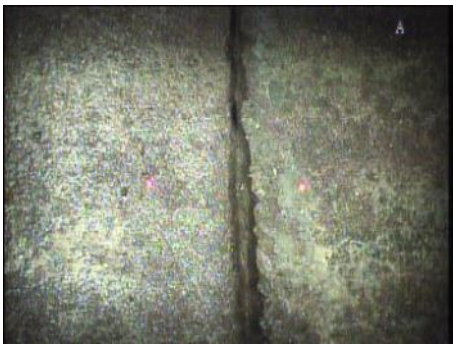
164.5 ft. D / Joint Offset

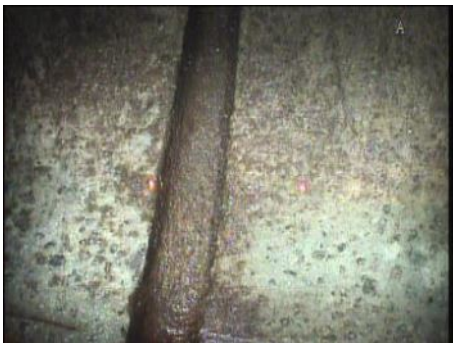
199.4 ft. D / Joint Offset

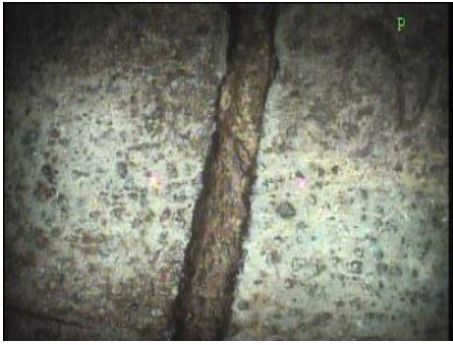
207.7 ft. D / Joint Offset

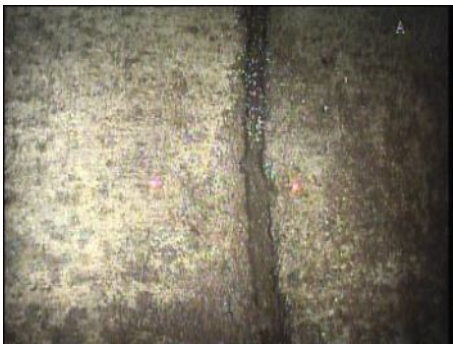
223.9 ft. D / Joint Offset

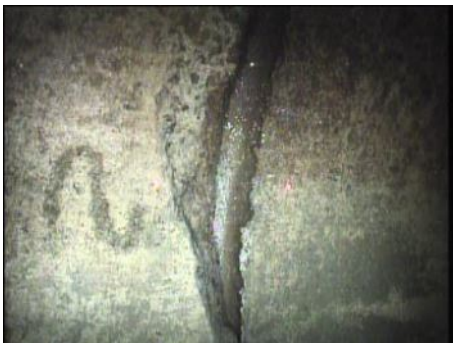
224.0 ft. D 3 / Broken

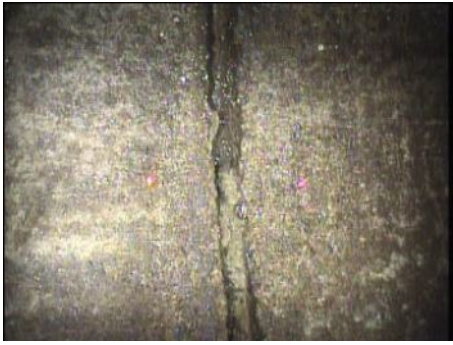
228.2 ft. D / Joint Offset

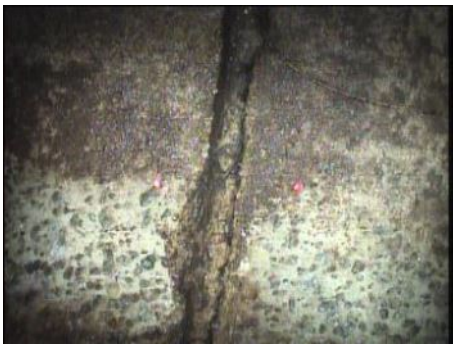
232.4 ft. D / Joint Offset

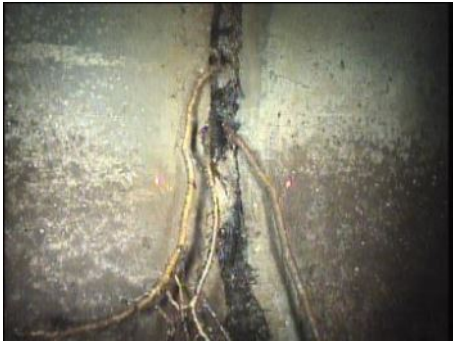
248.6 ft. D / Root-in-Joint

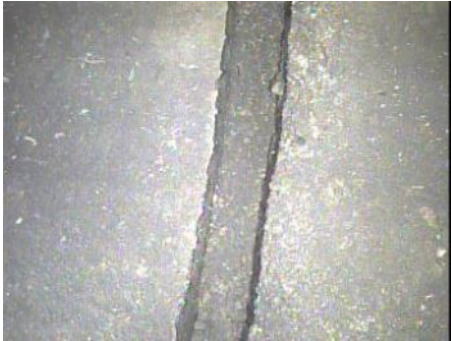
Distance	Dir.	Length	From/To Code	Modifier/Severity	Rating	Comments
56.9 ft.	U		/ Joint Offset

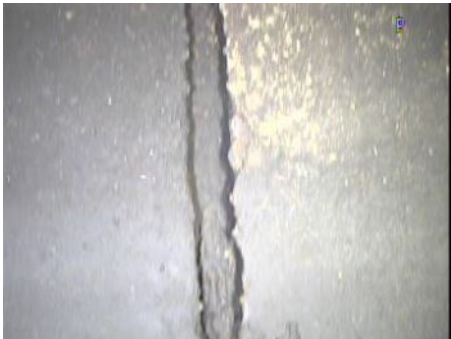
61.1 ft.	U		/ Joint Offset			
----------	---	--	----------------	--	--	--

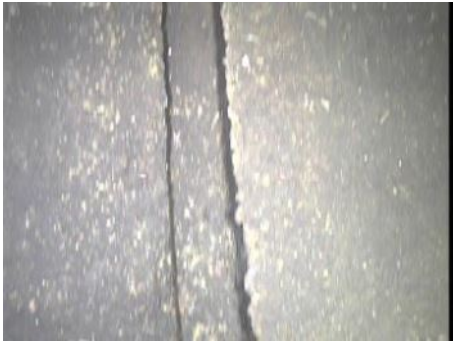
65.2 ft.	U		/	Joint Offset			
----------	---	--	---	--------------	--	--	--

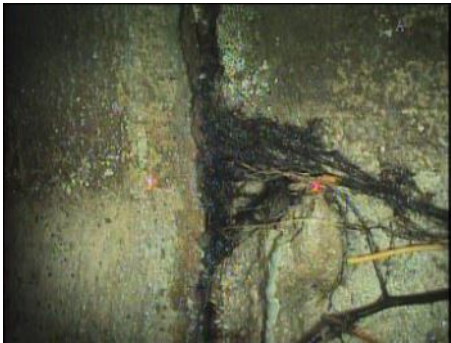
Distance	Dir.	Length	From/To	Code	Modifier/Severity	Rating	Comments
6.0 ft.	U		4 / 7	Root-in-Joint

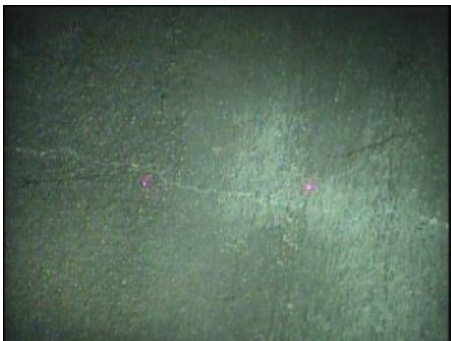
6.0 ft.	U	115.7 ft.	12 /	Crack			
---------	---	-----------	------	-------	--	--	--

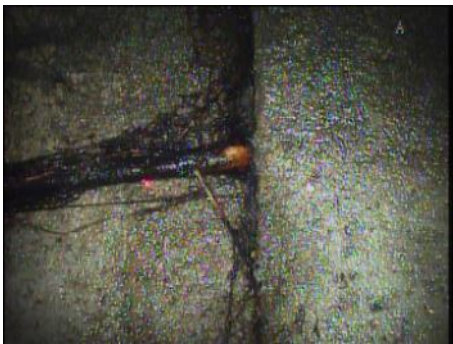
21.8 ft. U / Root-in-Joint

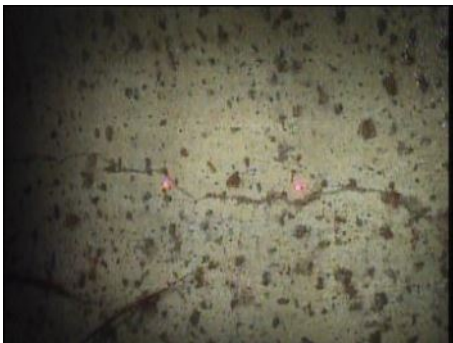
24.4 ft. U 5.6 ft. 6 / Crack

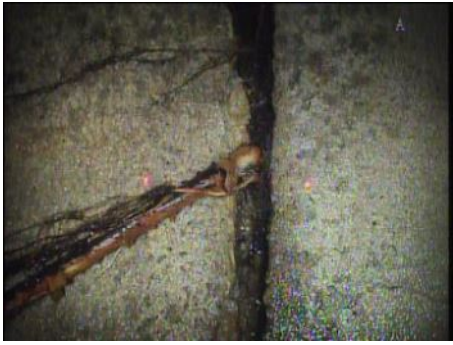
30.0 ft. U / Root-in-Joint

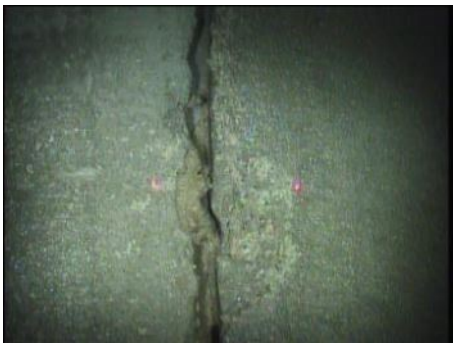
71.2 ft. U 10 / Chip

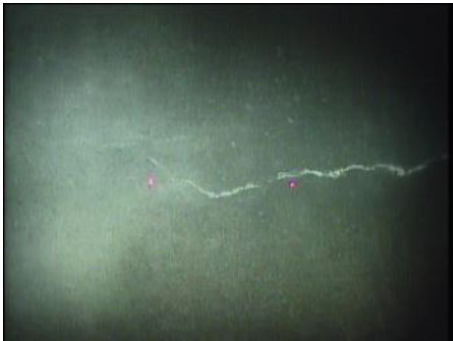
96.6 ft.	U		9 /	Crack		
----------	---	--	-----	-------	--	--

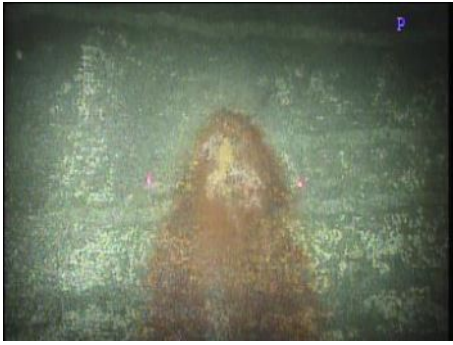
Distance	Dir.	Length	From/To Code	Modifier/Severity	Rating	Comments
141.7 ft.	U		8 /	Surface Damage

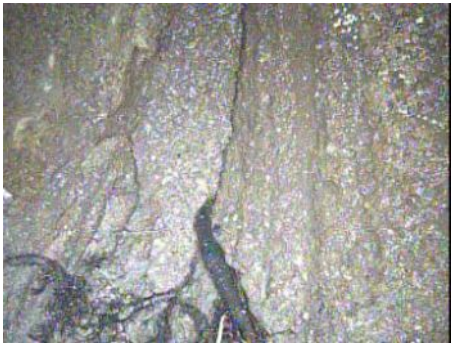
Distance	Dir.	Length	From/To	Code	Modifier/Severity	Rating	Comments
2.9 ft.	U		/	Joint - Separated

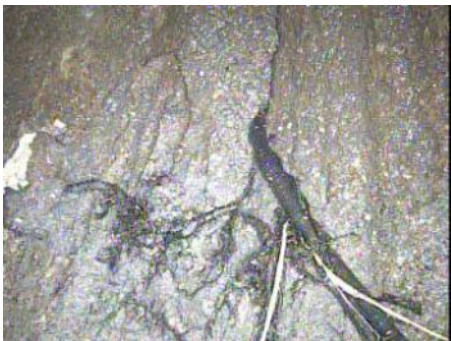
2.9 ft.	U		/	Root-in-Joint			
---------	---	--	---	---------------	--	--	--

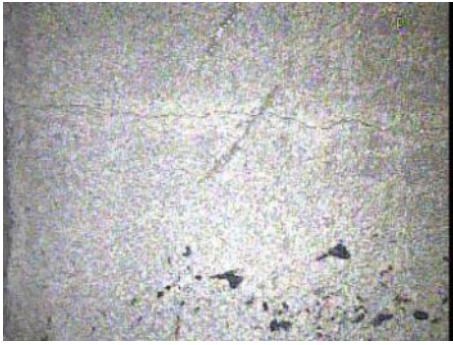
2.9 ft. U 12 / Crack

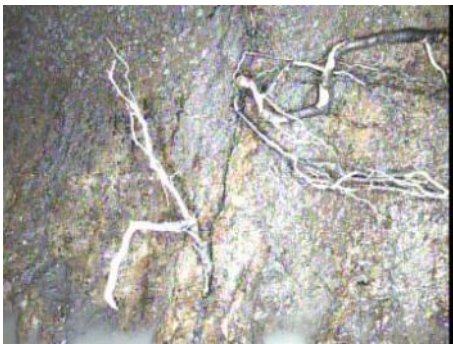
6.8 ft. U / Root-in-Joint

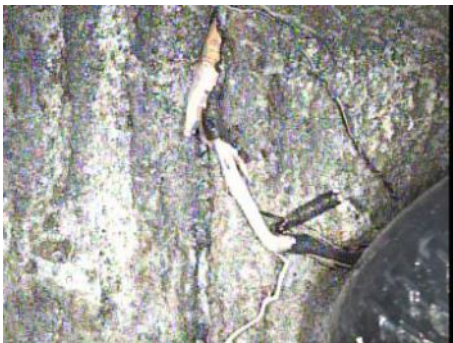
11.5 ft. U / Root-in-Joint

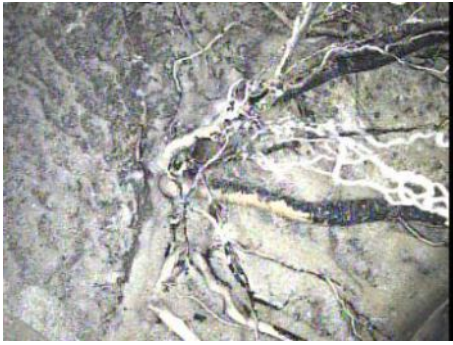
19.8 ft. U / Root-in-Joint

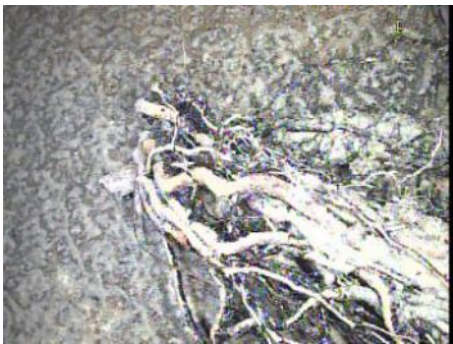
23.8 ft. U / Root-in-Joint

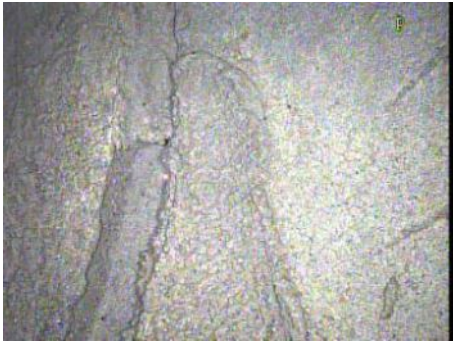
Distance	Dir.	Length	From/To Code	Modifier/Severity	Rating	Comments
60.5 ft.	U		/	Broken

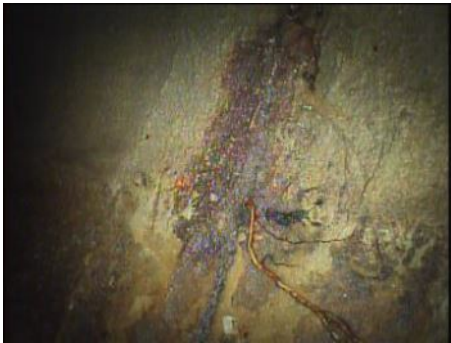
Distance	Dir.	Length	From/To	Code	Modifier/Severity	Rating	Comments
3.3 ft.	U		/	Root-in-Joint

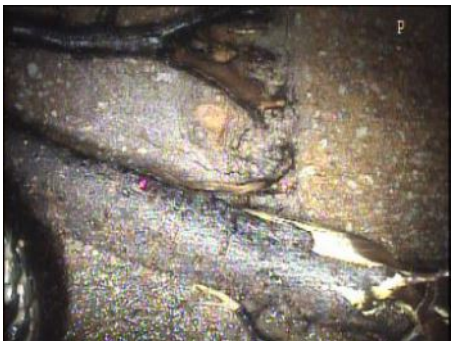
20.5 ft.	U		/	Root-in-Joint			
----------	---	--	---	---------------	--	--	--

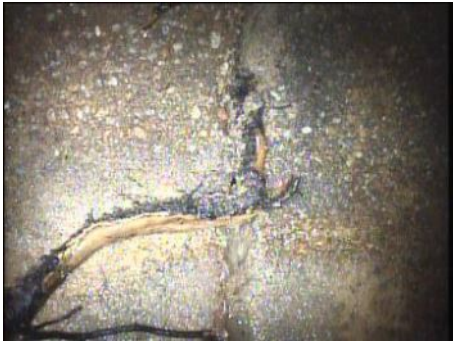
32.0 ft. U / Root-in-Joint

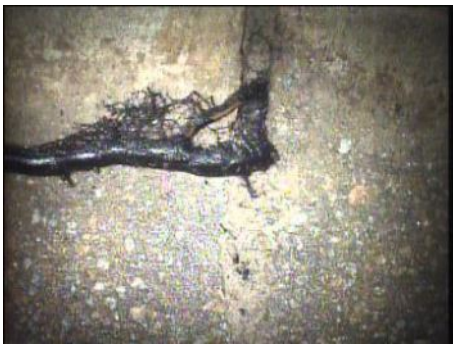
36.3 ft. U / Root-in-Joint

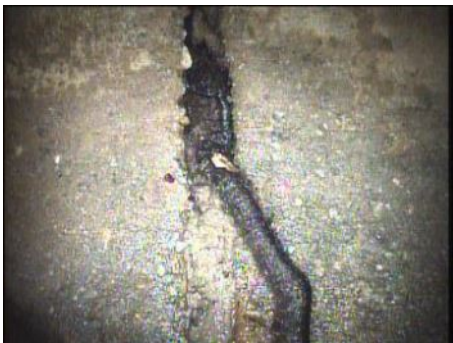
40.7 ft. U / Root-in-Joint

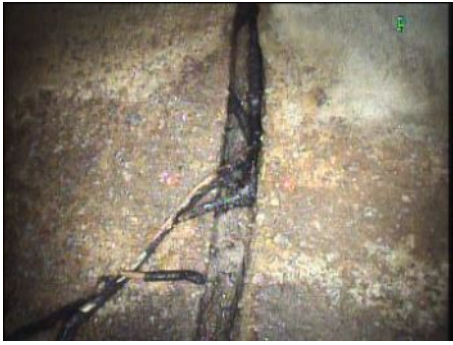
44.6 ft. U / Root-in-Joint

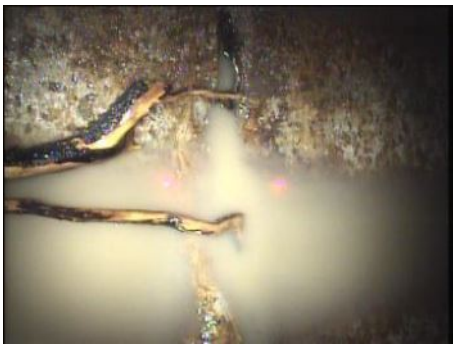
48.4 ft. U / Root-in-Joint

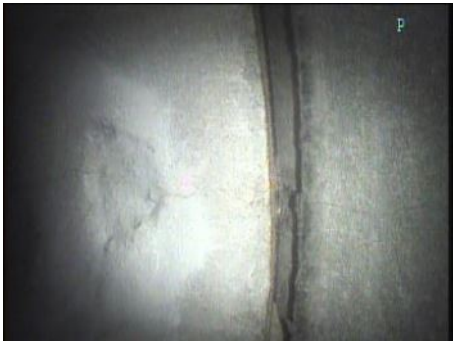
52.6 ft. U 108.1 ft. 12 / Crack

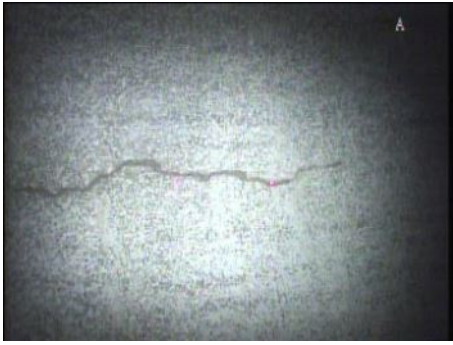
103.0 ft. U 9 / Crack

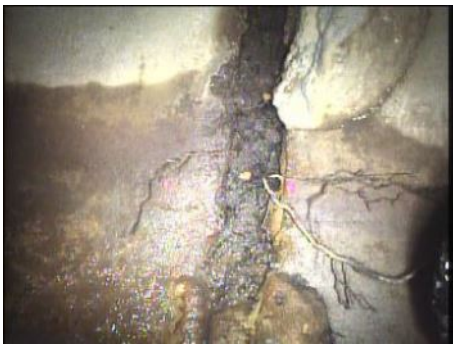
135.5 ft. U / Root-in-Joint

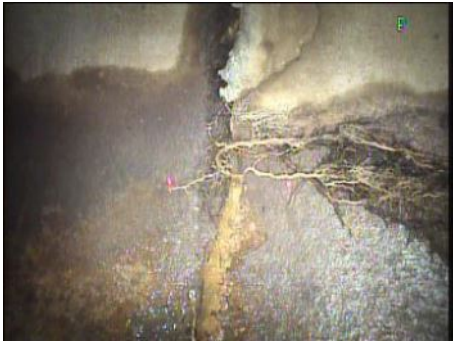
143.7 ft. U / Root-in-Joint

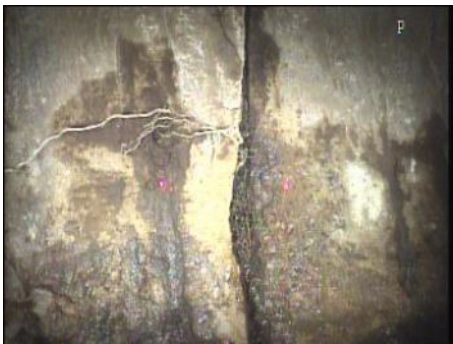
148.0 ft. U / Root-in-Joint

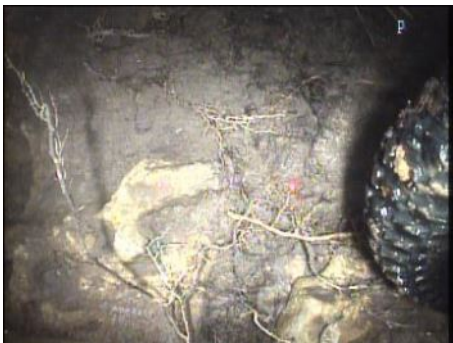
152.5 ft. U / Root-in-Joint

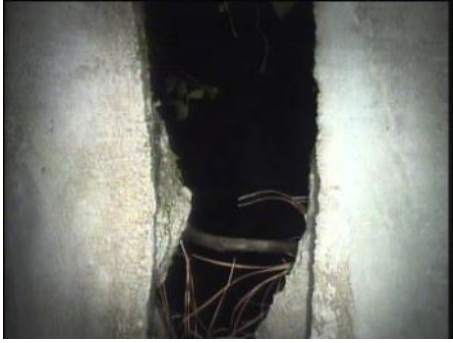
Distance	Dir.	Length	From/To Code	Modifier/Severity	Rating	Comments
156.3 ft.	U		/	Joint - Separated

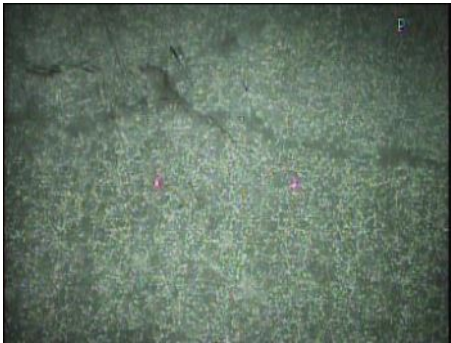
Distance	Dir.	Length	From/To	Code	Modifier/Severity	Rating	Comments
5.3 ft.	U	77.3 ft.	12 /	Crack

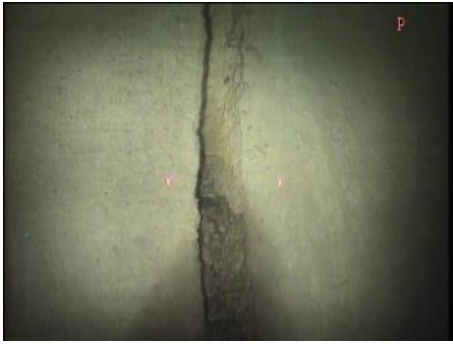
76.7 ft. U / Joint Offset

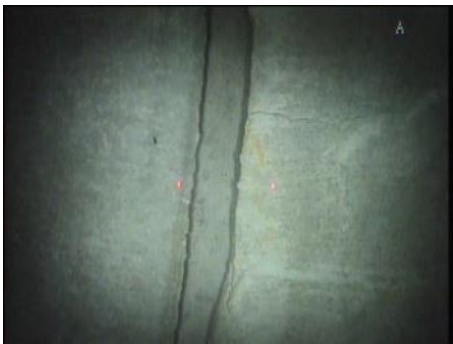
81.3 ft. U / Joint Offset

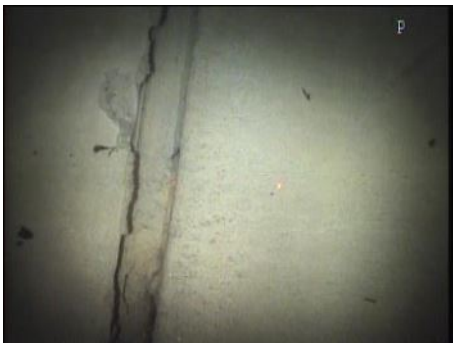
89.5 ft. U / Joint Offset

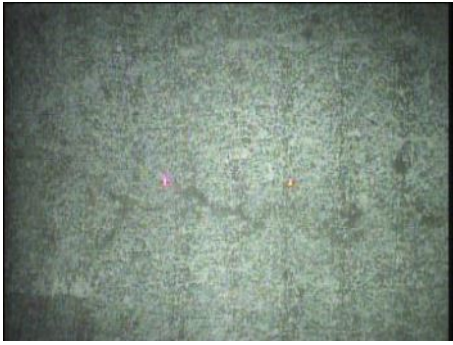
91.1 ft. U 12 / Crack

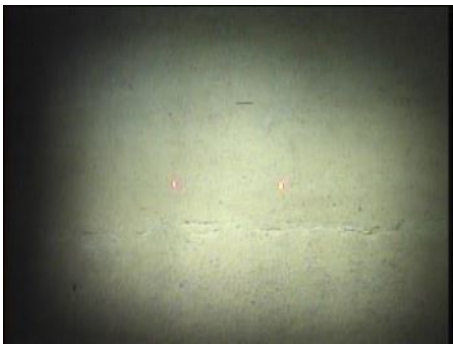
123.8 ft. U 9 / Crack

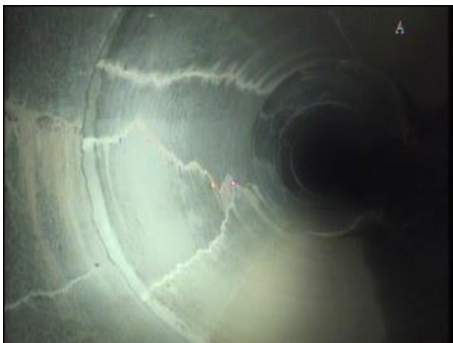
124.3 ft. U 14.8 ft. 10 / Crack

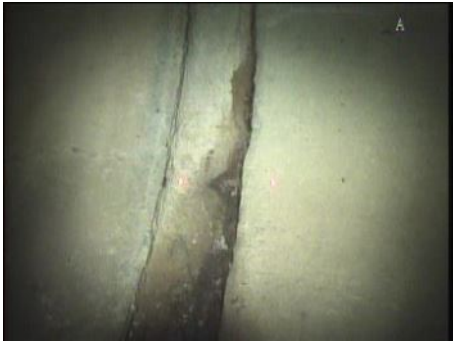
130.3 ft. U / Joint Offset

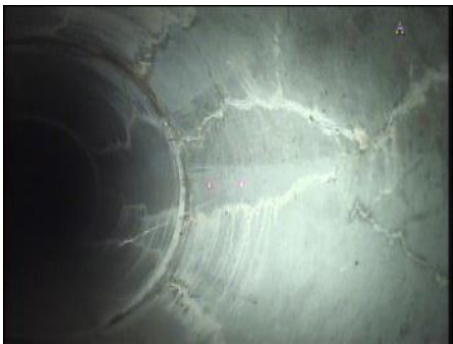
131.0 ft. U 10 / 2 Crack Multiple - Wider

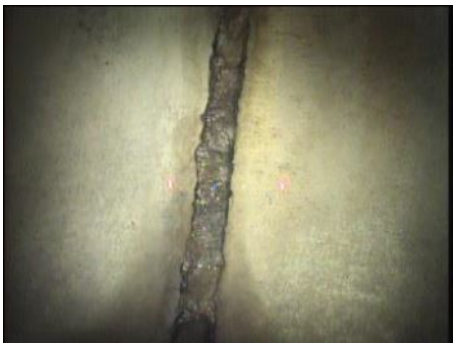
139.1 ft. U / Joint - Infiltration

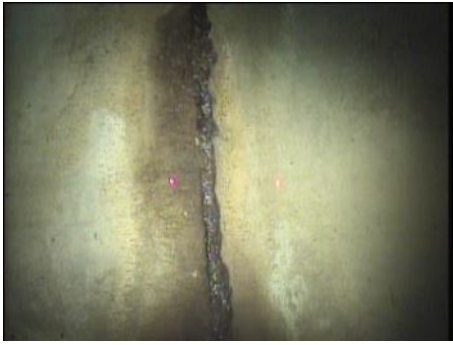
142.9 ft. U / Joint - Infiltration

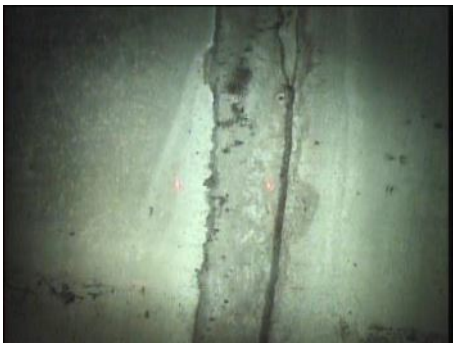
155.5 ft. U / Joint- Wide

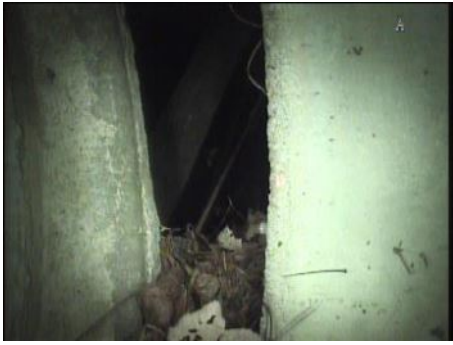
159.5 ft. U / Joint - Separated

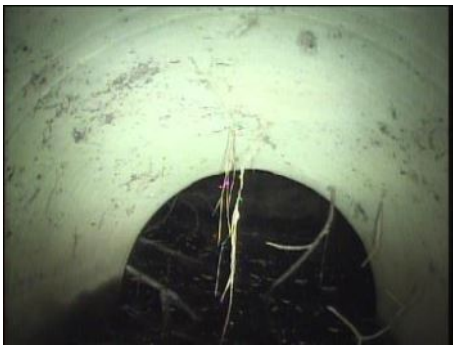
160.0 ft. U / Abandoned Survey

Last Joint Separated from Pipe

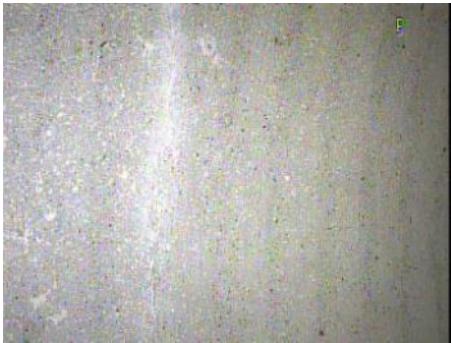
Distance	Dir.	Length	From/To Code	Modifier/Severity	Rating	Comments
3.0 ft.	U		5 / 10 Crack

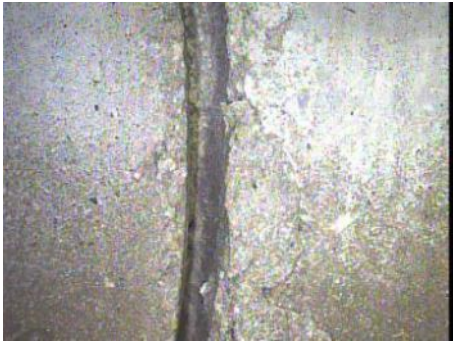
14.4 ft. U / Joint Offset

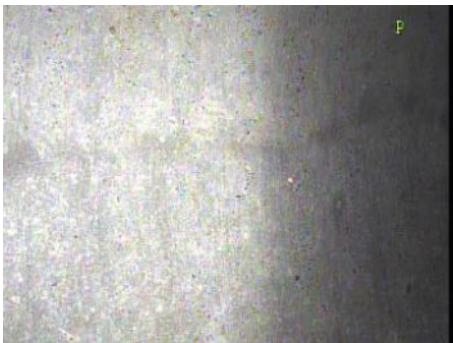
19.3 ft. U 10.6 ft. 12 / Crack

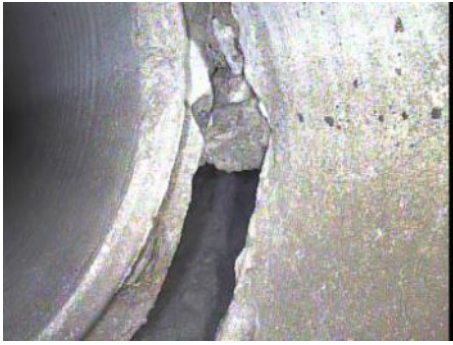
29.7 ft.	U		/	Joint - Separated			
----------	---	--	---	-------------------	--	--	--

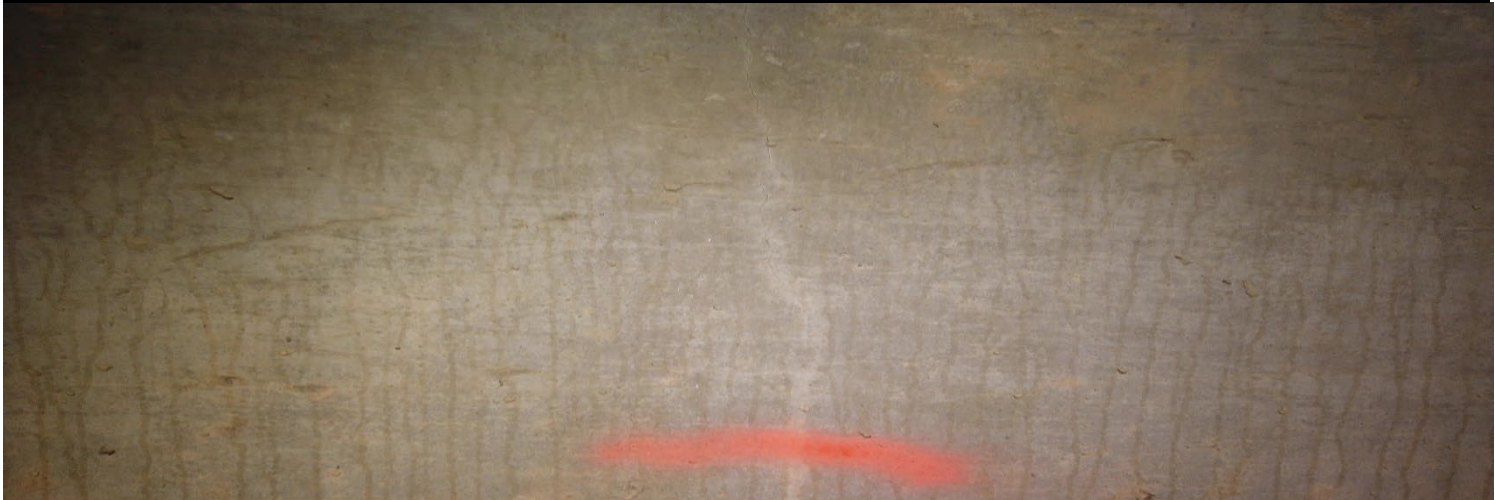
Footage	Defect Description	Top	Right	Left	Bottom
18 ft	Crack			Y

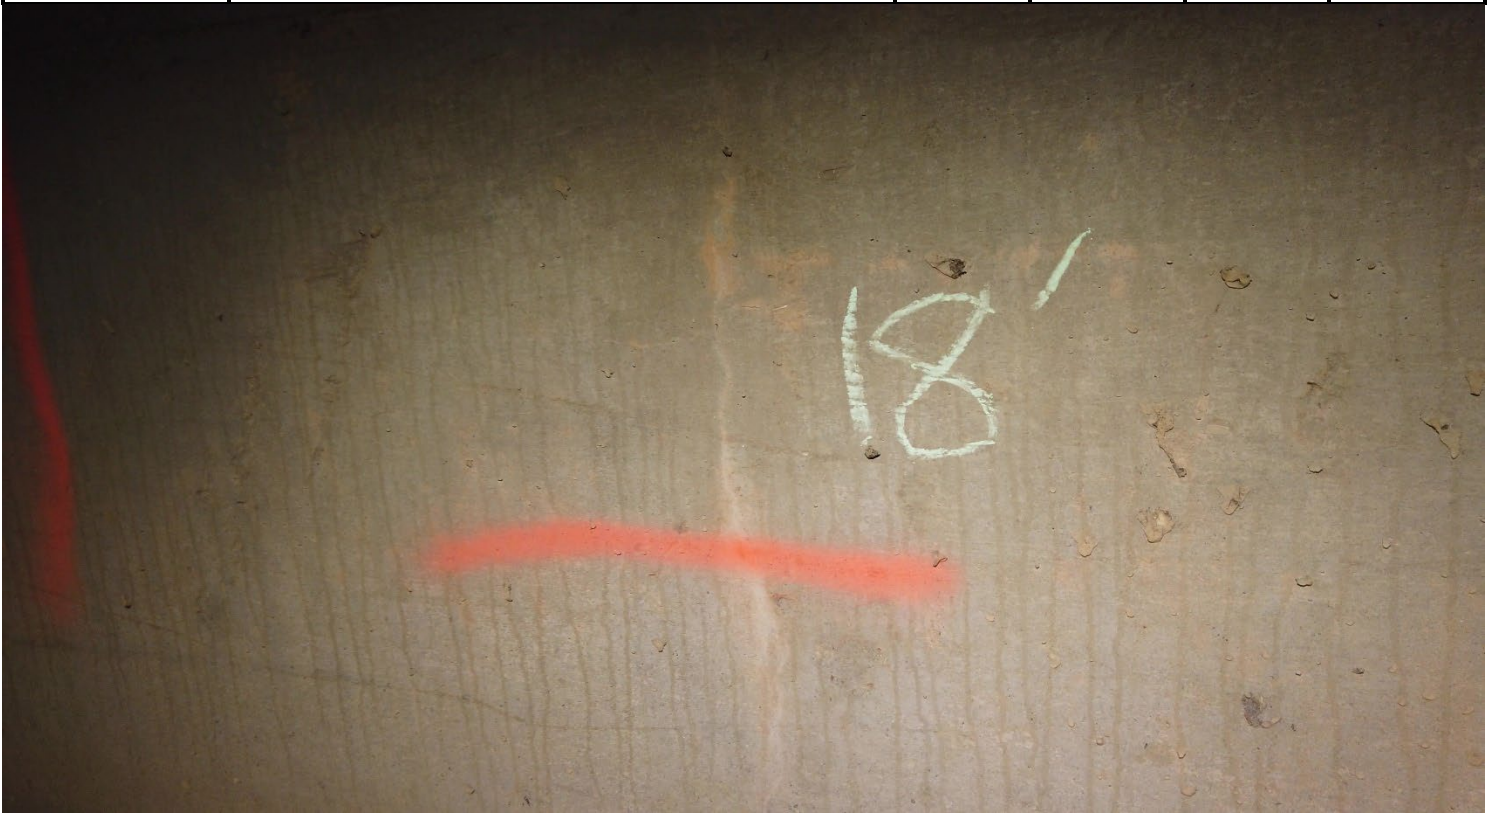
Footage	Defect Description	Top	Right	Left	Bottom
18 ft	Crack and Infiltration		Y

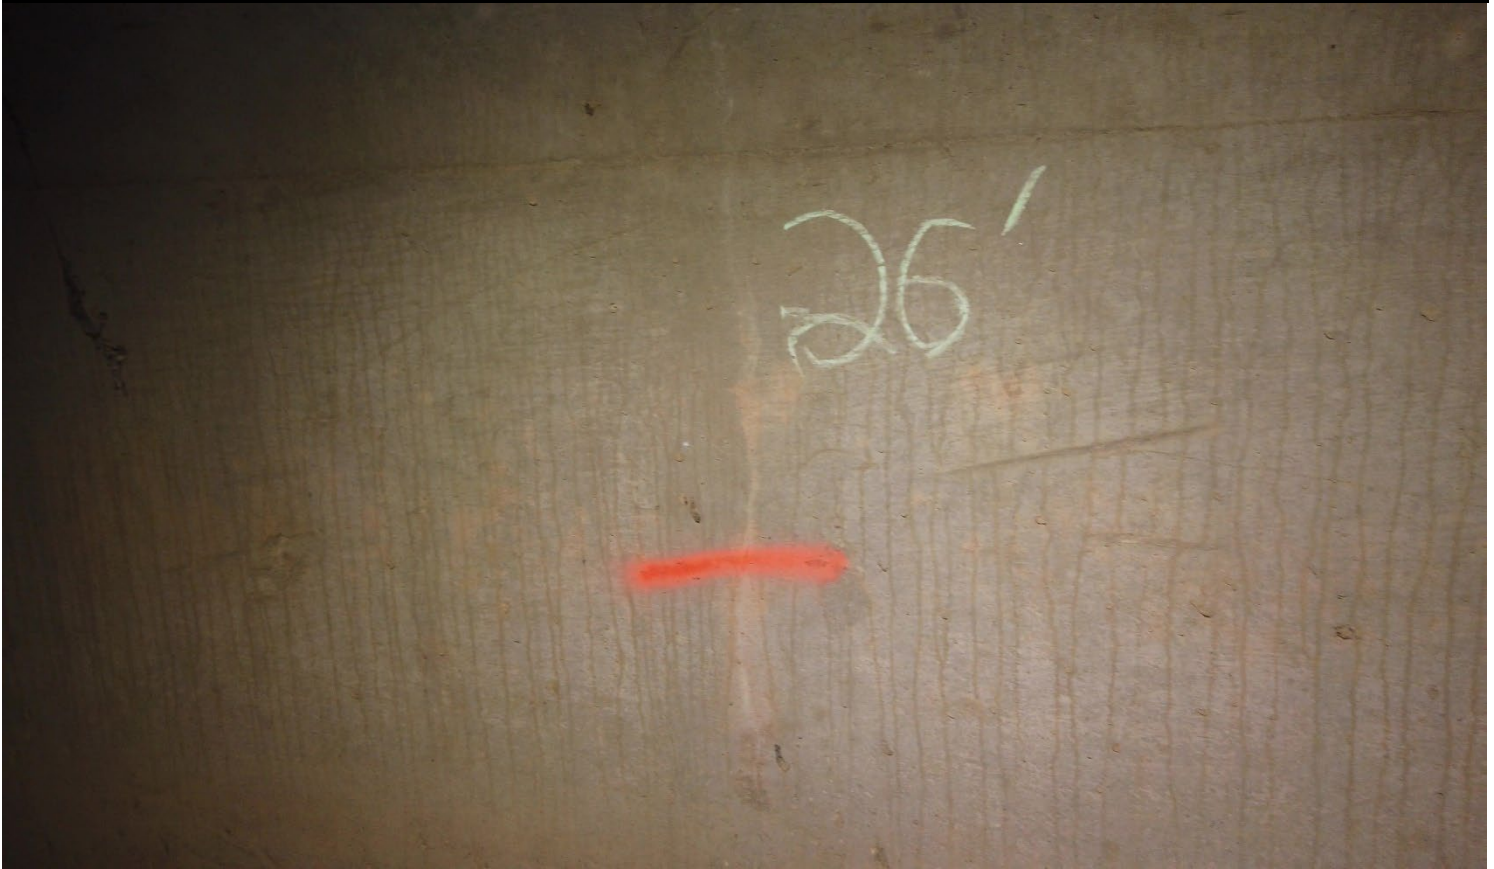
Footage	Defect Description	Top	Right	Left	Bottom
26 ft	Crack and Infiltration		Y

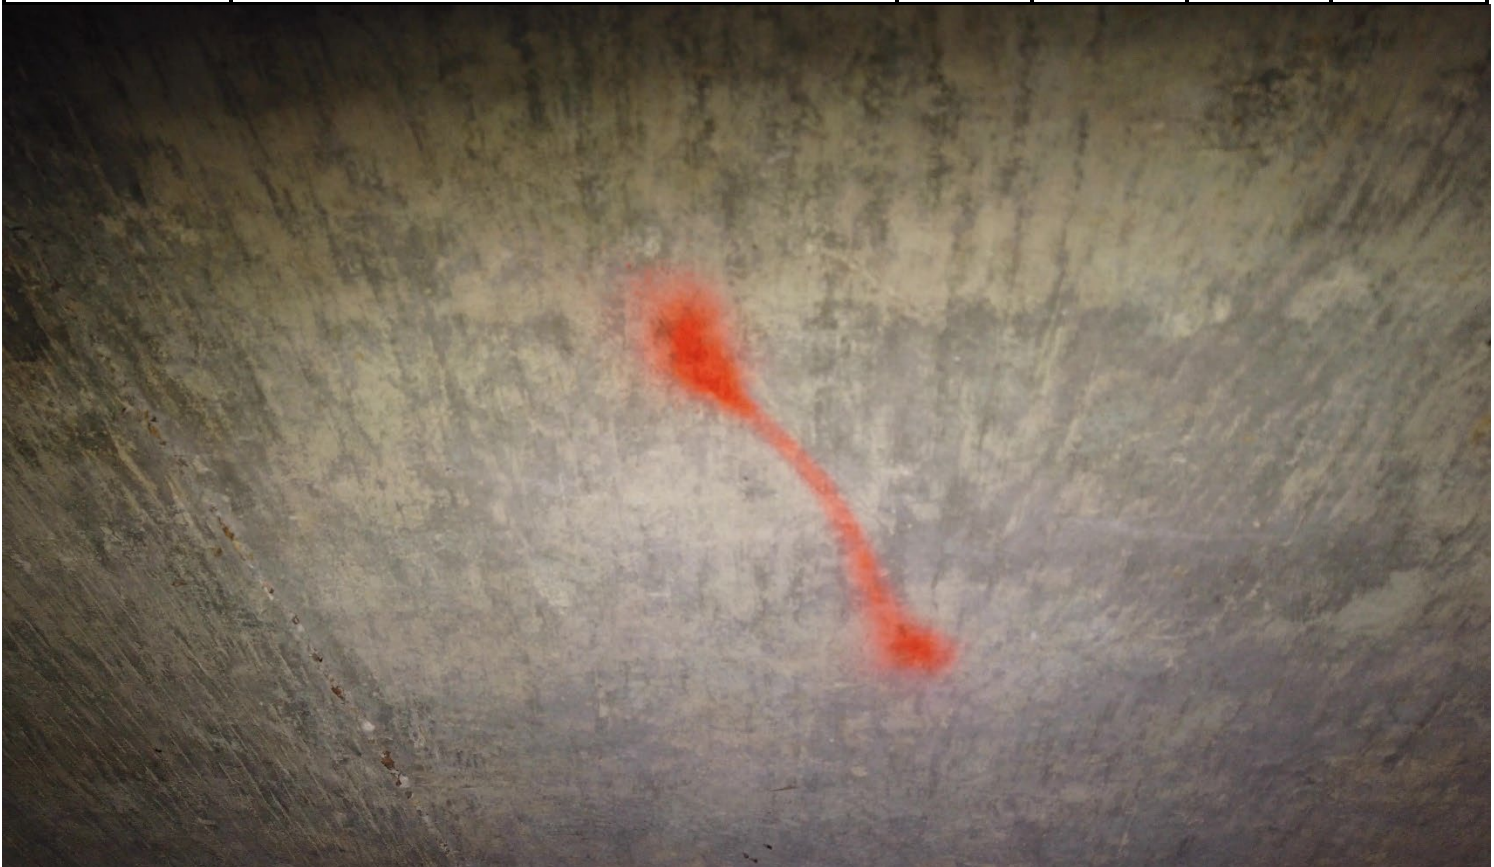
Footage	Defect Description	Top	Right	Left	Bottom
26 ft	Crack	Y

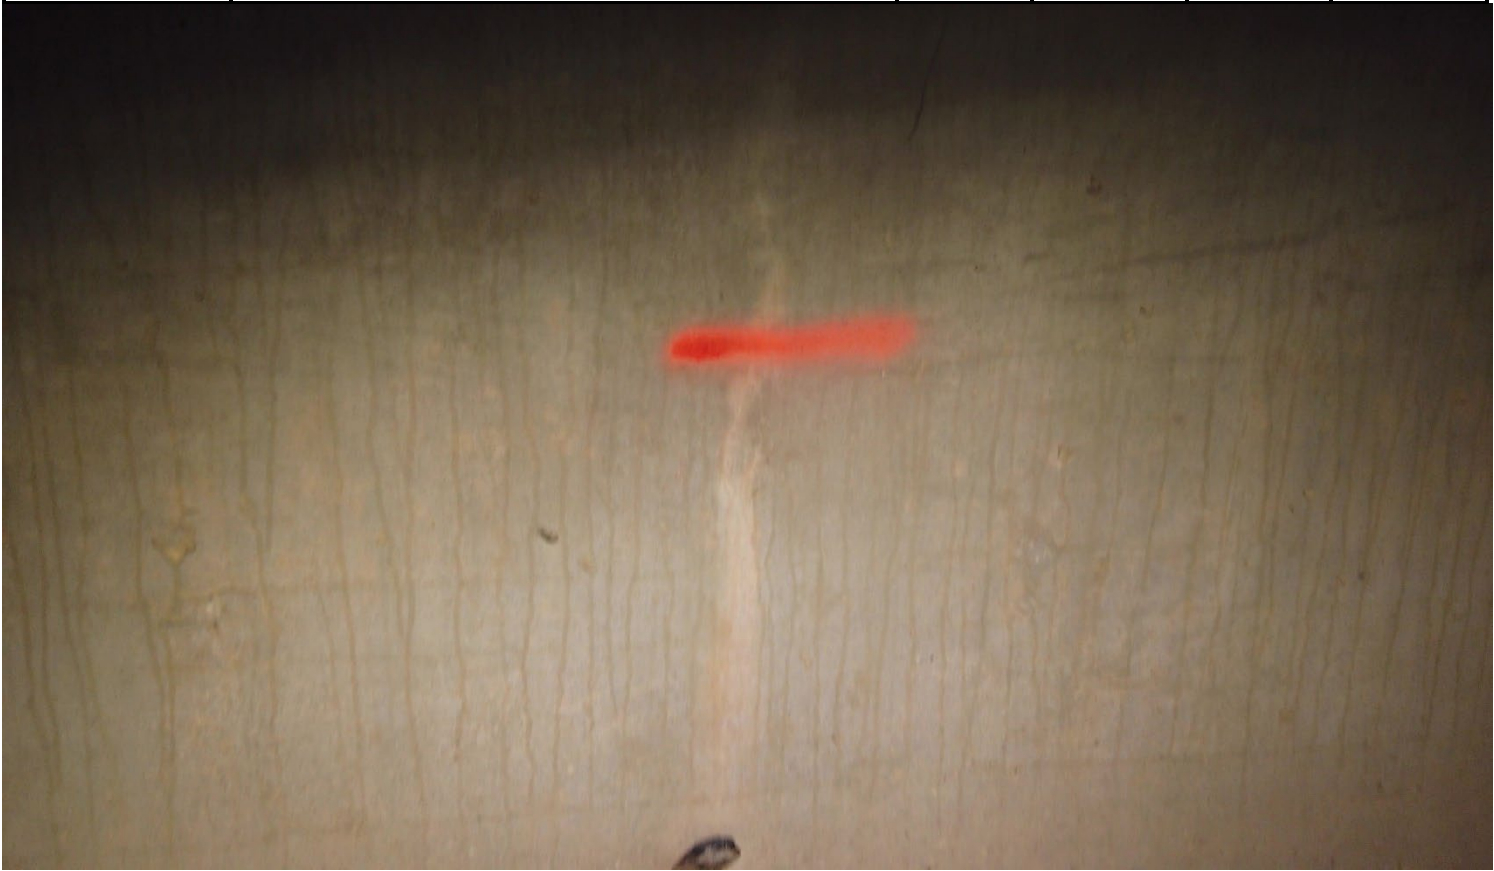
Footage	Defect Description	Top	Right	Left	Bottom
34 ft	Crack			Y

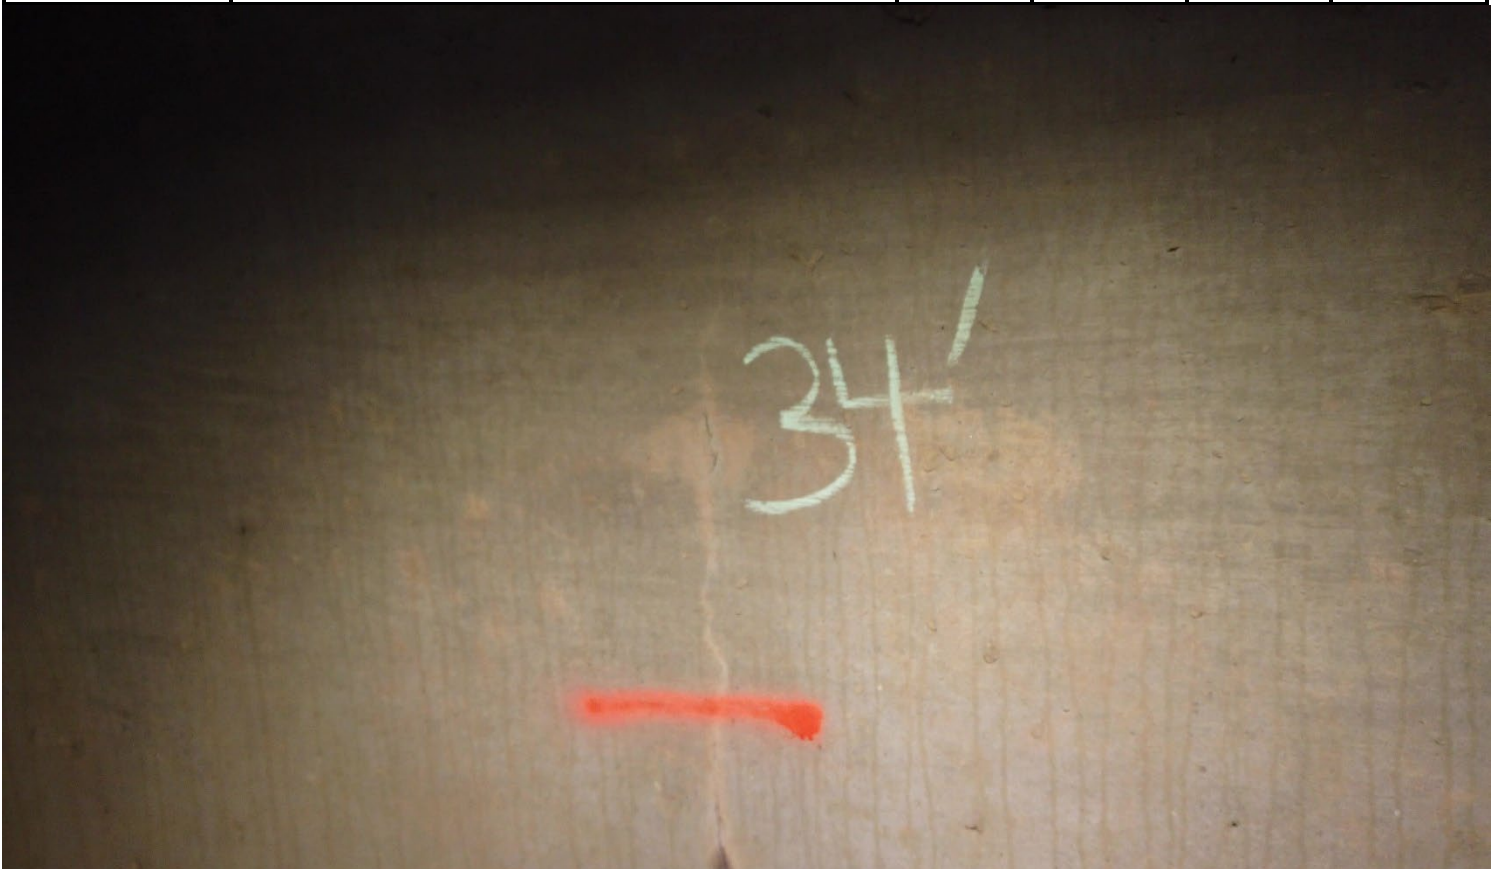
Footage	Defect Description	Top	Right	Left	Bottom
34 ft	Crack		Y

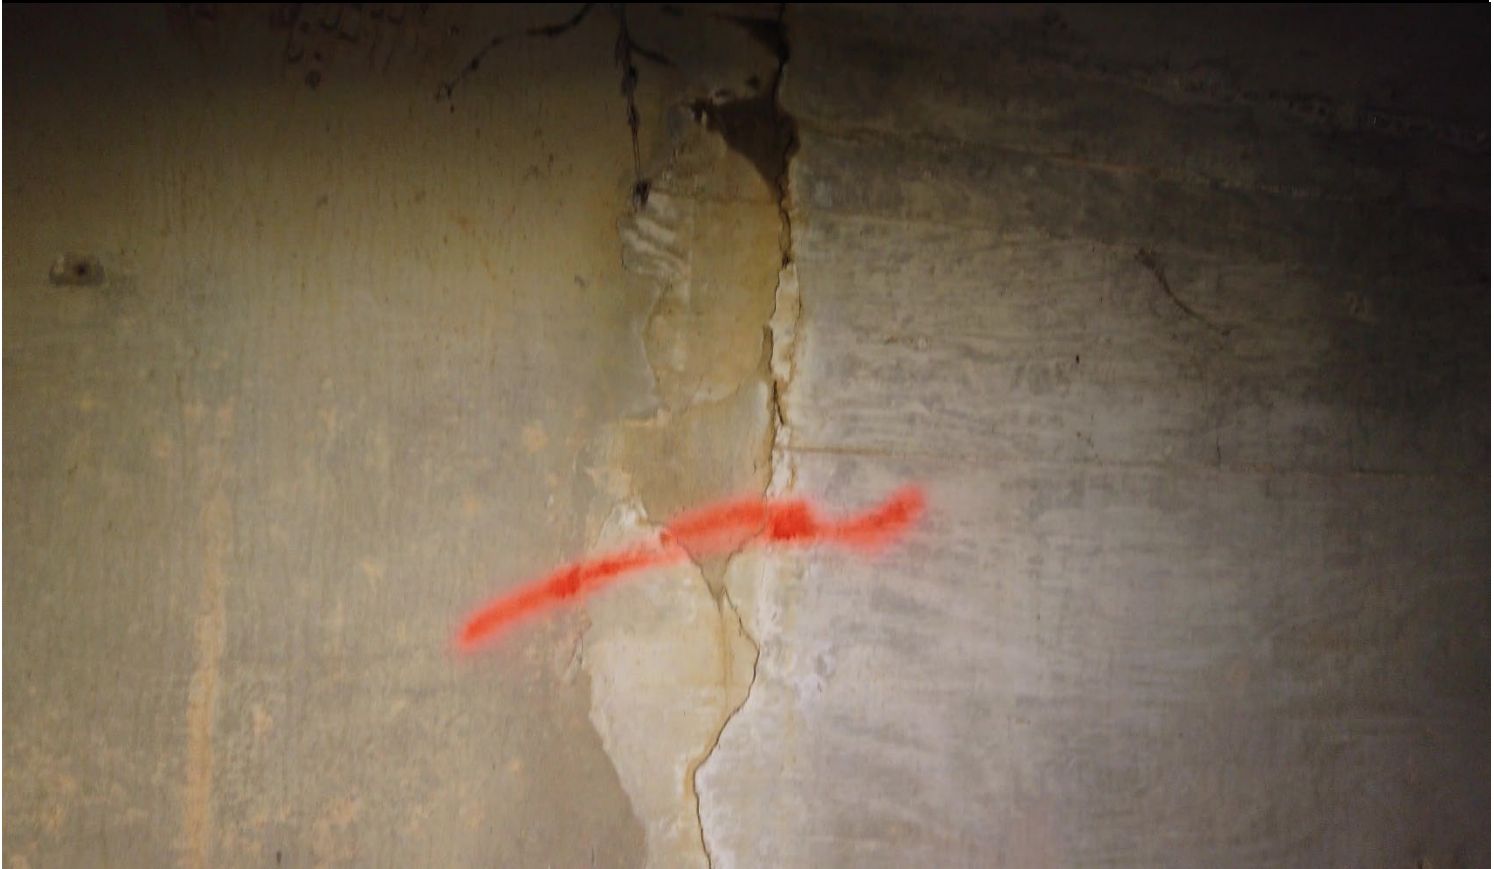
Footage	Defect Description	Top	Right	Left	Bottom
45 ft	Crack and Infiltration			Y

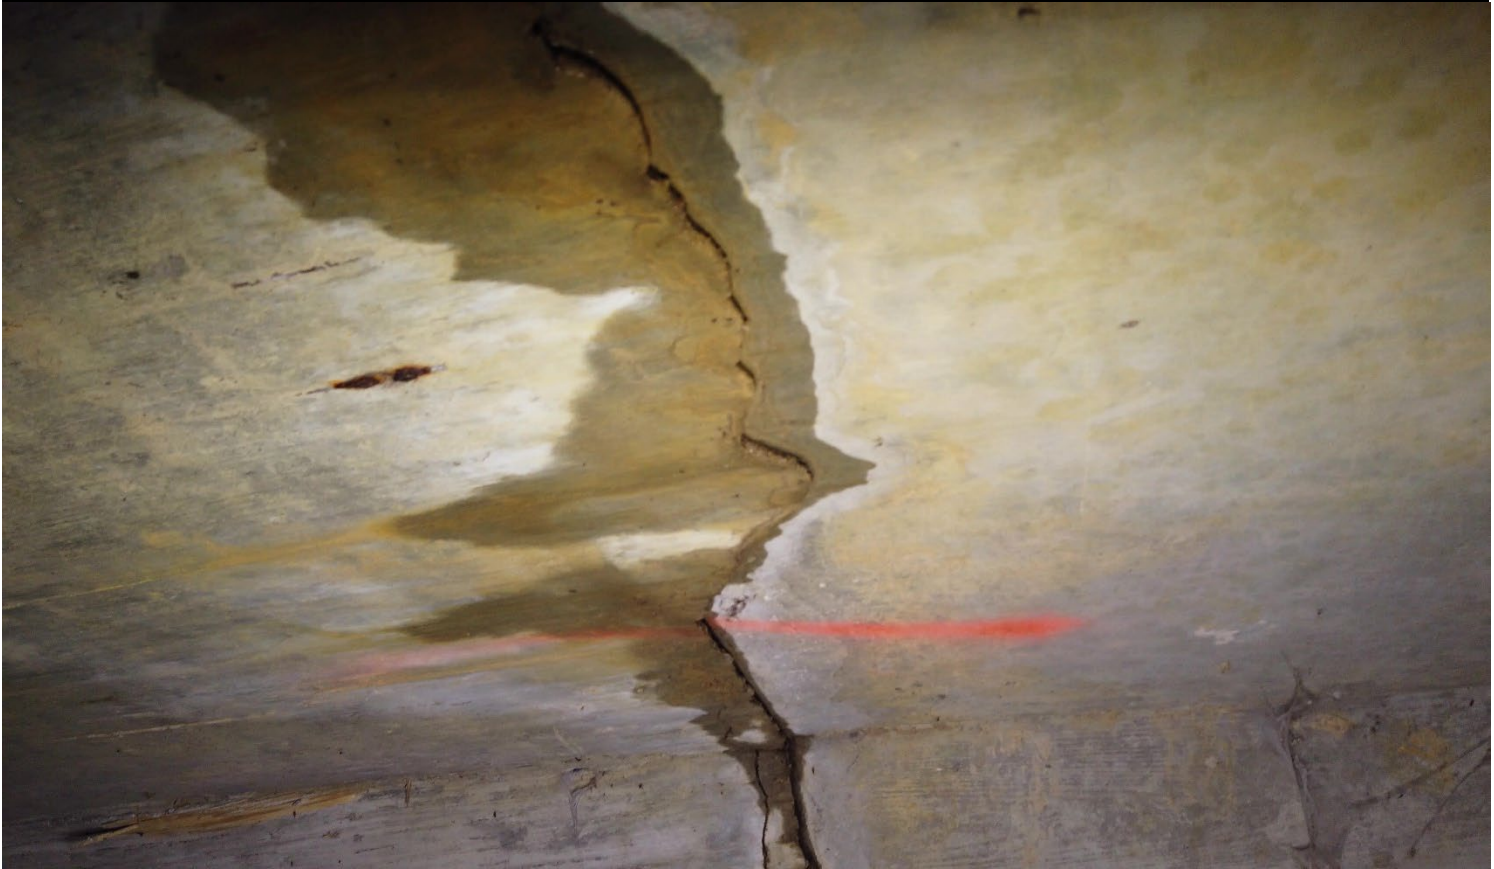
Footage	Defect Description	Top	Right	Left	Bottom
45 ft	Crack and Infiltration	Y

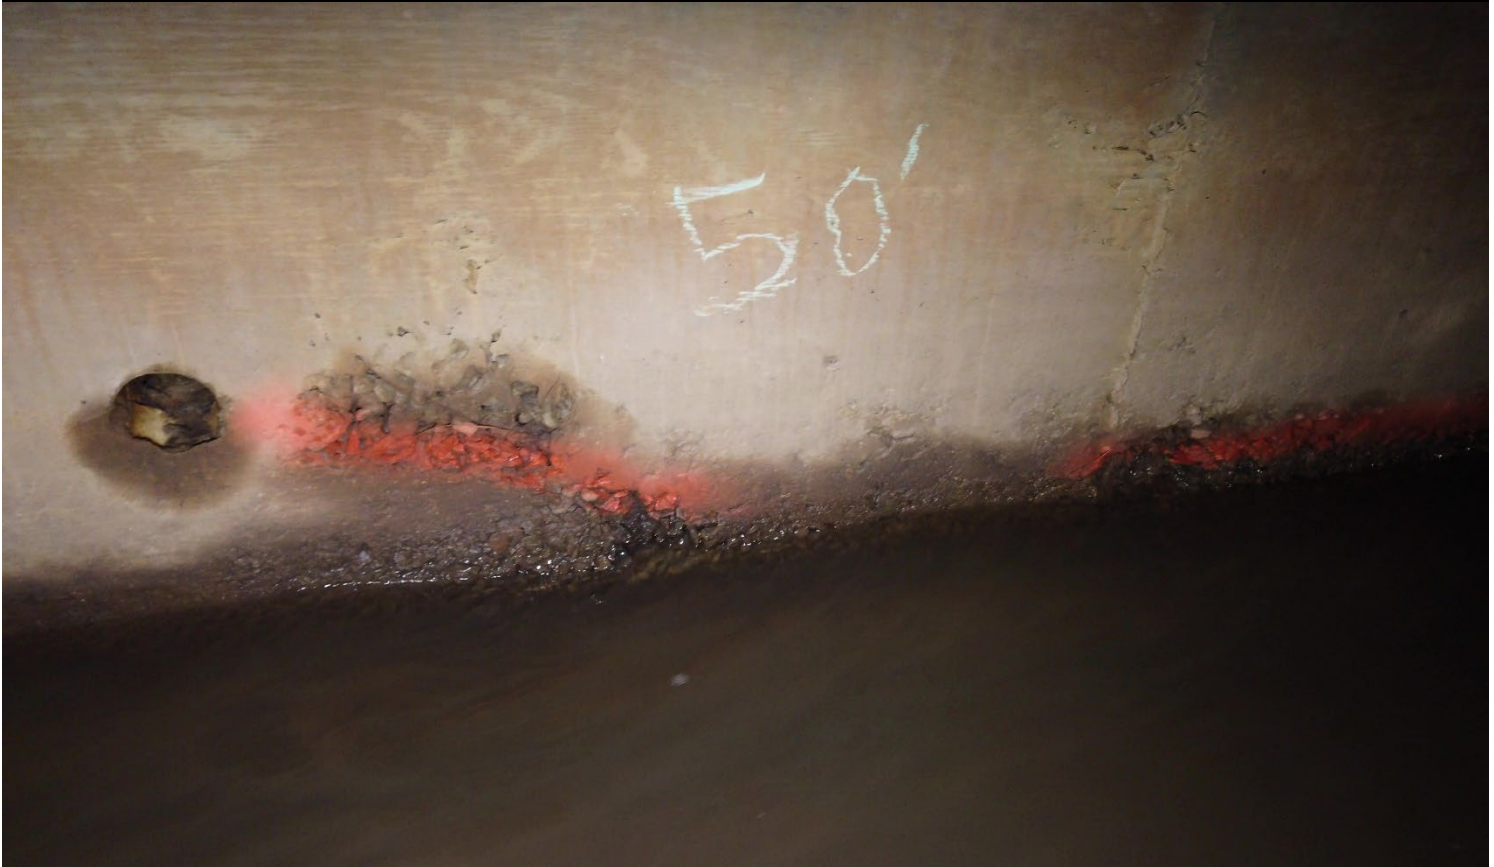
Footage	Defect Description	Top	Right	Left	Bottom
50 ft	Surface Damage			Y

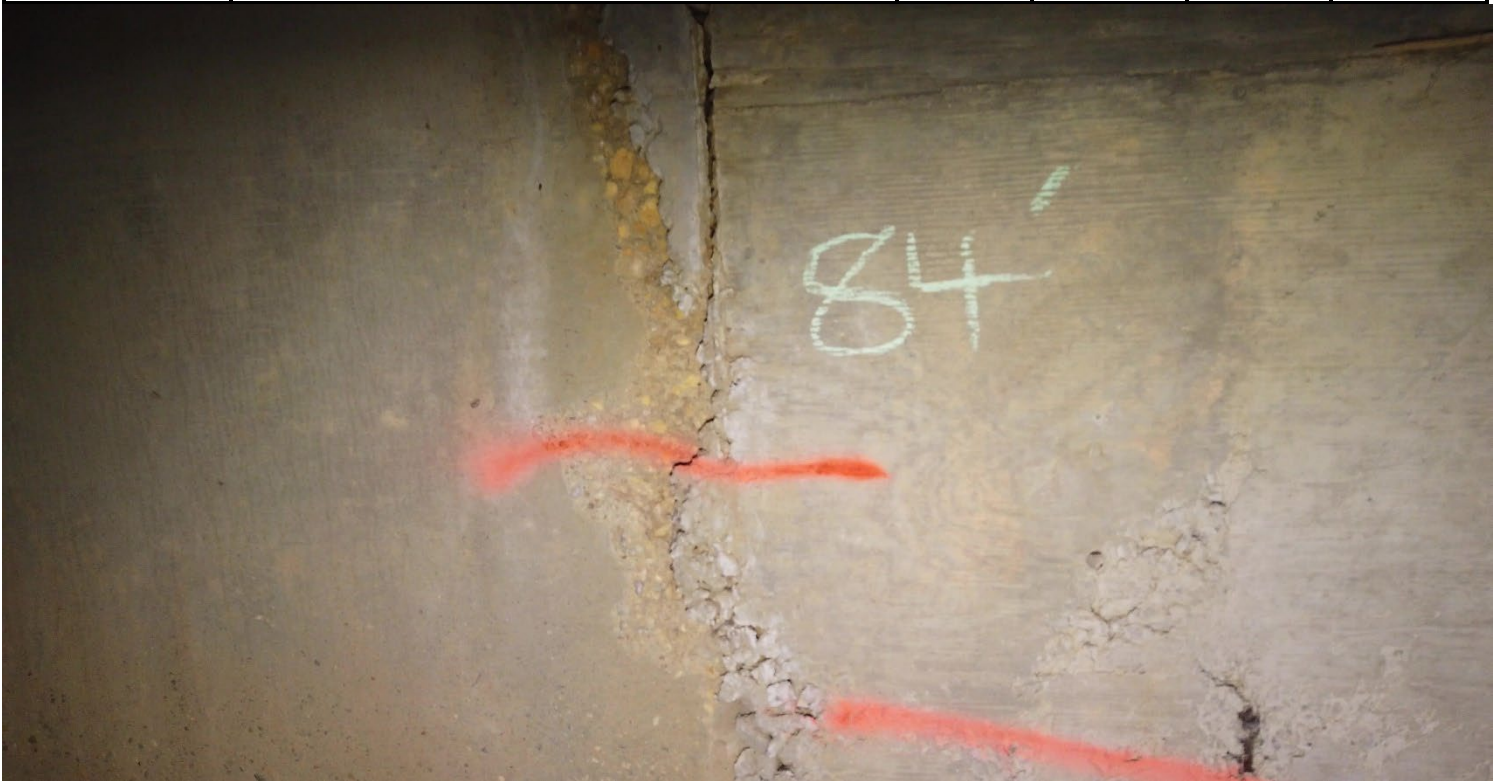
Footage	Defect Description	Top	Right	Left	Bottom
84 ft	Crack and Infiltration		Y
