I-26 & I-95 INTERCHANGE IMPROVEMENTS

June 29, 2023

PIPE INSPECTION REPORT

This report contains the results of the video pipe inspection and assessment of the existing storm water drainage pipes within the project area in Orangeburg and Dorchester Counties.

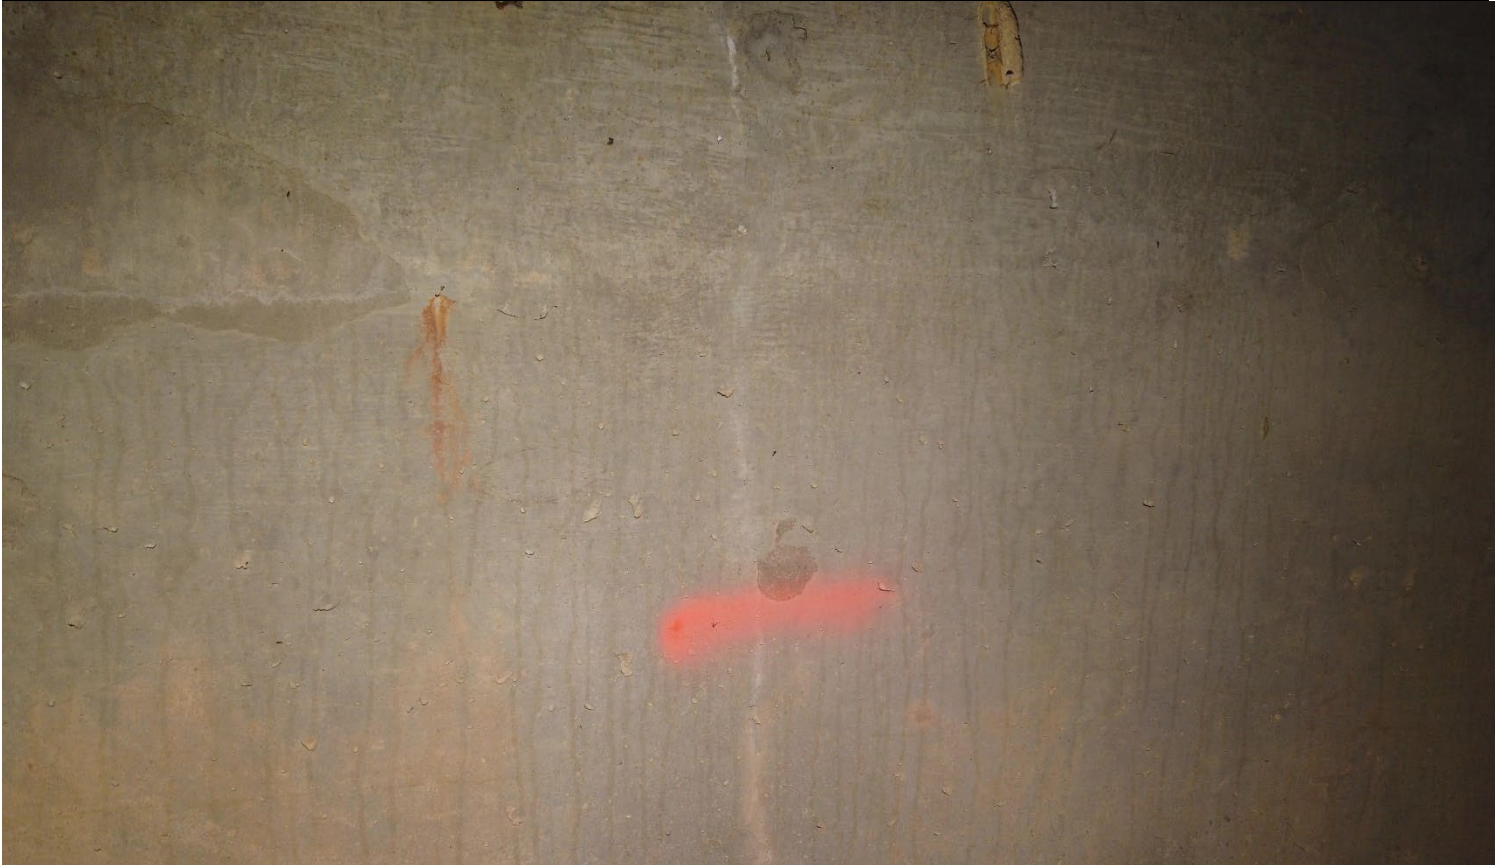
Footage	Defect Description	Top	Right	Left	Bottom
95 ft	Crack			Y

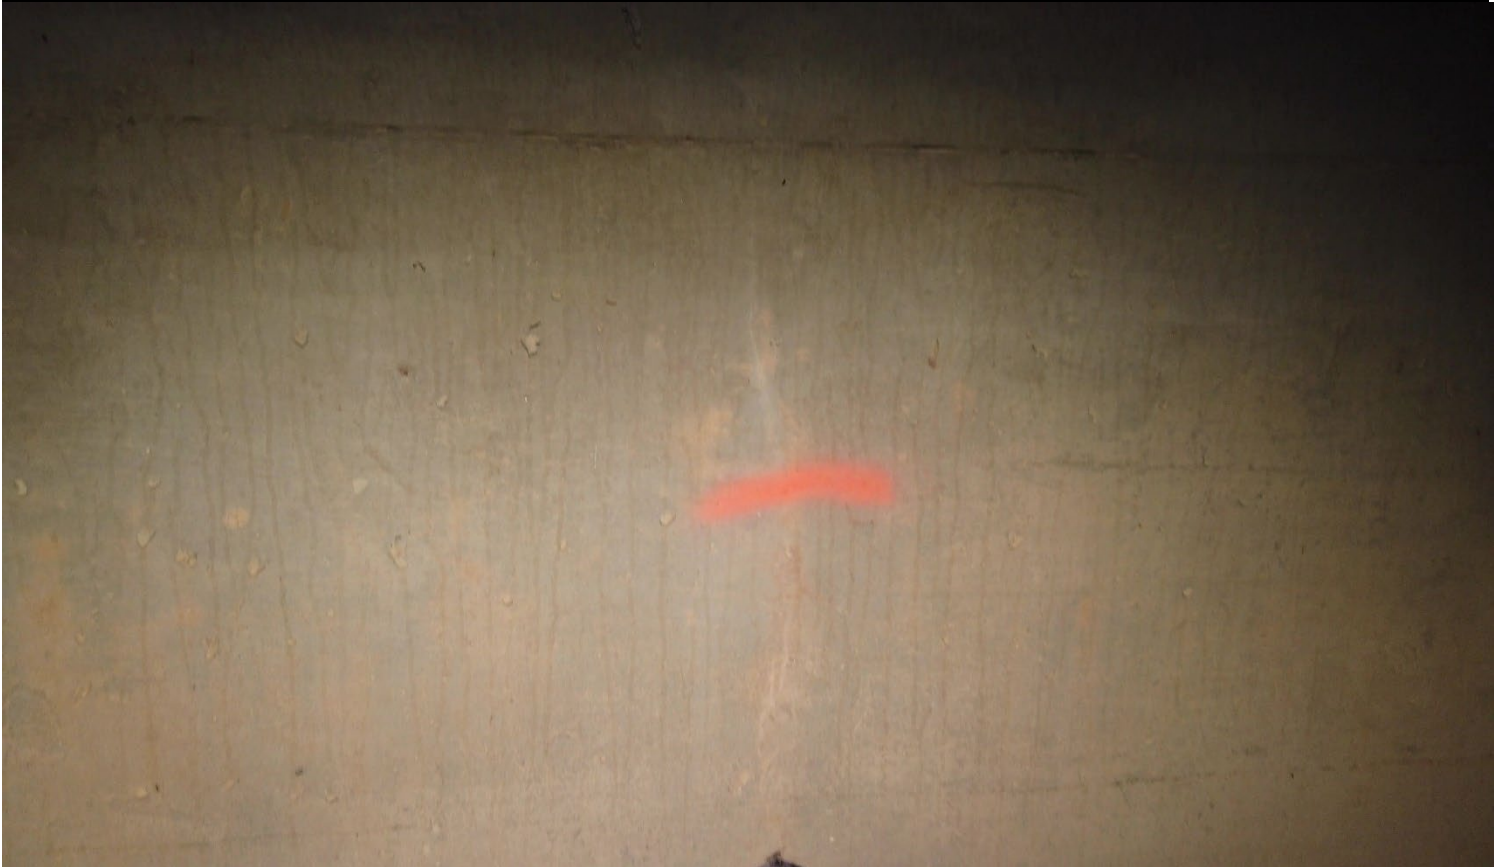
Footage	Defect Description	Top	Right	Left	Bottom
104 ft	Crack			Y

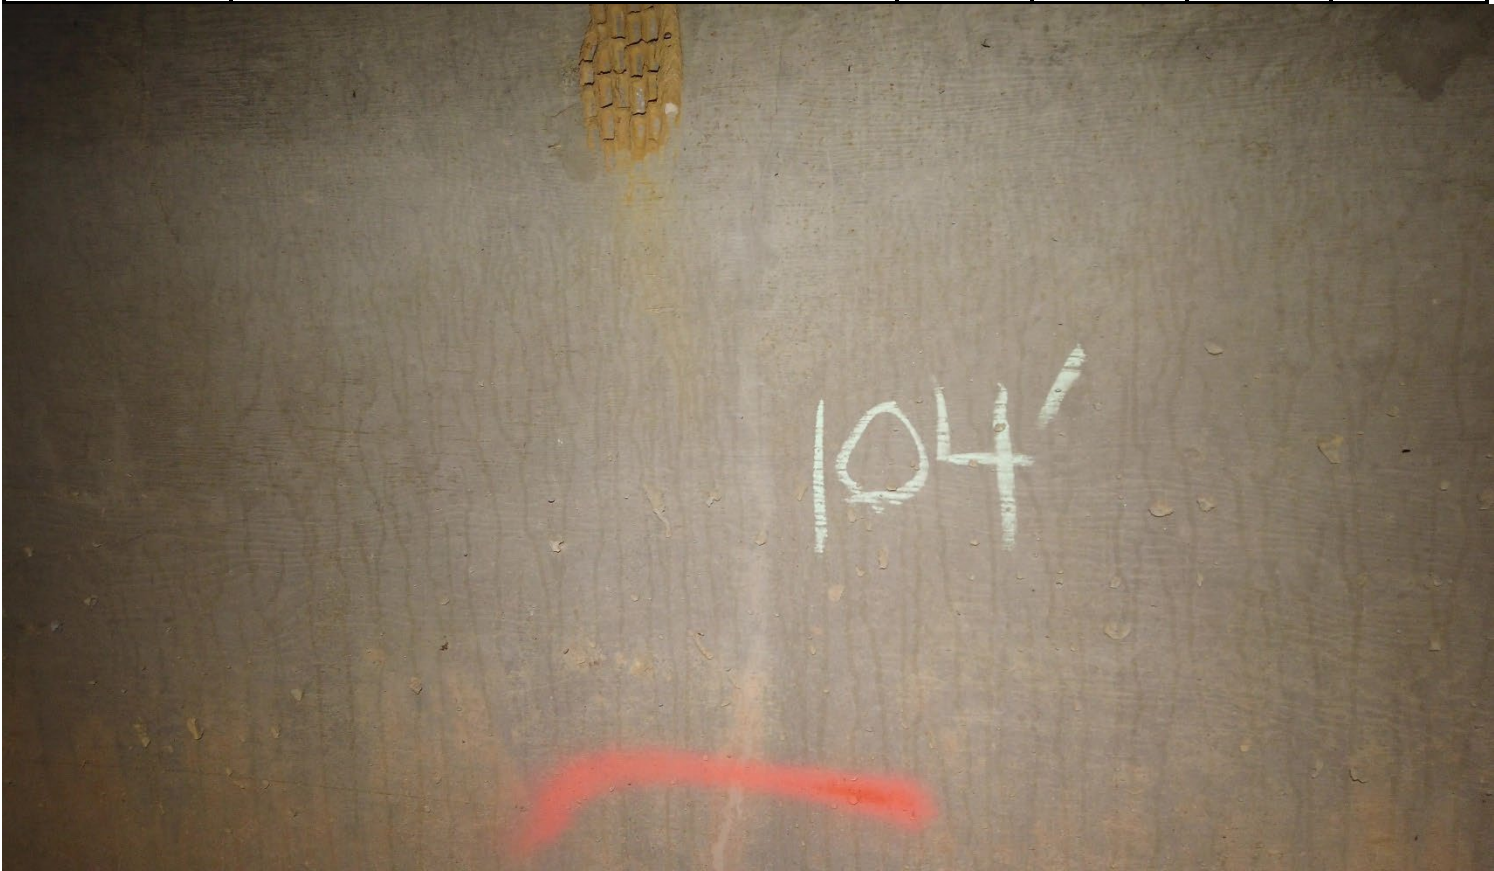
Footage	Defect Description	Top	Right	Left	Bottom
104 ft	Crack		Y

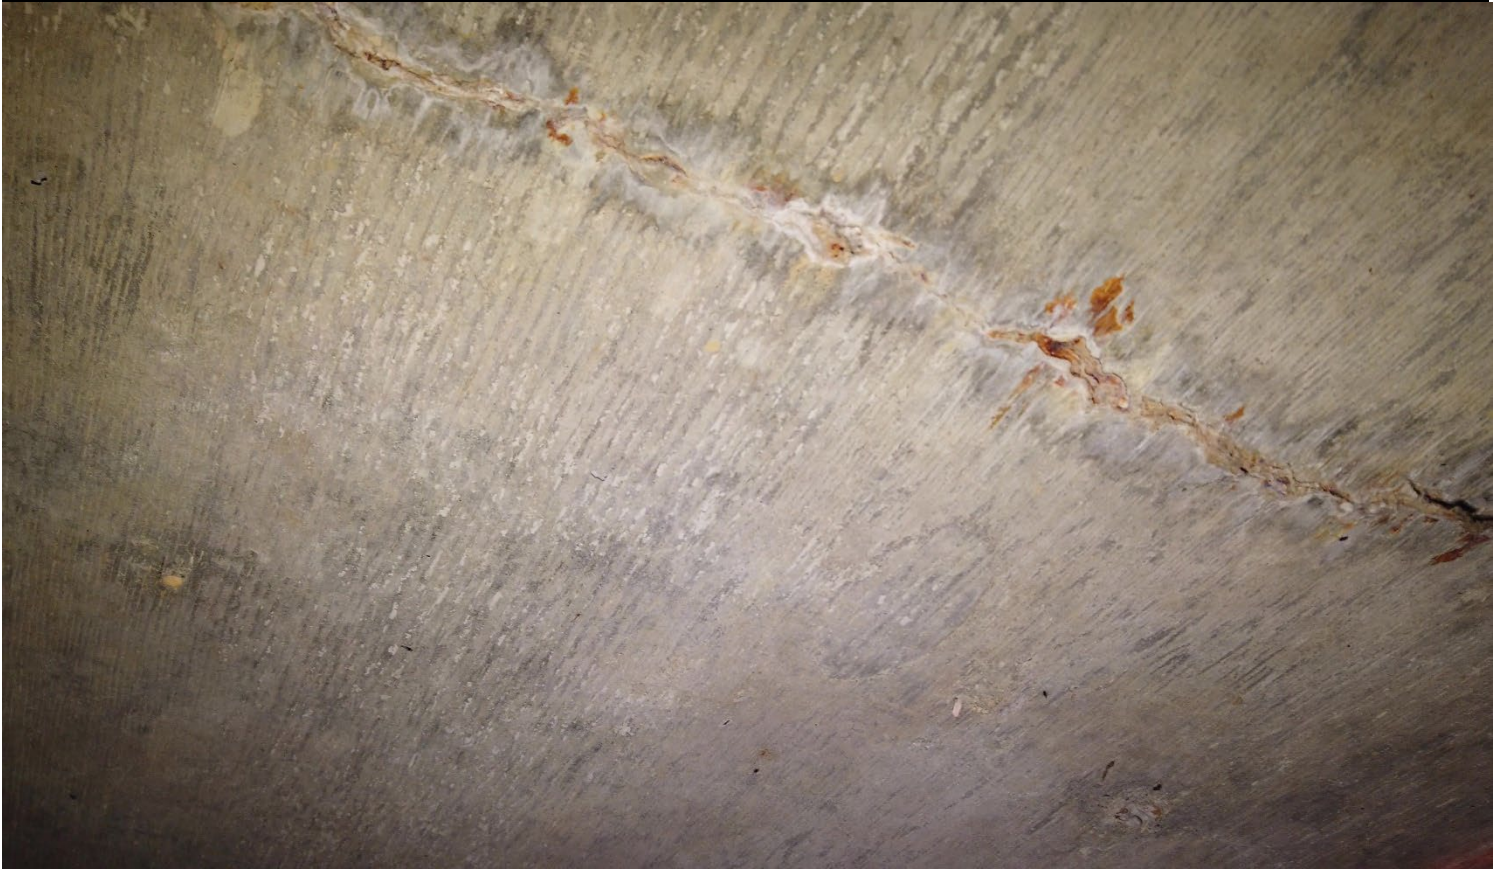
Footage	Defect Description	Top	Right	Left	Bottom
111 ft	Crack and Infiltration	Y

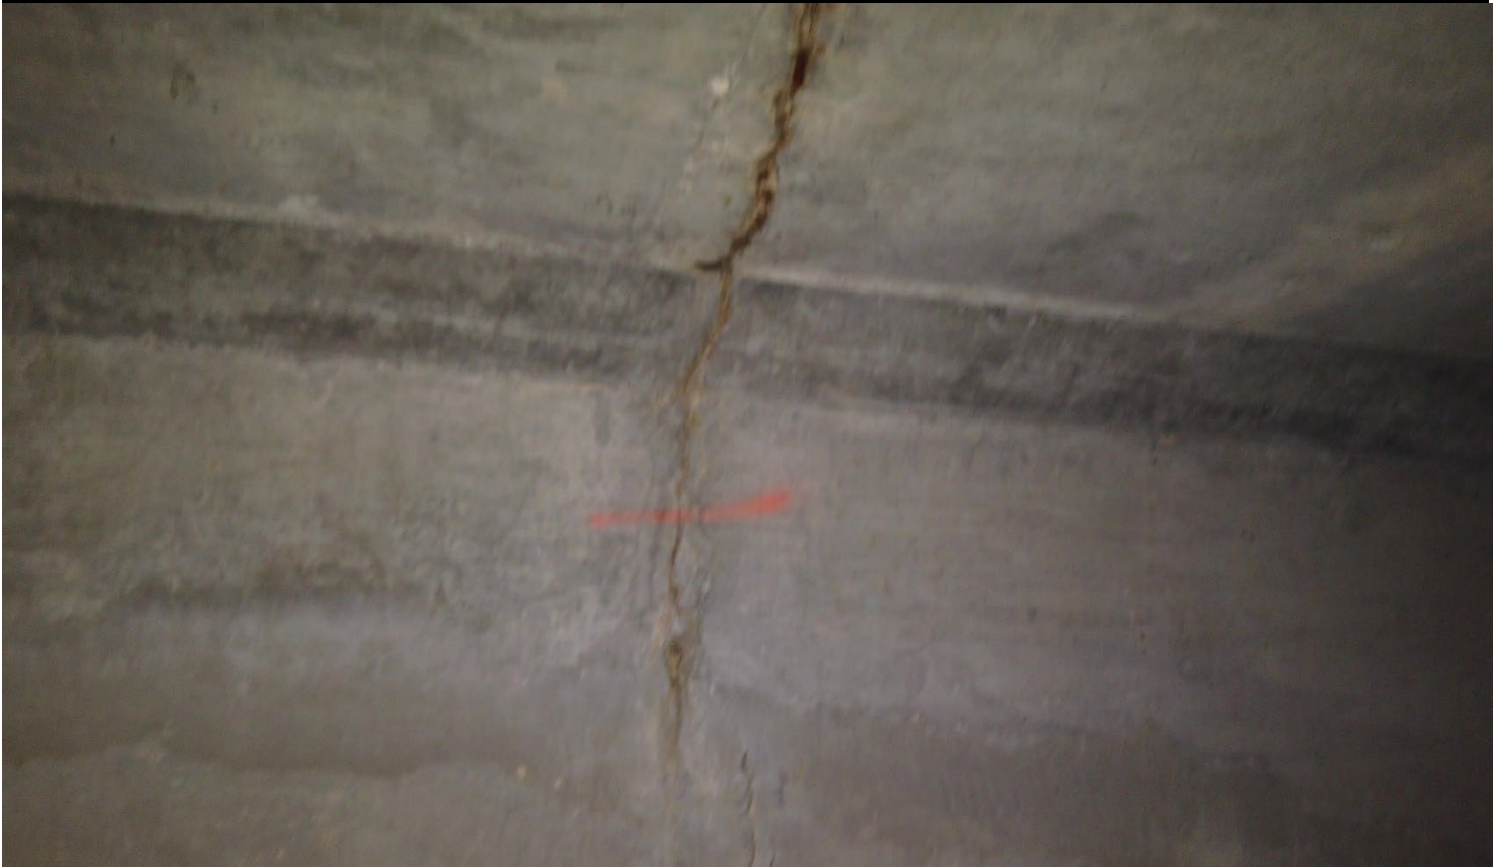
Footage	Defect Description	Top	Right	Left	Bottom
116 ft	Crack and Infiltration			Y

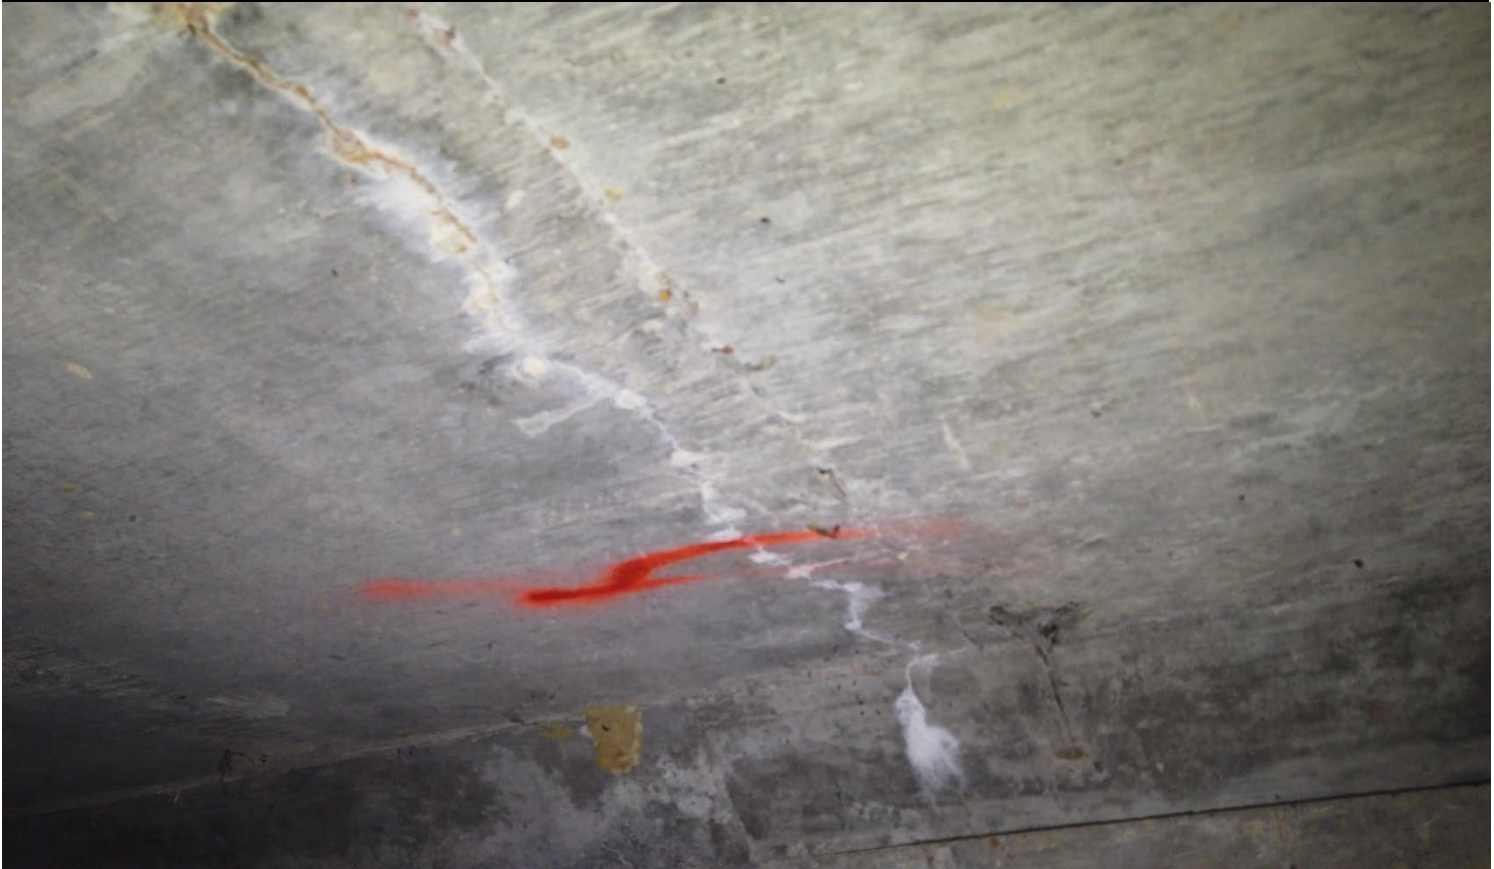
Footage	Defect Description	Top	Right	Left	Bottom
116 ft	Crack and Infiltration	Y

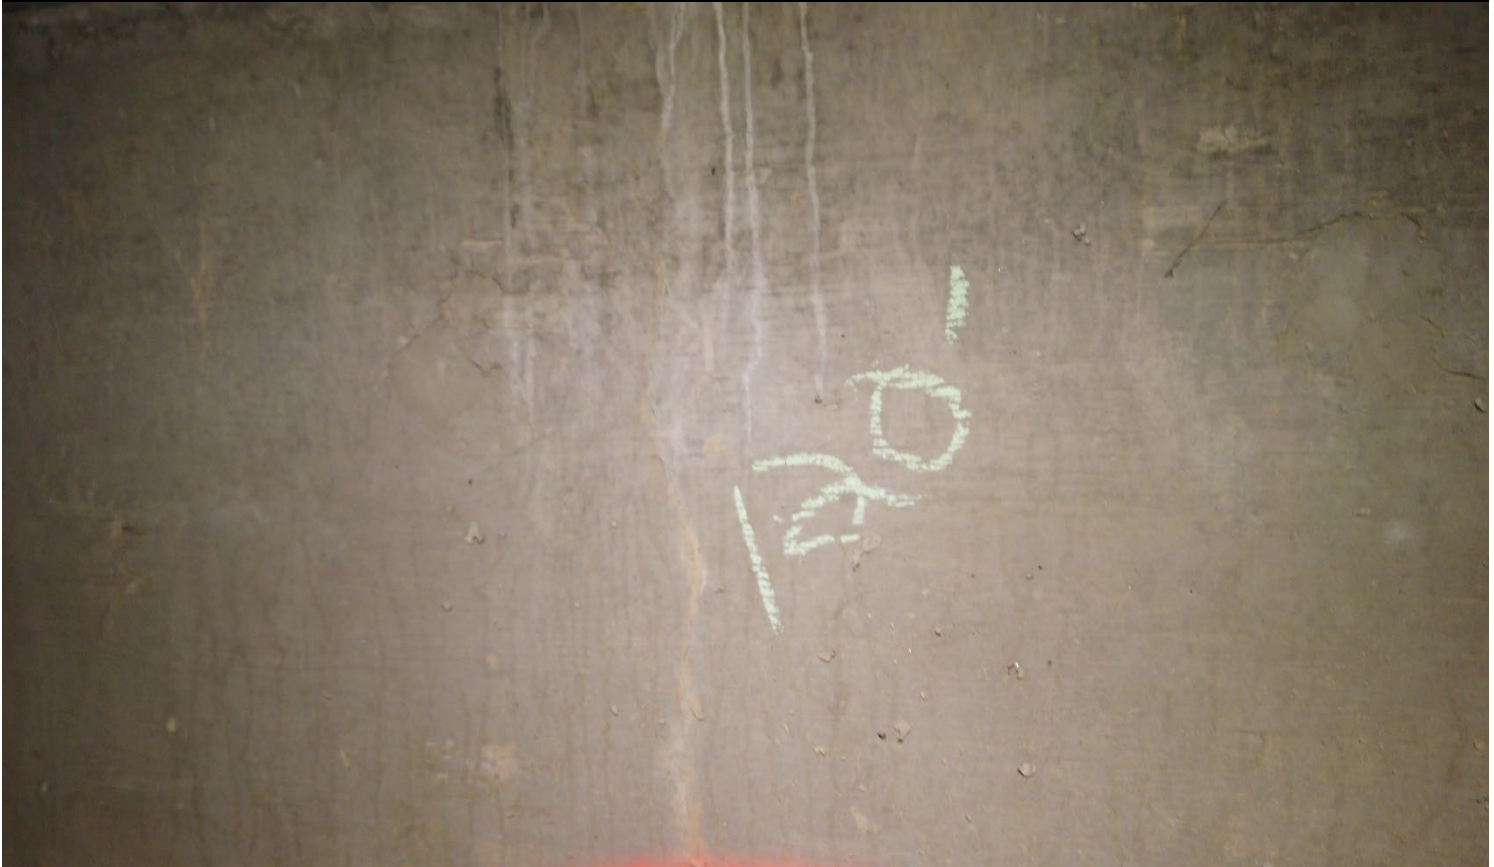
Footage	Defect Description	Top	Right	Left	Bottom
120 ft	Crack		Y

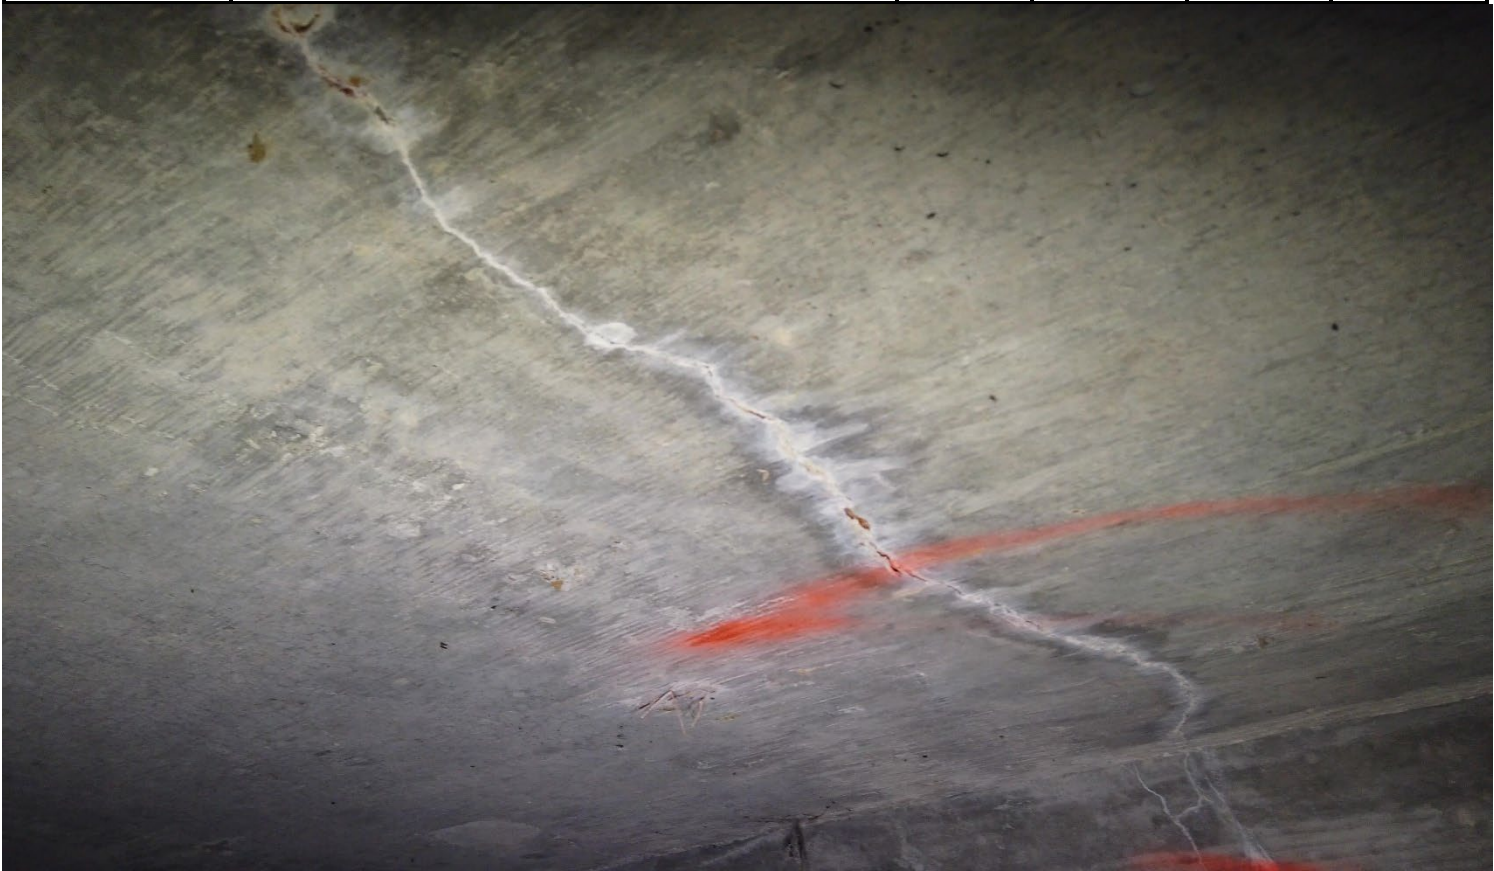
Footage	Defect Description	Top	Right	Left	Bottom
120 ft	Crack and Infiltration	Y

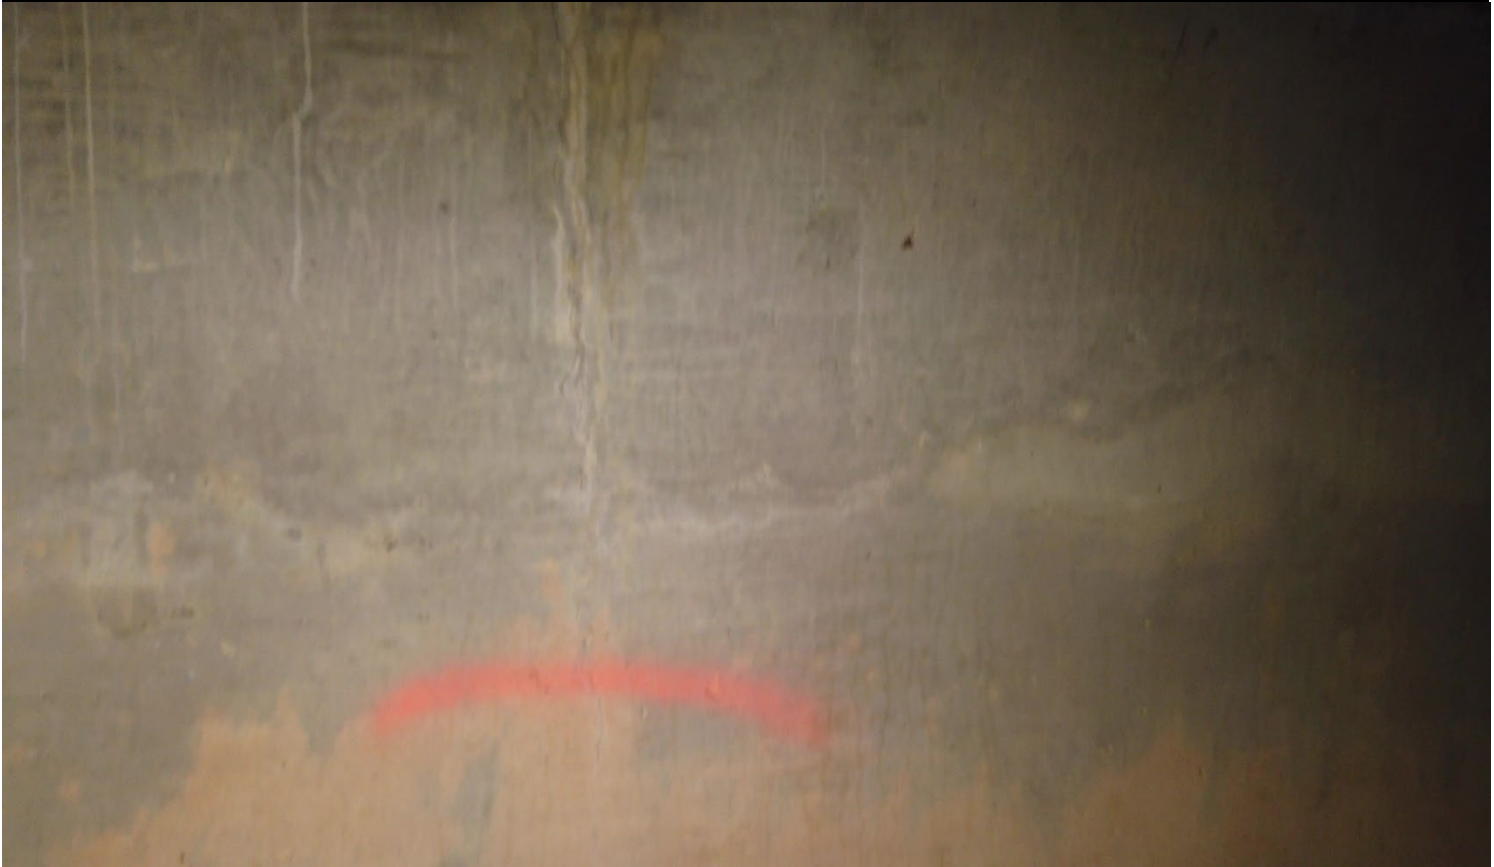
Footage	Defect Description	Top	Right	Left	Bottom
128 ft	Crack			Y

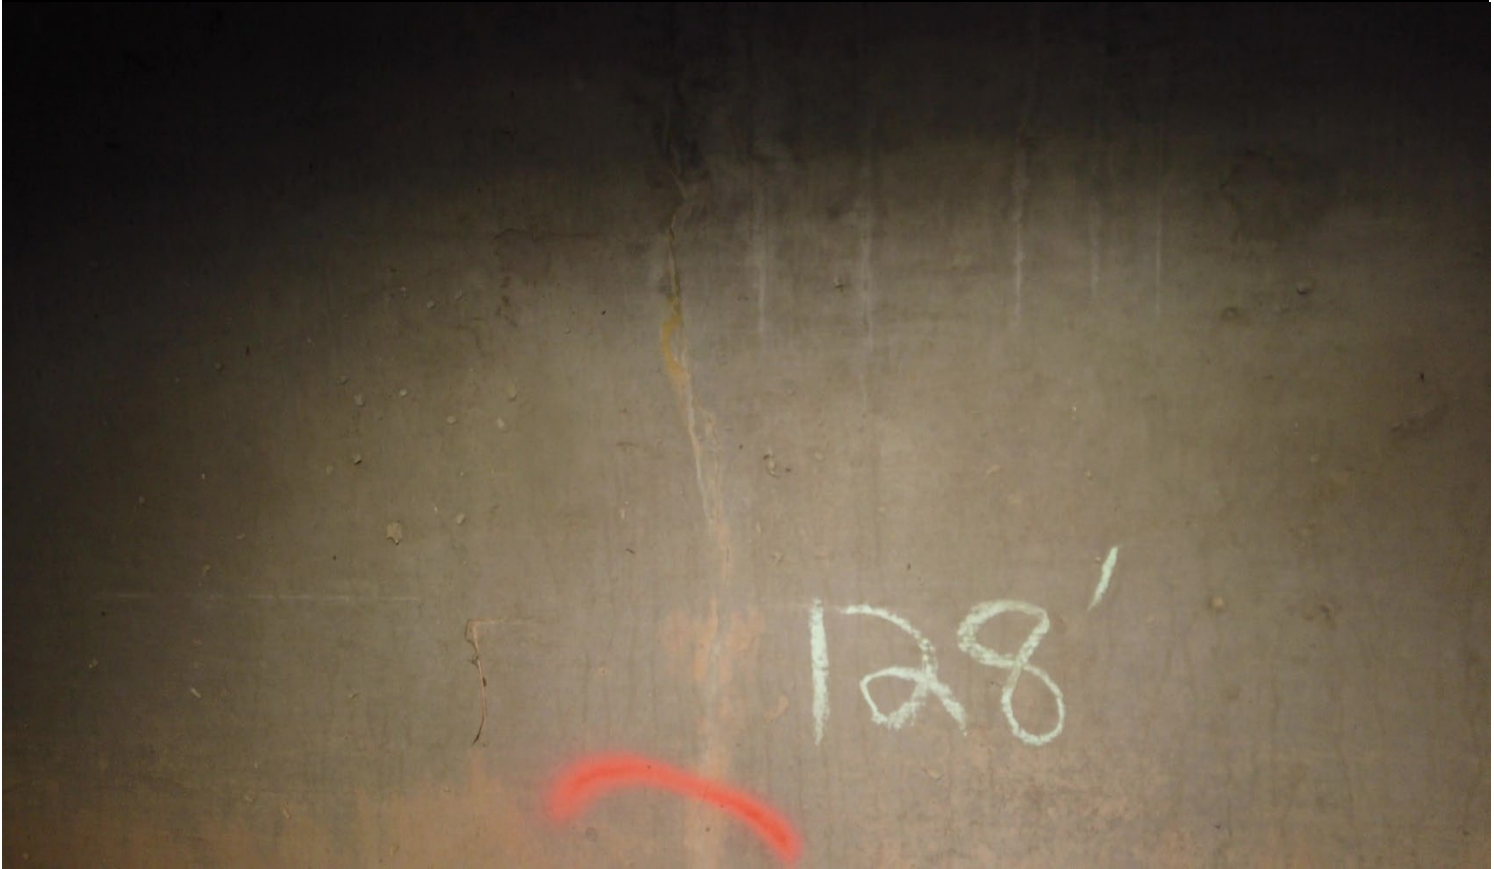
Footage	Defect Description	Top	Right	Left	Bottom
128 ft	Crack		Y

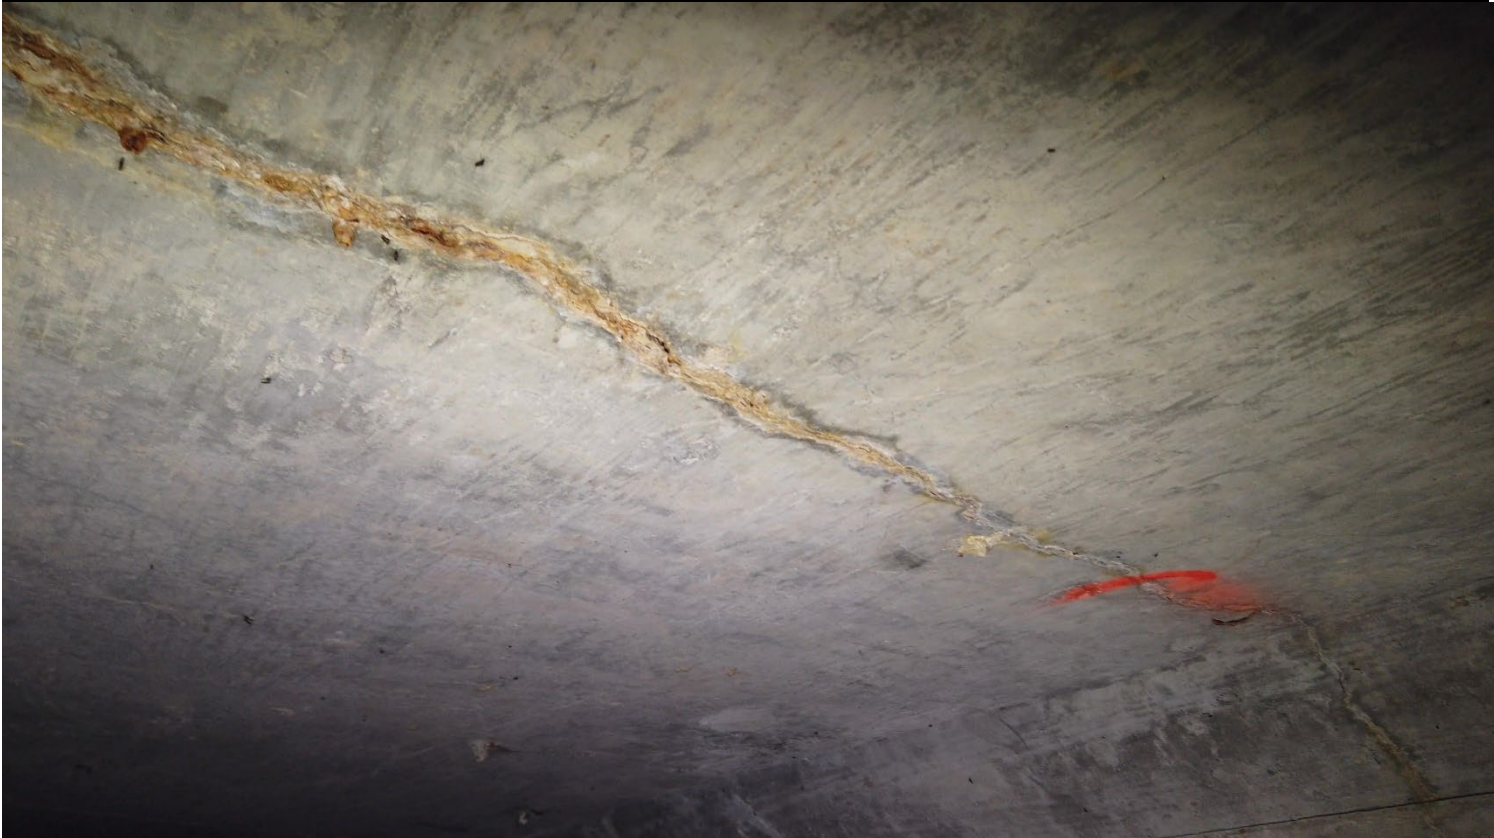
Footage	Defect Description	Top	Right	Left	Bottom
128 ft	Crack and Infiltration	Y

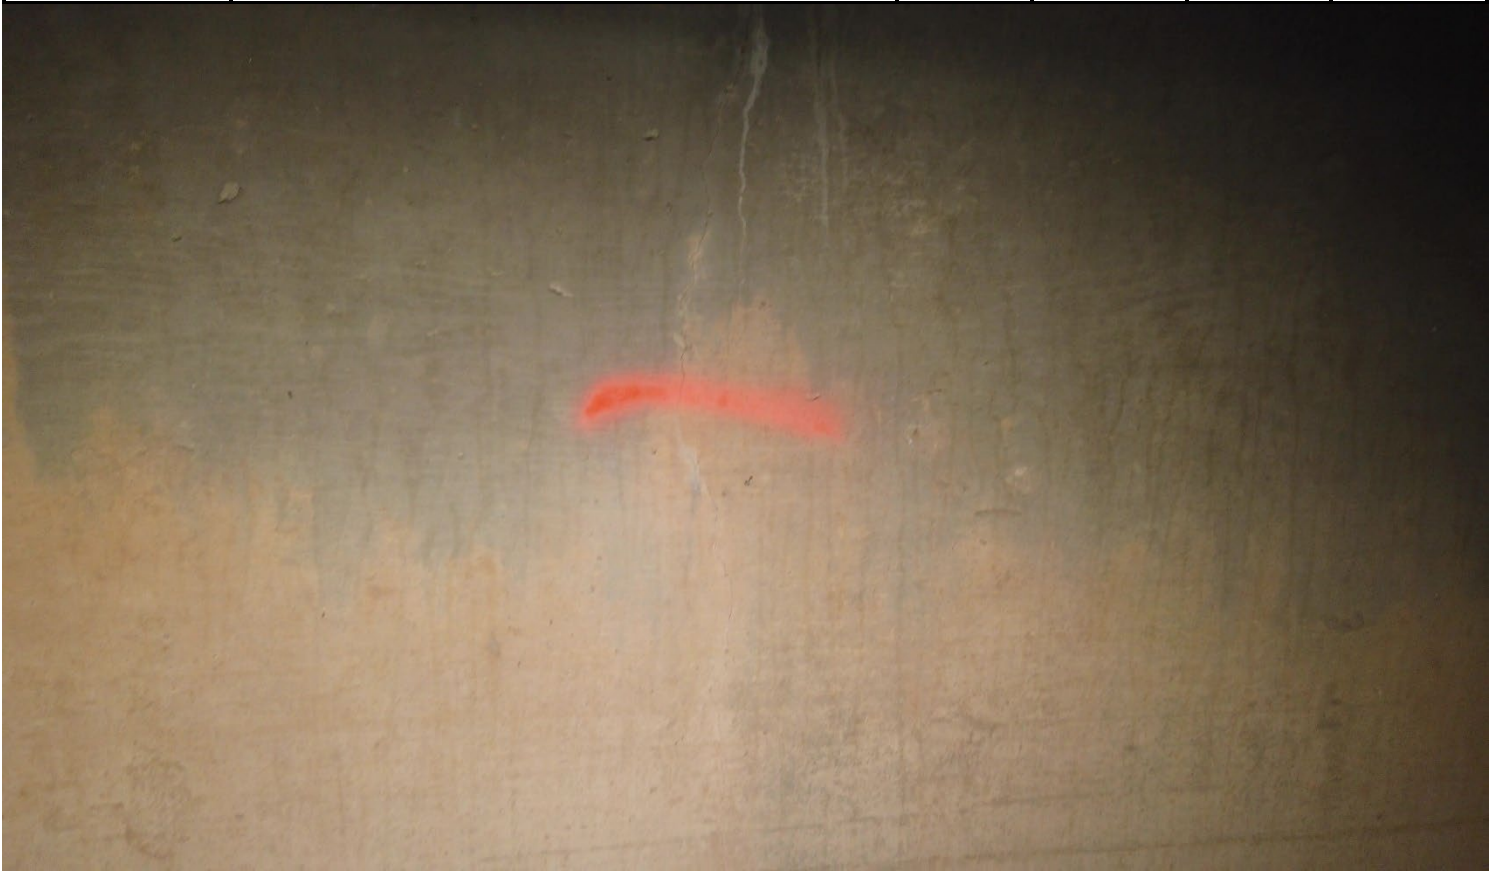
Footage	Defect Description	Top	Right	Left	Bottom
131 ft	Crack			Y

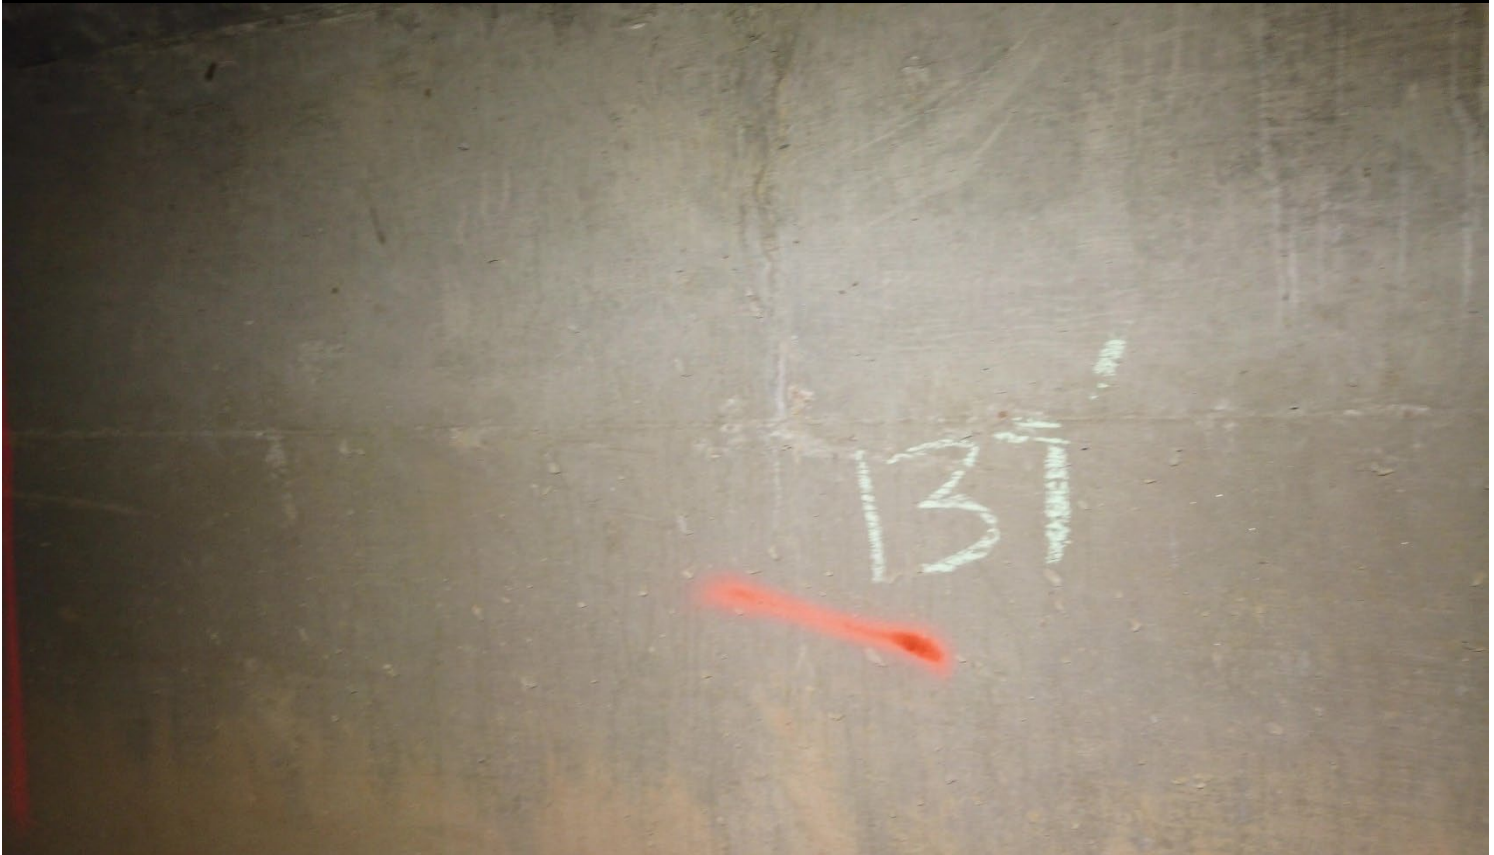
Footage	Defect Description	Top	Right	Left	Bottom
131 ft	Crack		Y

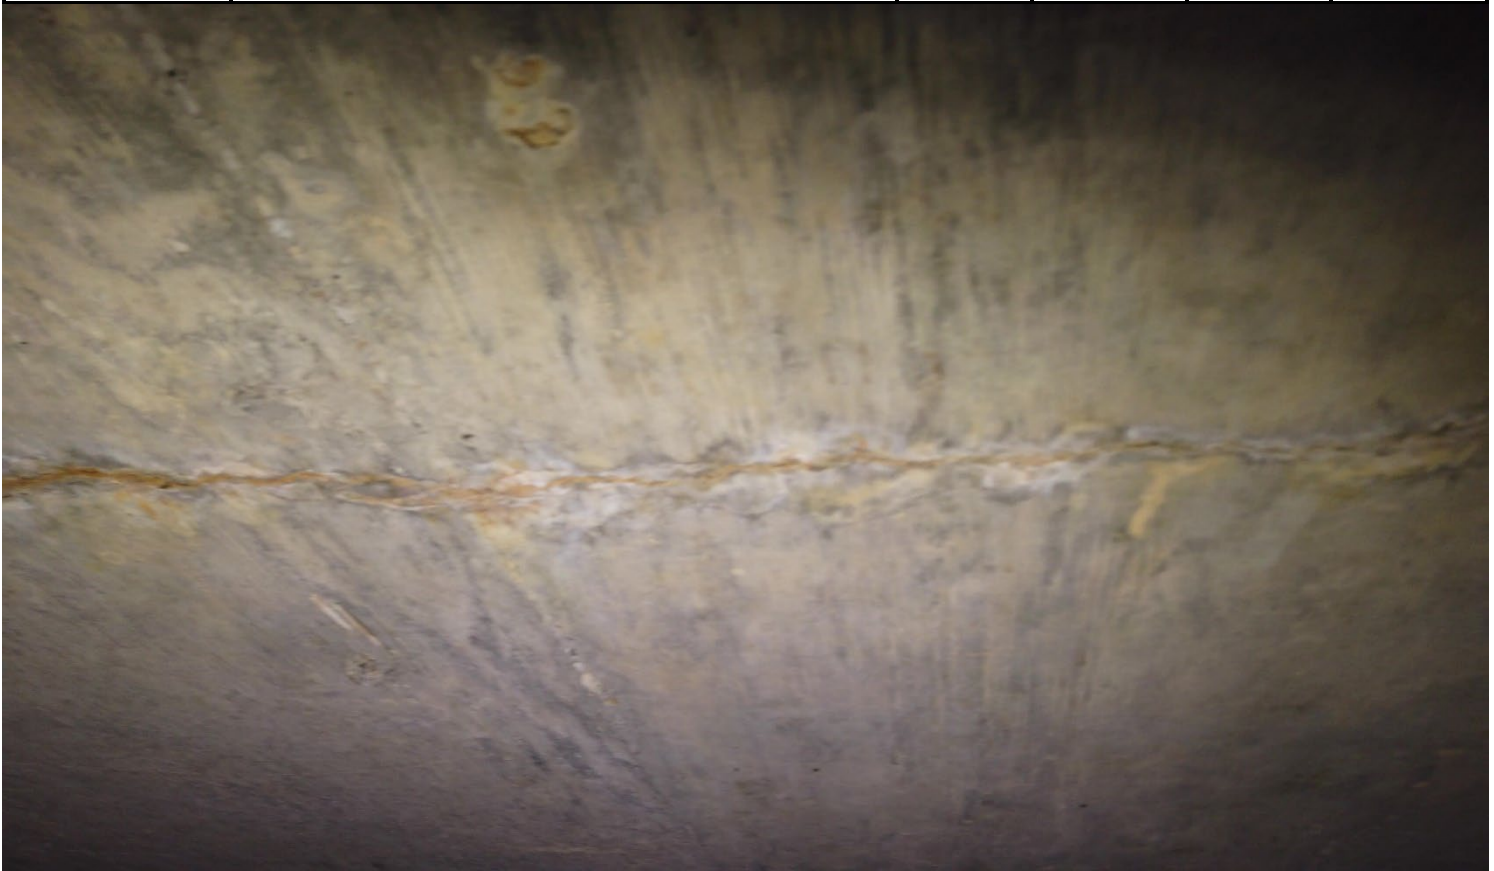
Footage	Defect Description	Top	Right	Left	Bottom
131 ft	Crack and Infiltration	Y

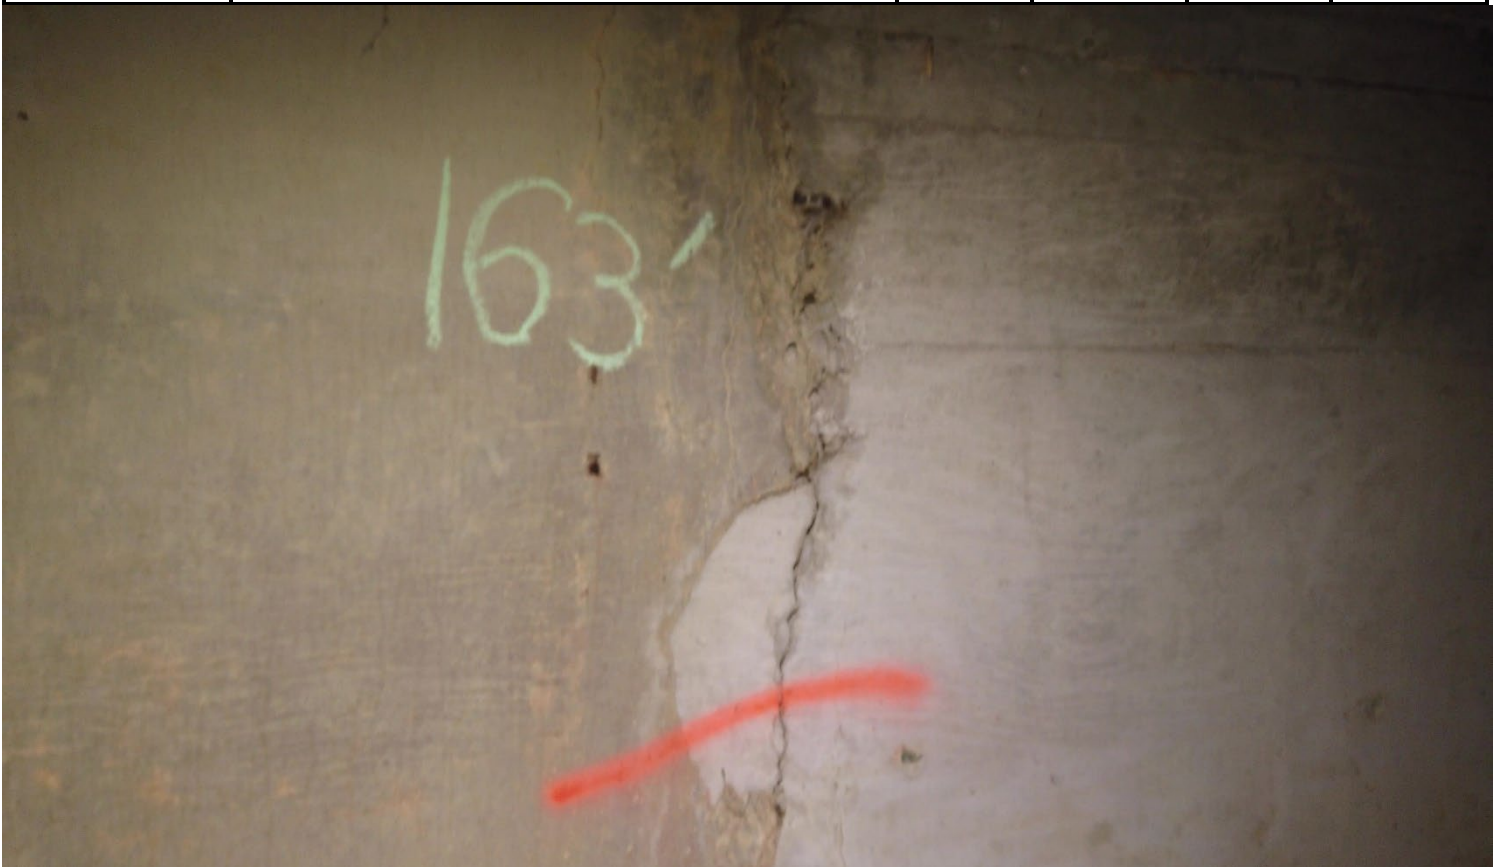
Footage	Defect Description	Top	Right	Left	Bottom
163 ft	Crack			Y

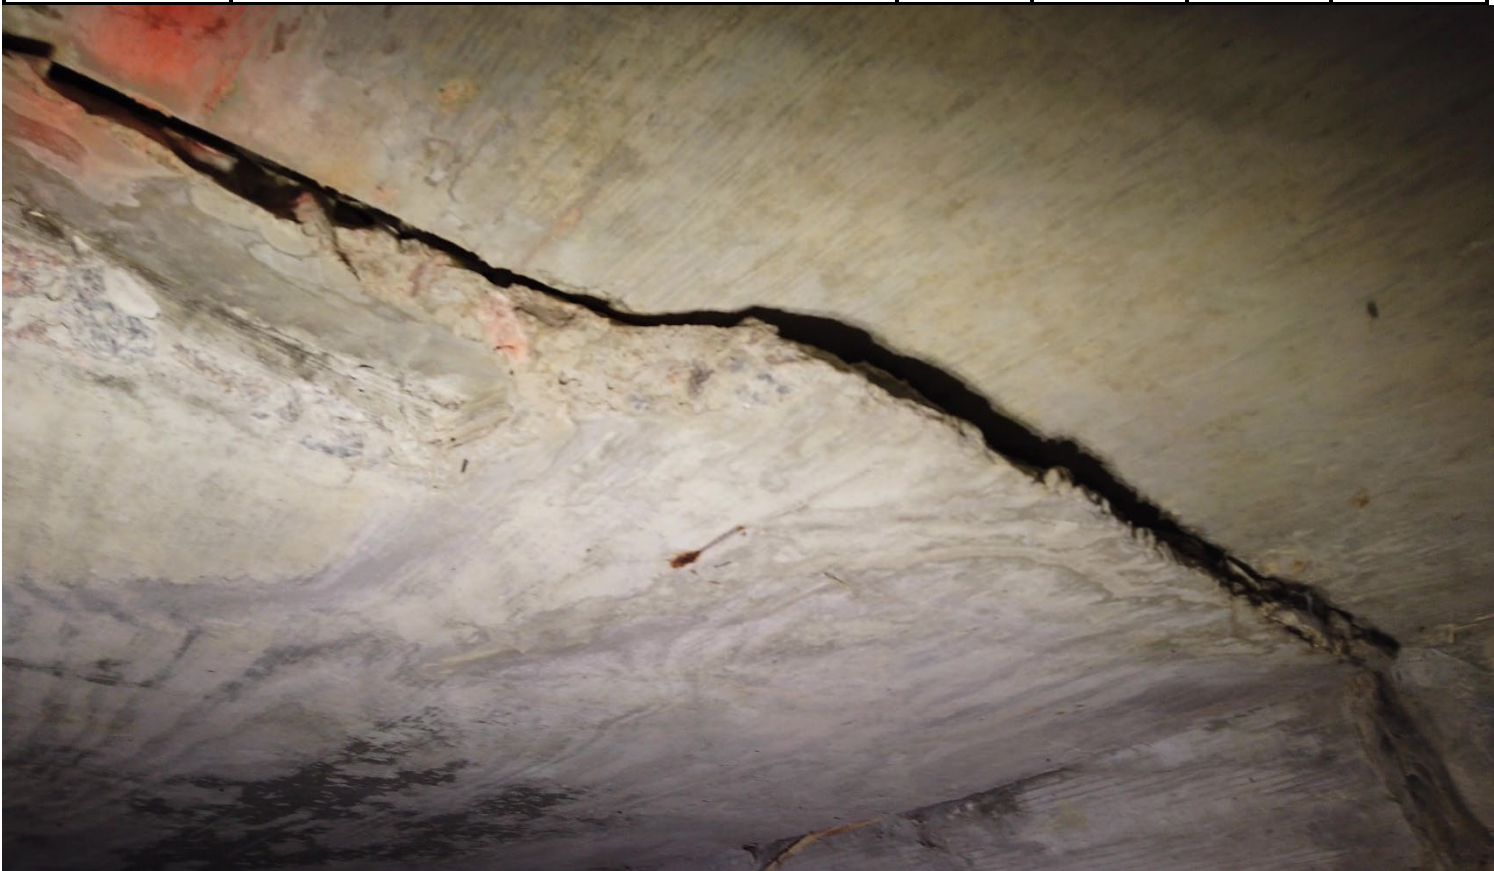
Footage	Defect Description	Top	Right	Left	Bottom
163 ft	Crack and Infiltration	Y

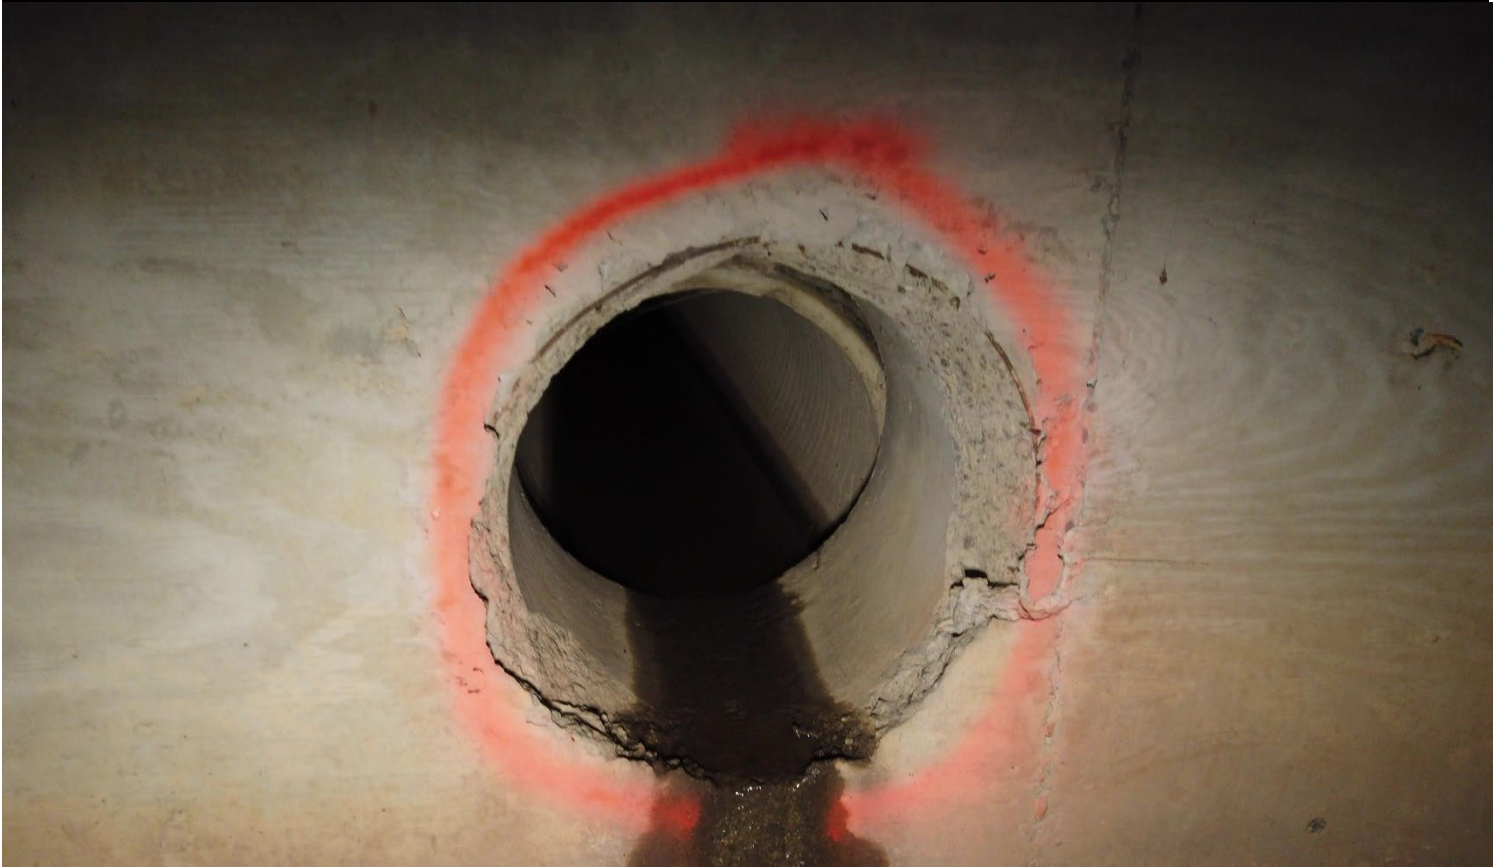
Footage	Defect Description	Top	Right	Left	Bottom
187 ft	Pipe Intersection			Y
