I-26 & I-95 INTERCHANGE IMPROVEMENTS

June 29, 2023

PIPE INSPECTION REPORT

This report contains the results of the video pipe inspection and assessment of the existing storm water drainage pipes within the project area in Orangeburg and Dorchester Counties.

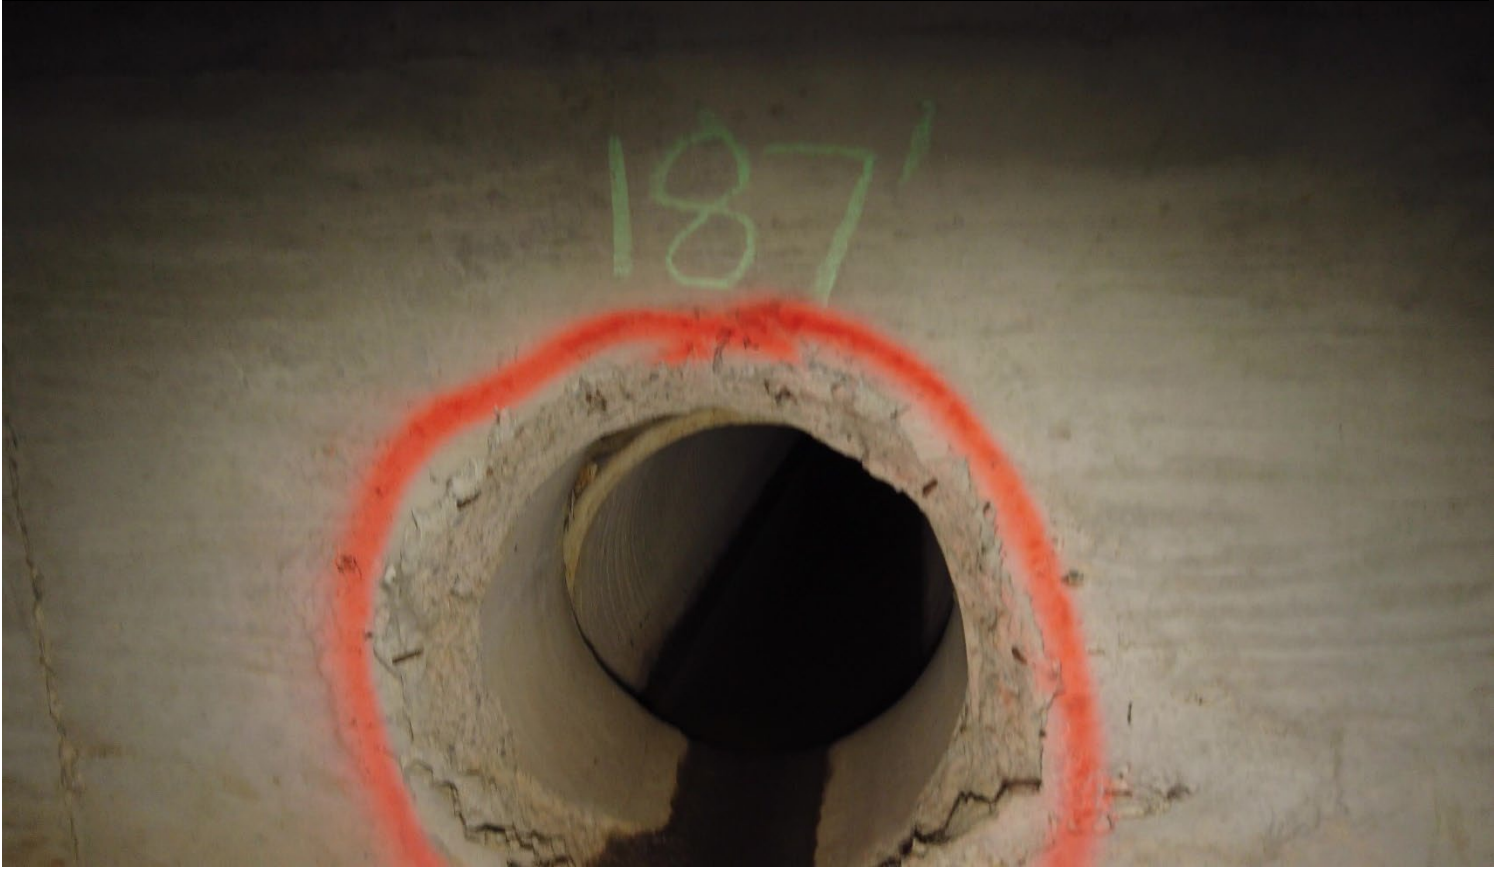
Footage	Defect Description	Top	Right	Left	Bottom
187 ft	Pipe Intersection		Y

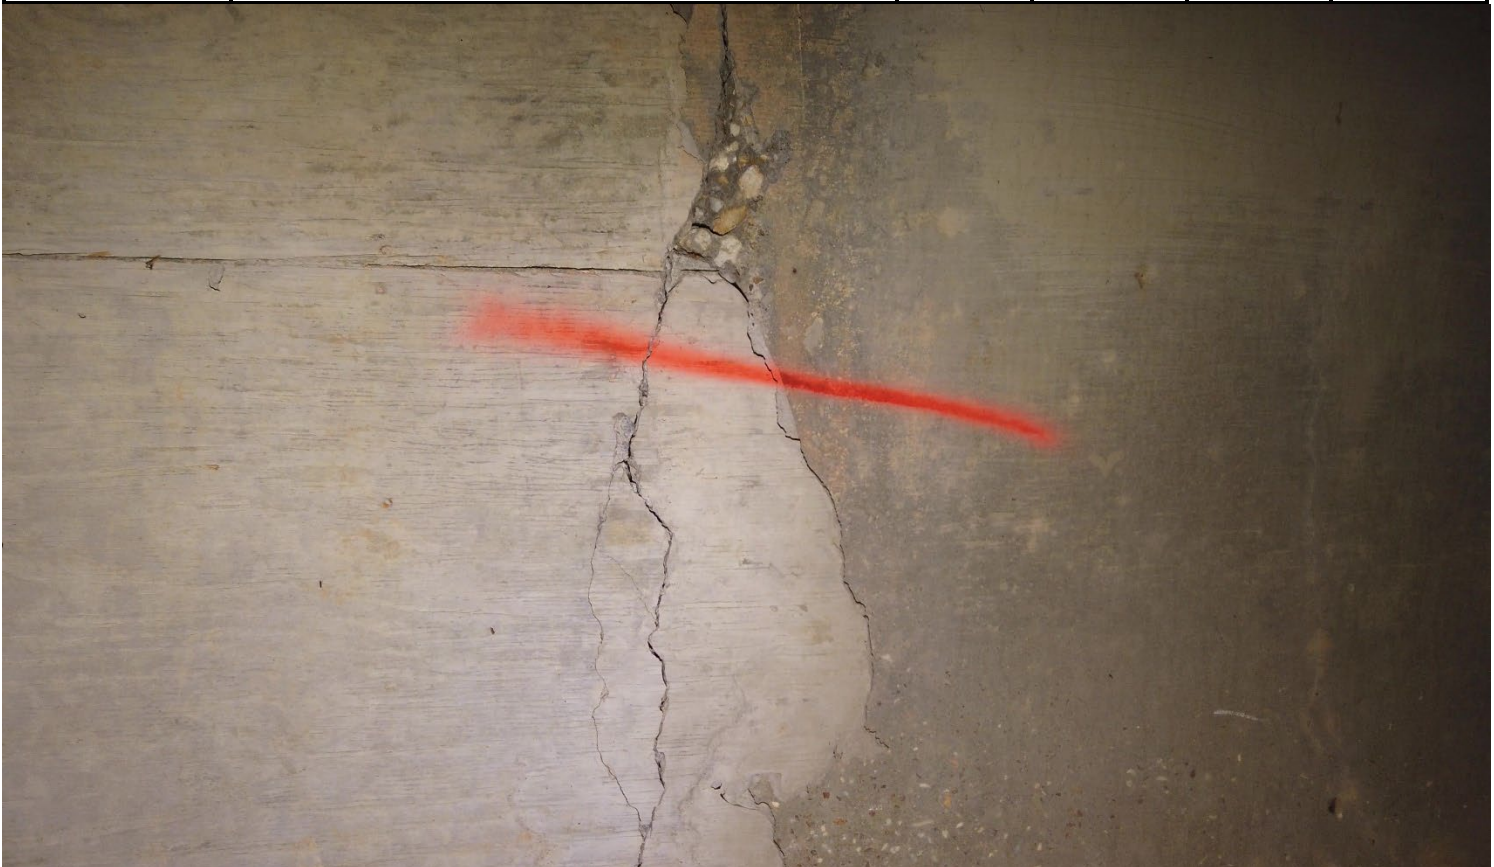
Footage	Defect Description	Top	Right	Left	Bottom
208 ft	Crack			Y

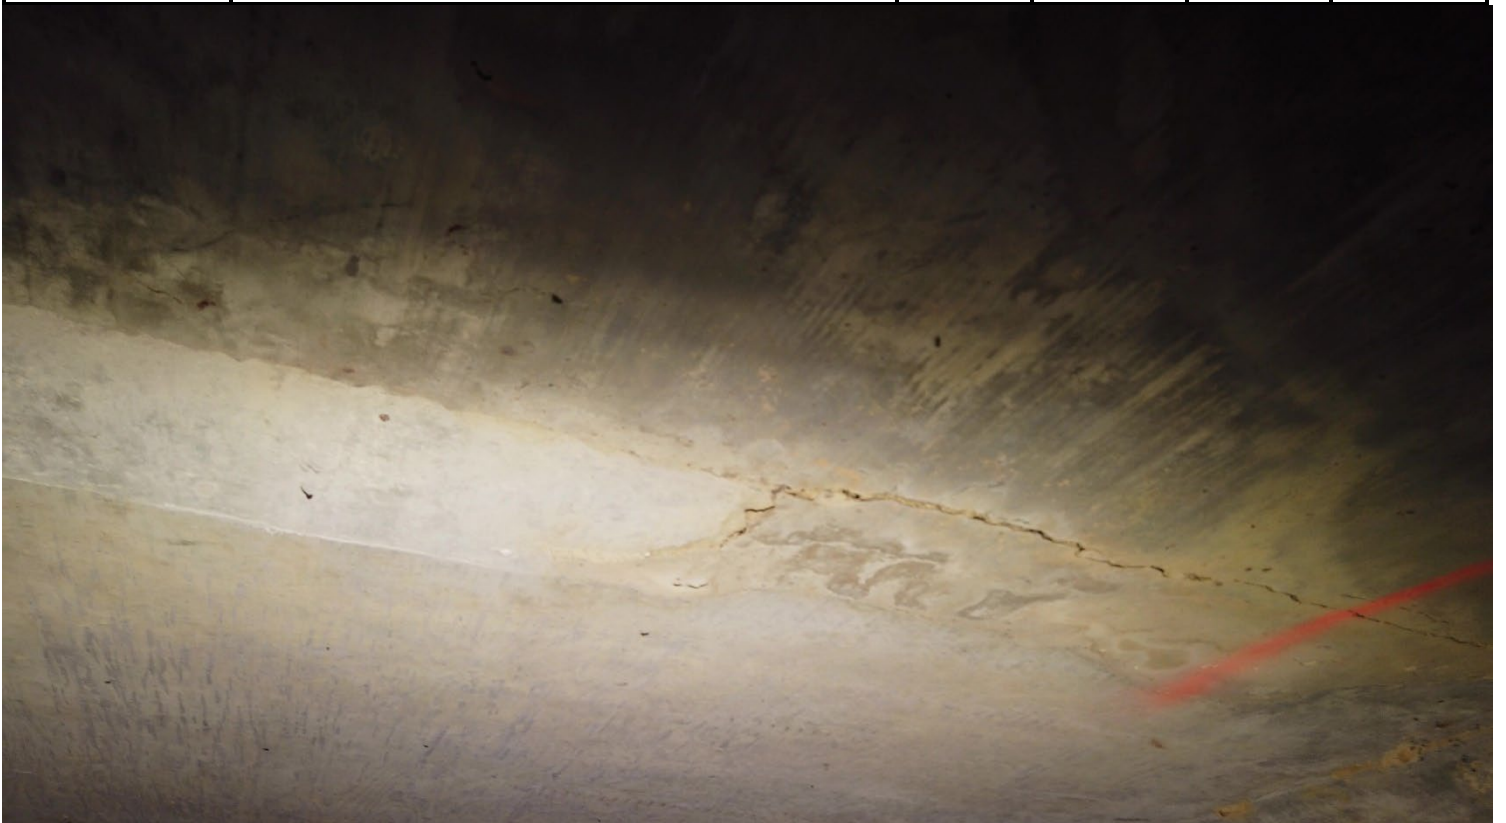
Footage	Defect Description	Top	Right	Left	Bottom
208 ft	Cracks	Y

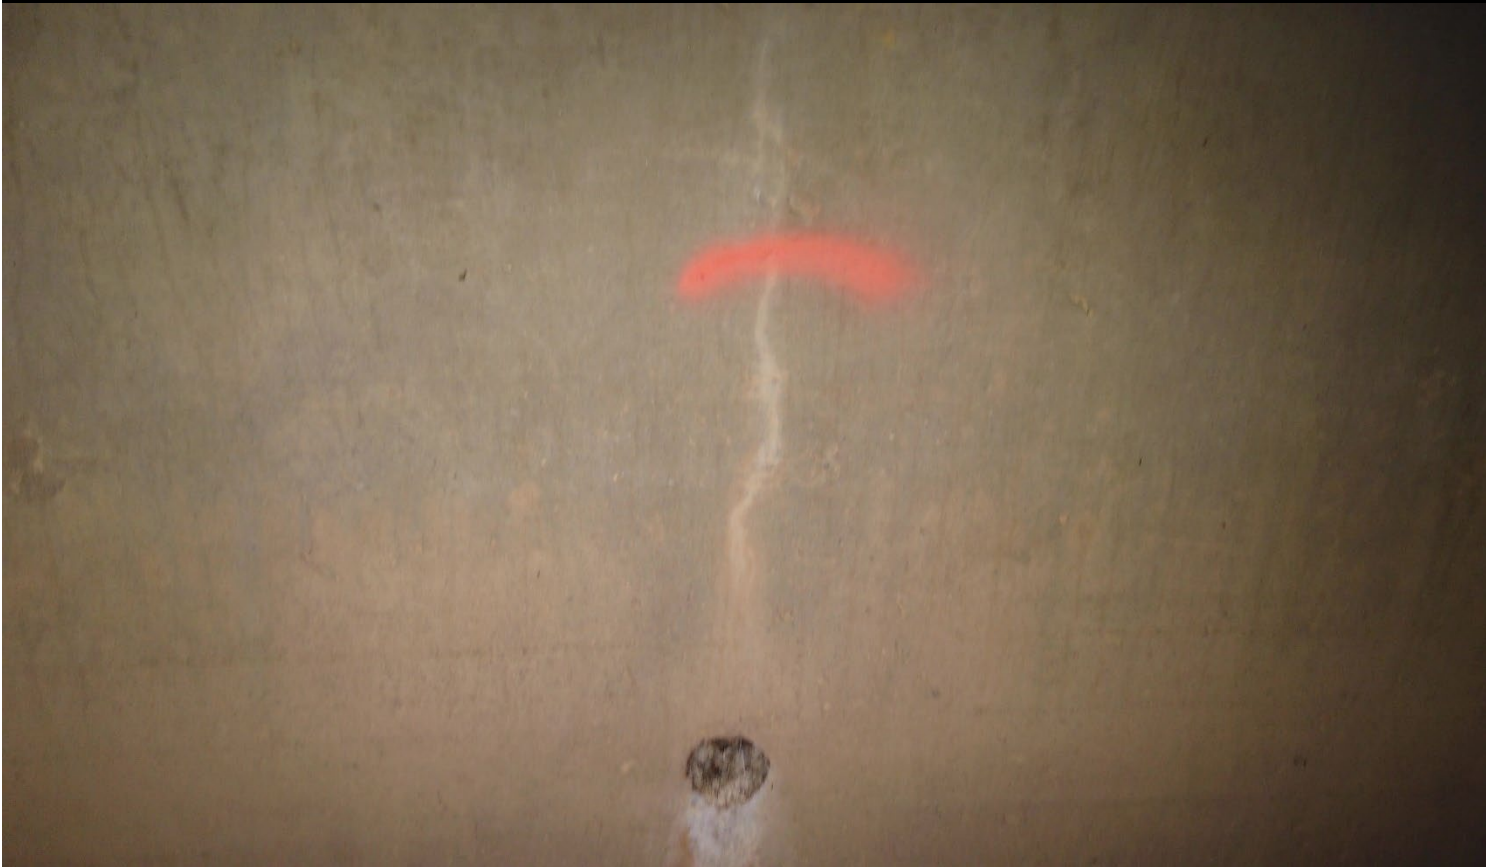
Footage	Defect Description	Top	Right	Left	Bottom
218 ft	Crack			Y

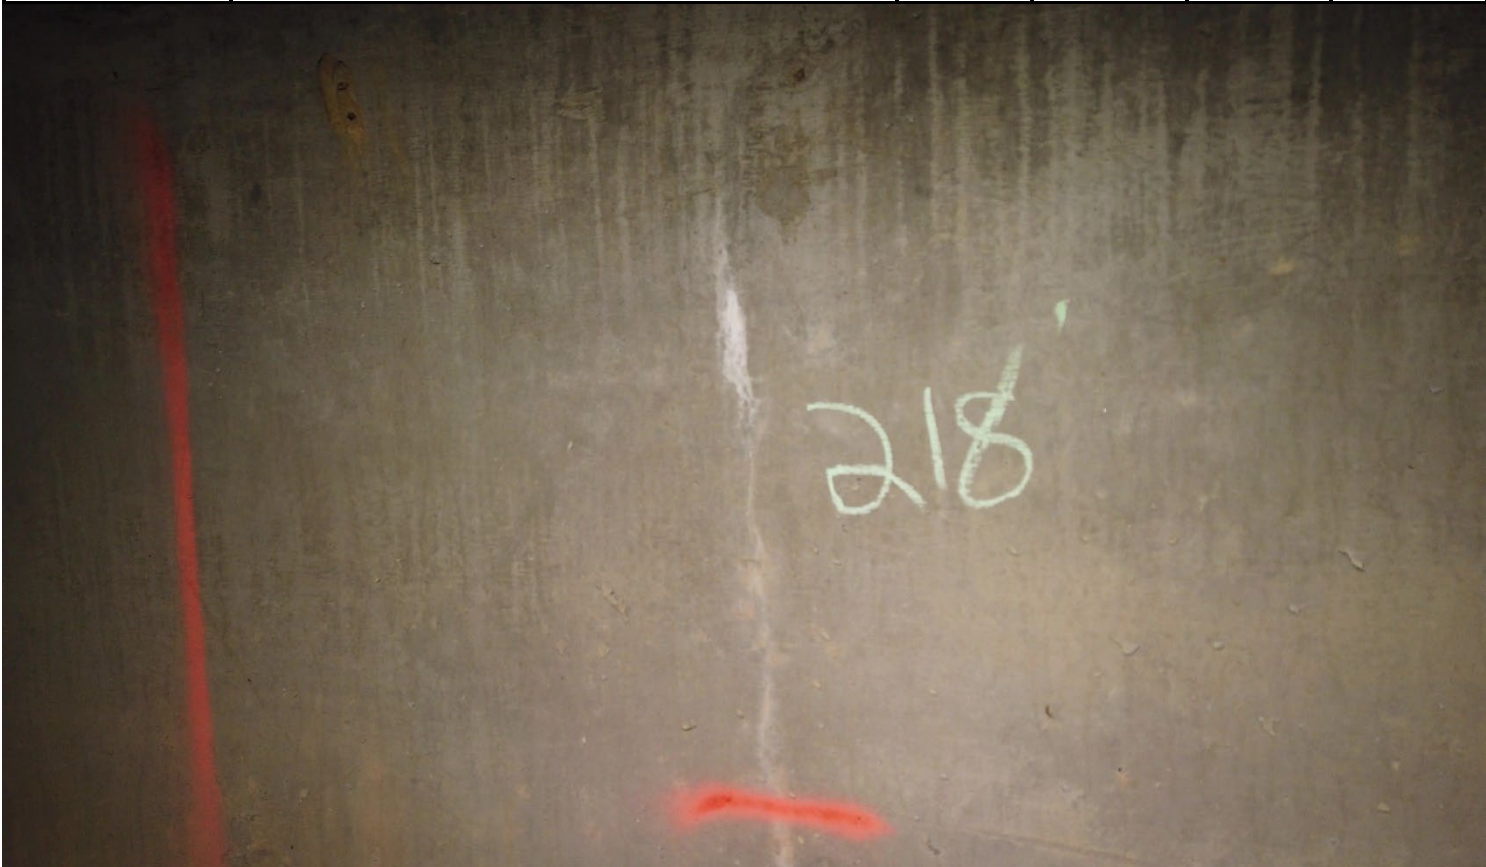
Footage	Defect Description	Top	Right	Left	Bottom
218 ft	Crack		Y

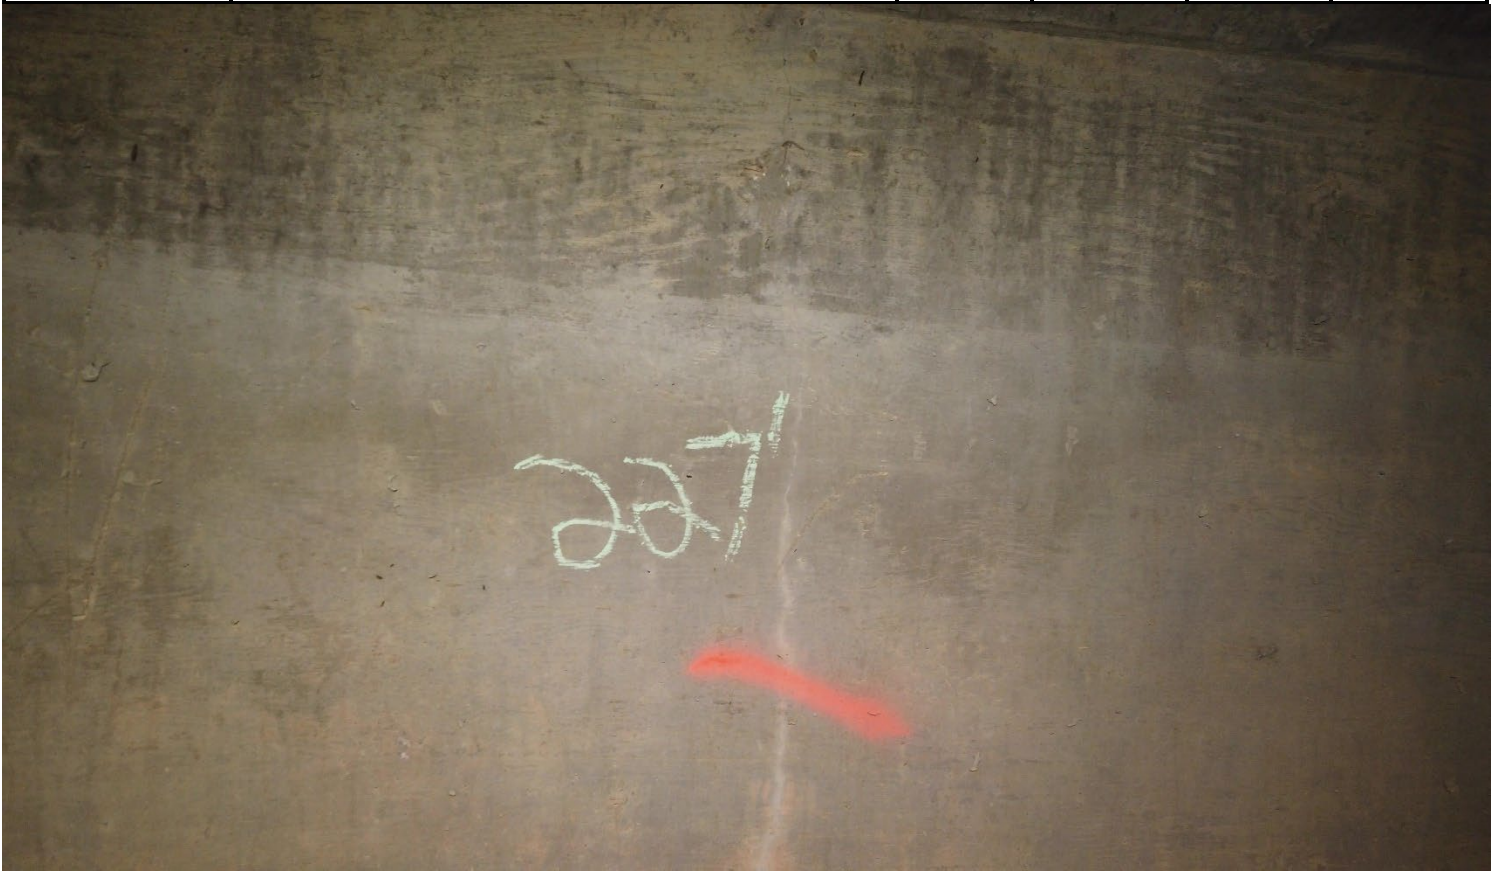
Footage	Defect Description	Top	Right	Left	Bottom
227 ft	Crack			Y

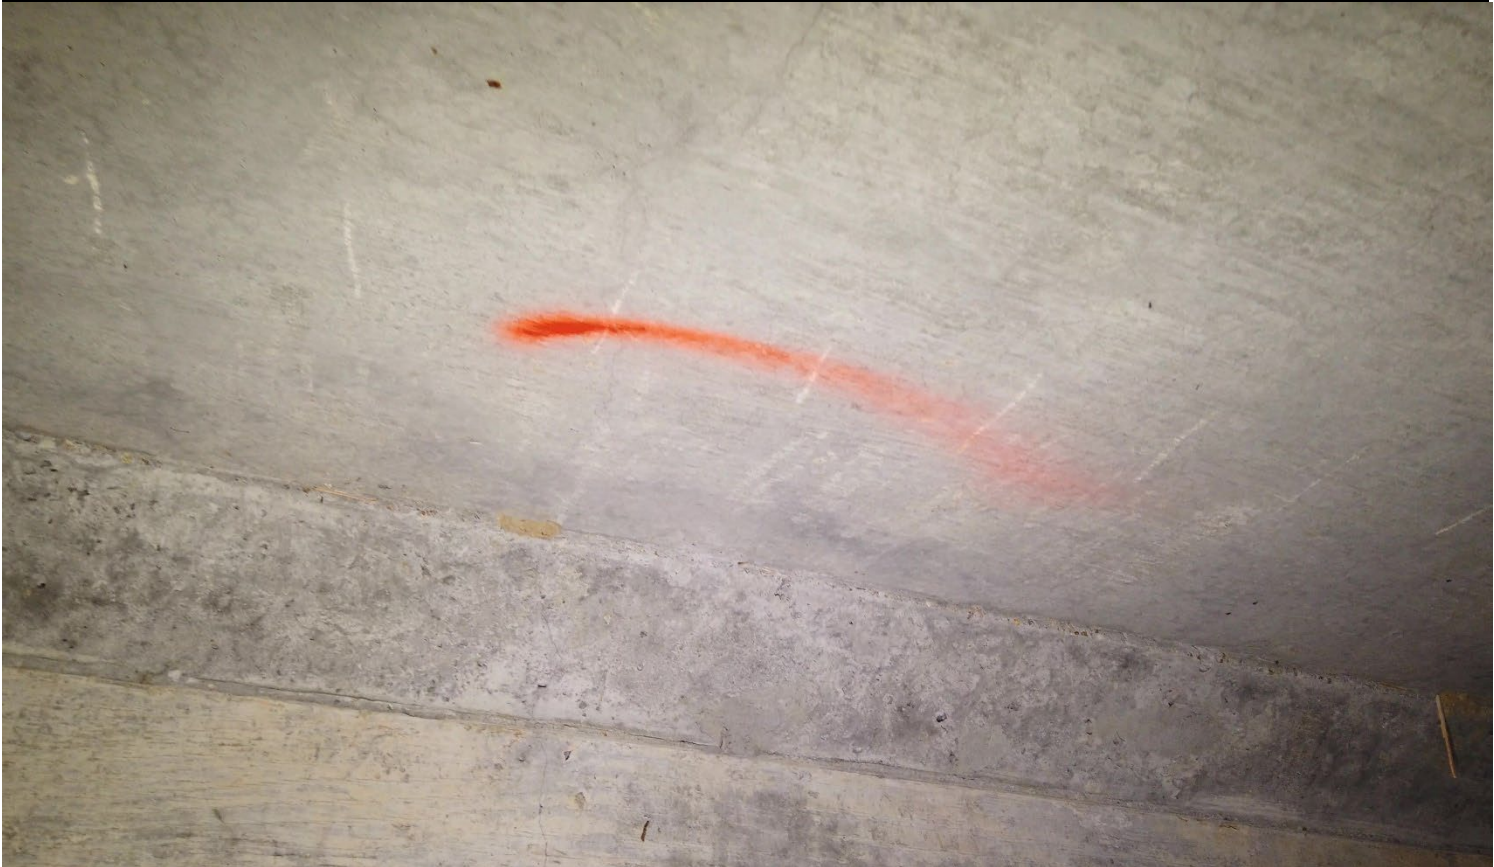
Footage	Defect Description	Top	Right	Left	Bottom
227 ft	Crack	Y

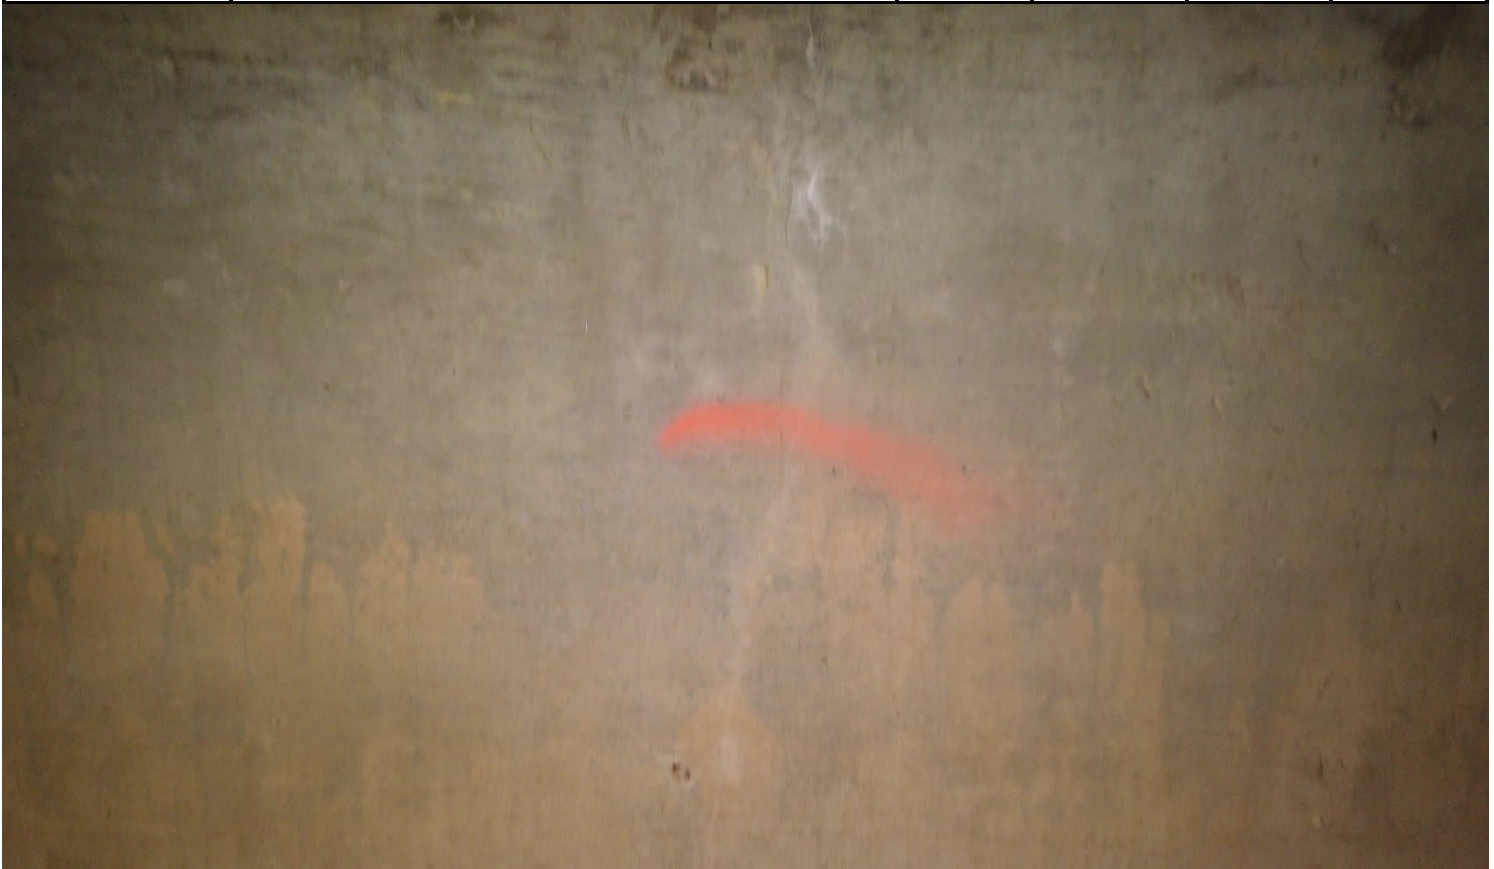
Footage	Defect Description	Top	Right	Left	Bottom
235 ft	Crack			Y

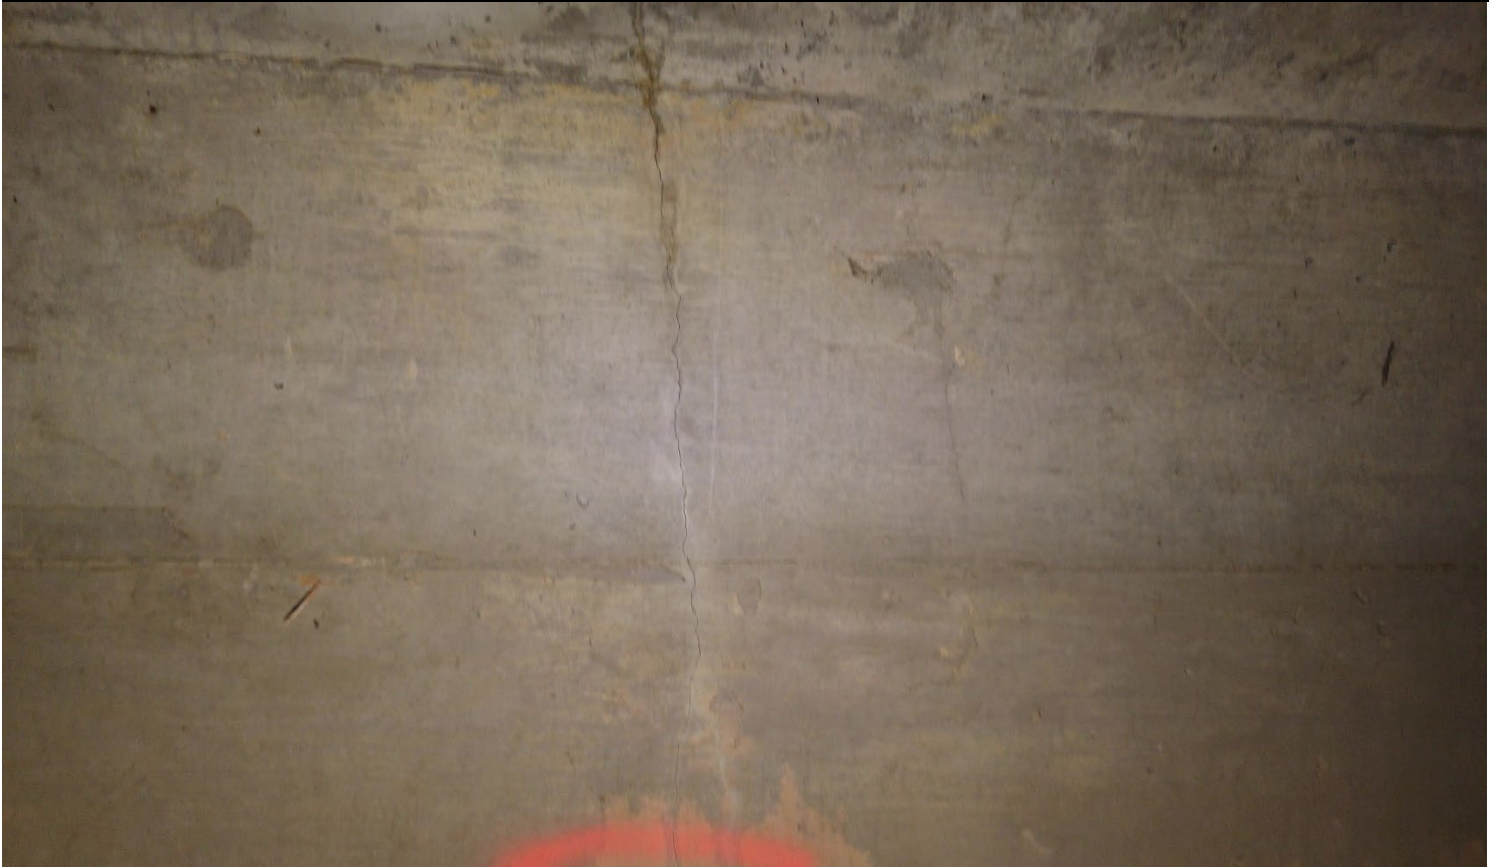
Footage	Defect Description	Top	Right	Left	Bottom
243 ft	Crack			Y

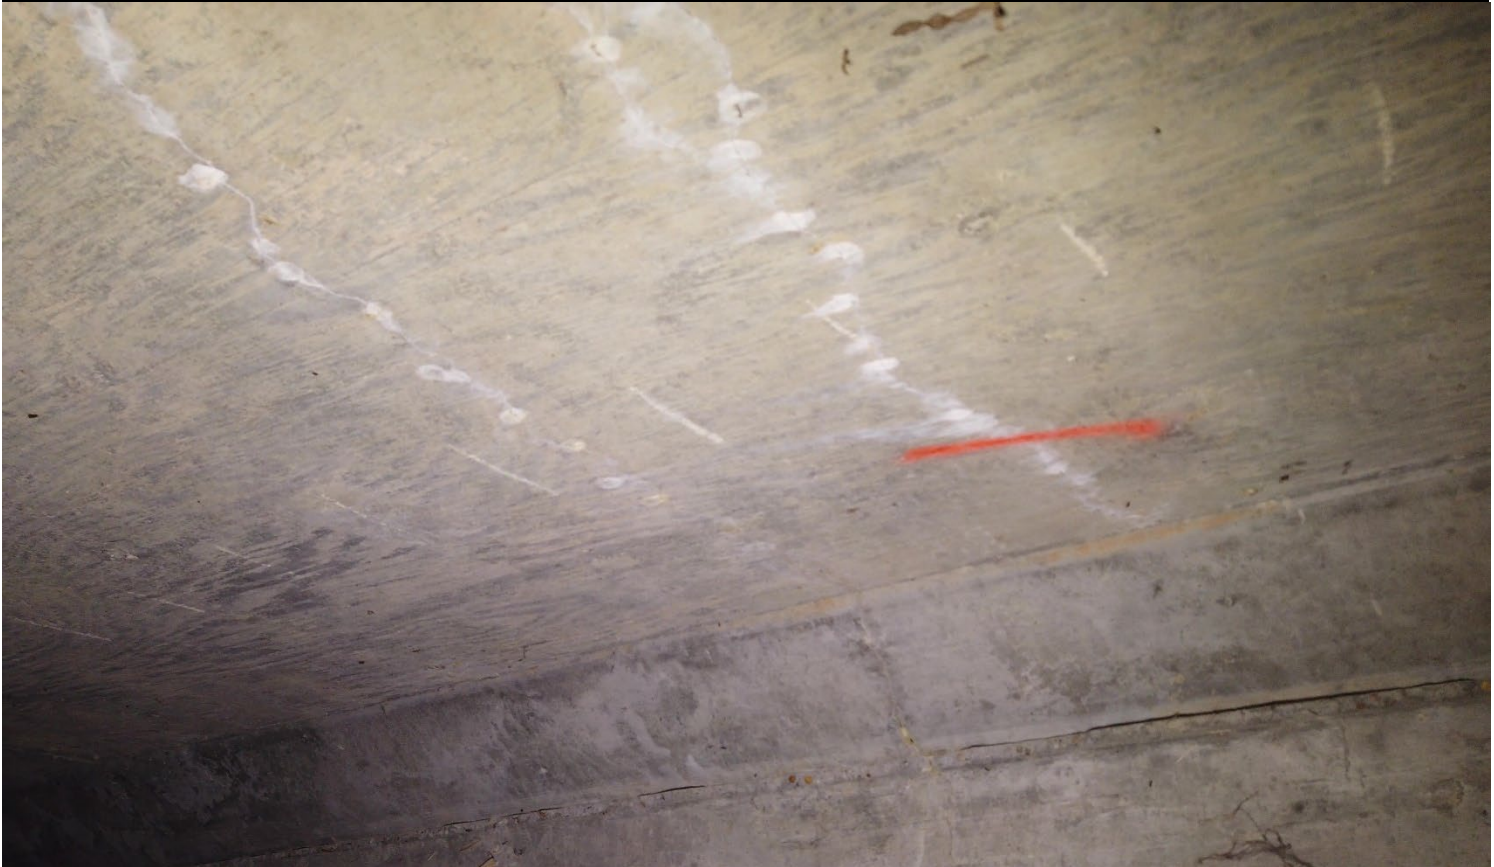
Footage	Defect Description	Top	Right	Left	Bottom
243 ft	Crack	Y

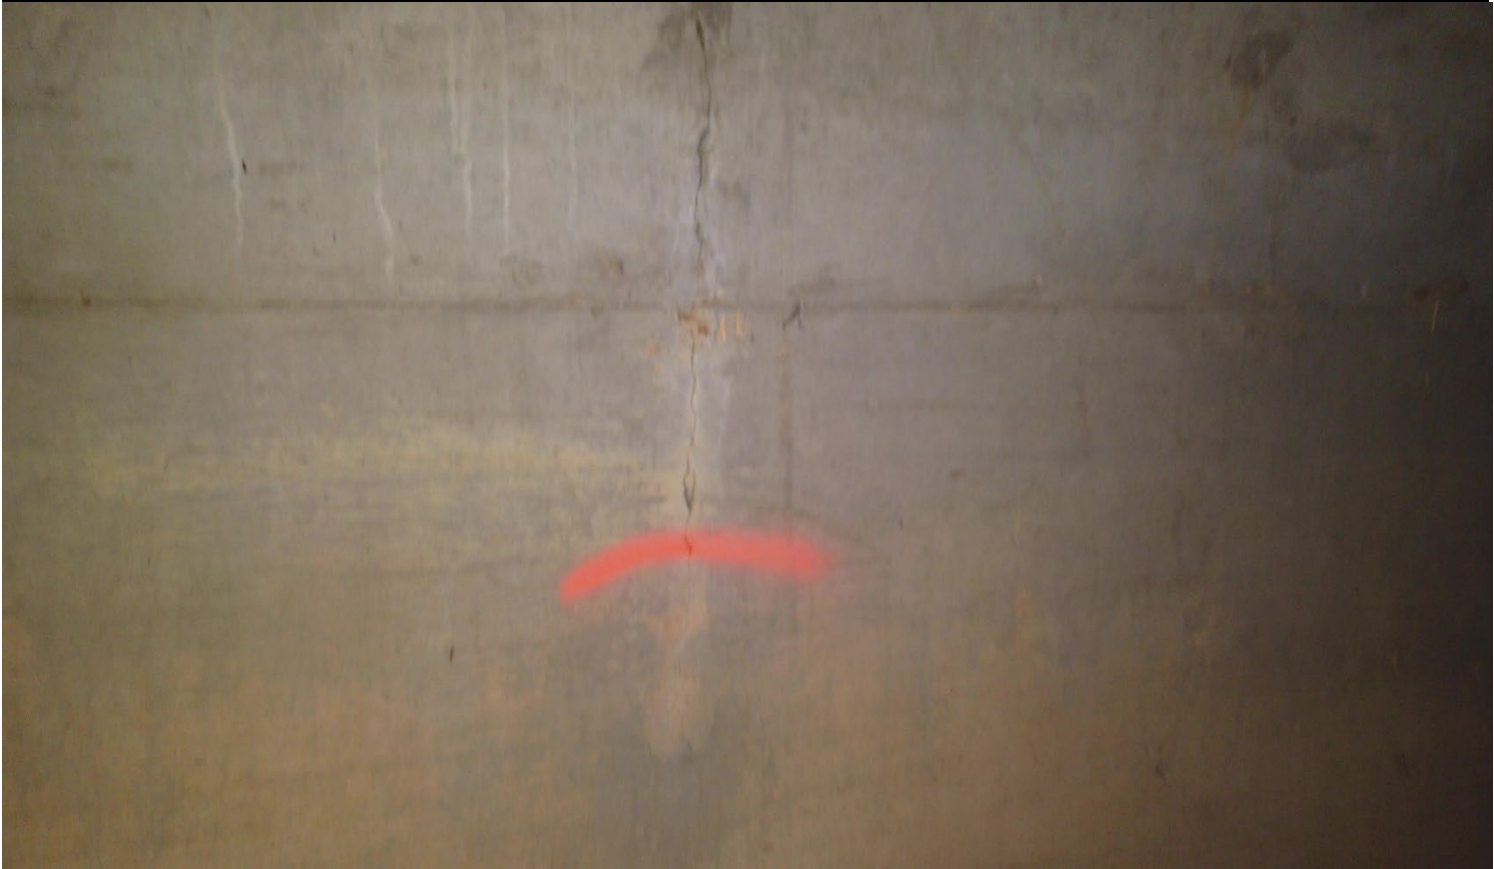
Footage	Defect Description	Top	Right	Left	Bottom
252 ft	Crack			Y

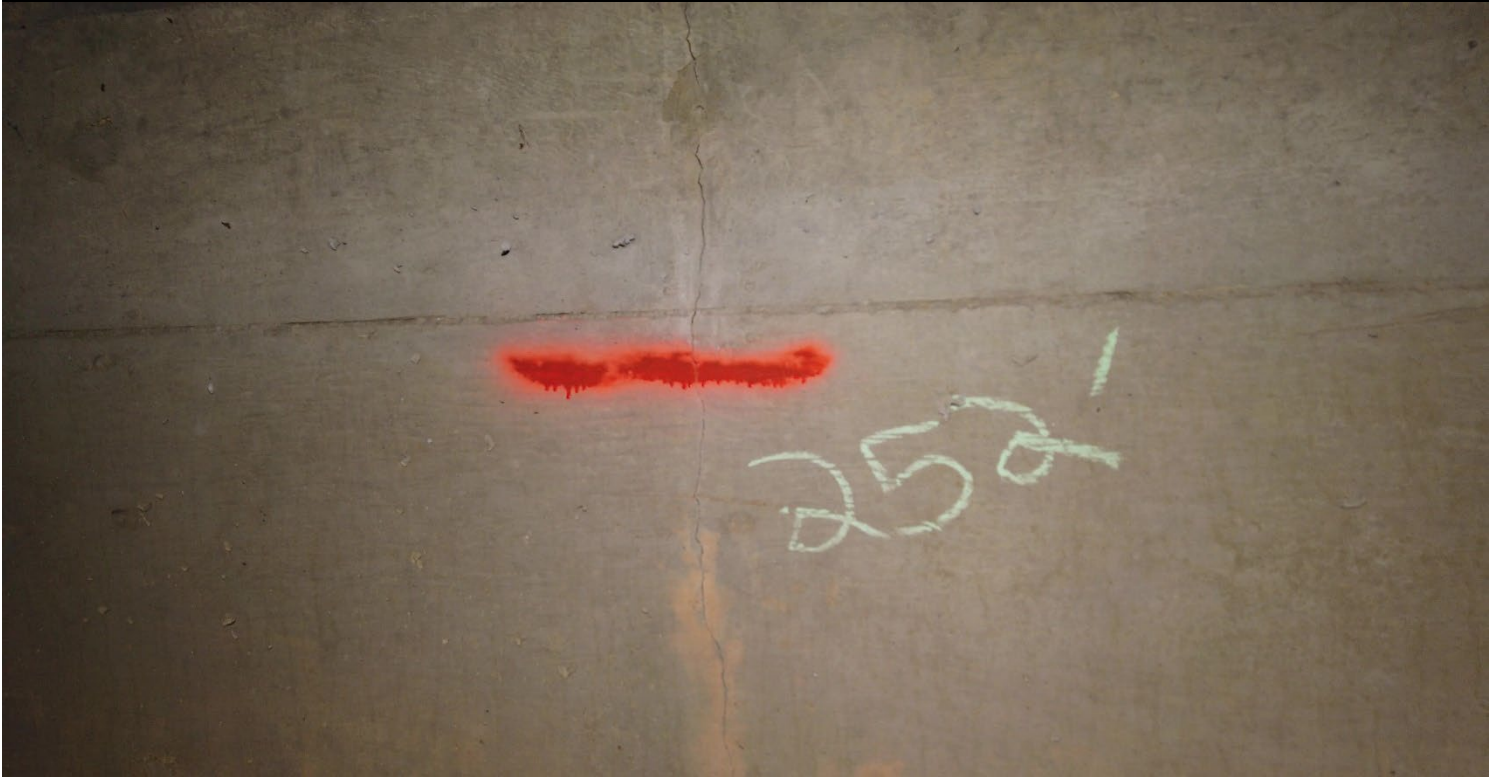
Footage	Defect Description	Top	Right	Left	Bottom
252 ft	Crack		Y

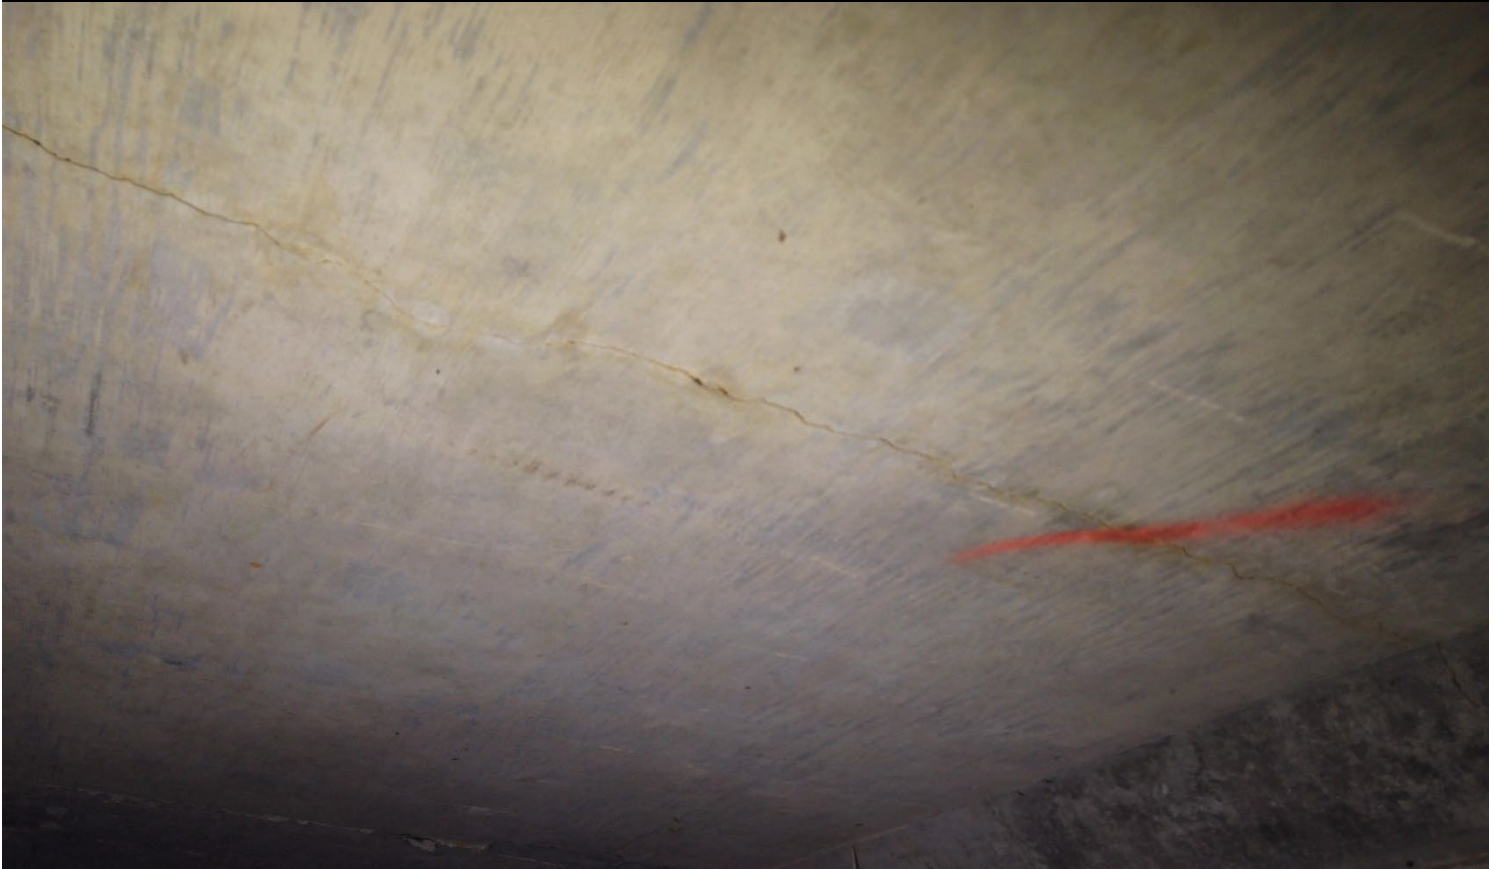
Footage	Defect Description	Top	Right	Left	Bottom
252 ft	Crack	Y

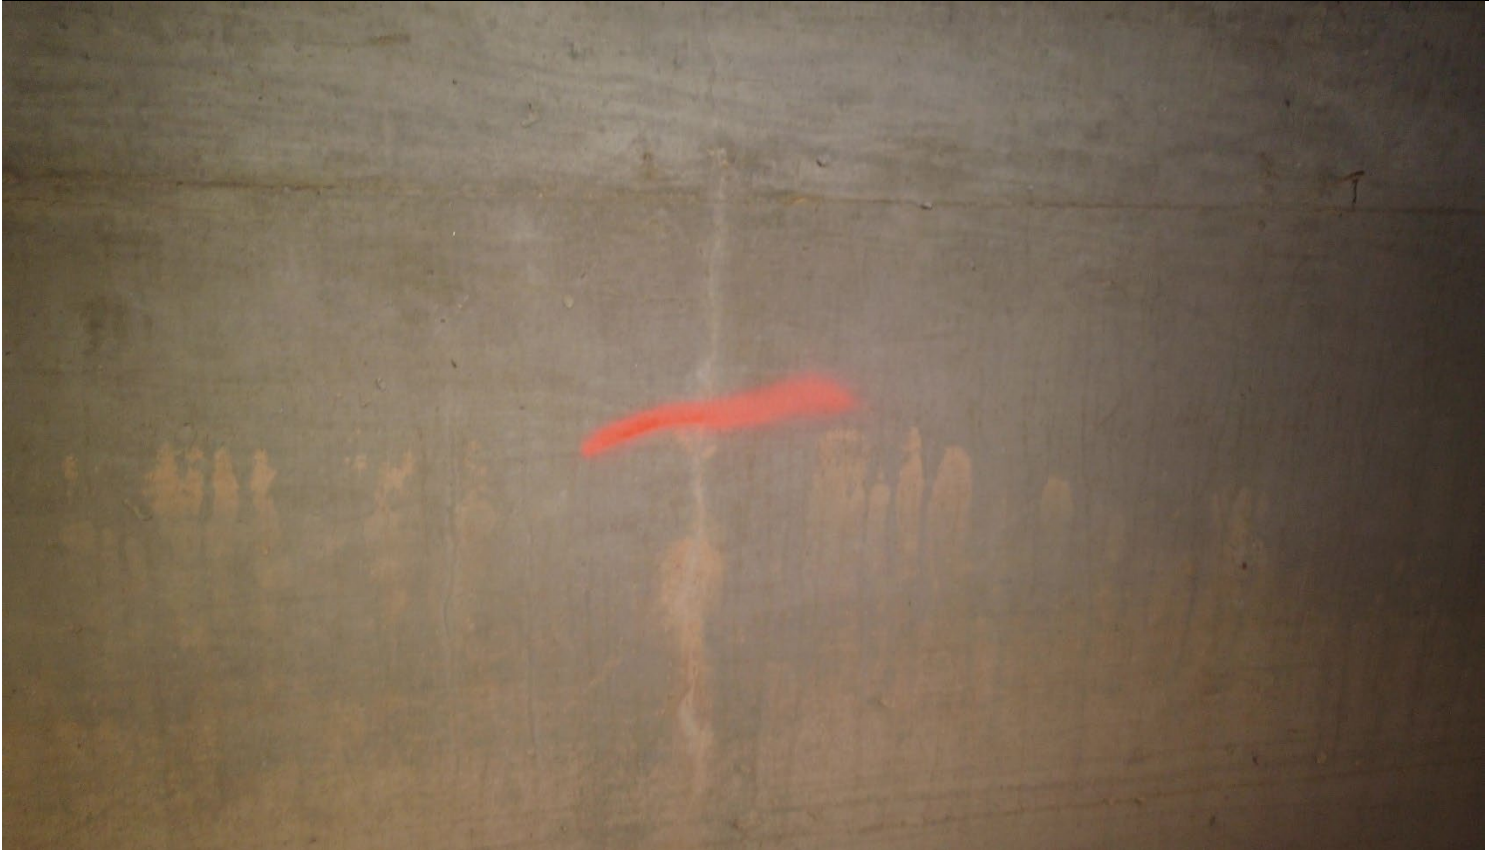
Footage	Defect Description	Top	Right	Left	Bottom
260 ft	Crack			Y

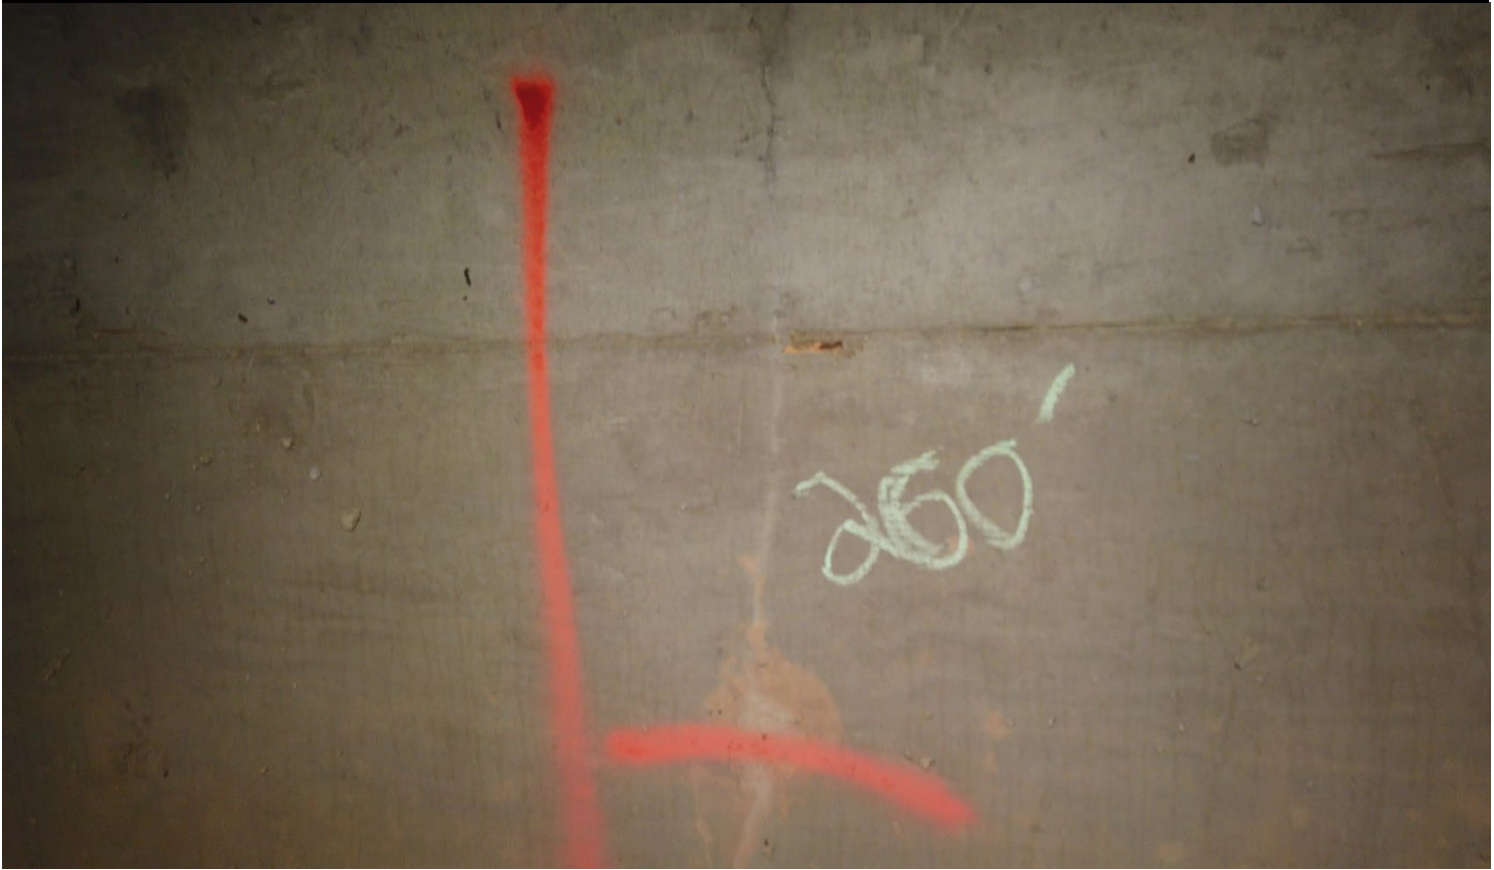
Footage	Defect Description	Top	Right	Left	Bottom
260 ft	Crack		Y

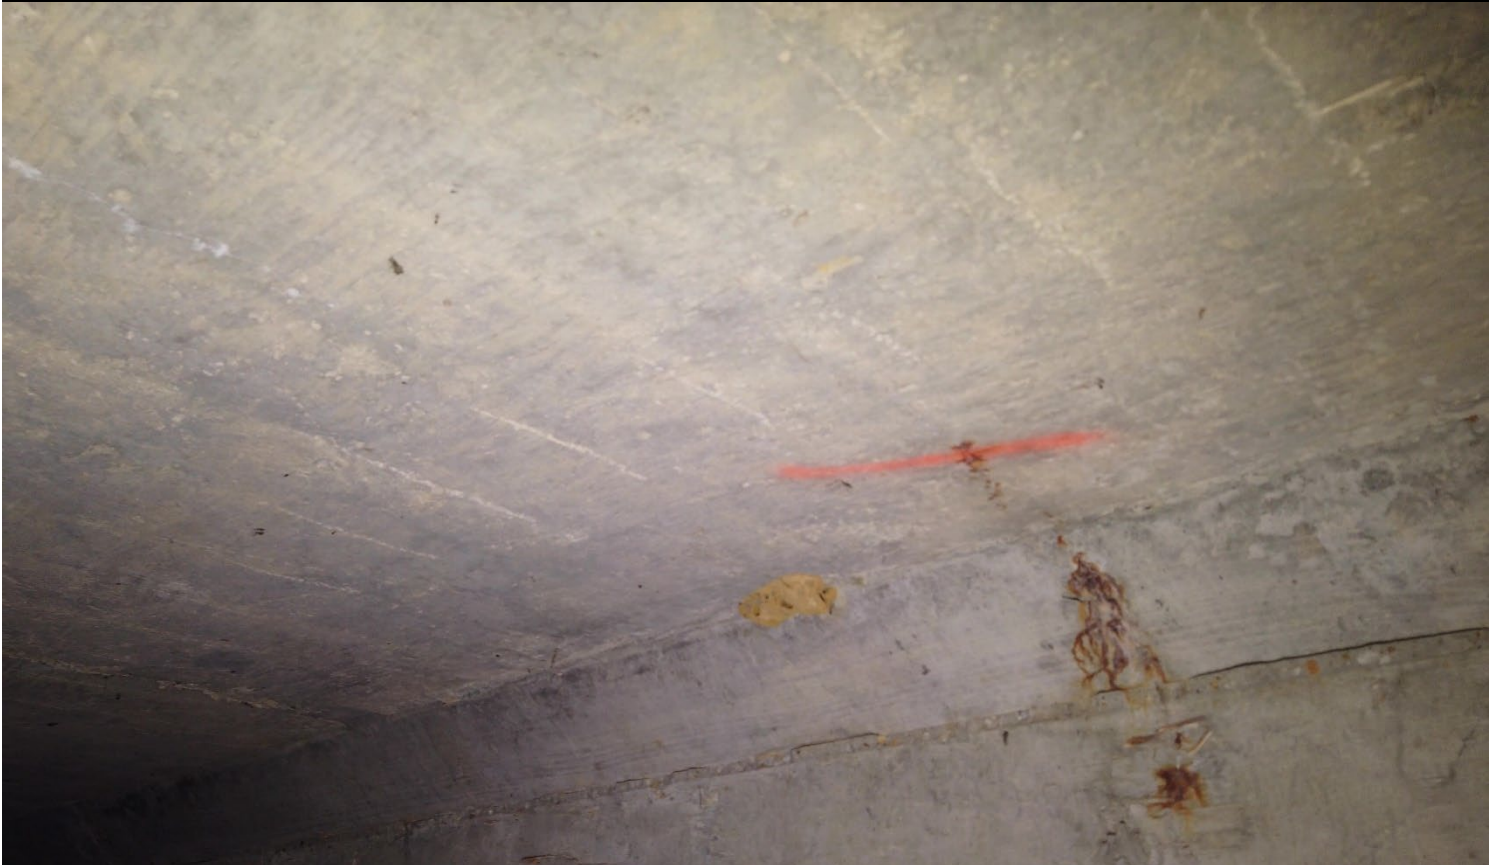
Footage	Defect Description	Top	Right	Left	Bottom
260 ft	Crack	Y

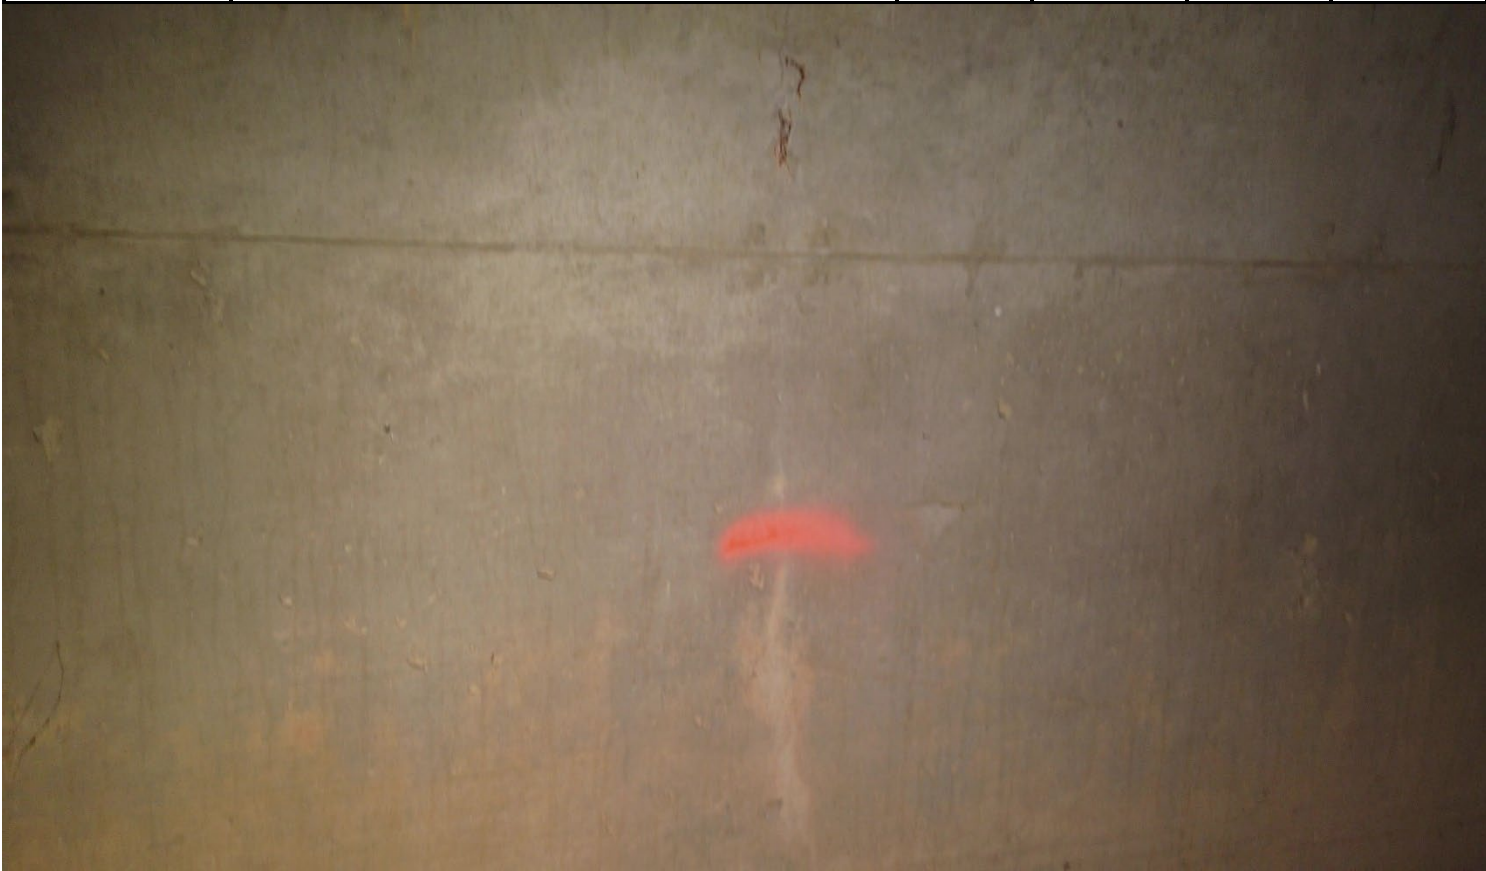
Footage	Defect Description	Top	Right	Left	Bottom
268 ft	Crack			Y
