I-26 & I-95 INTERCHANGE IMPROVEMENTS

June 29, 2023

PIPE INSPECTION REPORT

This report contains the results of the video pipe inspection and assessment of the existing storm water drainage pipes within the project area in Orangeburg and Dorchester Counties.

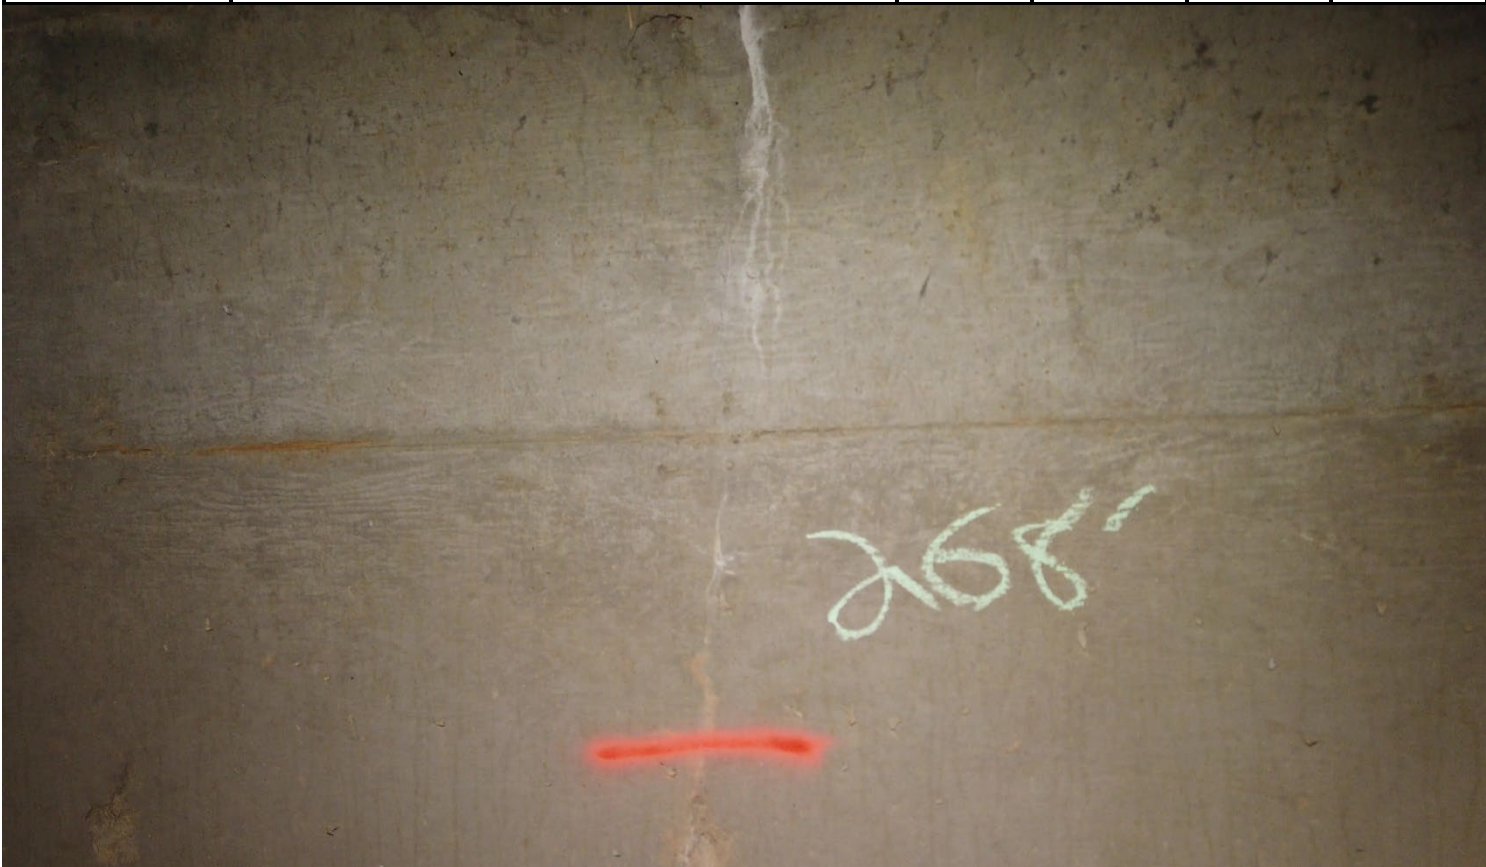
Footage	Defect Description	Top	Right	Left	Bottom
268 ft	Crack		Y

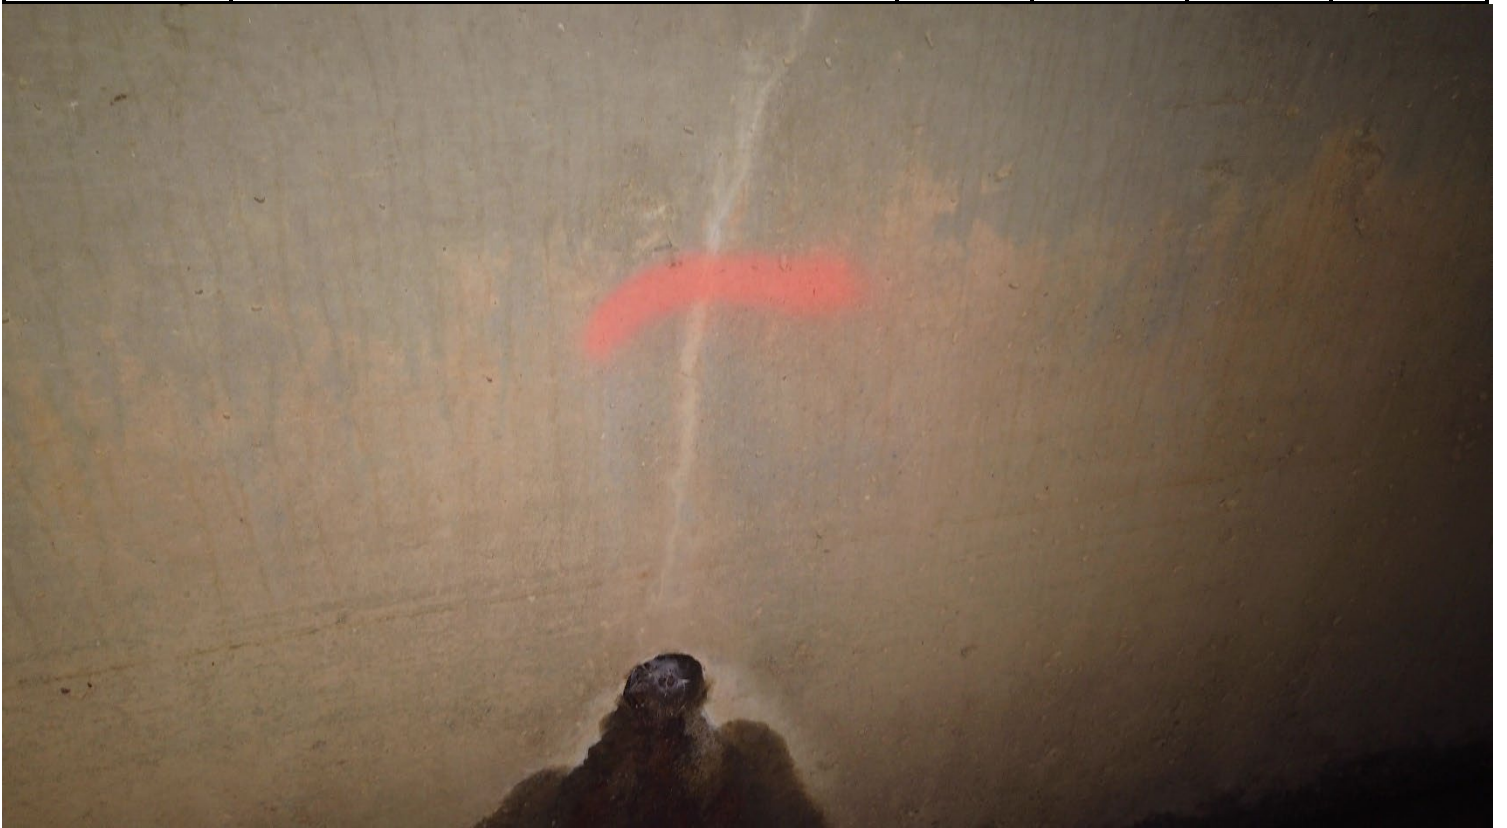
Footage	Defect Description	Top	Right	Left	Bottom
277 ft	Crack		Y	Y

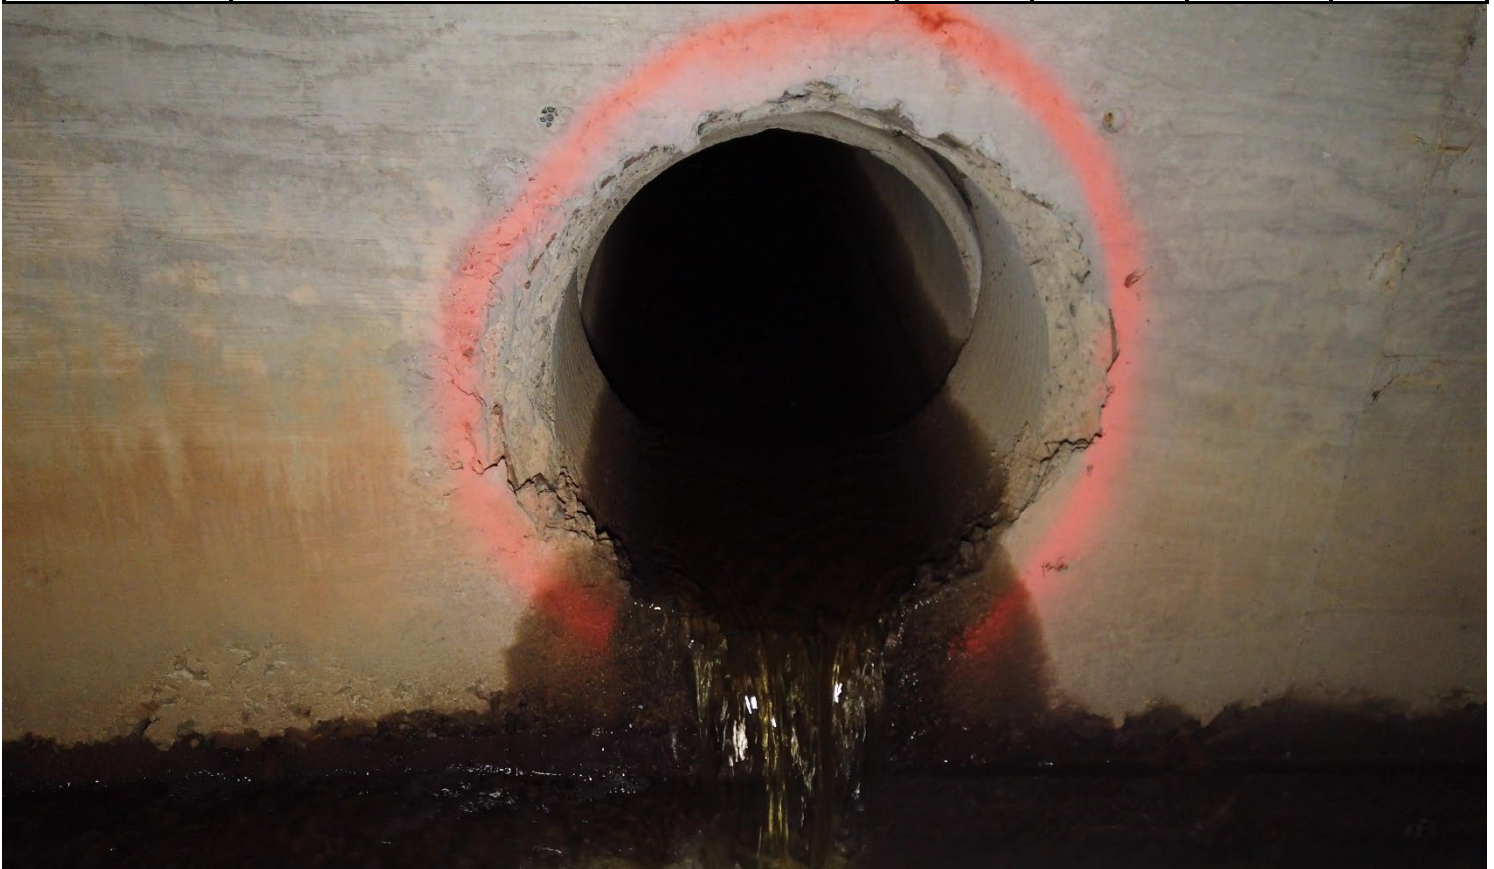
Footage	Defect Description	Top	Right	Left	Bottom
311 ft	Pipe Intersection		Y	Y

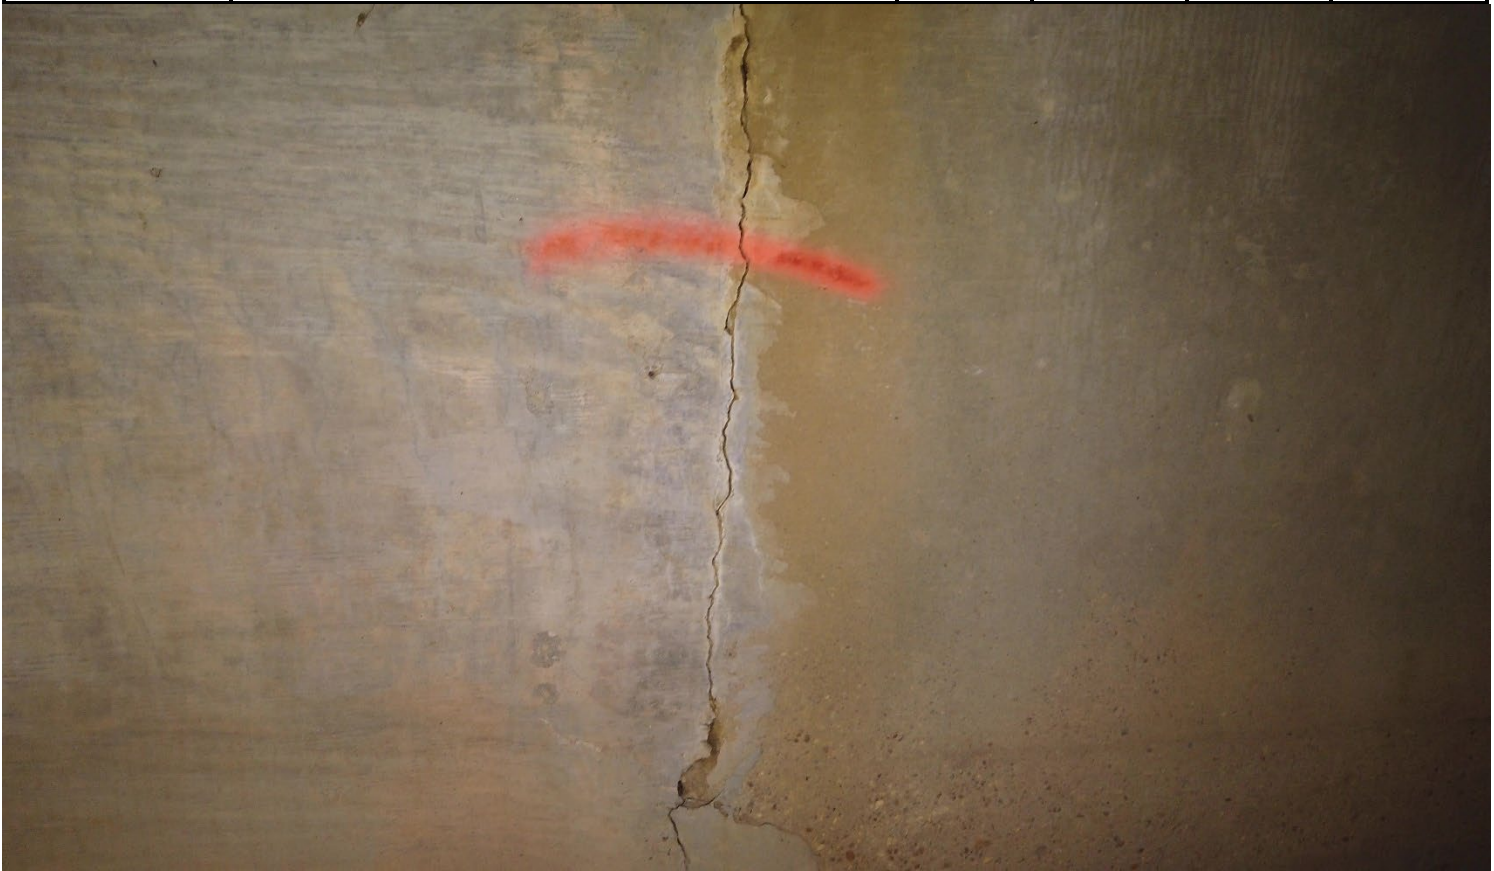
Footage	Defect Description	Top	Right	Left	Bottom
329 ft	Cracks all the way around	Y	Y	Y	Y

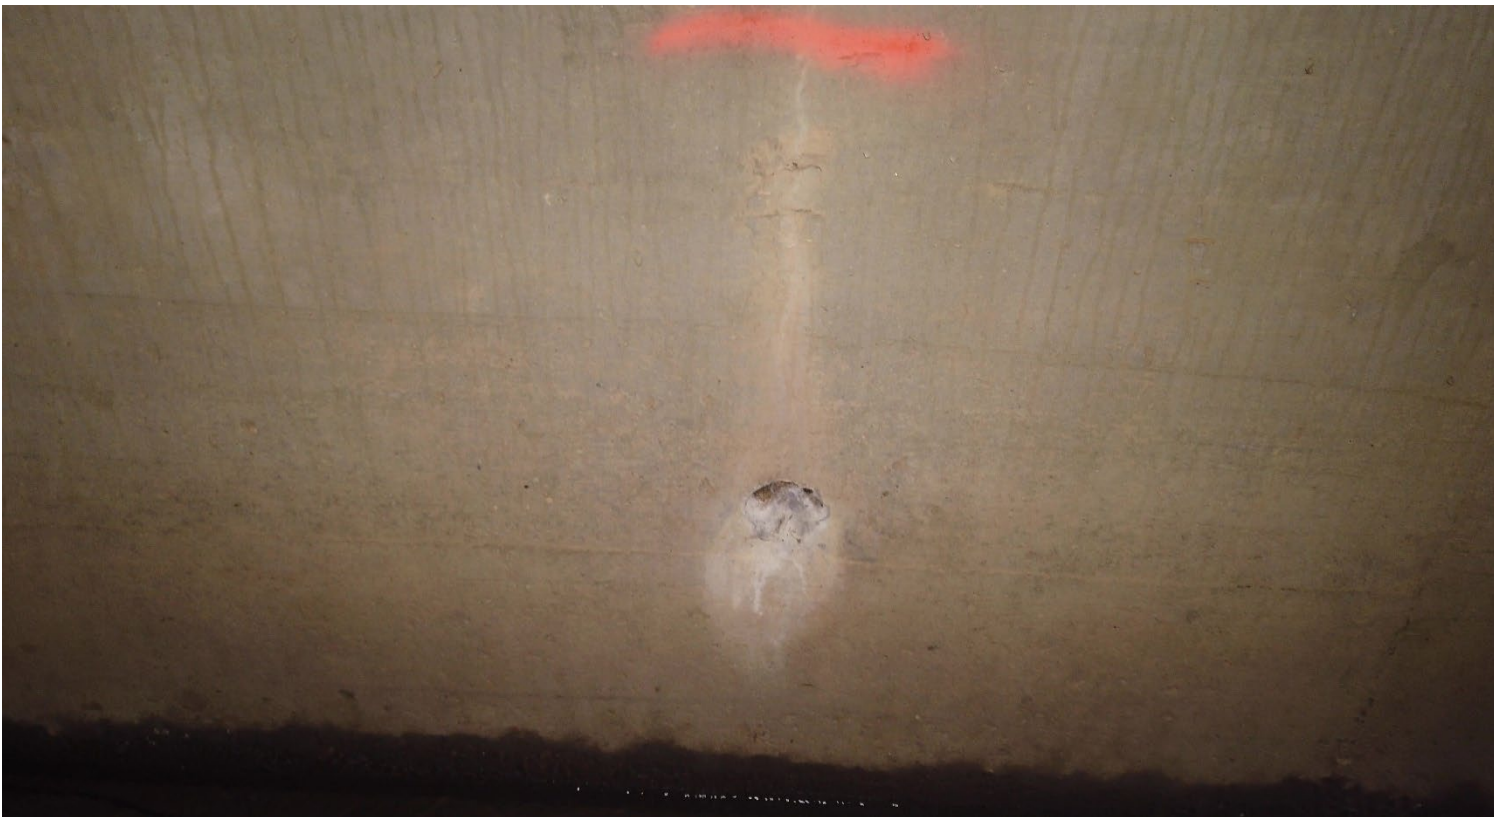
Footage	Defect Description	Top	Right	Left	Bottom
358 ft	Cracks		Y	Y

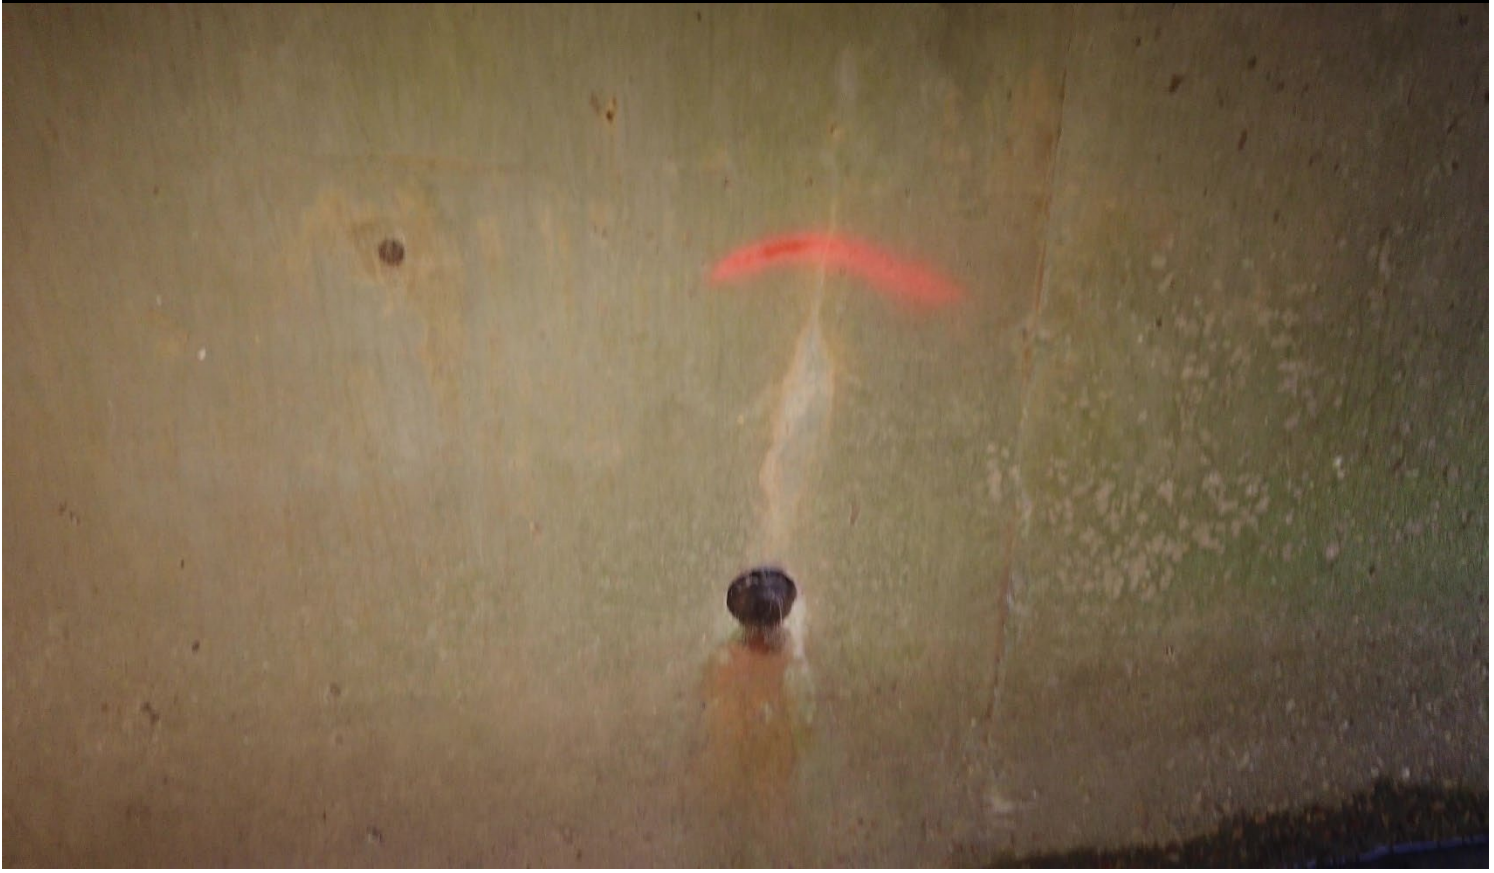
Footage	Defect Description	Top	Right	Left	Bottom
367 ft	Cracks		Y	Y

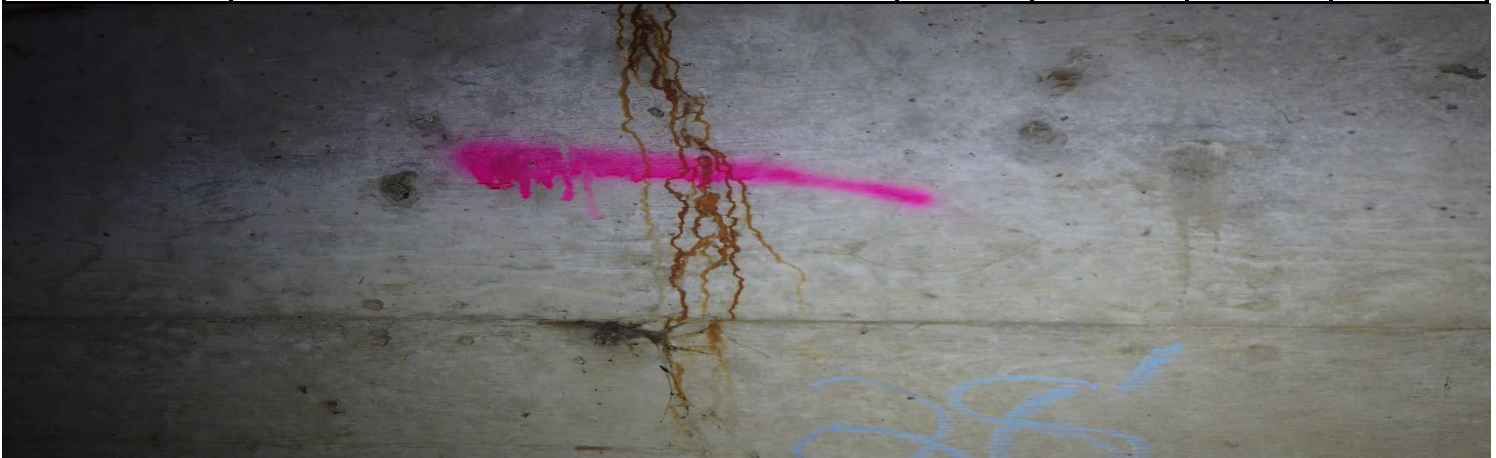
Footage	Defect Description	Top	Right	Left	Bottom
28 ft	Crack and Infiltration		Y

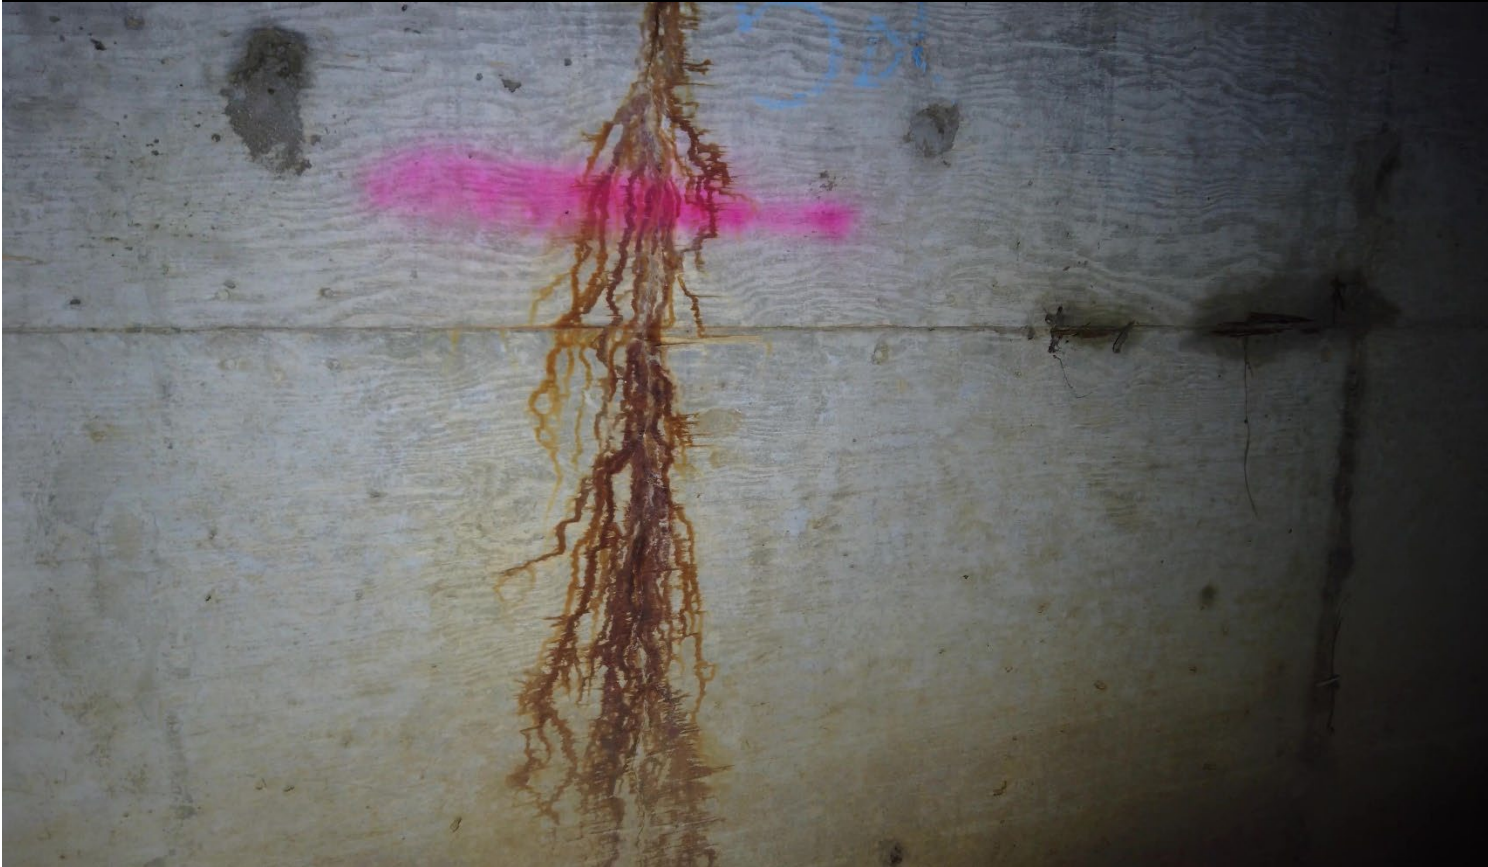
Footage	Defect Description	Top	Right	Left	Bottom
49 ft	Crack and Infiltration	Y	Y	Y

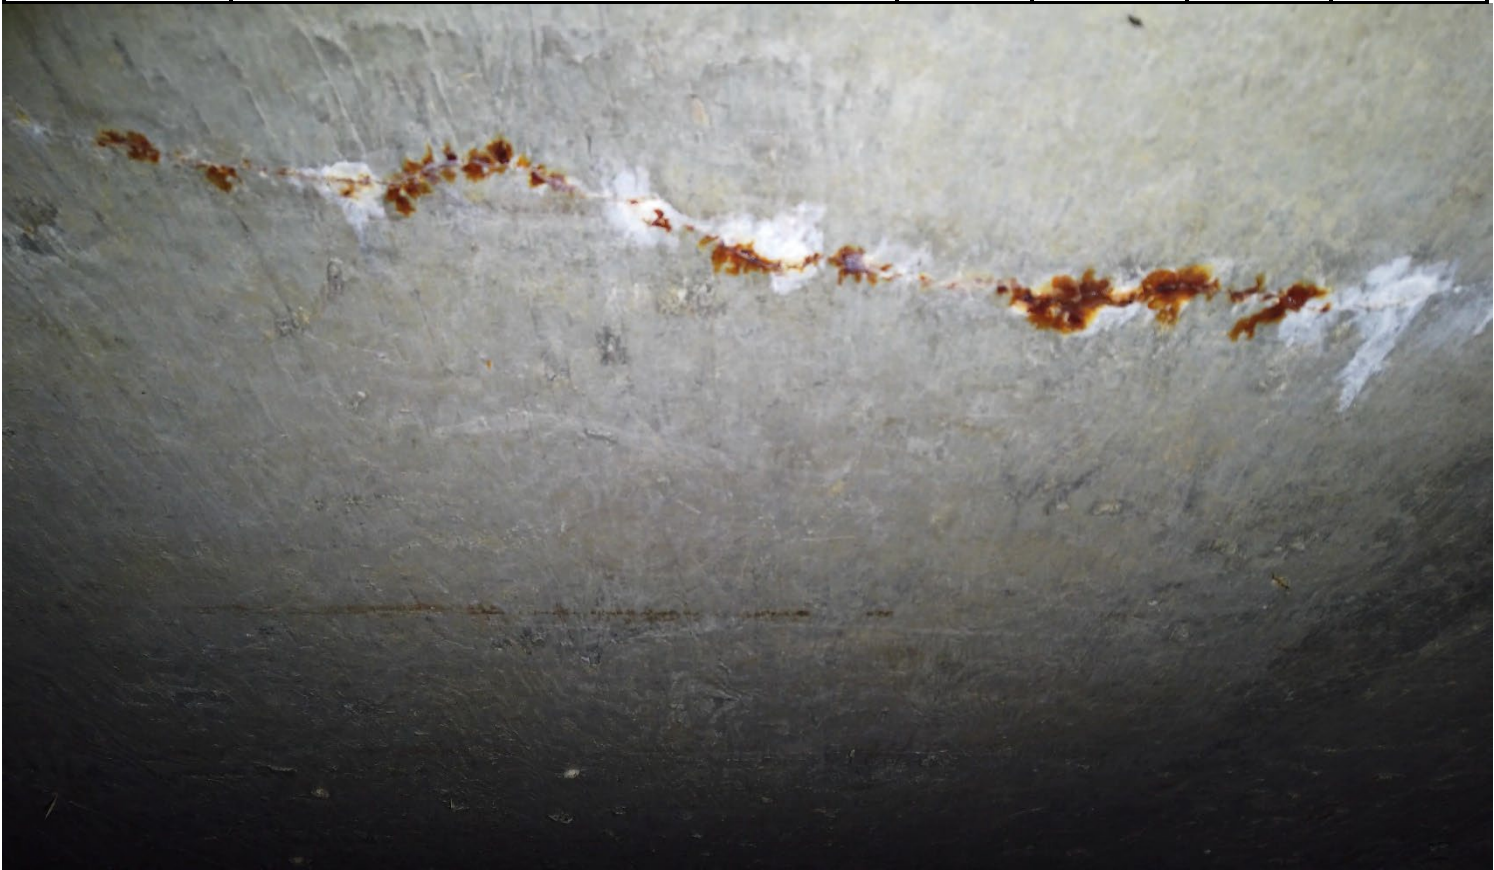
Footage	Defect Description	Top	Right	Left	Bottom
52 ft	Crack and Infiltration	Y

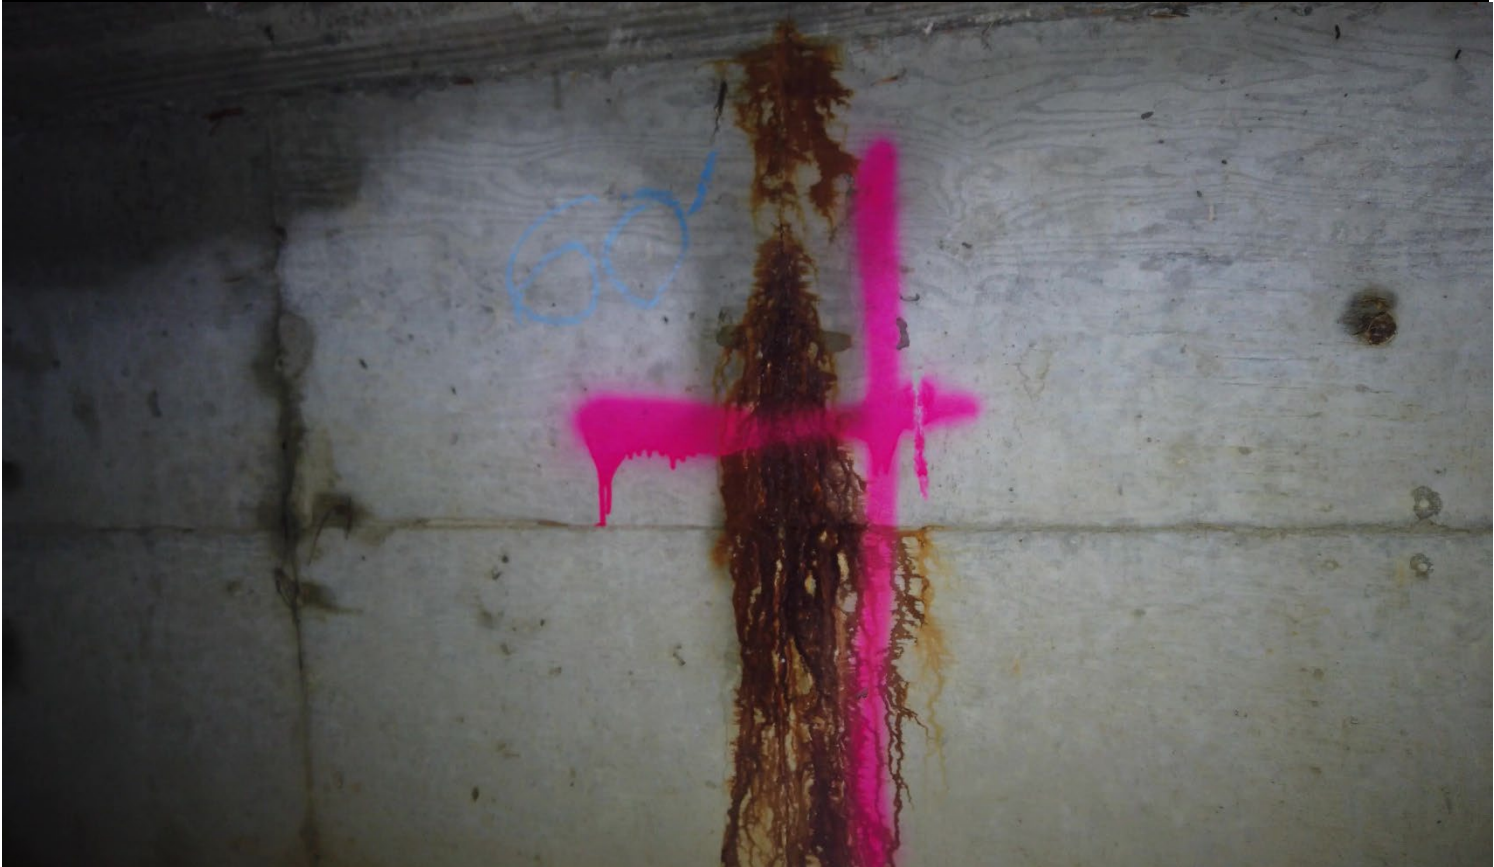
Footage	Defect Description	Top	Right	Left	Bottom
60 ft	Crack and Infiltration	Y	Y	Y

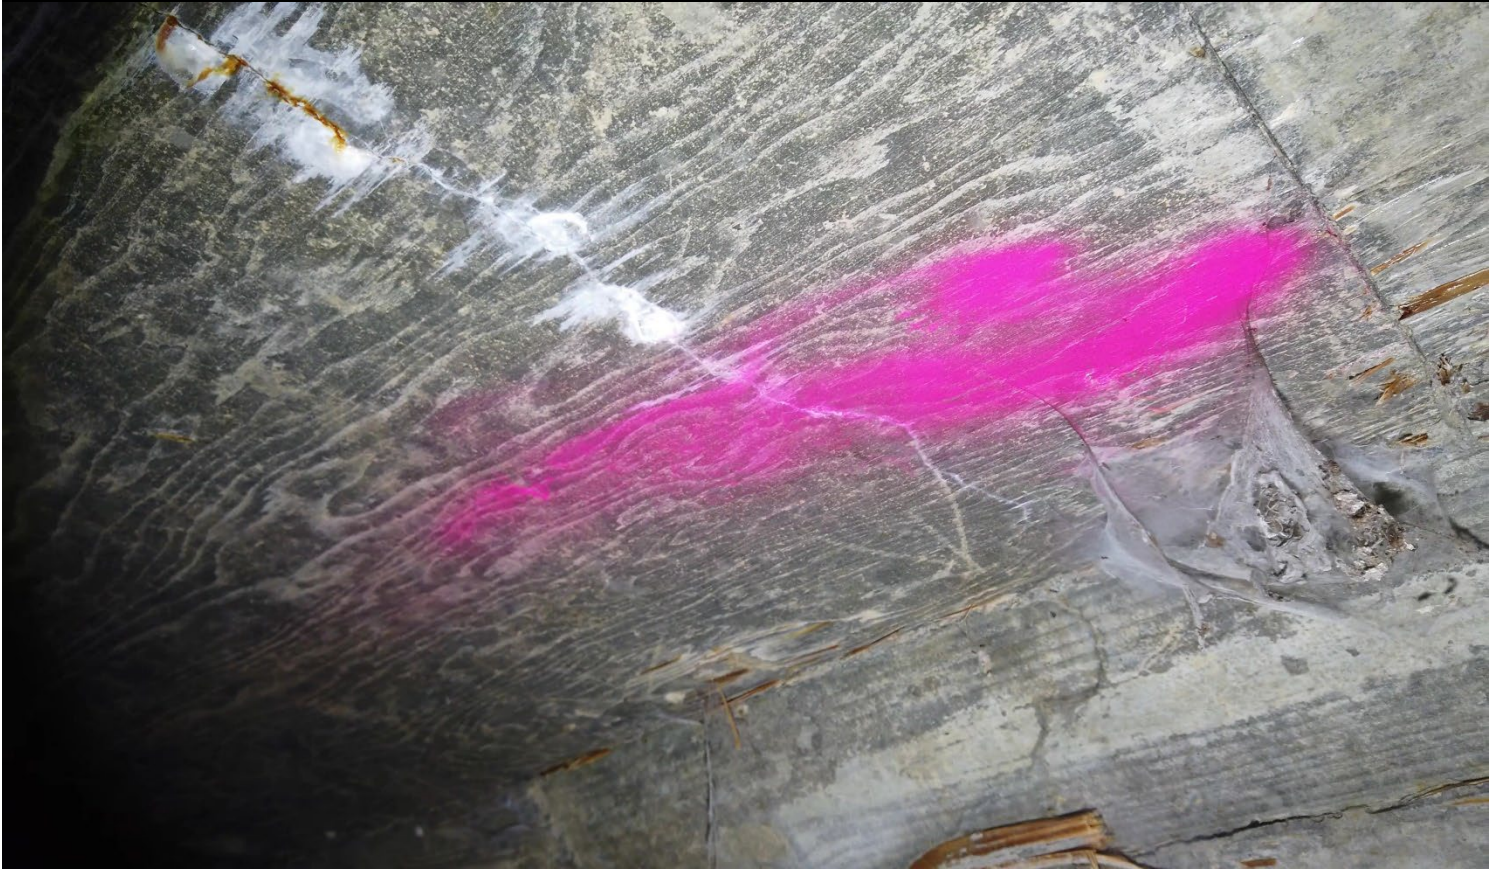
Footage	Defect Description	Top	Right	Left	Bottom
72 ft	Crack	Y

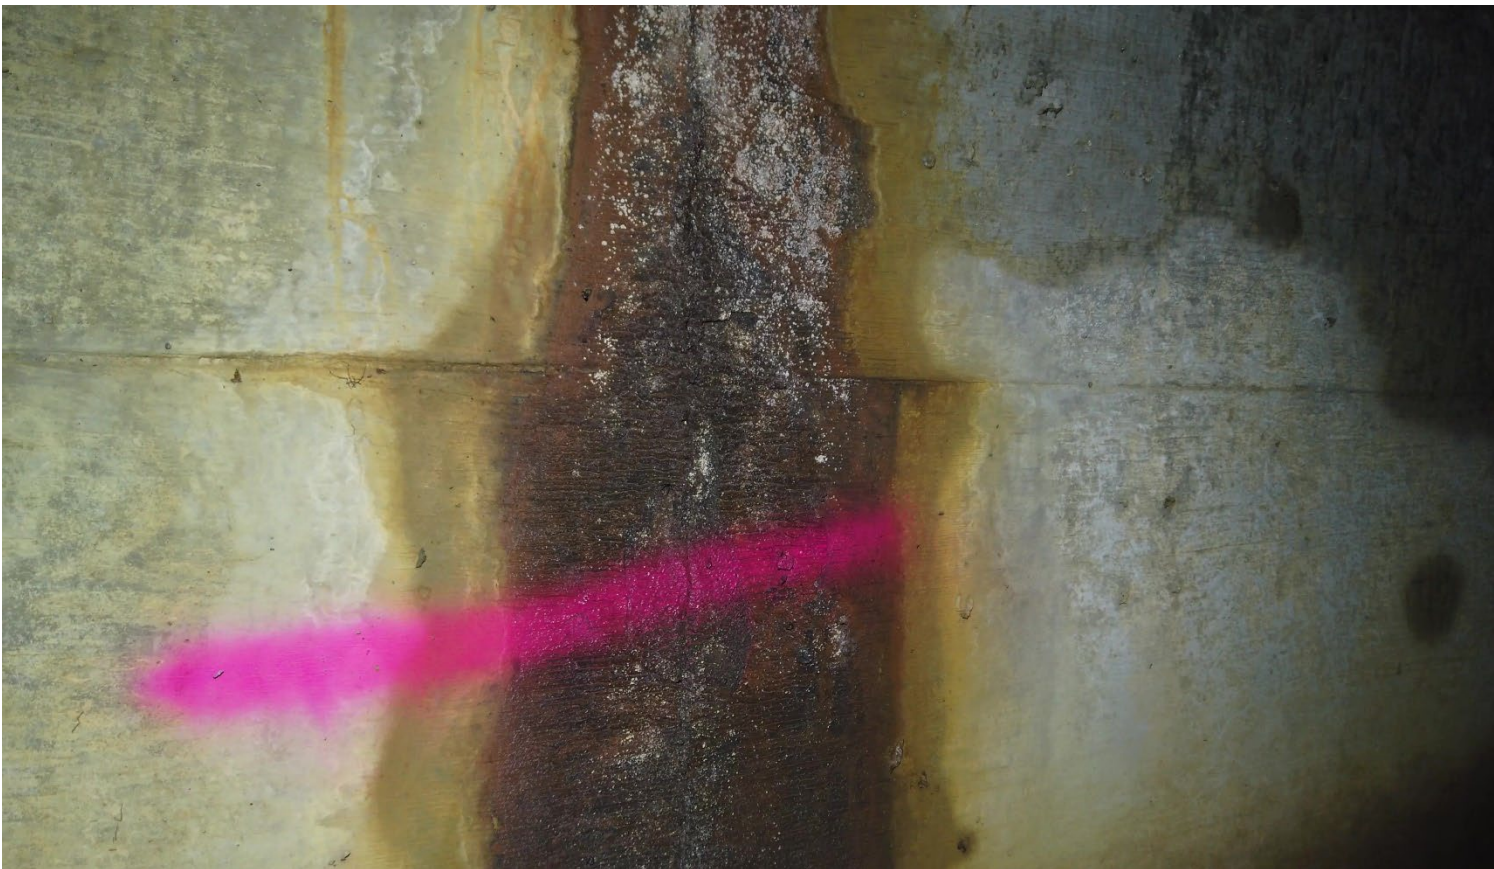
Footage	Defect Description	Top	Right	Left	Bottom
84 ft	Crack and Infiltration	Y	Y	Y

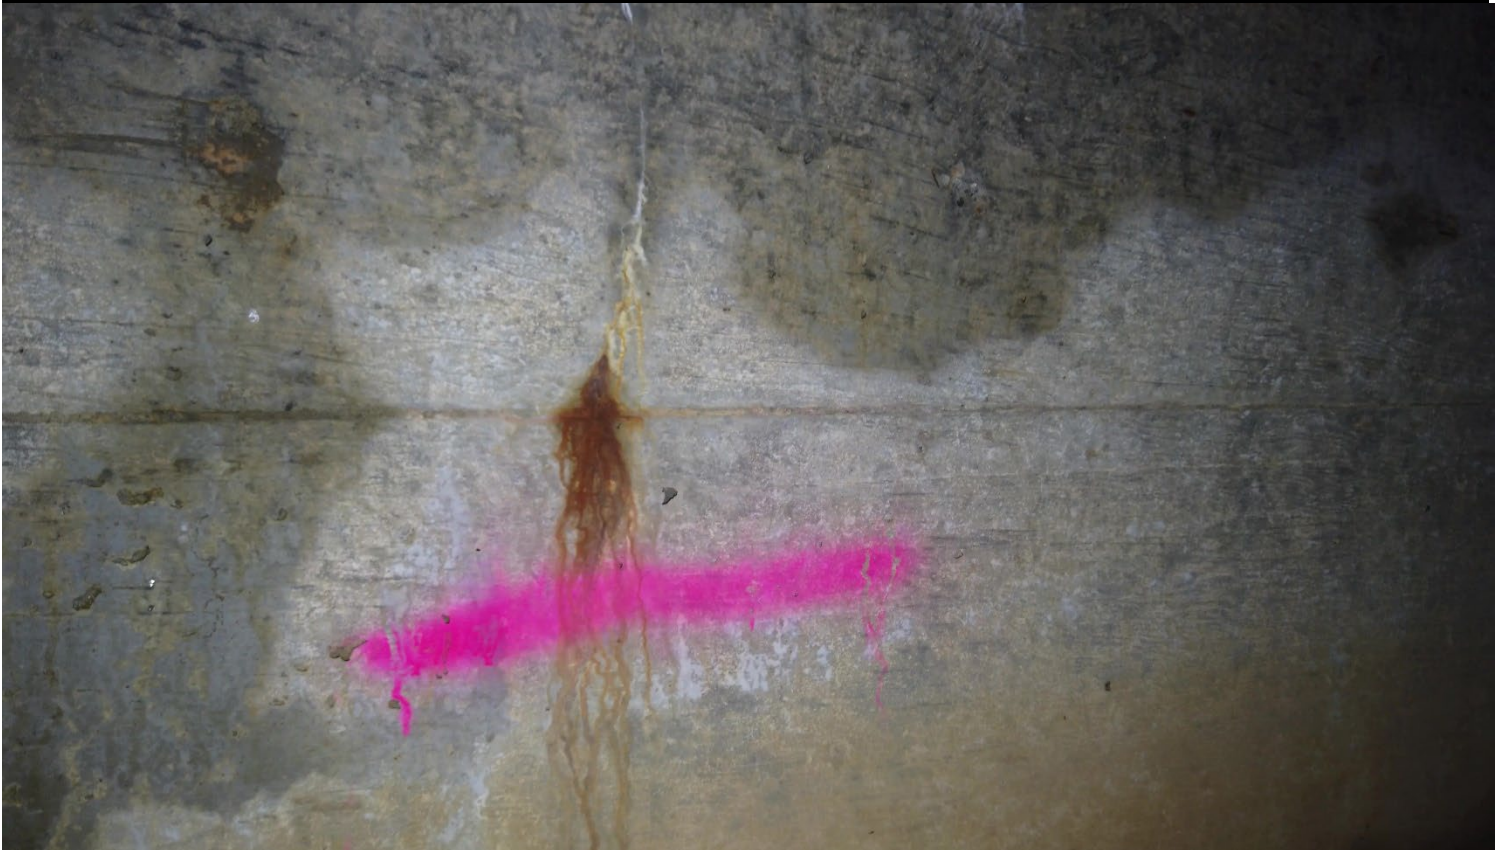
Footage	Defect Description	Top	Right	Left	Bottom
90 ft	Crack and Infiltration	Y	Y	Y

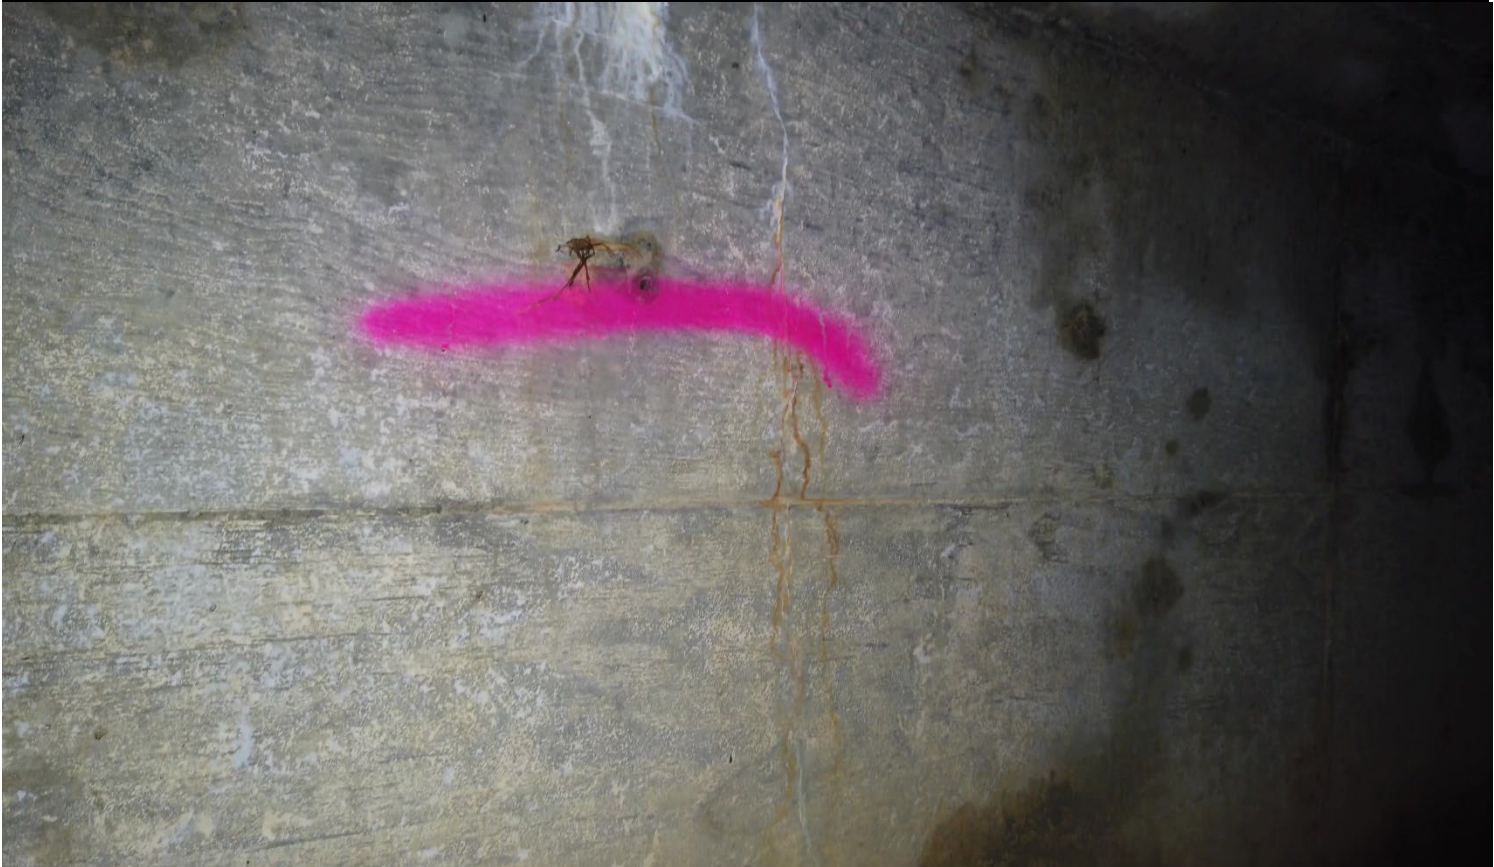
Footage	Defect Description	Top	Right	Left	Bottom
107 ft	Crack and Infiltration	Y	Y	Y

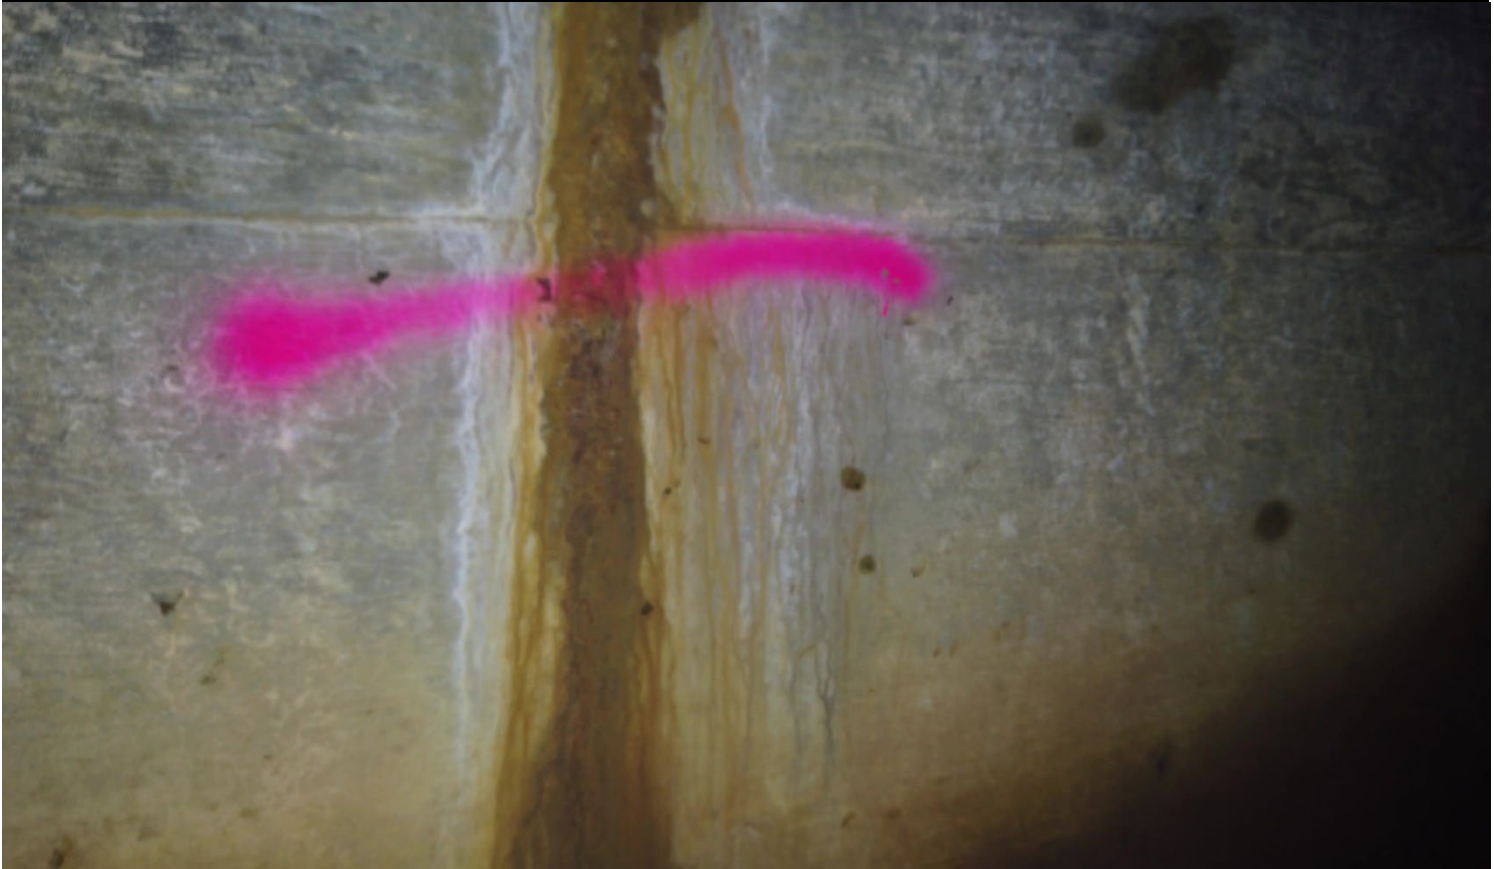
Footage	Defect Description	Top	Right	Left	Bottom
113 ft	Crack and Infiltration	Y	Y	Y

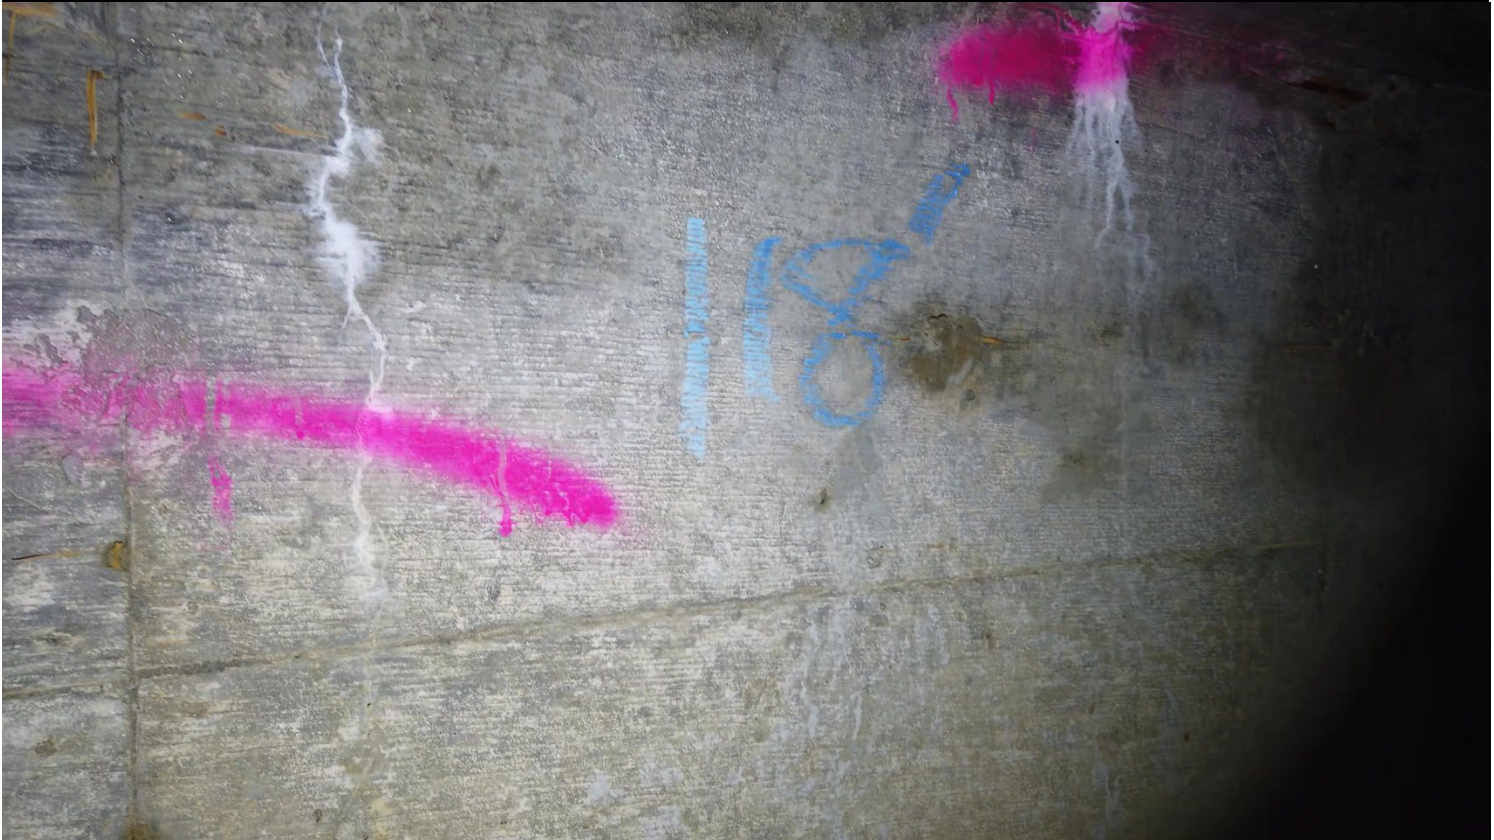
Footage	Defect Description	Top	Right	Left	Bottom
118 ft	Crack			Y

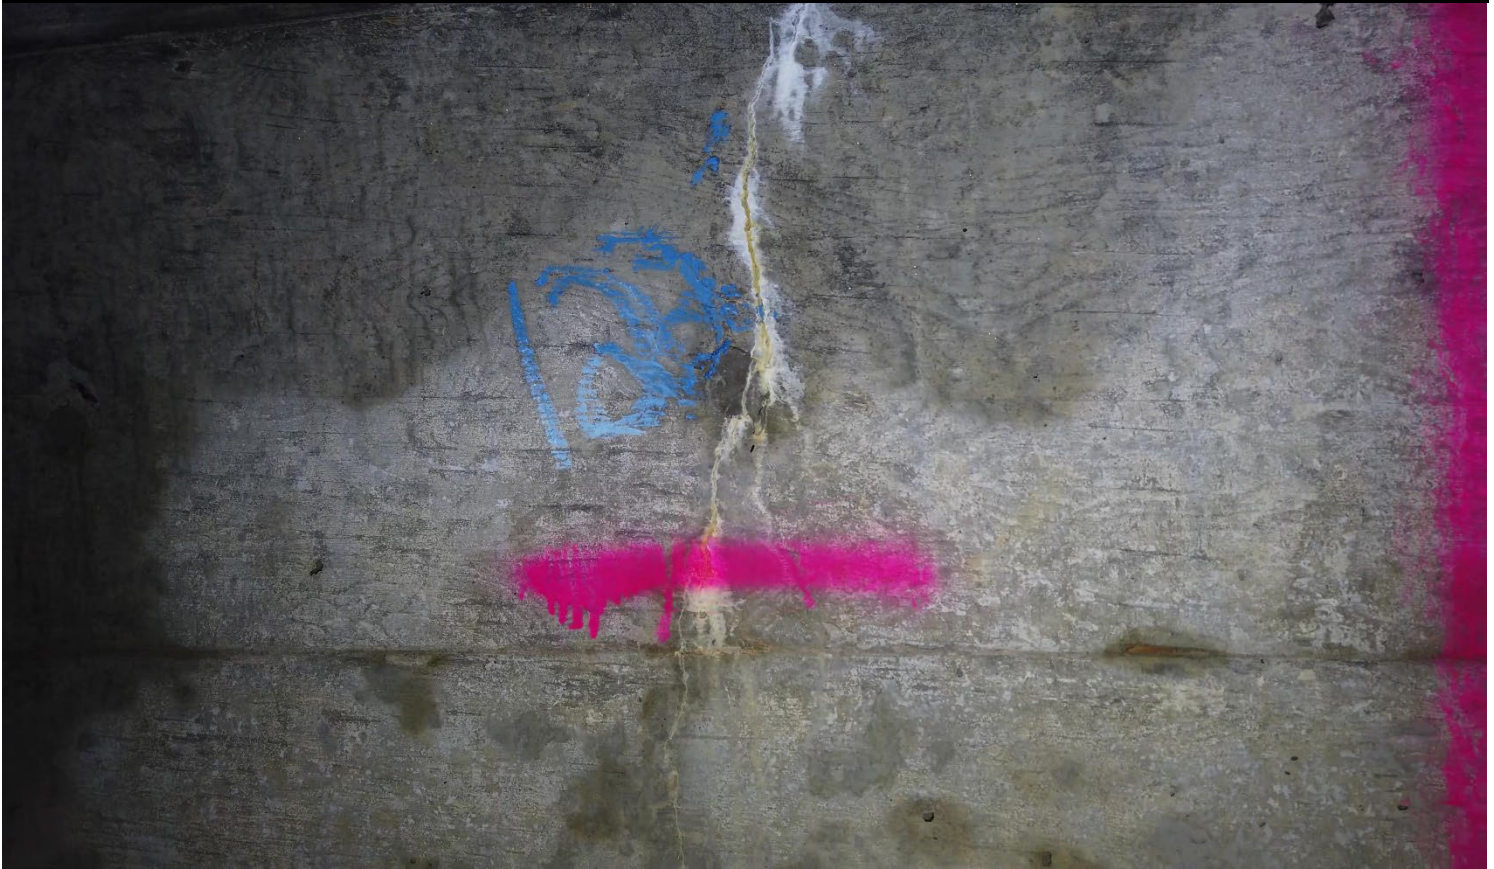
Footage	Defect Description	Top	Right	Left	Bottom
122 ft	Crack and Infiltration	Y	Y	Y

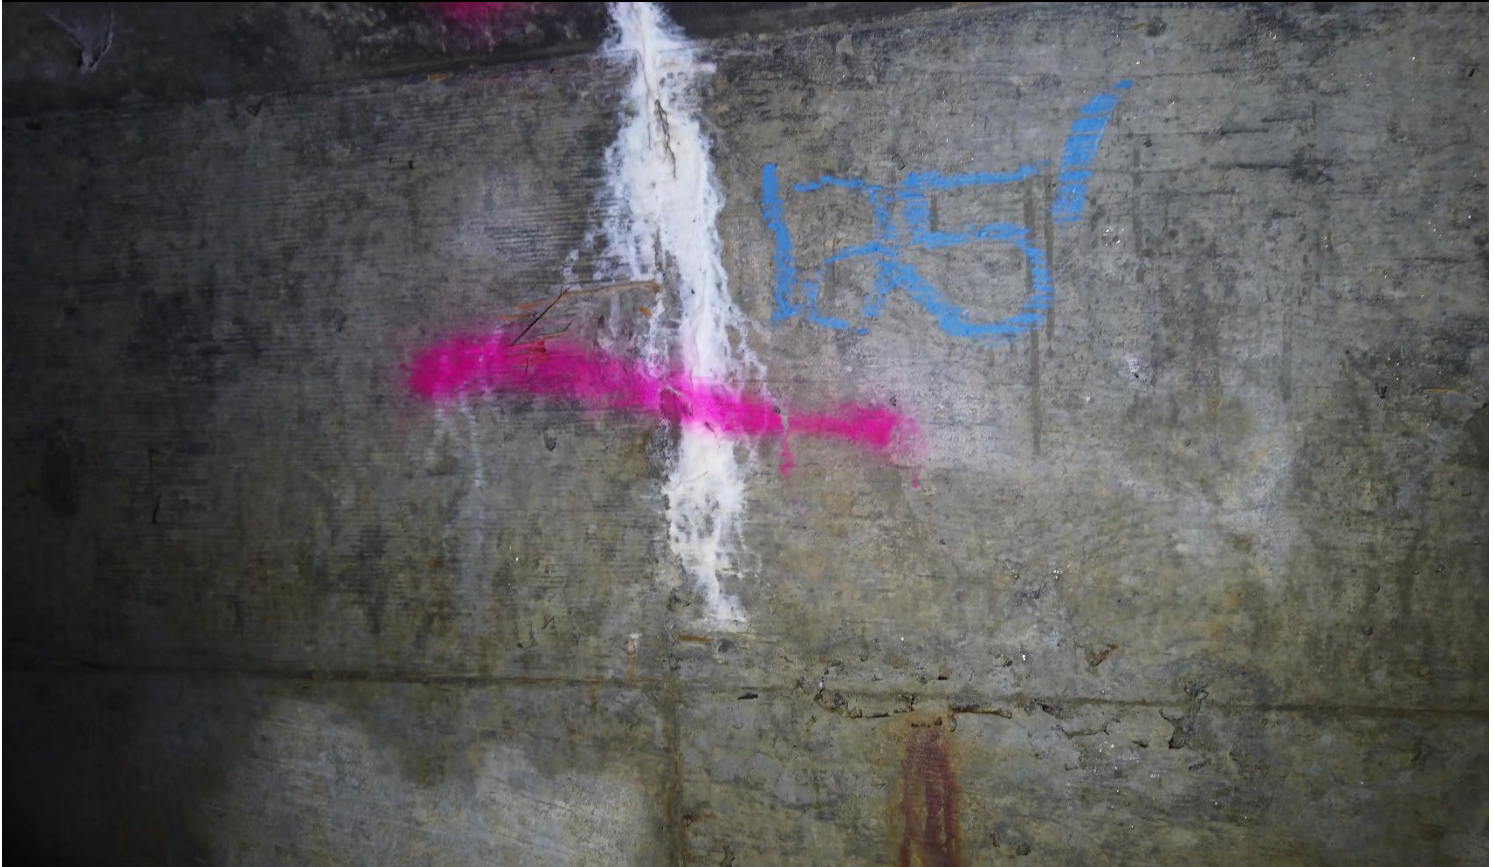
Footage	Defect Description	Top	Right	Left	Bottom
125 ft	Crack and Infiltration	Y	Y
