I-26 & I-95 INTERCHANGE IMPROVEMENTS

June 29, 2023

PIPE INSPECTION REPORT

This report contains the results of the video pipe inspection and assessment of the existing storm water drainage pipes within the project area in Orangeburg and Dorchester Counties.

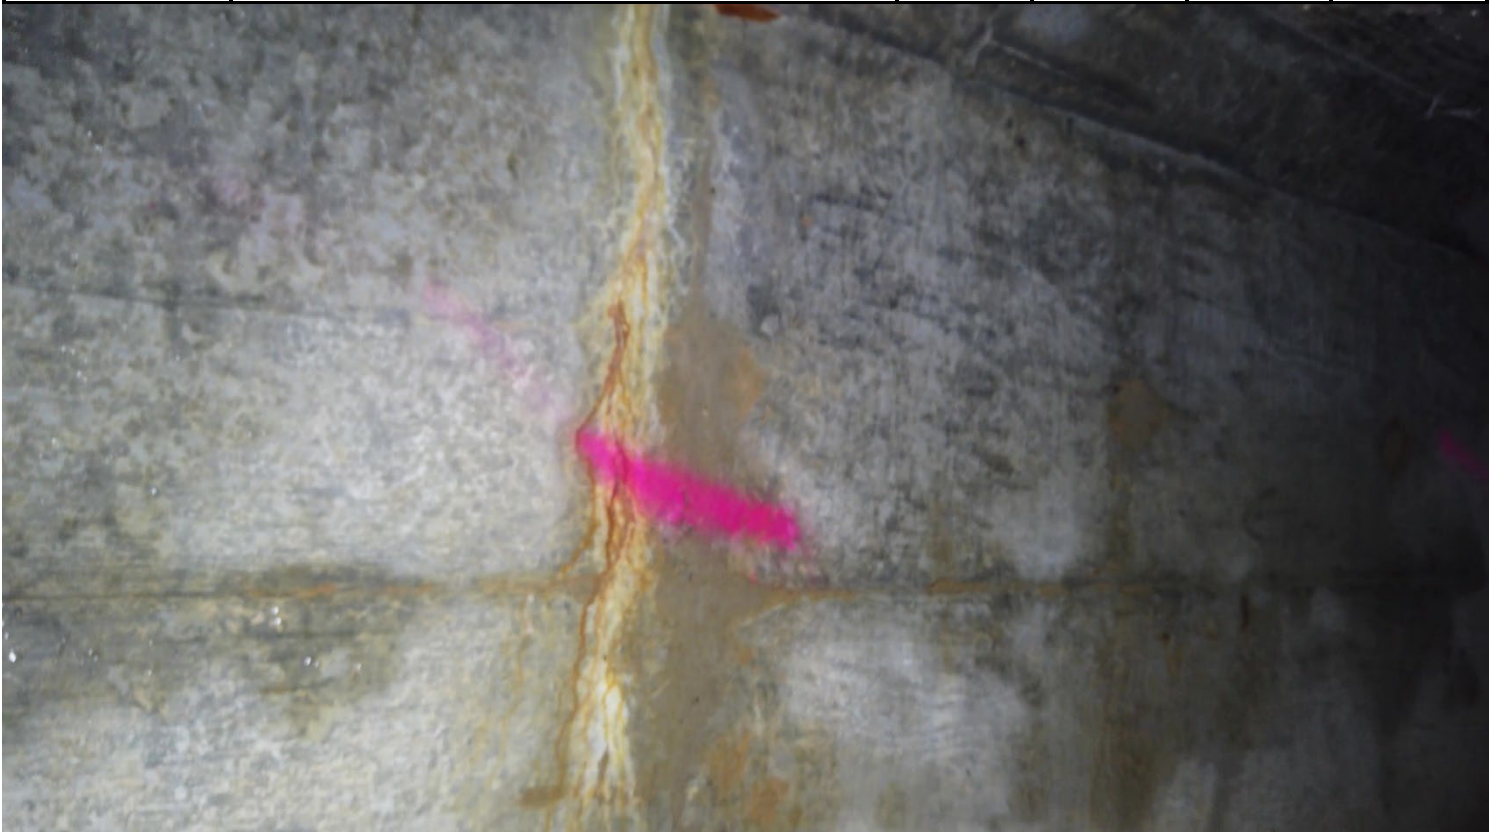
Footage	Defect Description	Top	Right	Left	Bottom
138 ft	Crack and Infiltration	Y	Y	Y

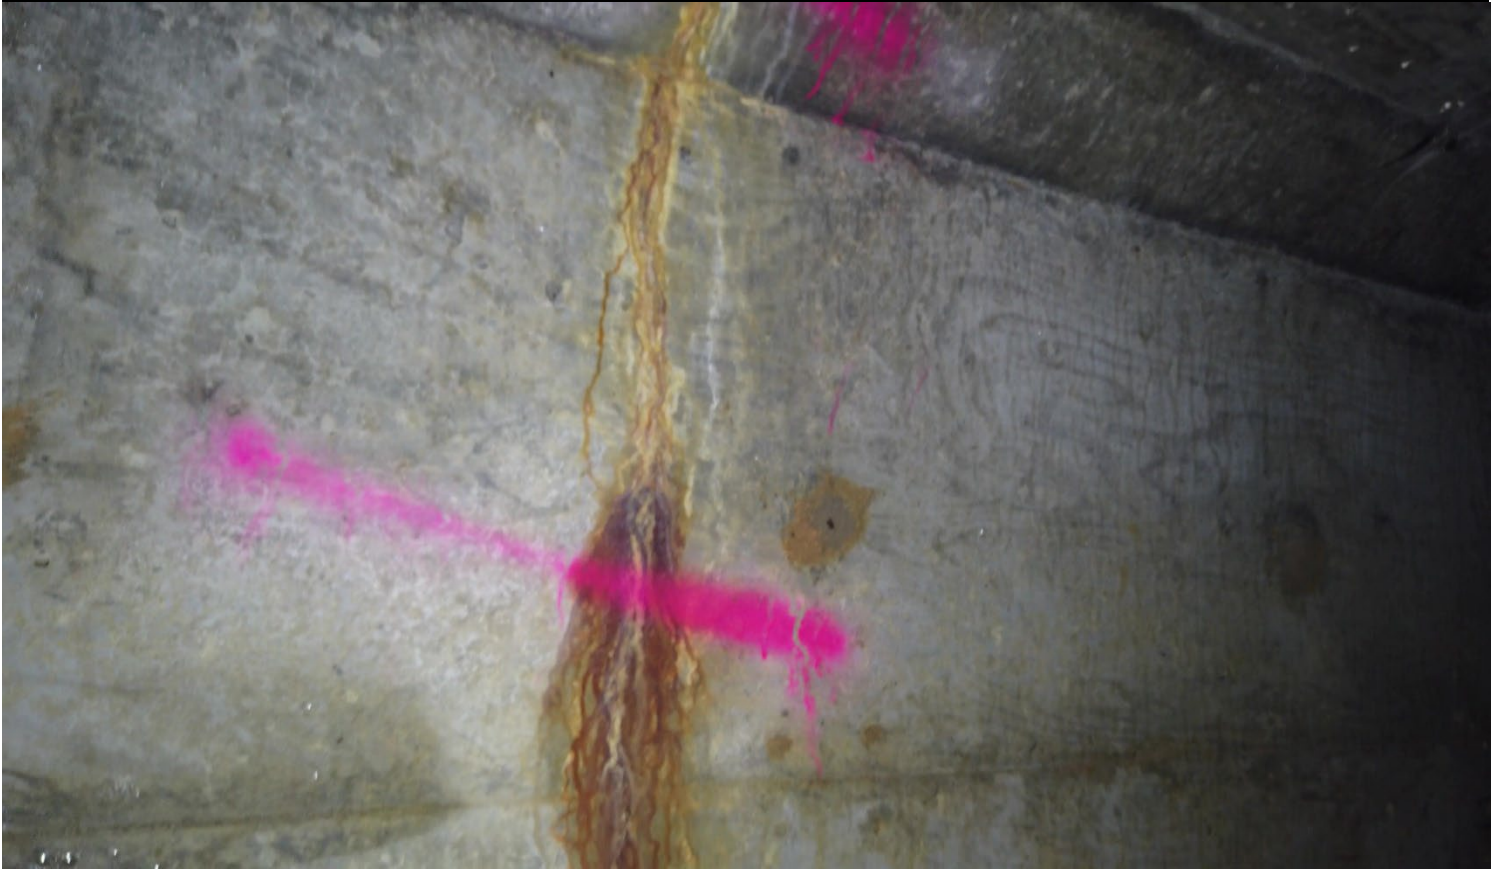
Footage	Defect Description	Top	Right	Left	Bottom
143 ft	Crack and Infiltration	Y	Y	Y

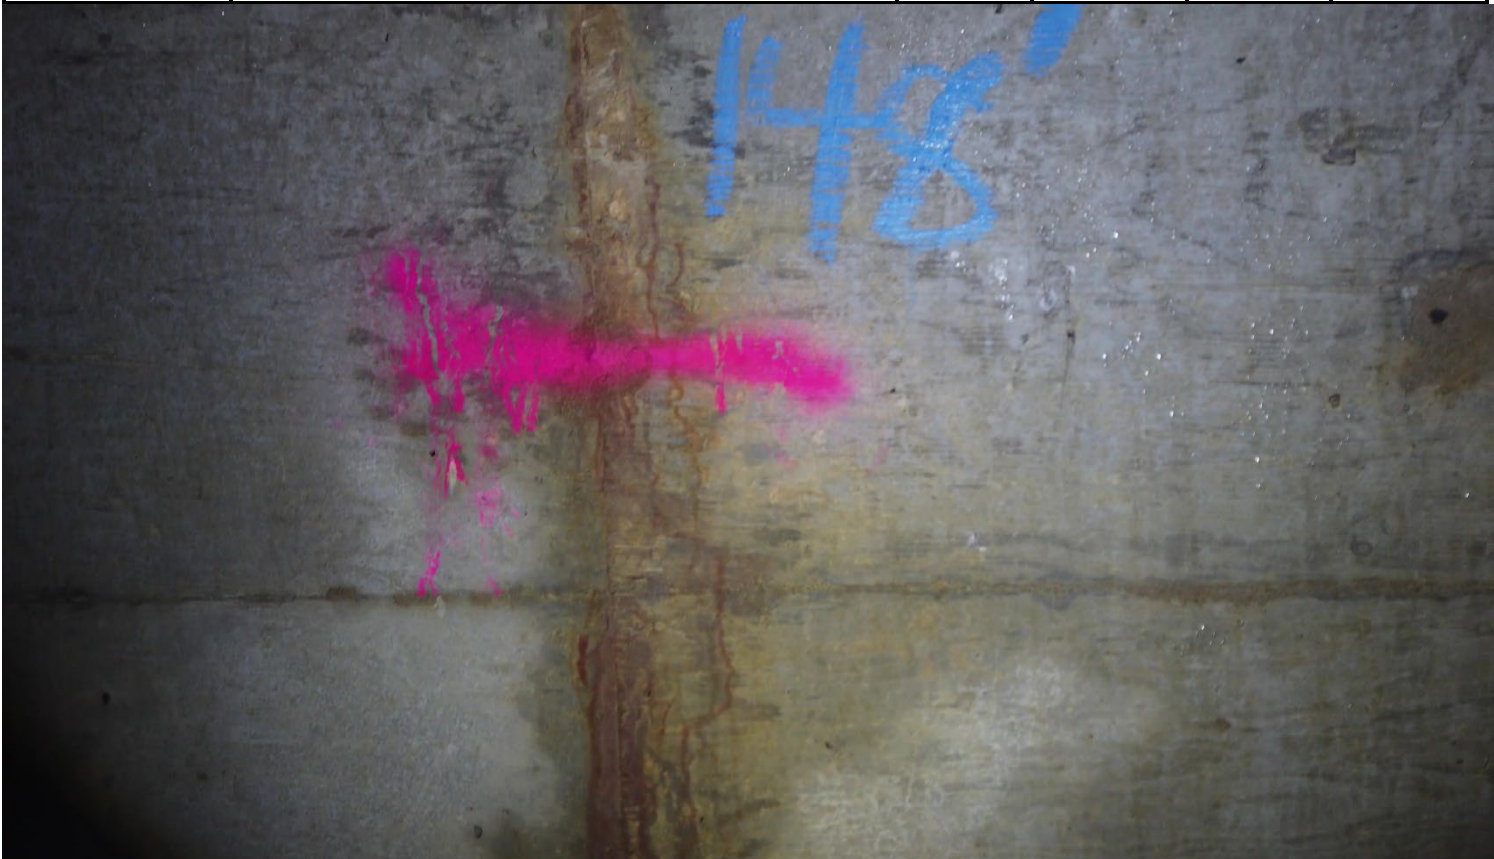
Footage	Defect Description	Top	Right	Left	Bottom
148 ft	Crack and Infiltration	Y	Y

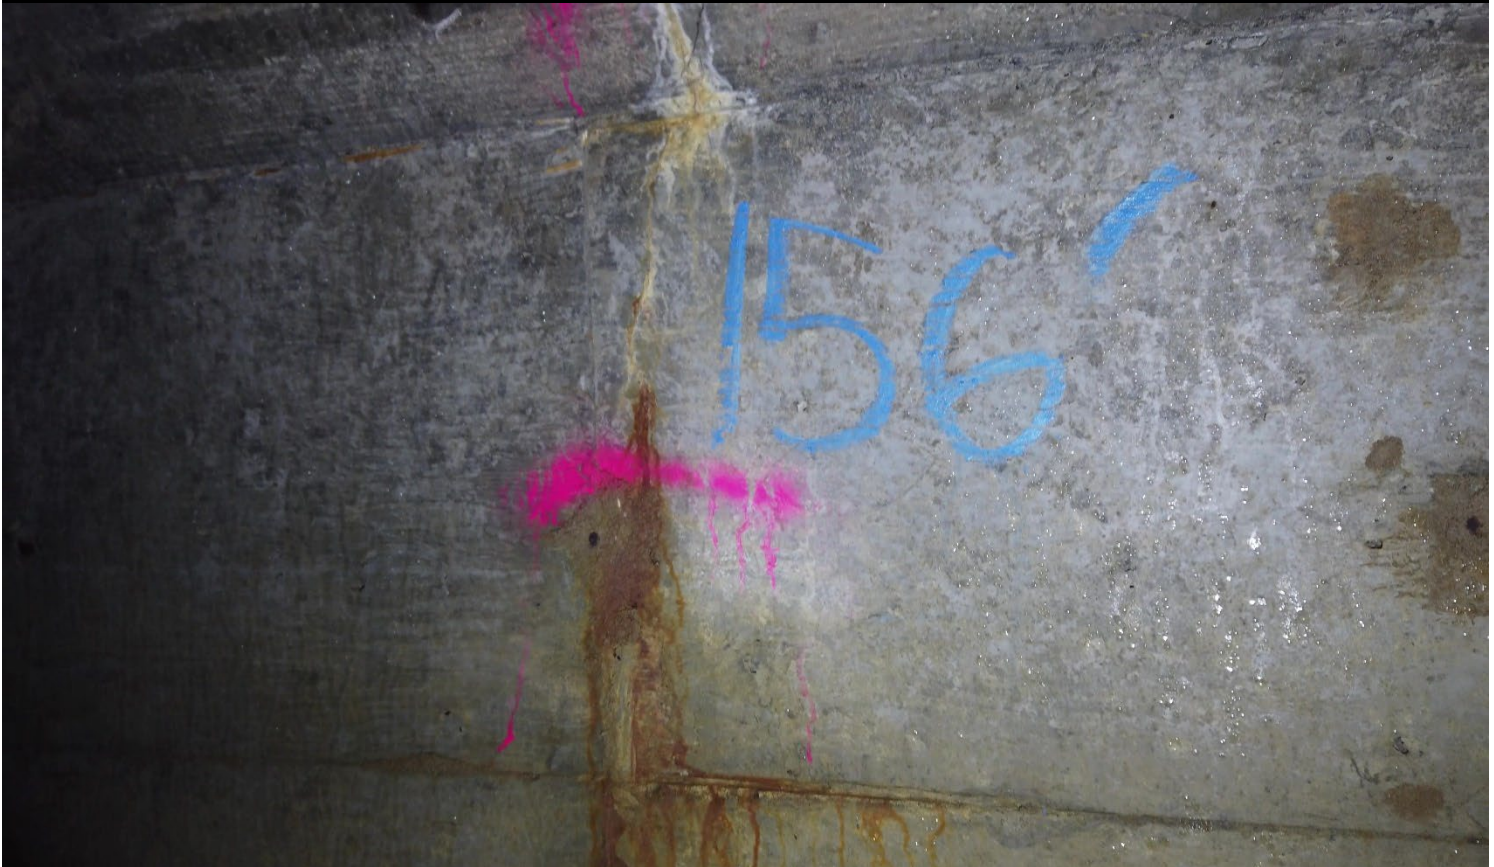
Footage	Defect Description	Top	Right	Left	Bottom
156 ft	Crack and Infiltration	Y	Y	Y

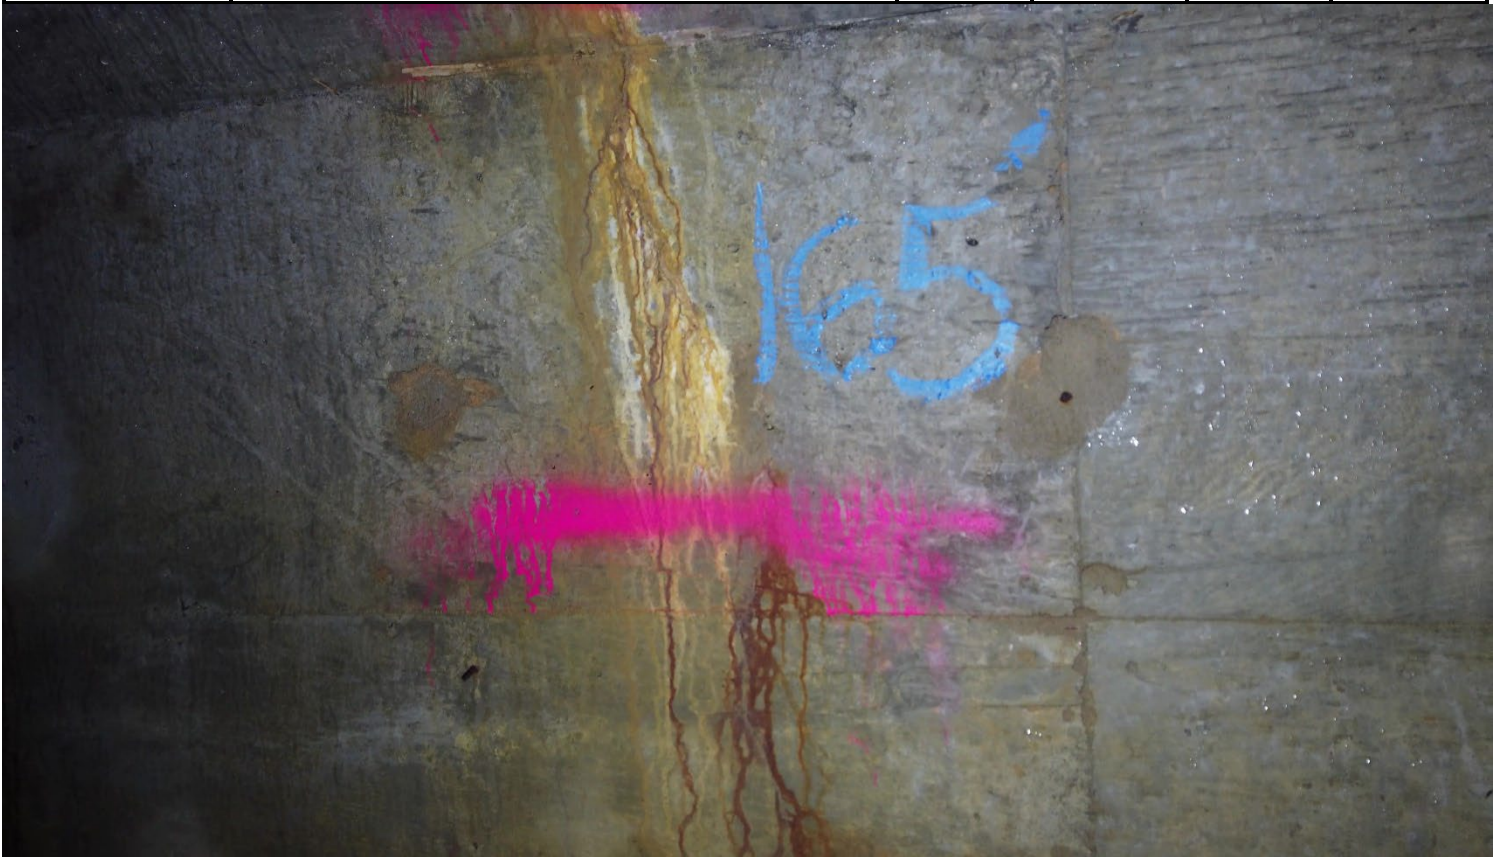
Footage	Defect Description	Top	Right	Left	Bottom
165 ft	Crack and Infiltration	Y	Y	Y

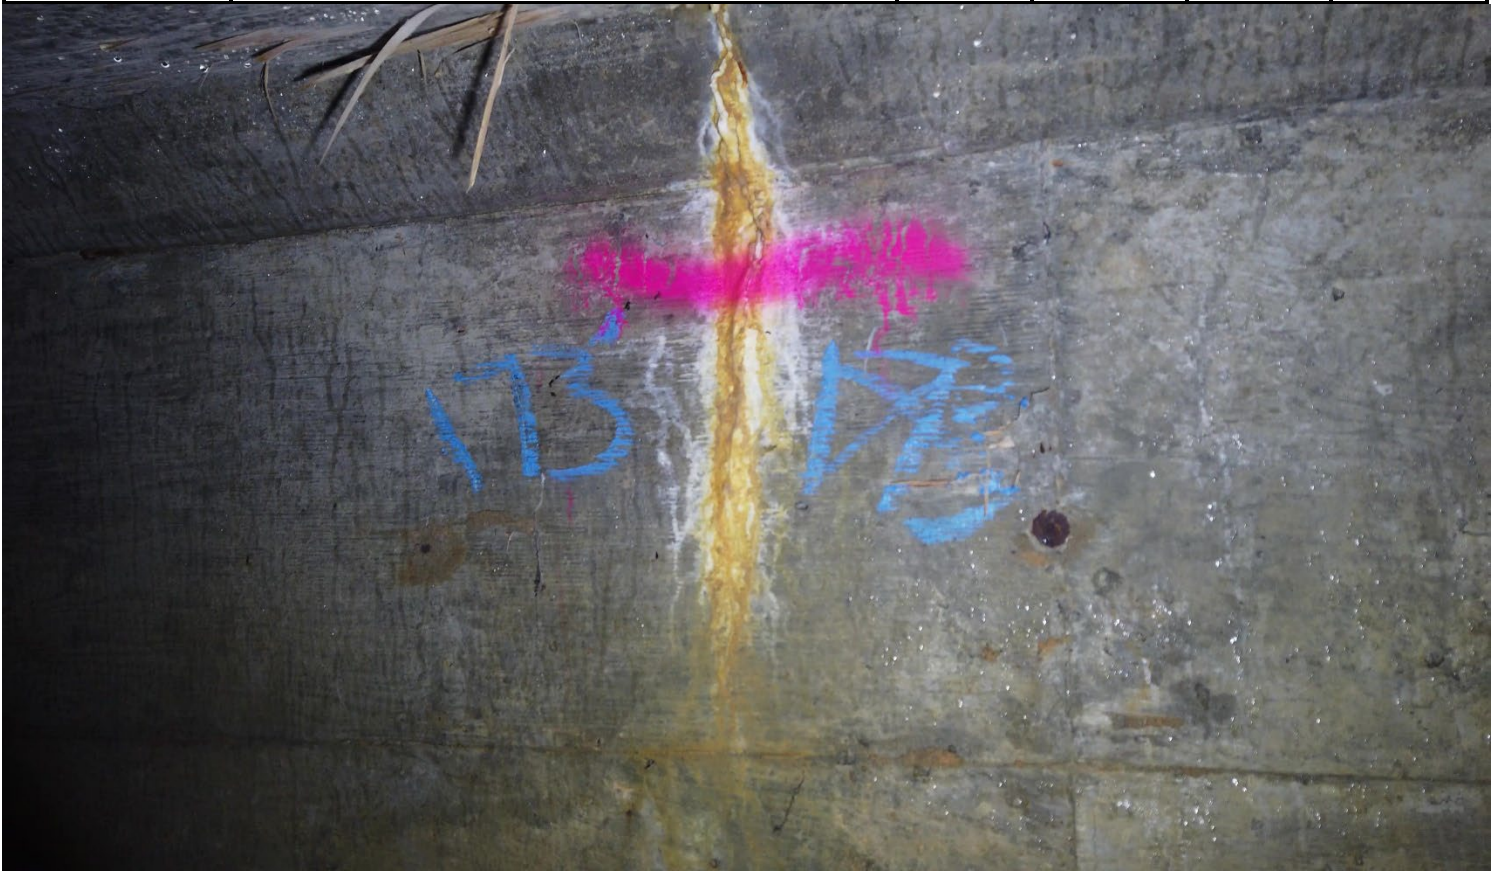
Footage	Defect Description	Top	Right	Left	Bottom
173 ft	Crack and Infiltration	Y	Y	Y

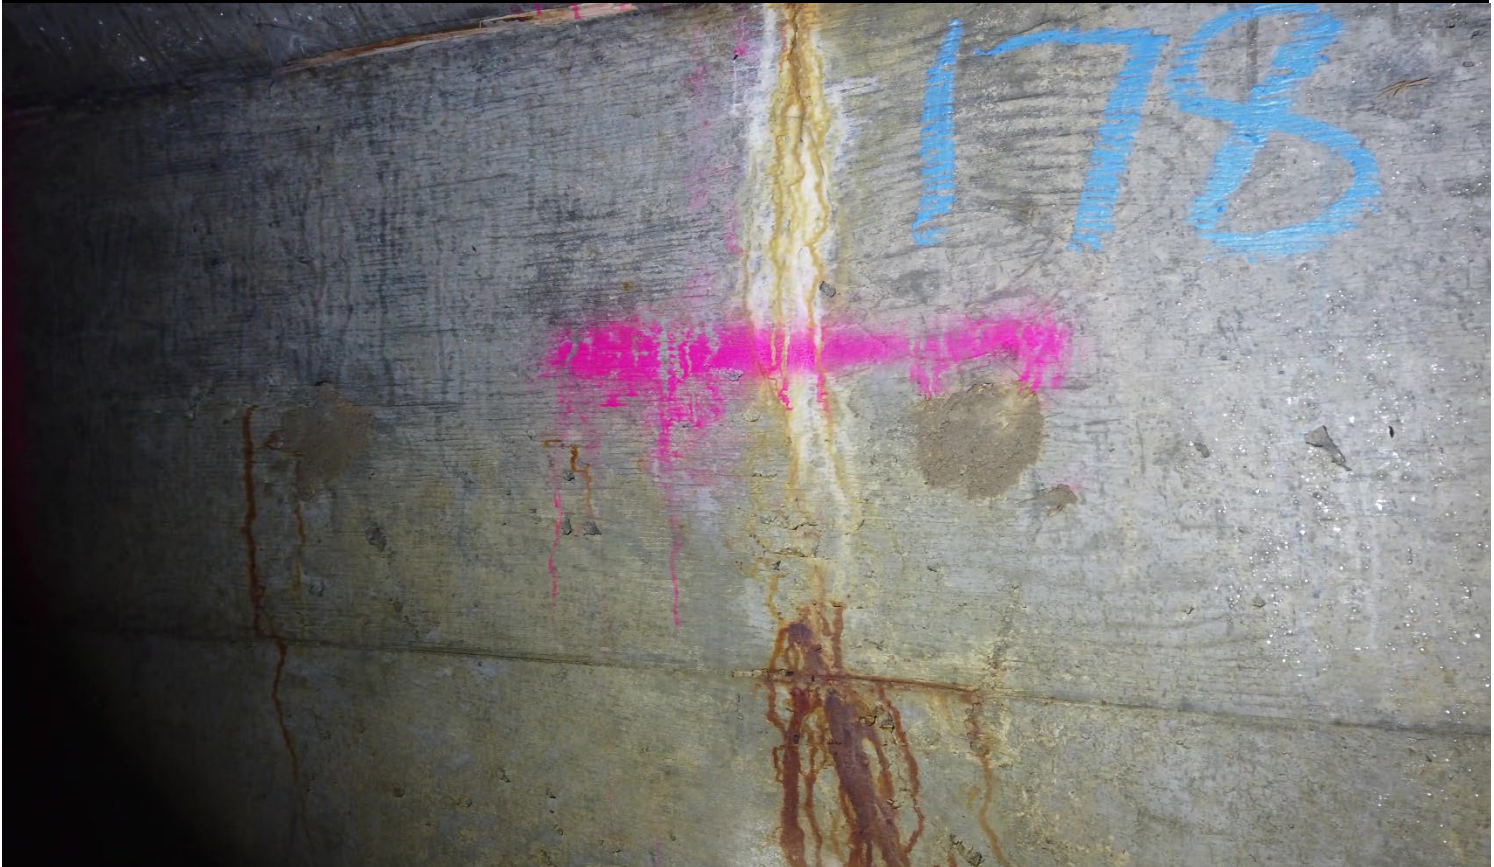
Footage	Defect Description	Top	Right	Left	Bottom
178 ft	Crack and Infiltration	Y	Y	Y

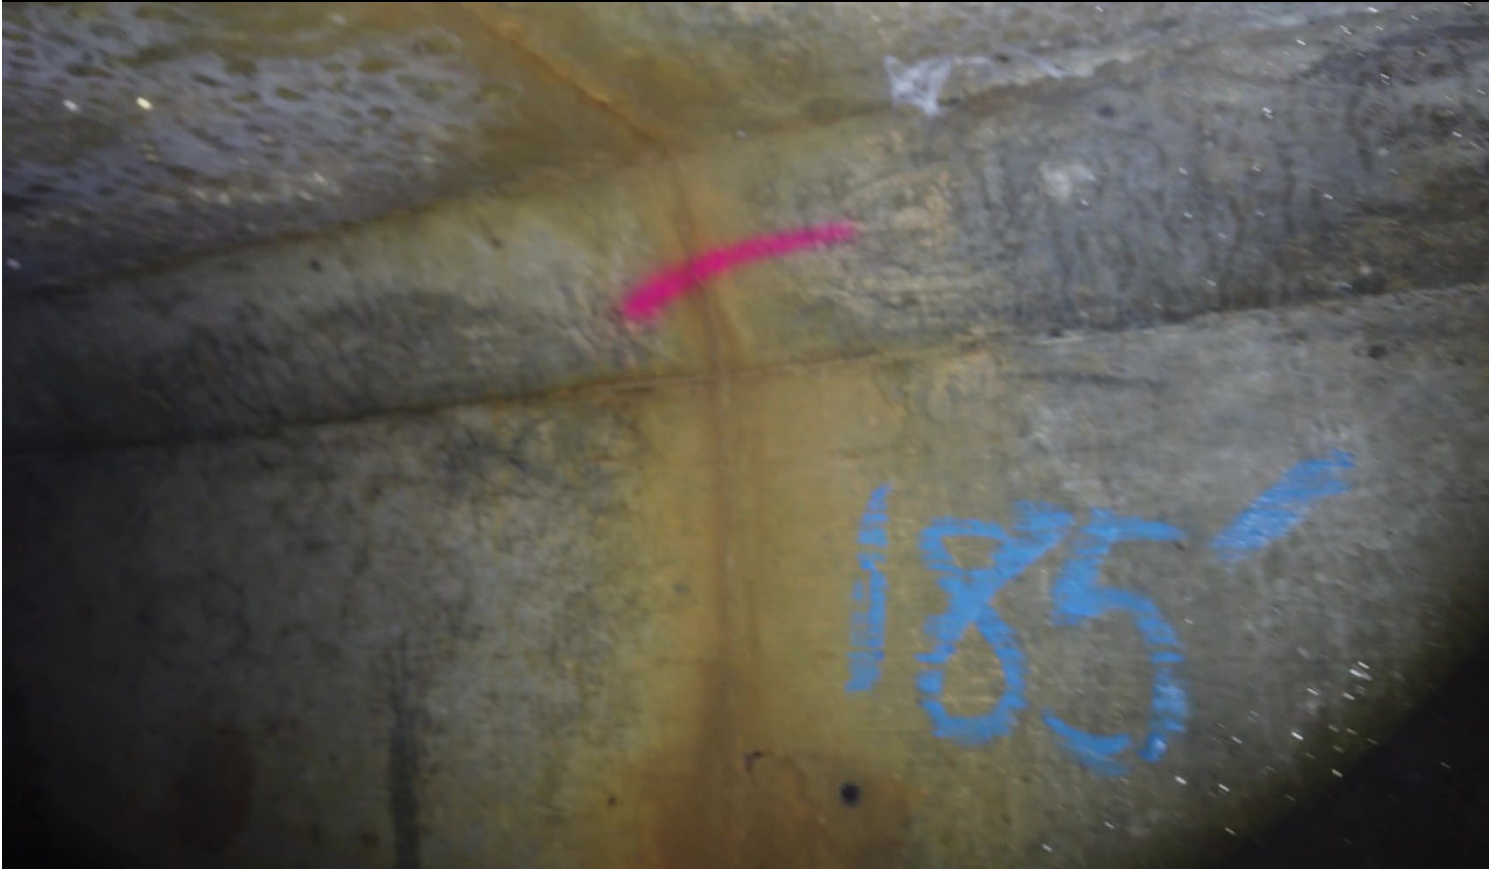
Footage	Defect Description	Top	Right	Left	Bottom
185 ft	Crack and Infiltration	Y	Y	Y

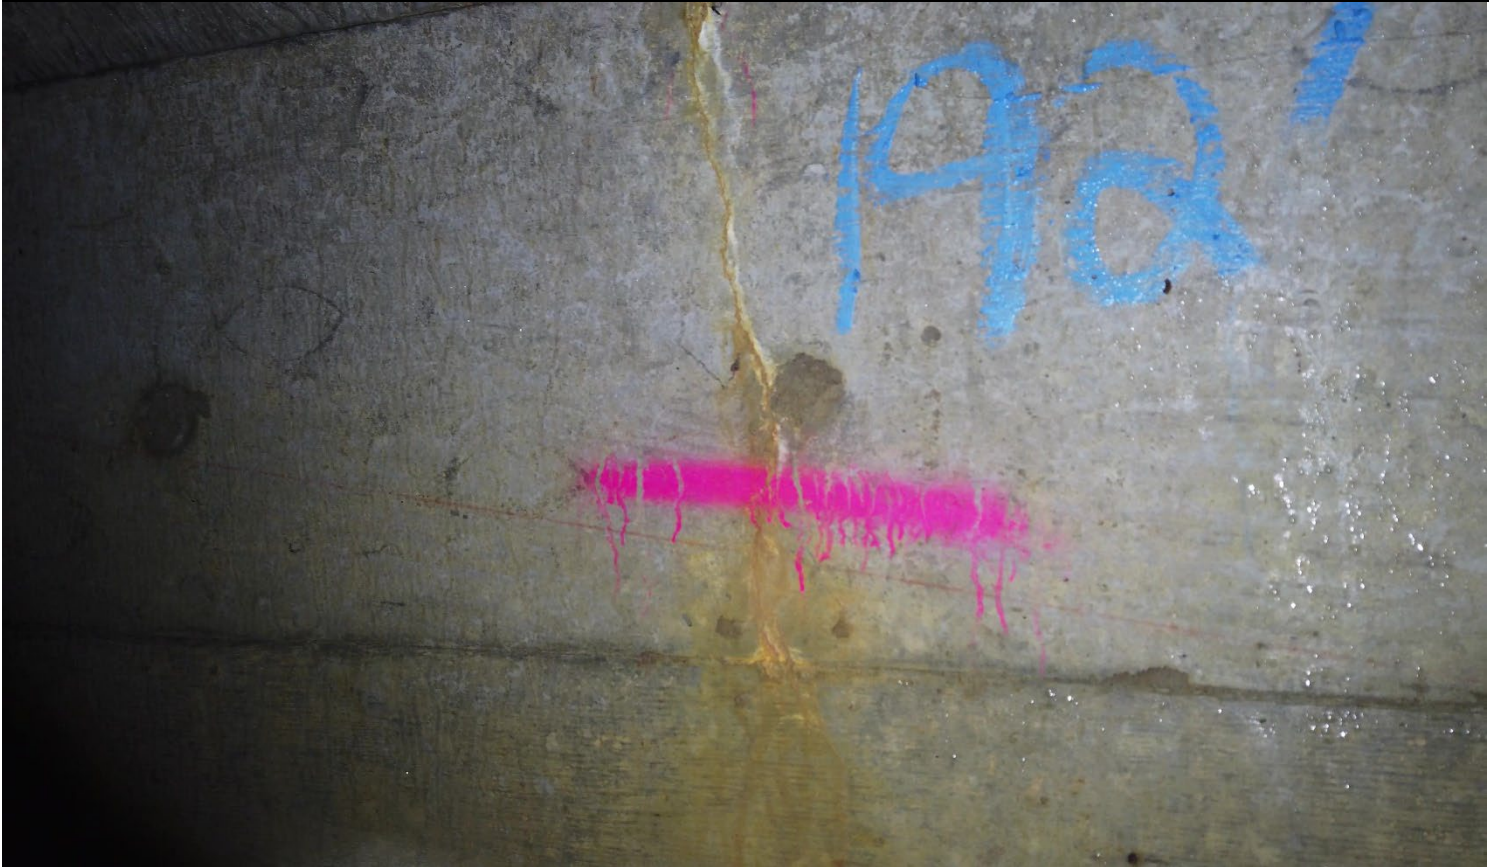
Footage	Defect Description	Top	Right	Left	Bottom
192 ft	Crack and Infiltration	Y	Y	Y

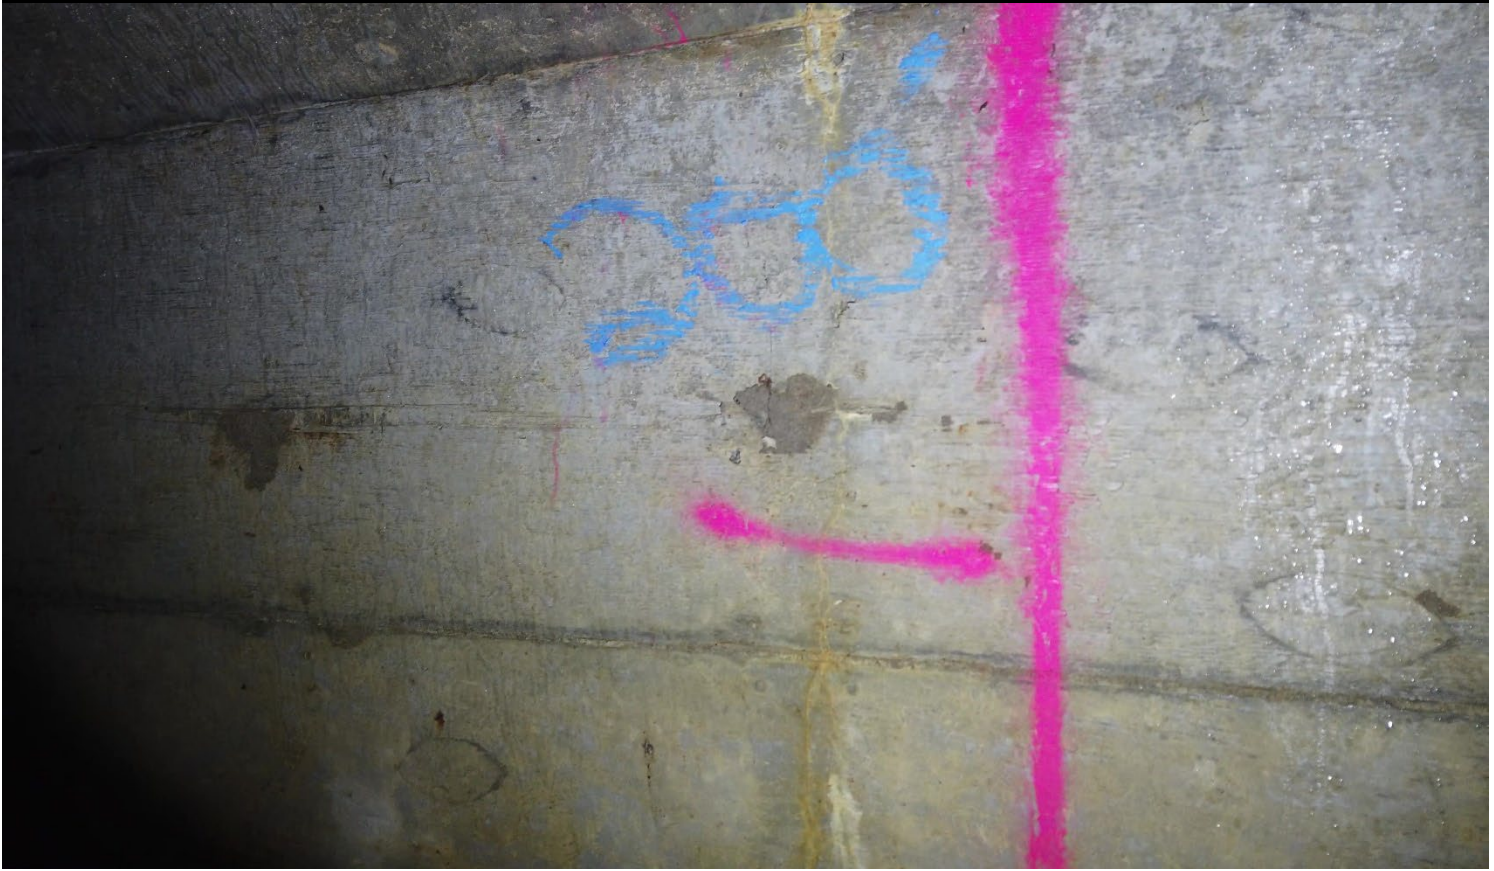
Footage	Defect Description	Top	Right	Left	Bottom
200 ft	Crack and Infiltration	Y	Y	Y

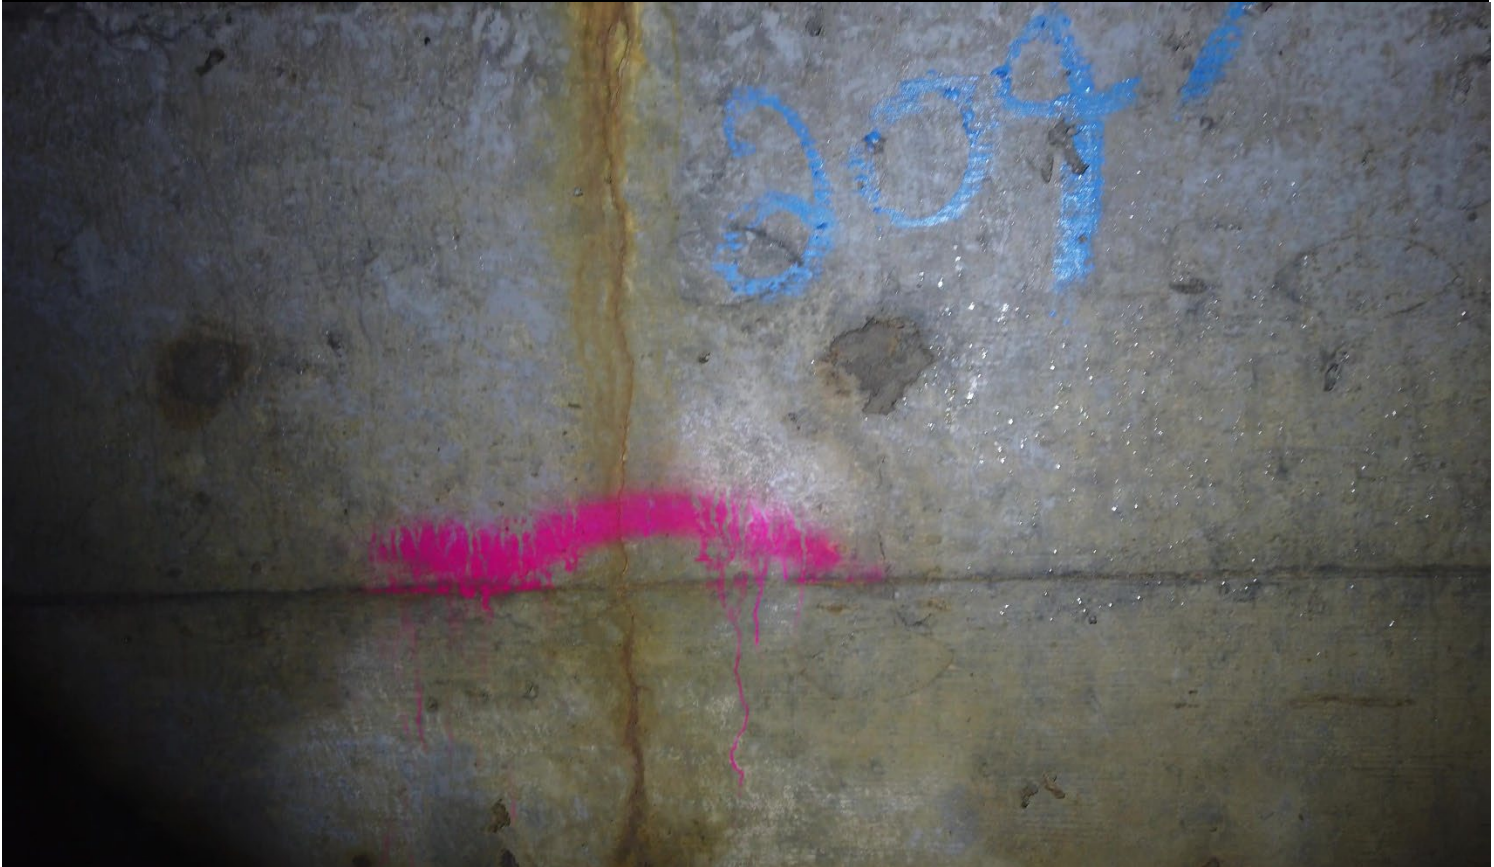
Footage	Defect Description	Top	Right	Left	Bottom
209 ft	Crack and Infiltration	Y	Y	Y

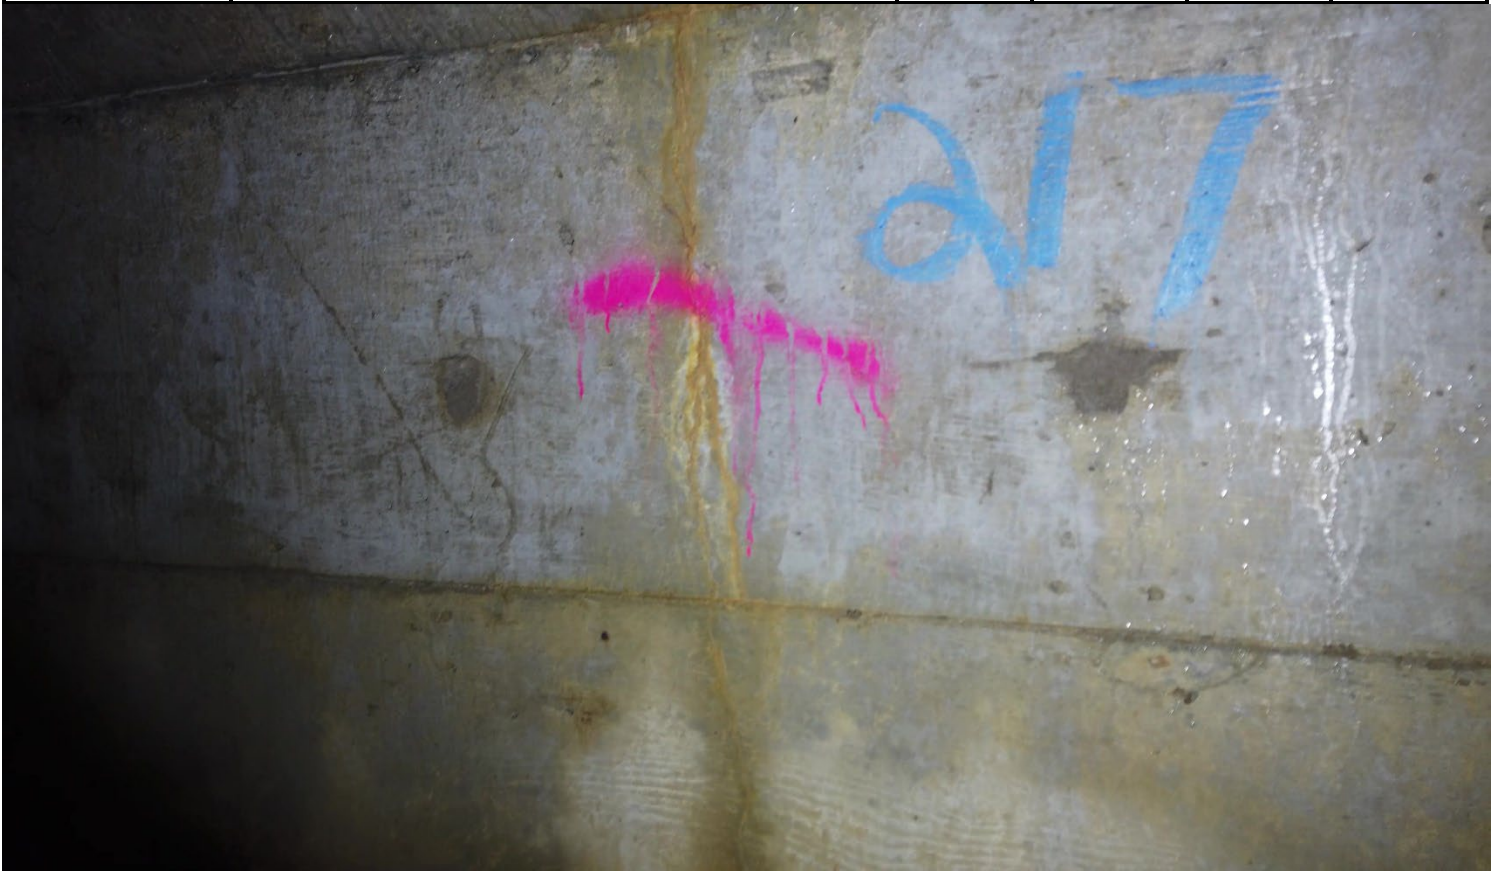
Footage	Defect Description	Top	Right	Left	Bottom
217 ft	Crack and Infiltration	Y	Y	Y

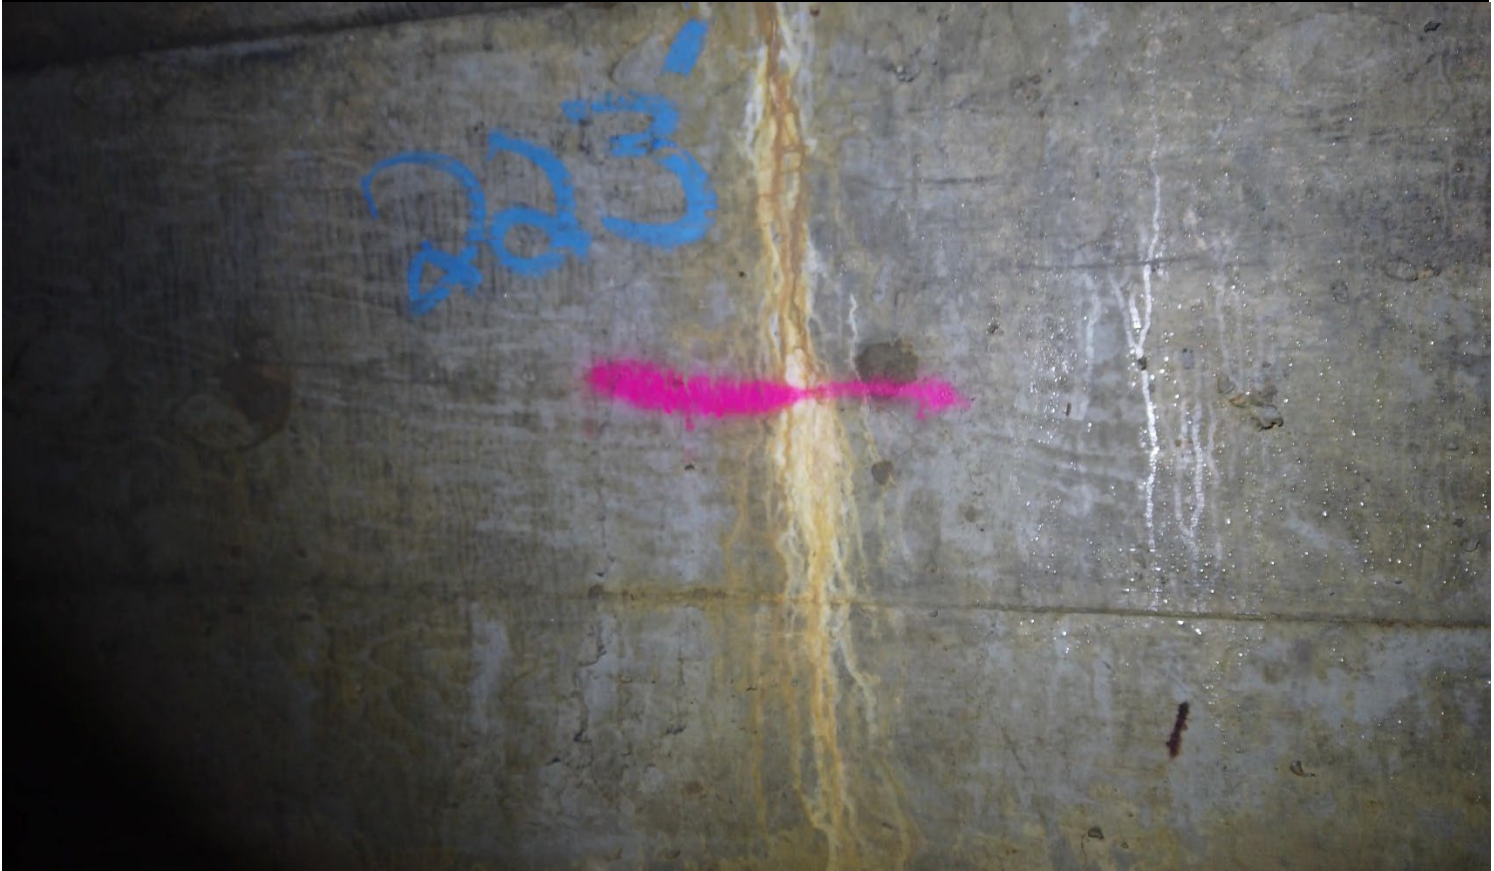
Footage	Defect Description	Top	Right	Left	Bottom
223 ft	Crack and Infiltration	Y	Y	Y

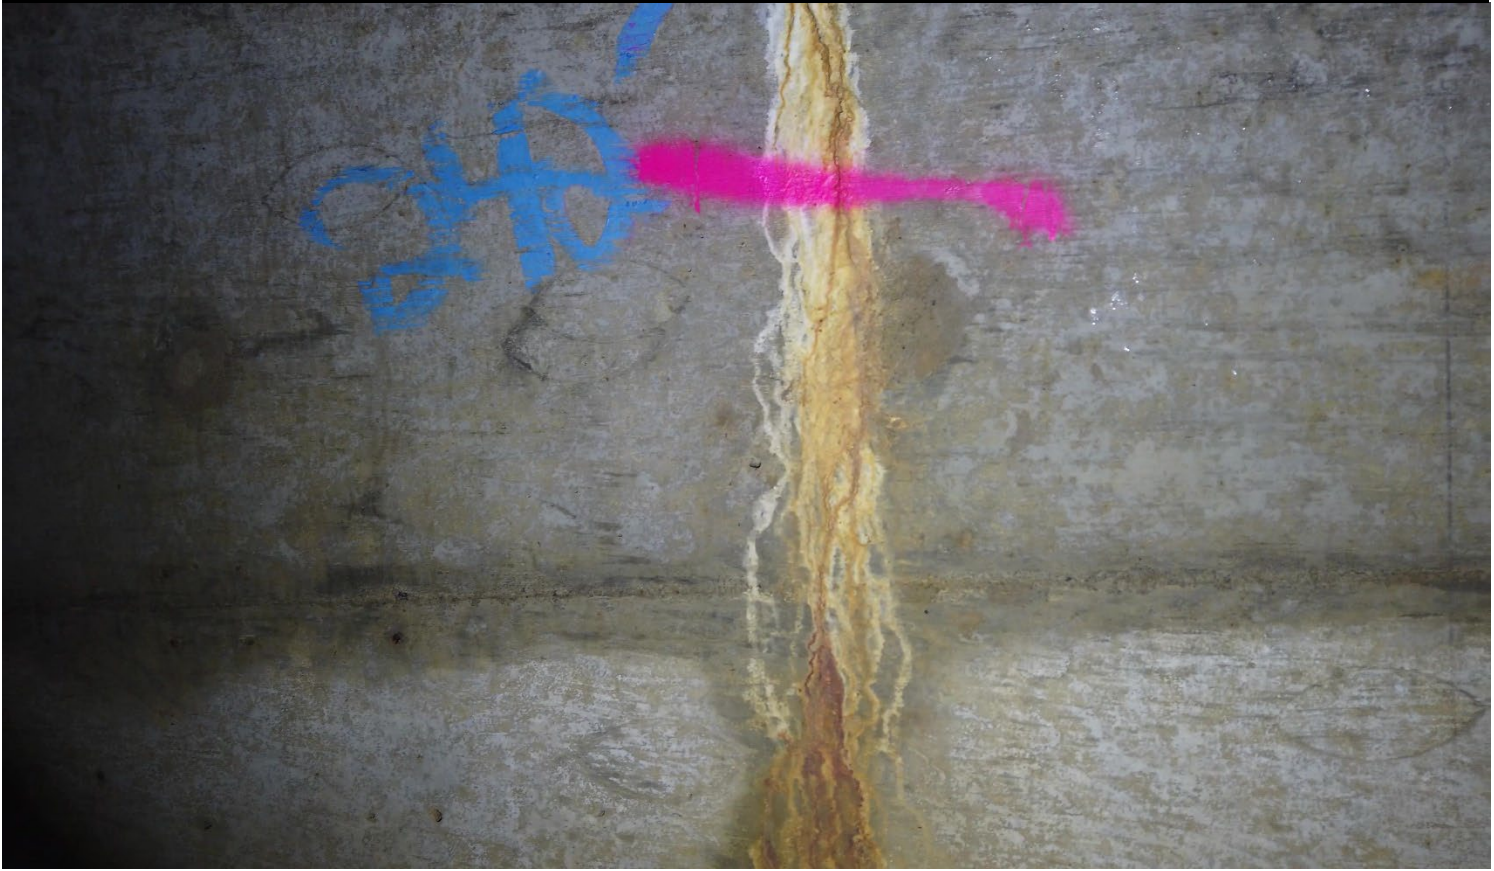
Footage	Defect Description	Top	Right	Left	Bottom
242 ft	Crack and Infiltration	Y	Y	Y

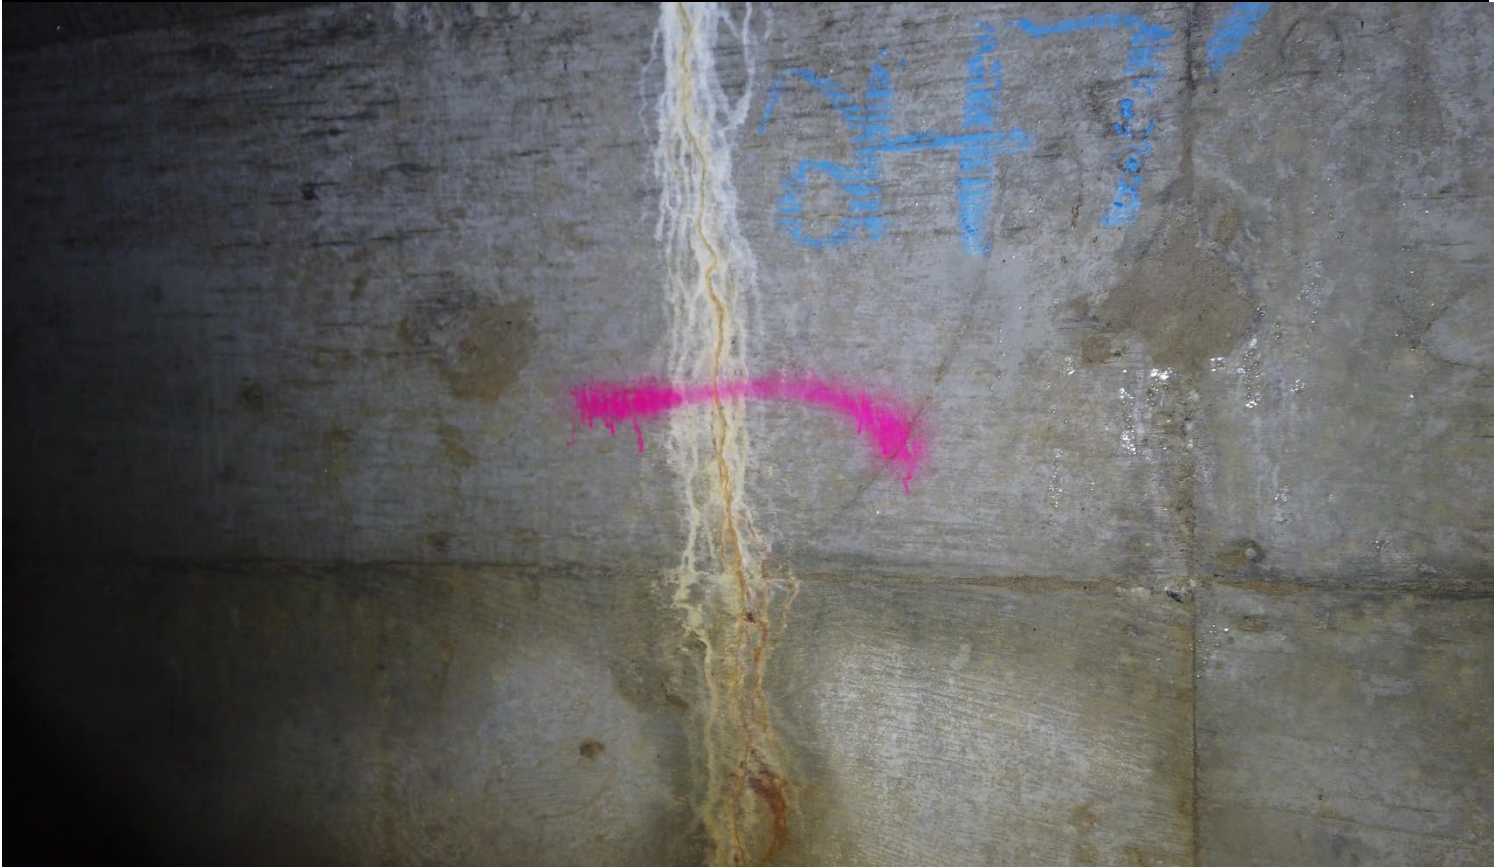
Footage	Defect Description	Top	Right	Left	Bottom
247 ft	Crack and Infiltration	Y	Y	Y

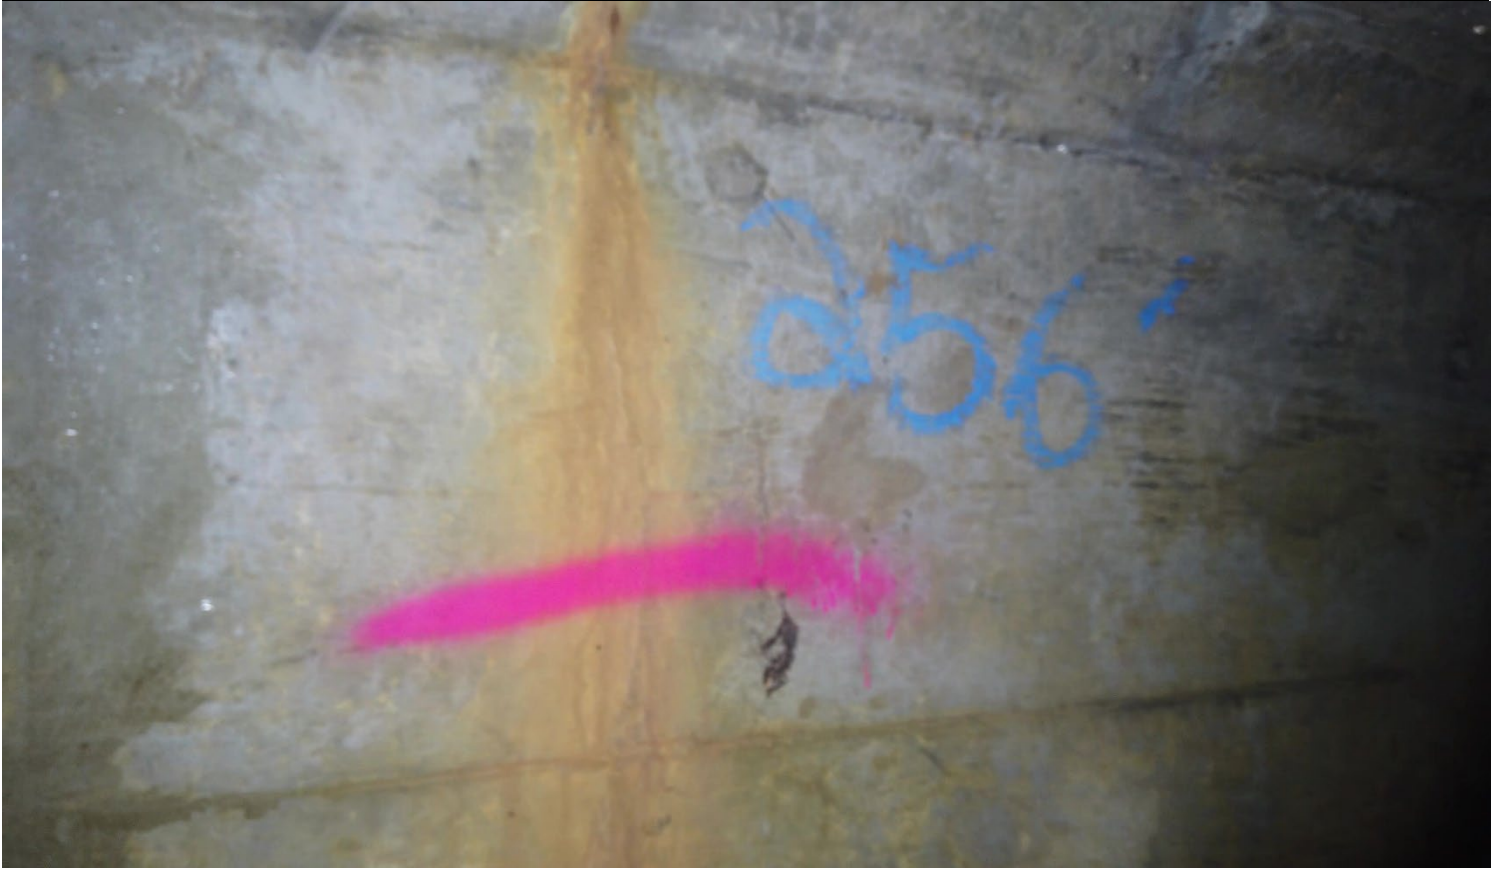
Footage	Defect Description	Top	Right	Left	Bottom
256 ft	Crack and Infiltration	Y	Y	Y

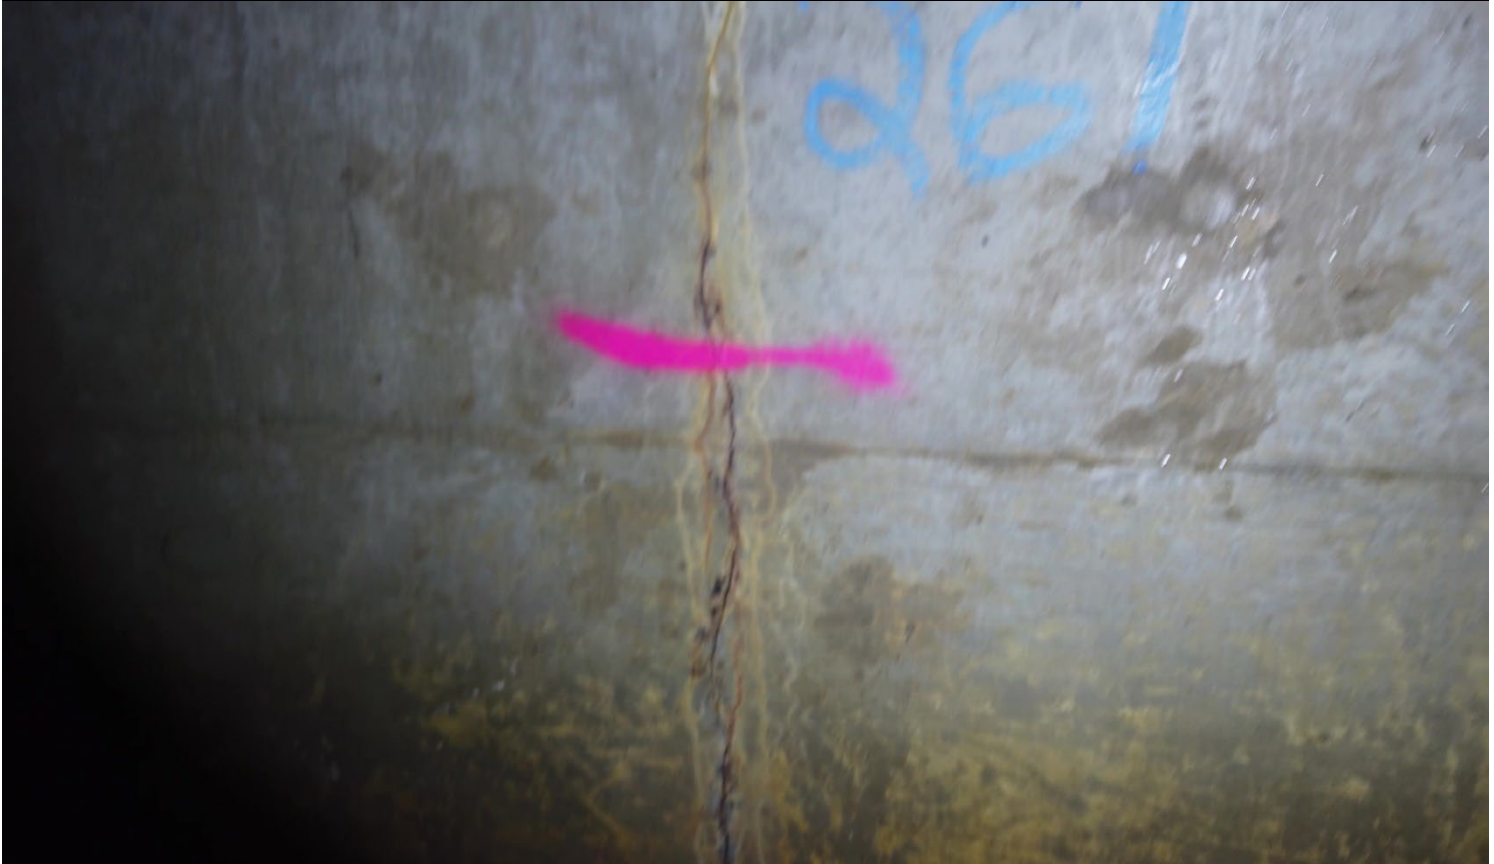
Footage	Defect Description	Top	Right	Left	Bottom
261 ft	Crack and Infiltration	Y	Y	Y
