I-26 & I-95 INTERCHANGE IMPROVEMENTS

June 29, 2023

PIPE INSPECTION REPORT

This report contains the results of the video pipe inspection and assessment of the existing storm water drainage pipes within the project area in Orangeburg and Dorchester Counties.

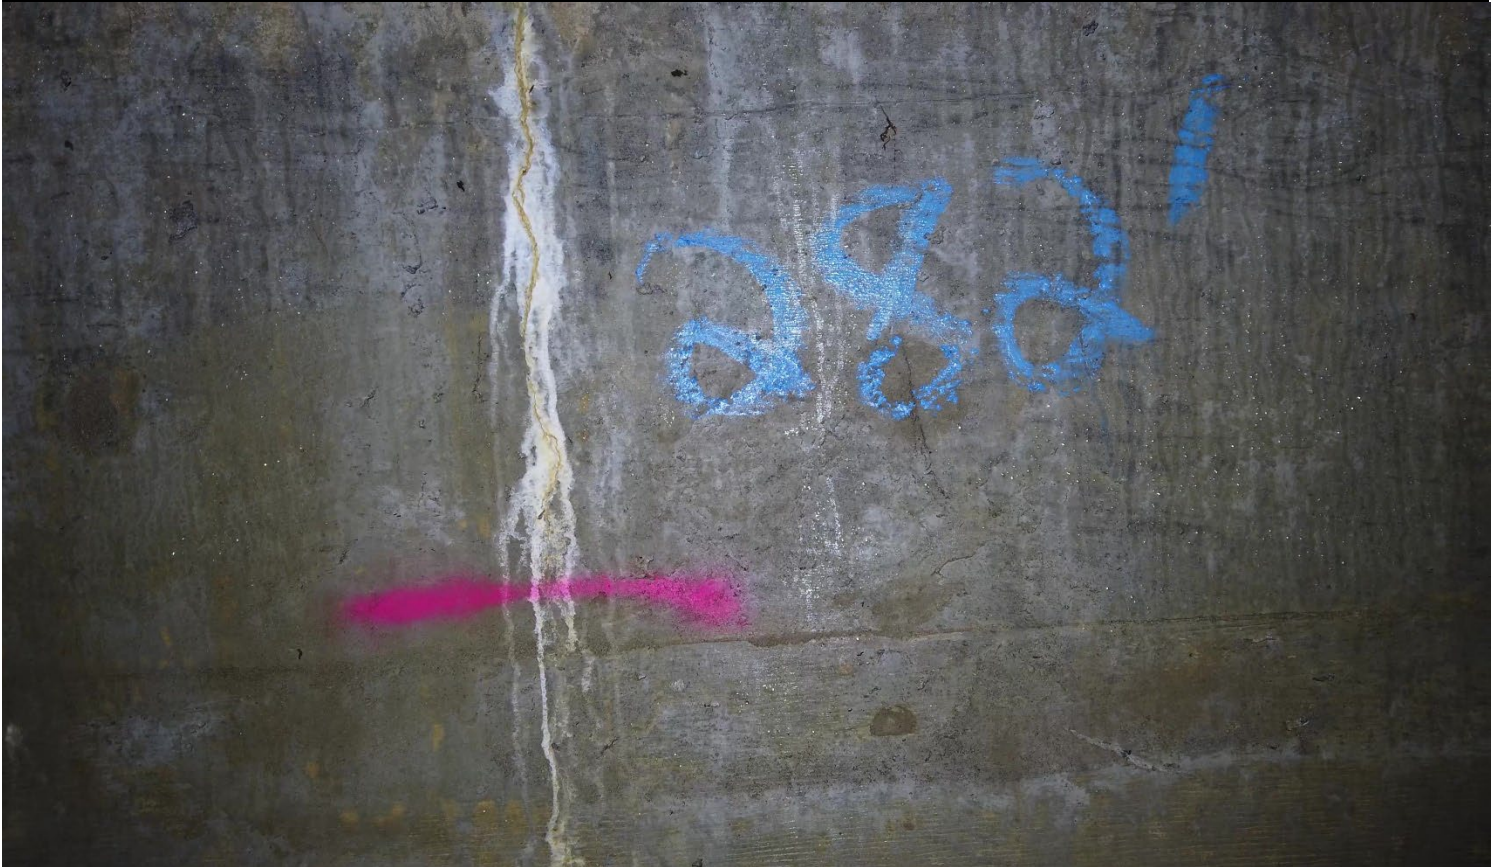
Footage	Defect Description	Top	Right	Left	Bottom
282 ft	Crack and Infiltration	Y	Y	Y

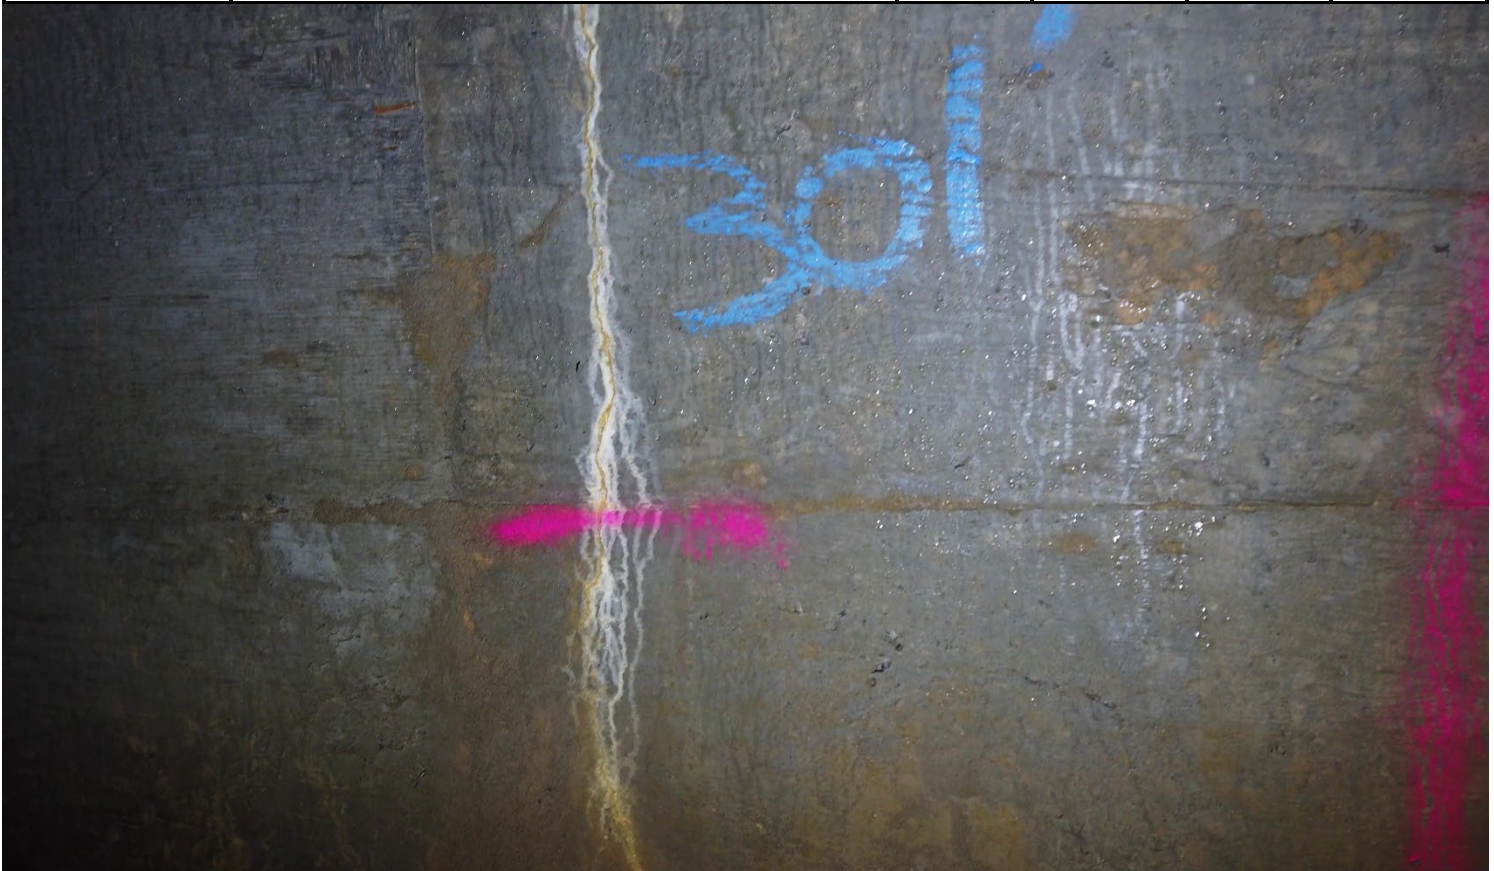
Footage	Defect Description	Top	Right	Left	Bottom
301 ft	Crack and Infiltration	Y	Y	Y

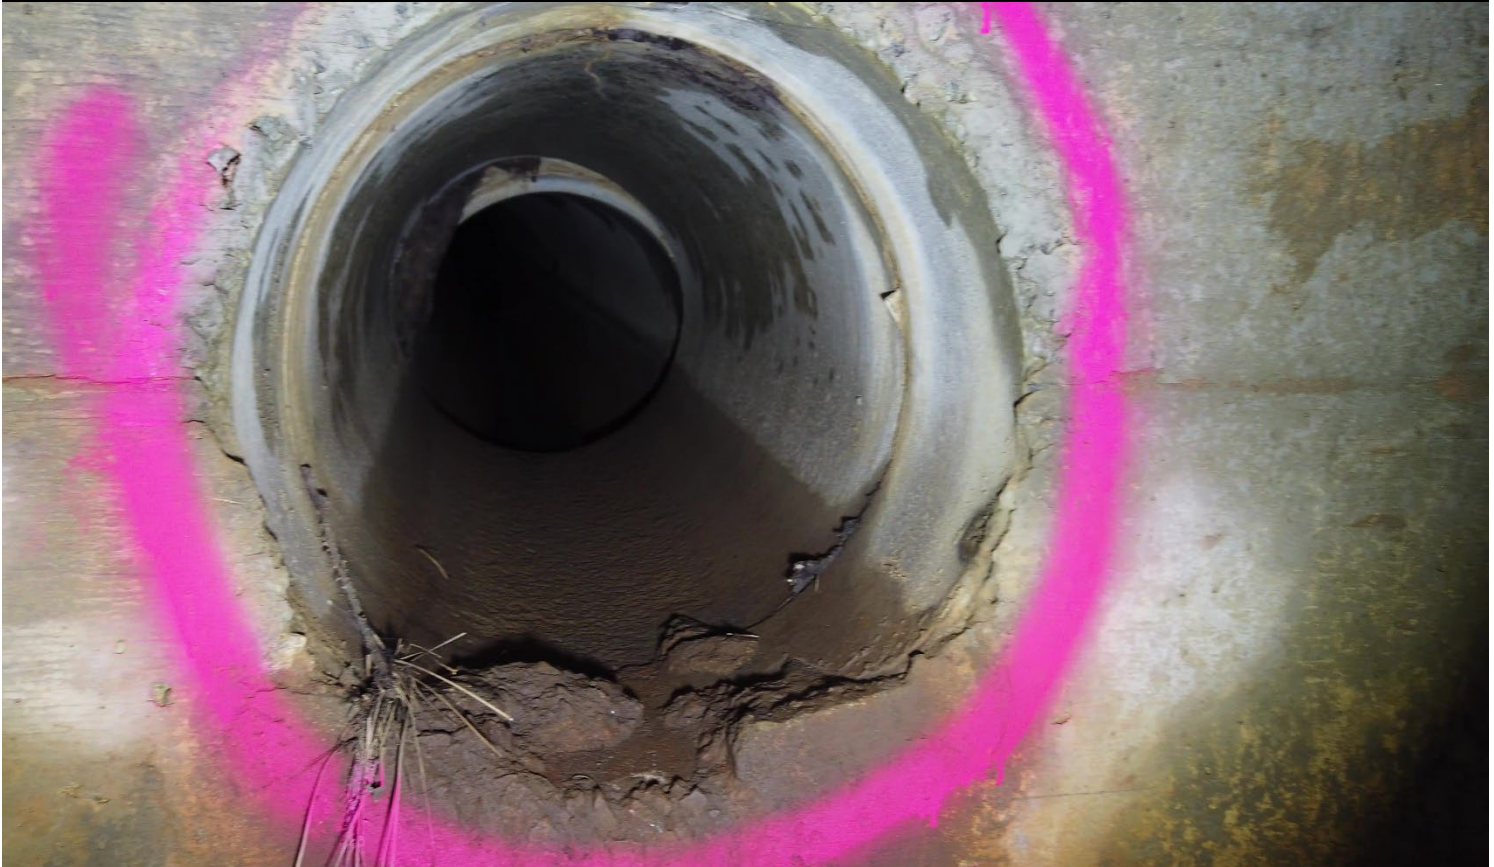
Footage	Defect Description	Top	Right	Left	Bottom
309 ft	Pipe Intersection			Y

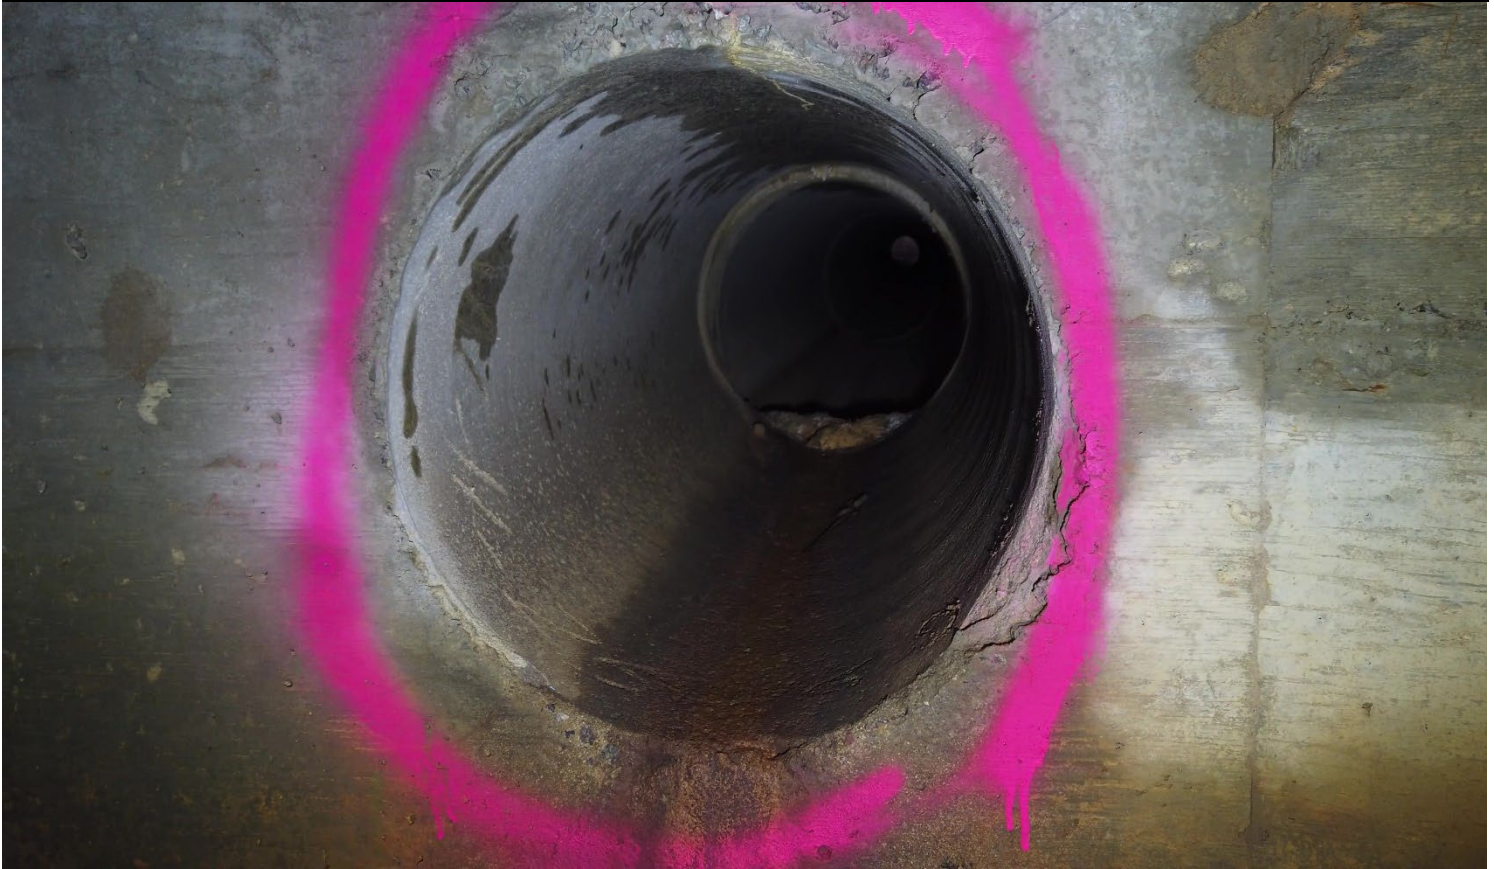
Footage	Defect Description	Top	Right	Left	Bottom
309 ft	Pipe Intersection		Y

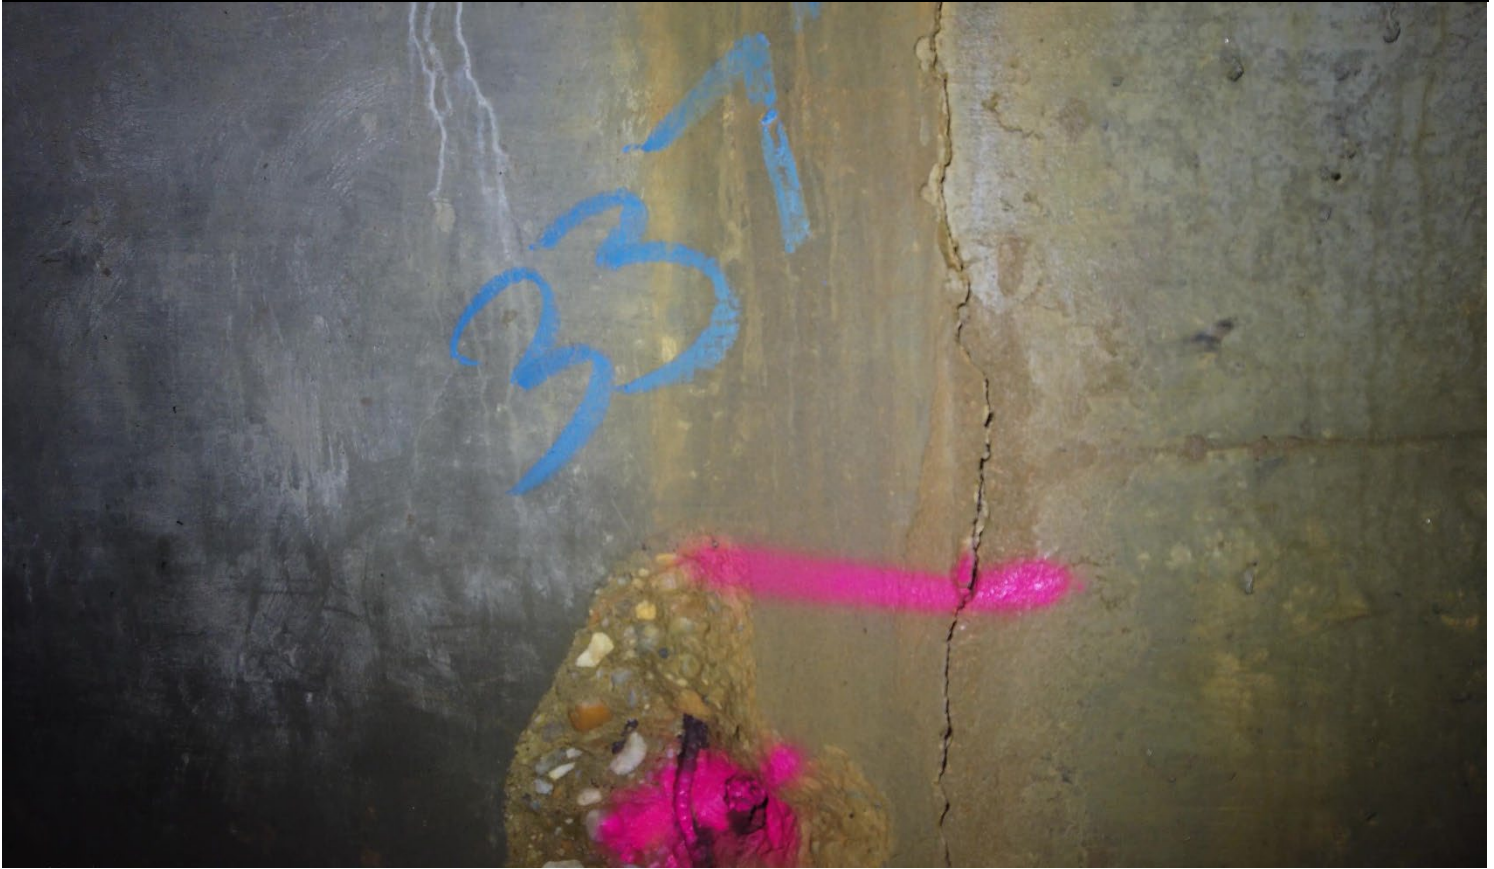
Footage	Defect Description	Top	Right	Left	Bottom
337 ft	Crack and Rebar Showing		Y

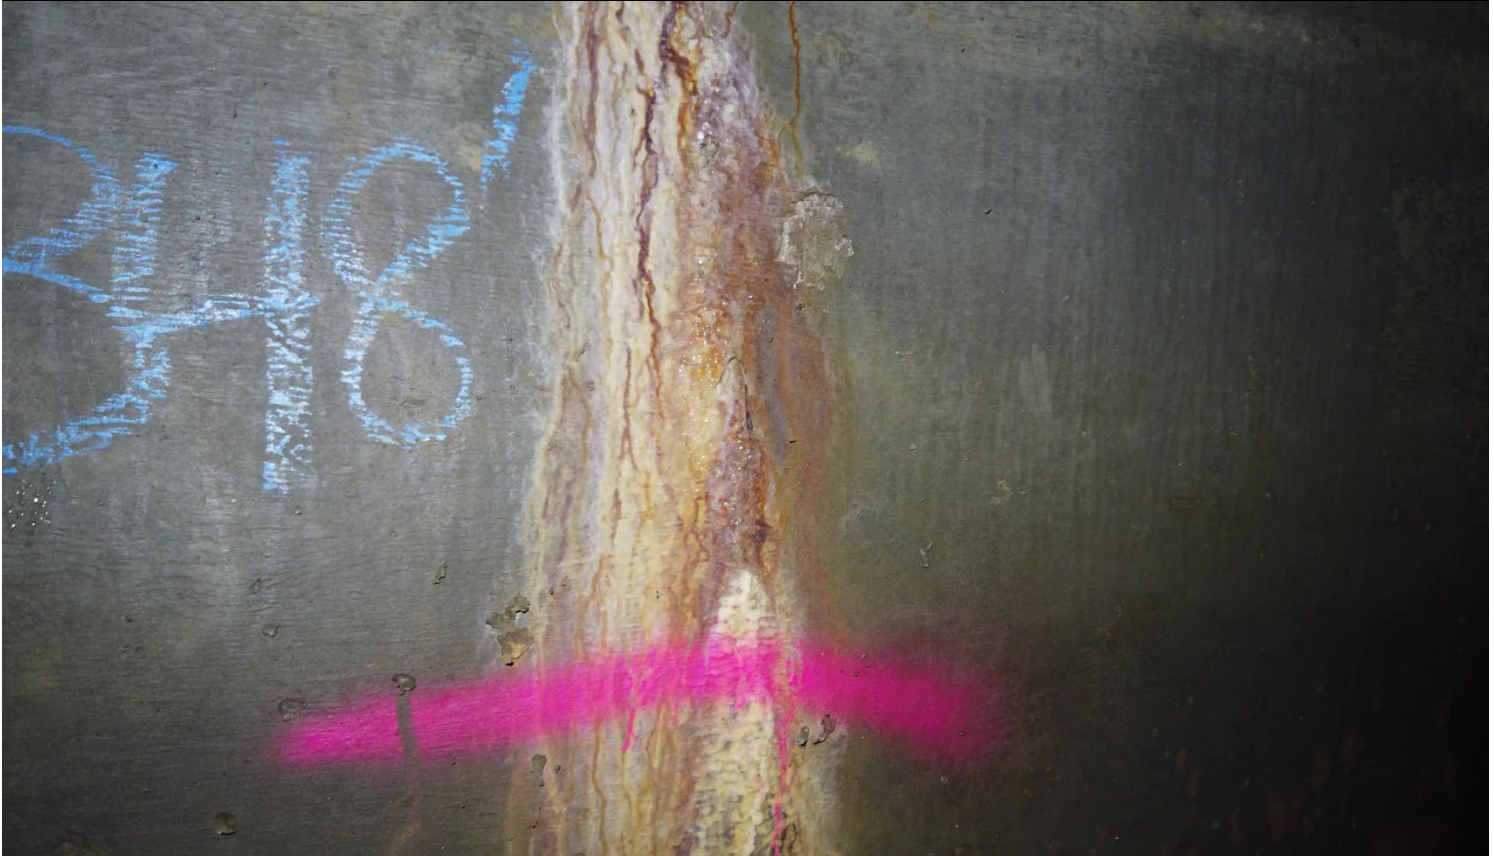
Footage	Defect Description	Top	Right	Left	Bottom
348 ft	Crack and Infiltration	Y		Y

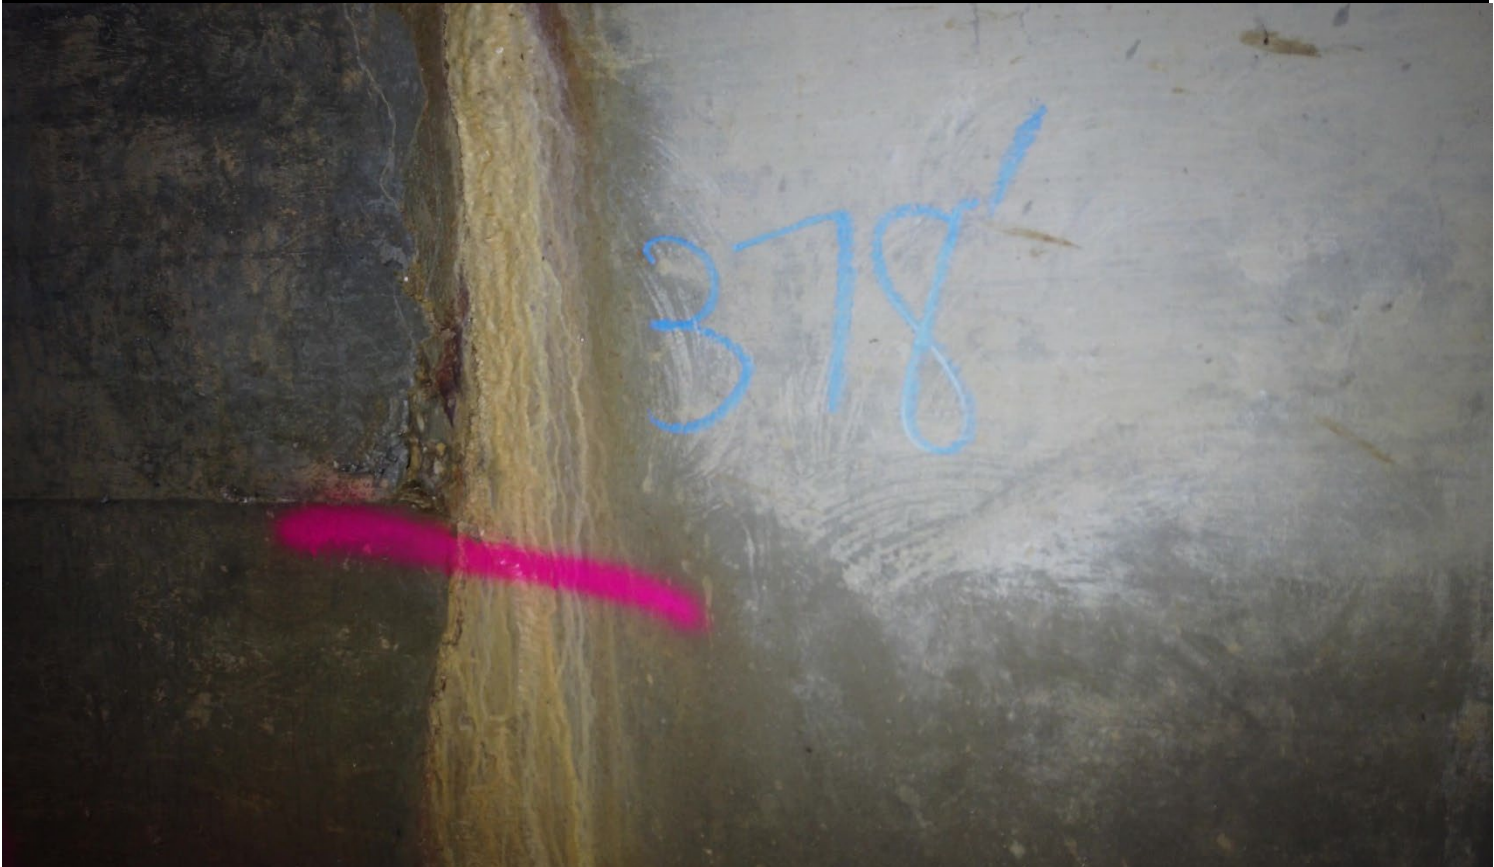
Footage	Defect Description	Top	Right	Left	Bottom
378 ft	Crack and Infiltration	Y	Y	Y

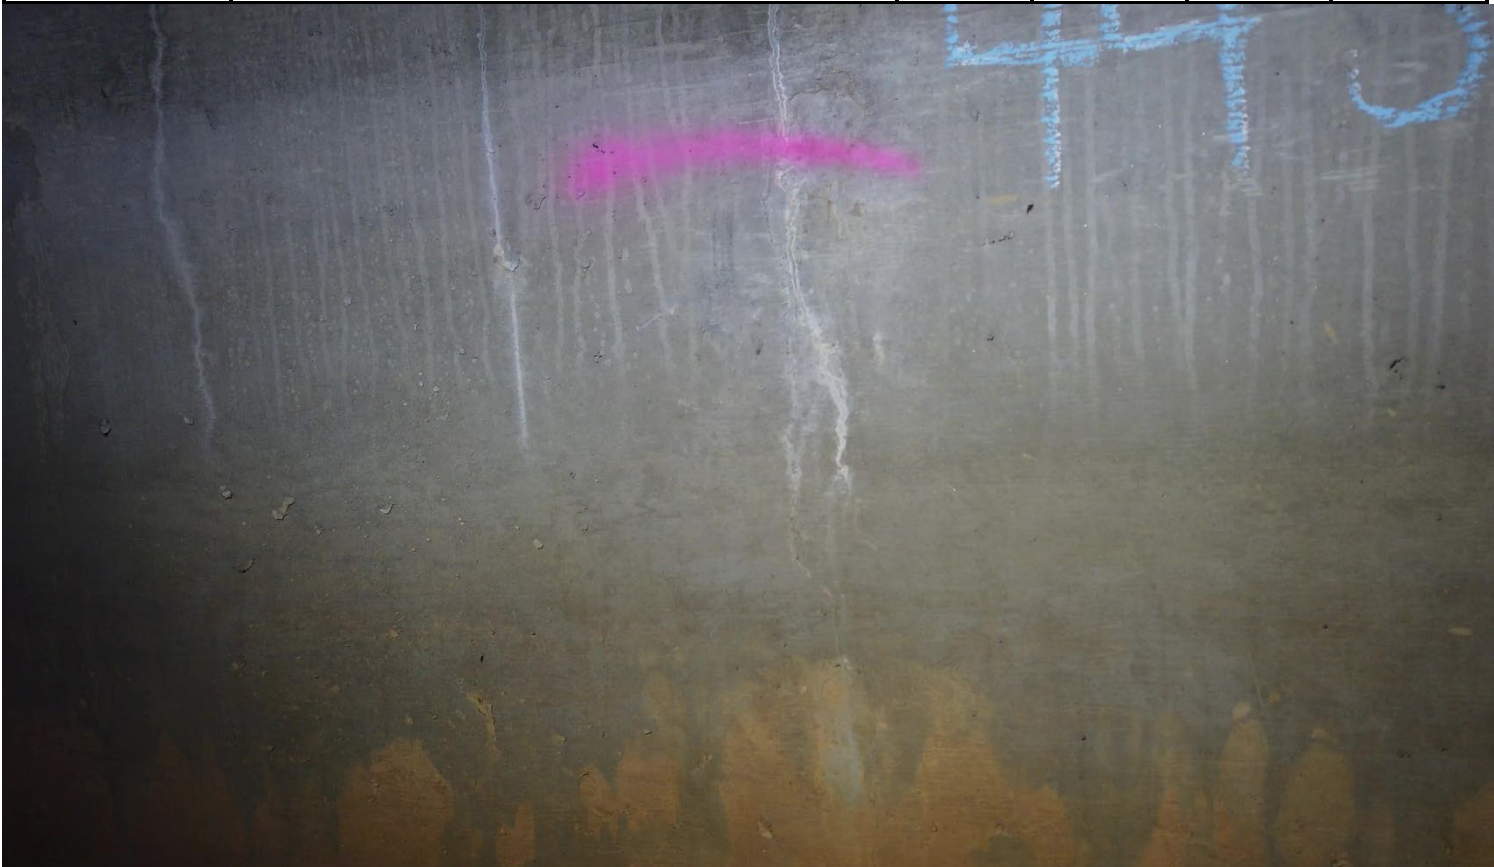
Footage	Defect Description	Top	Right	Left	Bottom
443 ft	Crack and Infiltration	Y	Y	Y

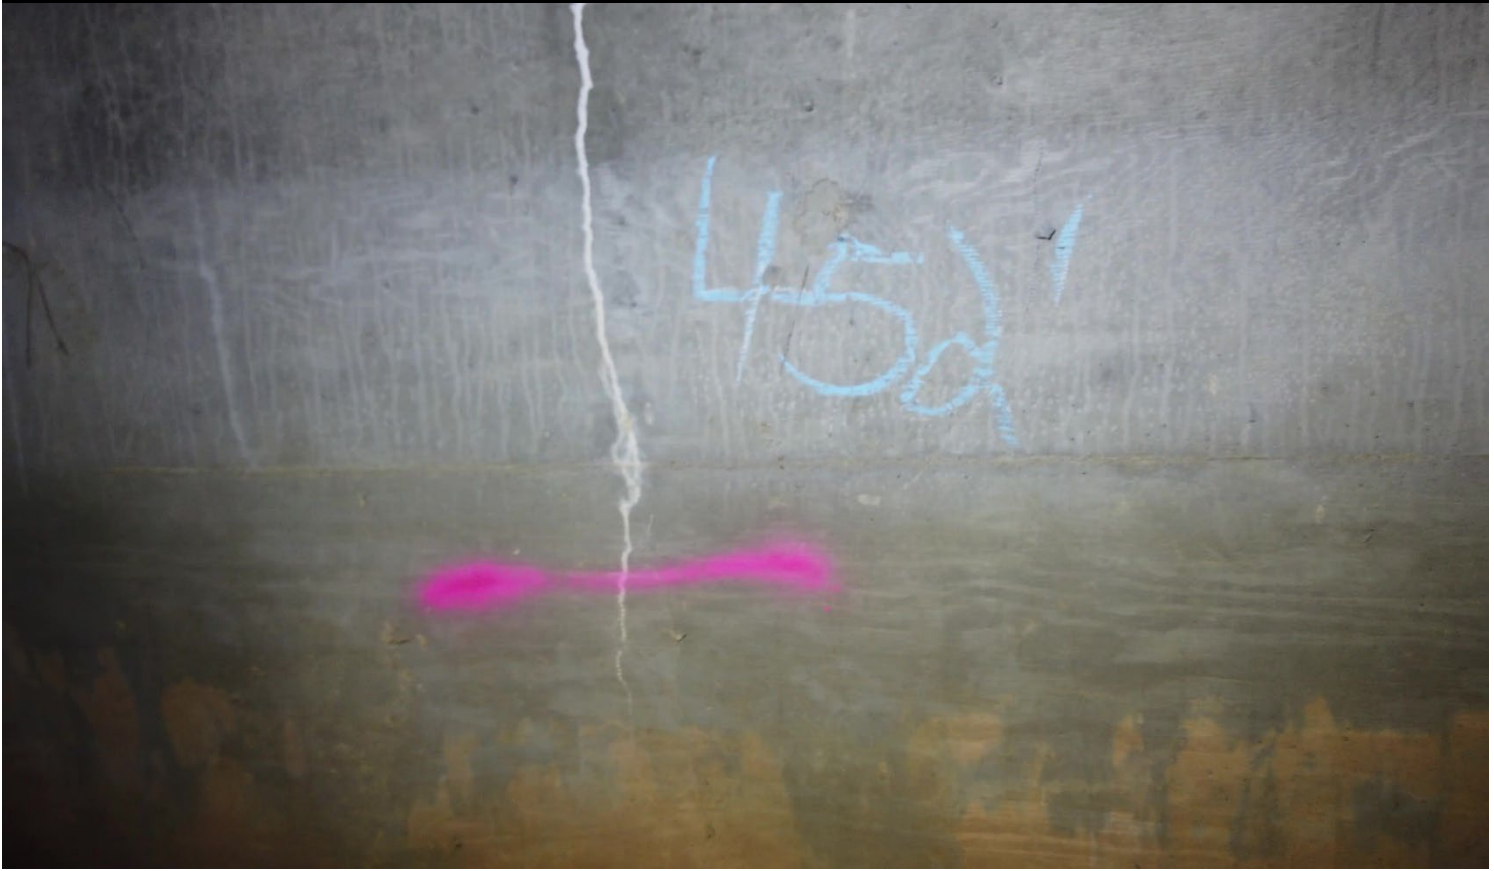
Footage	Defect Description	Top	Right	Left	Bottom
452 ft	Crack and Infiltration	Y	Y	Y

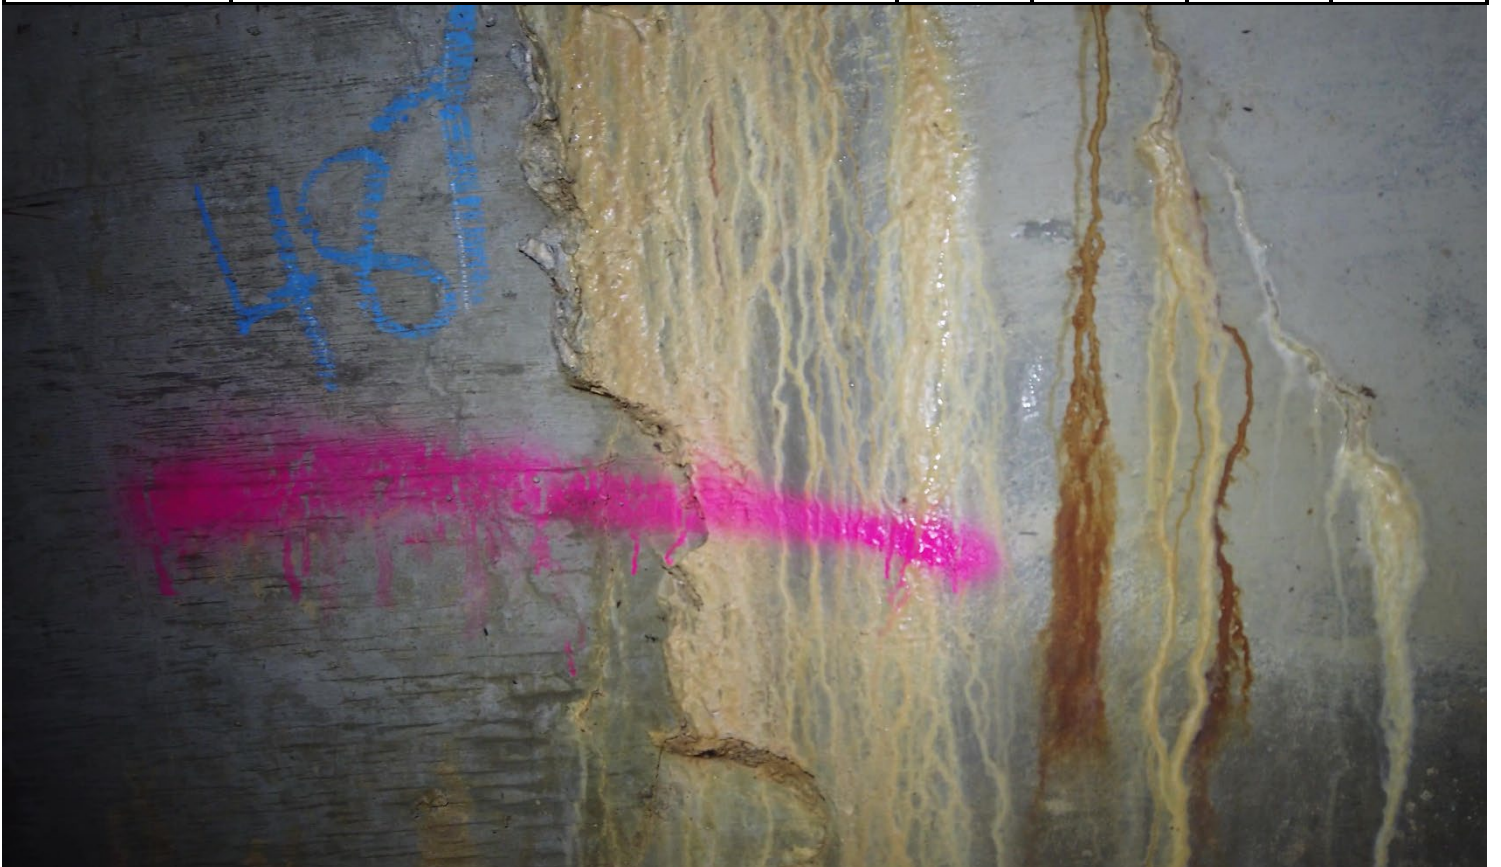
Footage	Defect Description	Top	Right	Left	Bottom
481 ft	Crack and Infiltration	Y	Y	Y

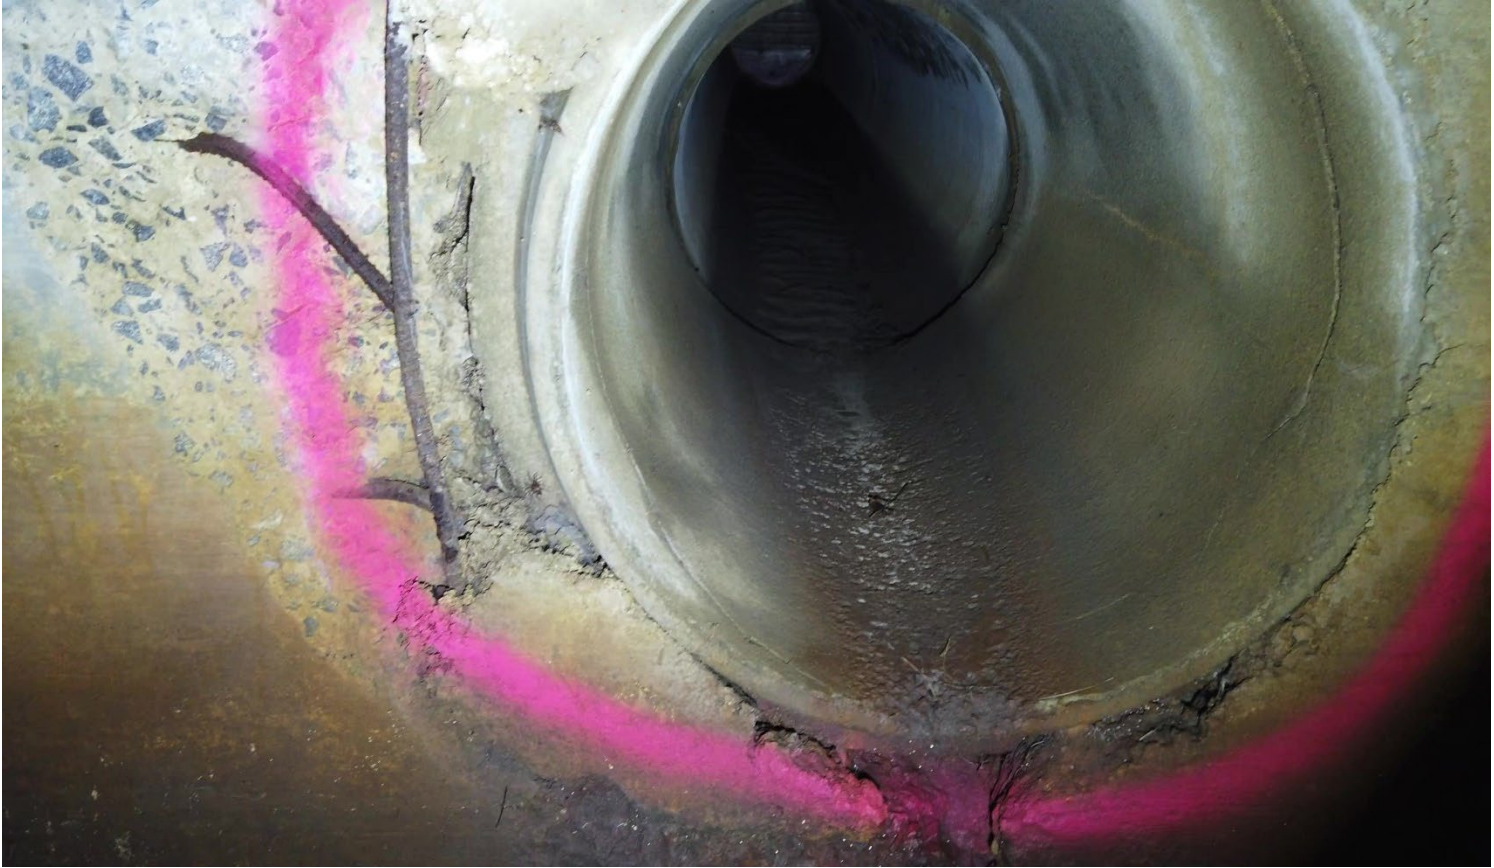
Footage	Defect Description	Top	Right	Left	Bottom
506 ft	Pipe Intersection			Y

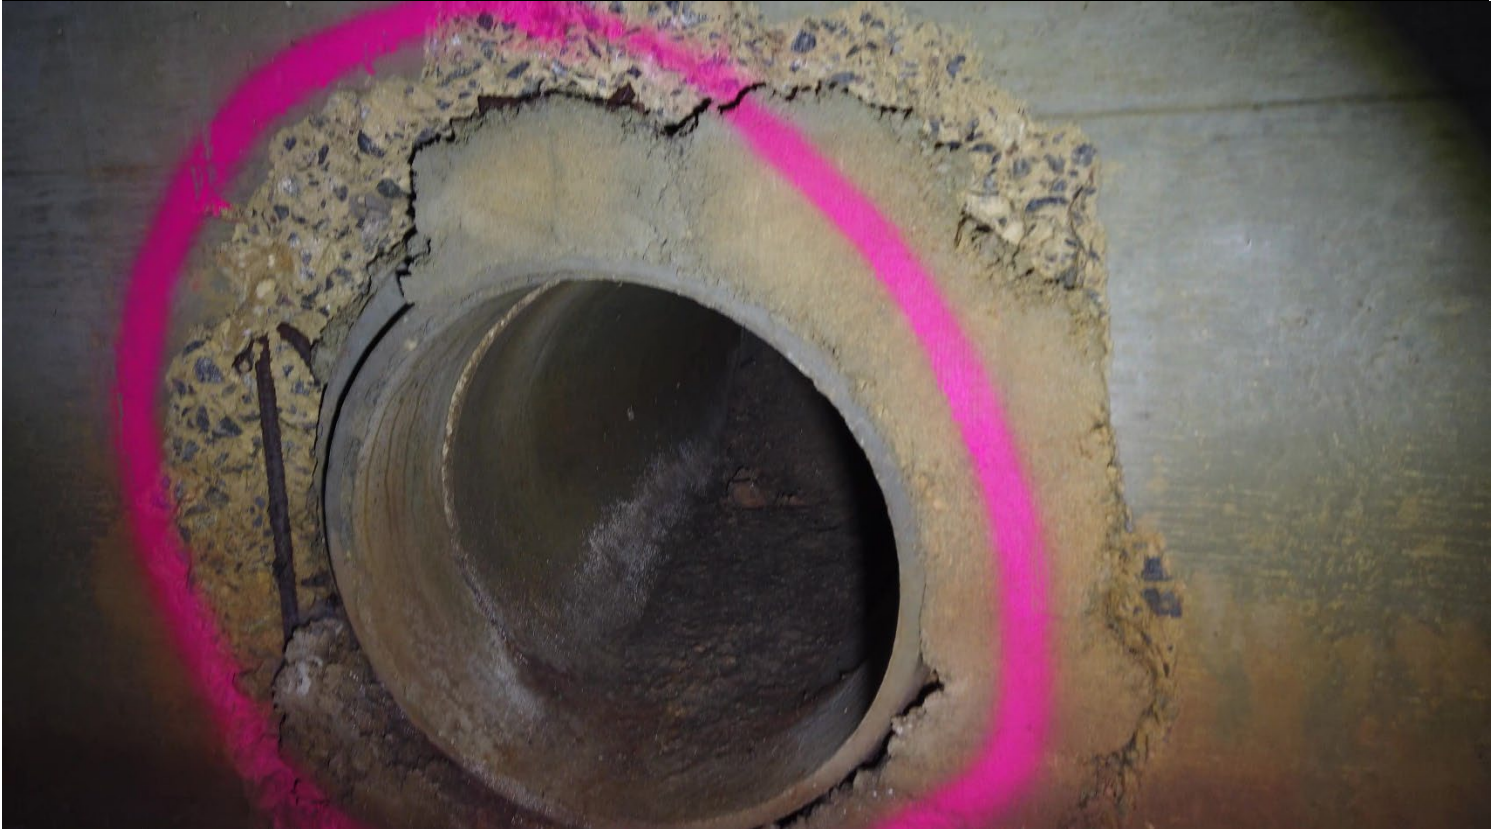
Footage	Defect Description	Top	Right	Left	Bottom
506 ft	Pipe Intersection		Y

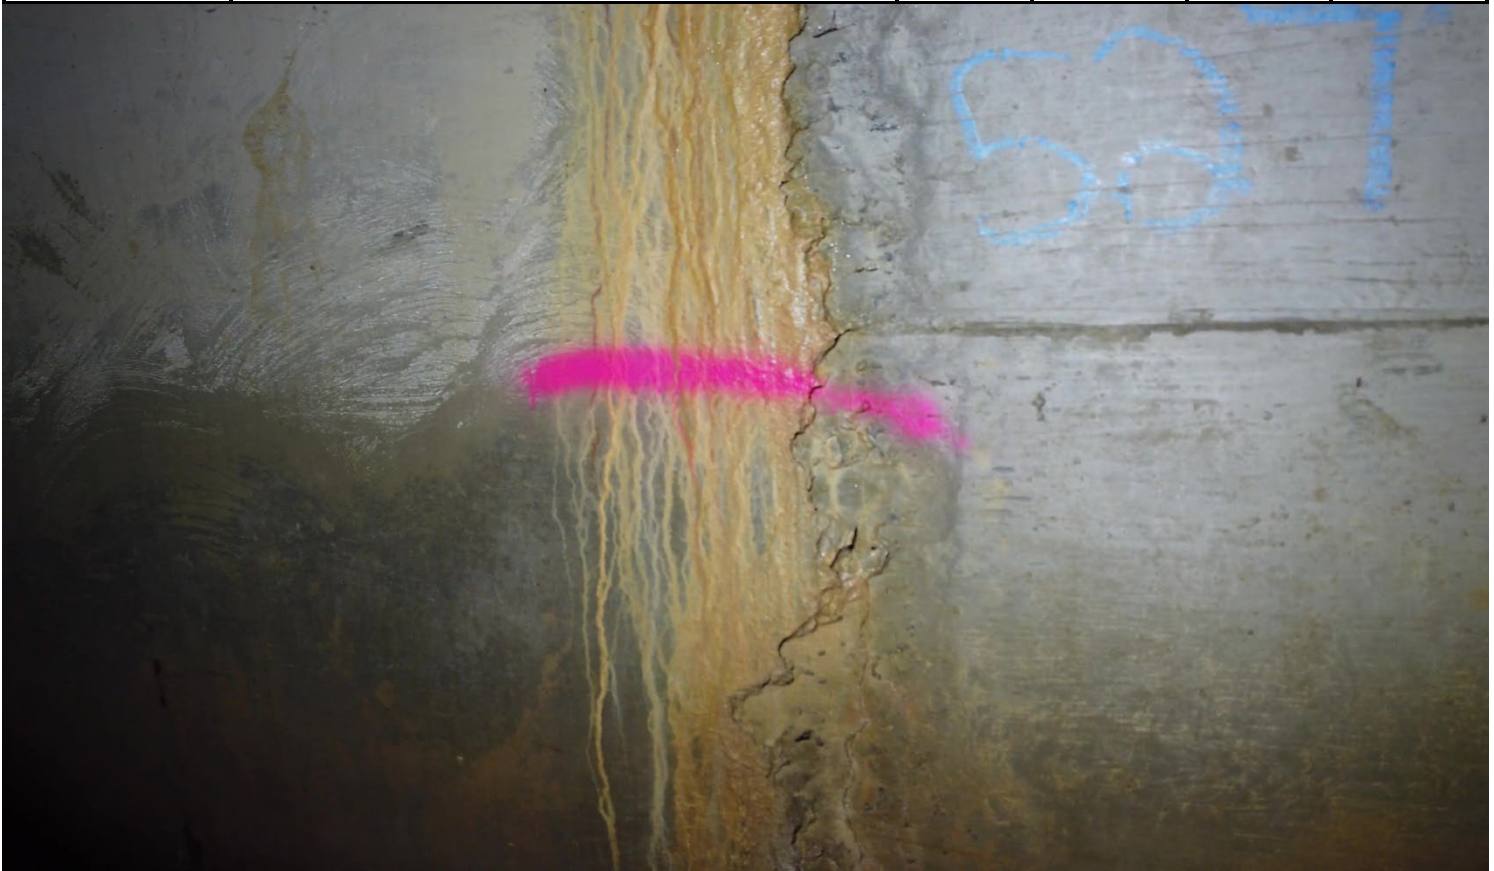
Footage	Defect Description	Top	Right	Left	Bottom
527 ft	Crack and Infiltration	Y	Y	Y

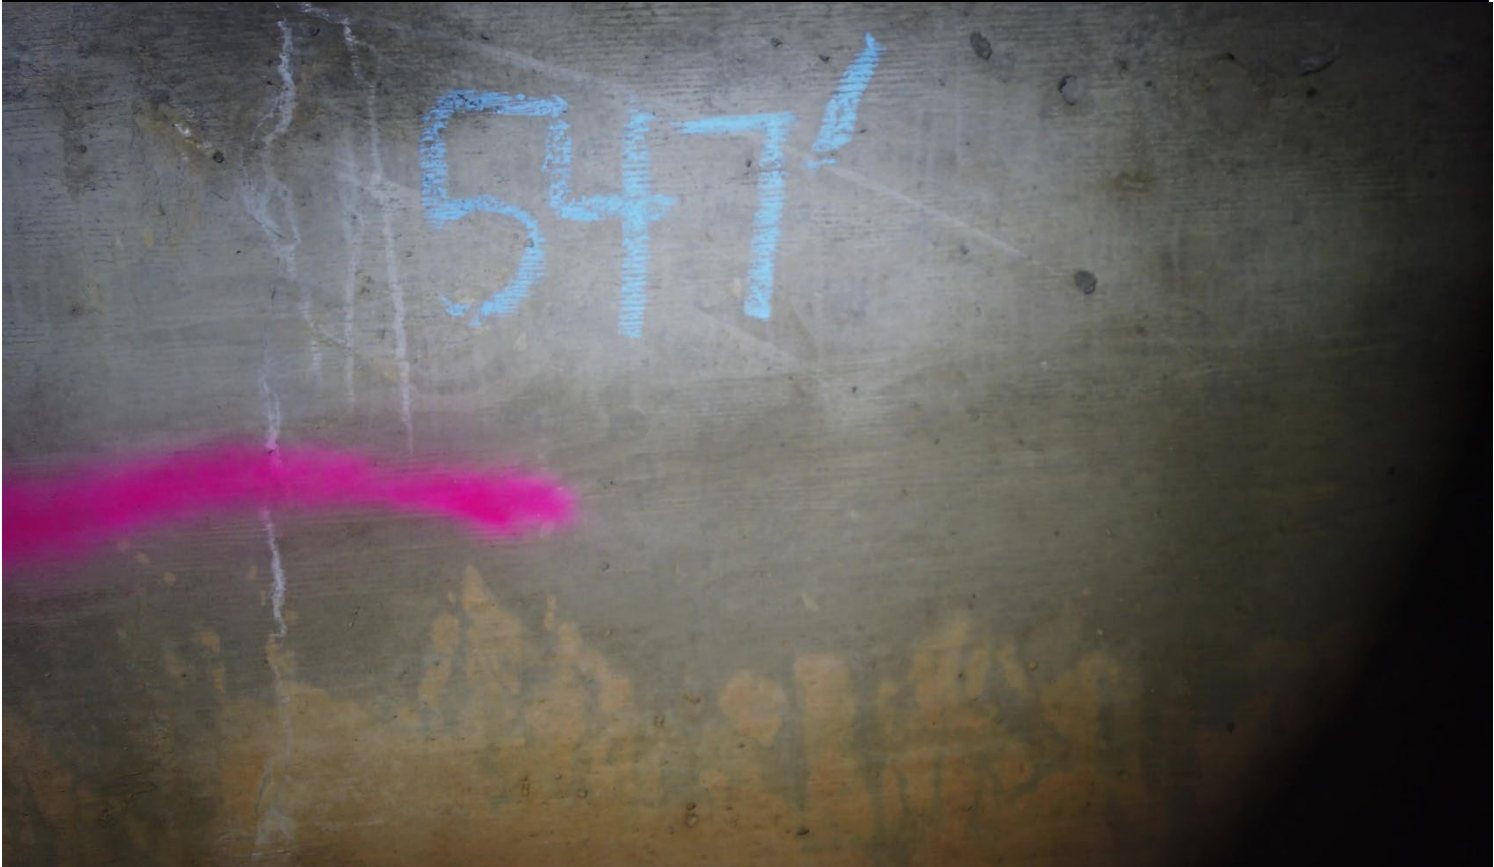
Footage	Defect Description	Top	Right	Left	Bottom
547 ft	Crack and Infiltration	Y	Y	Y

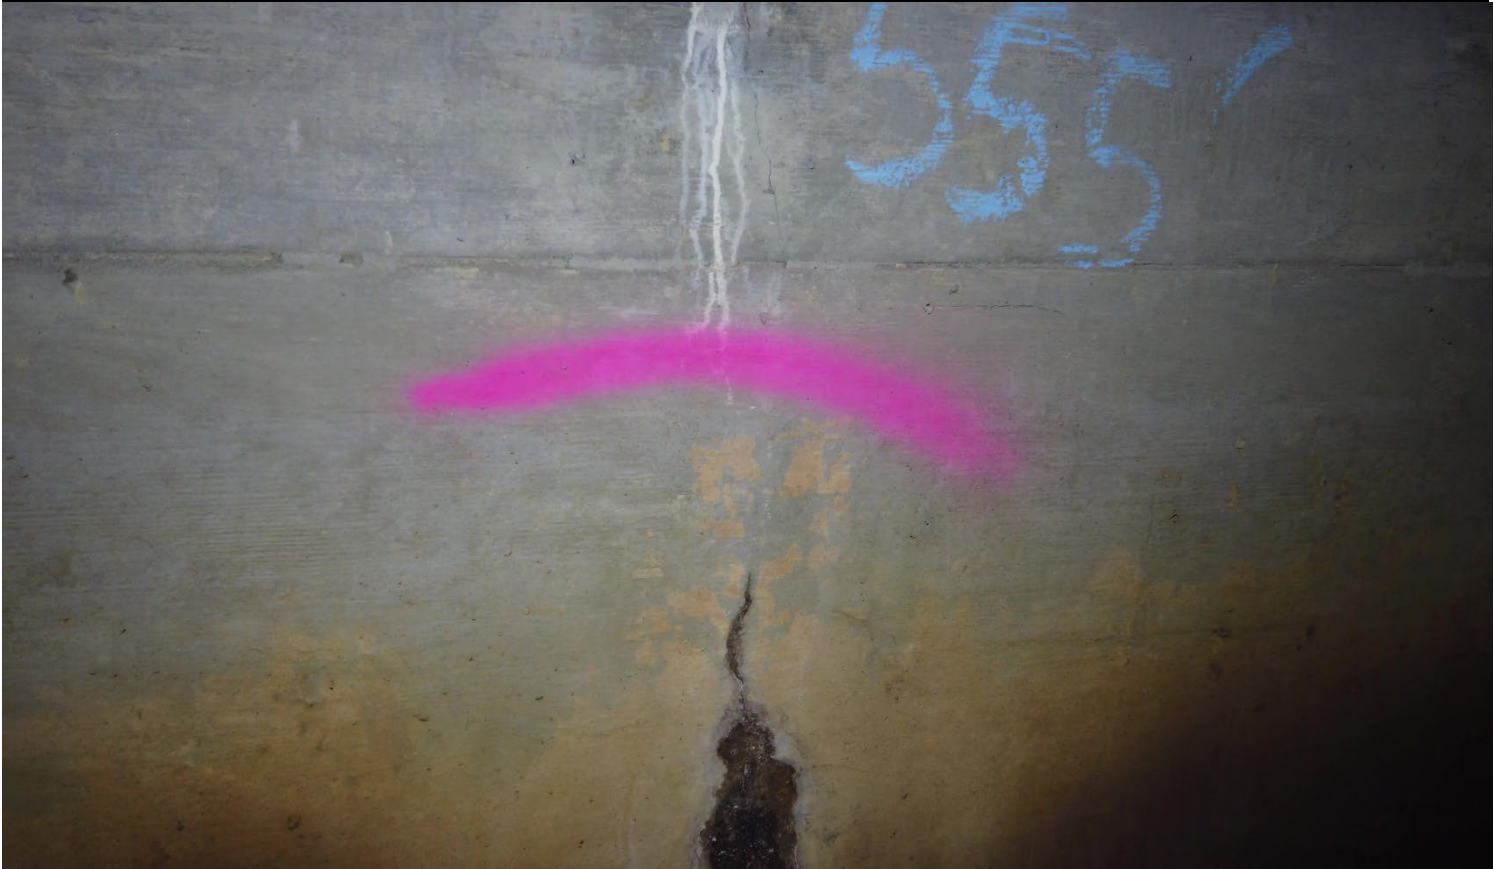
Footage	Defect Description	Top	Right	Left	Bottom
555 ft	Crack			Y

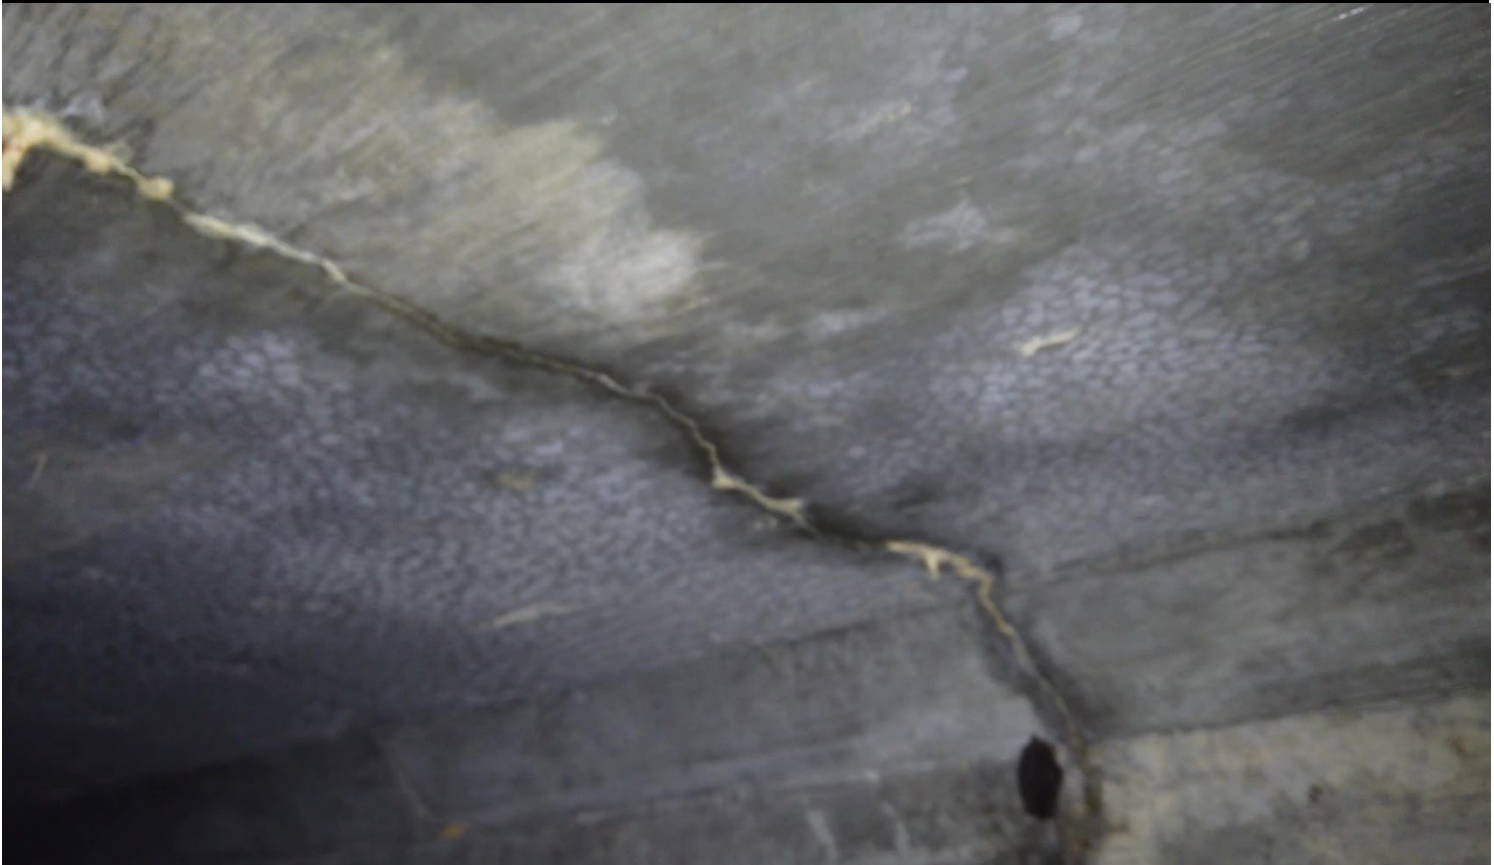
Footage	Defect Description	Top	Right	Left	Bottom
559 ft	Crack and Infiltration	Y	Y	Y

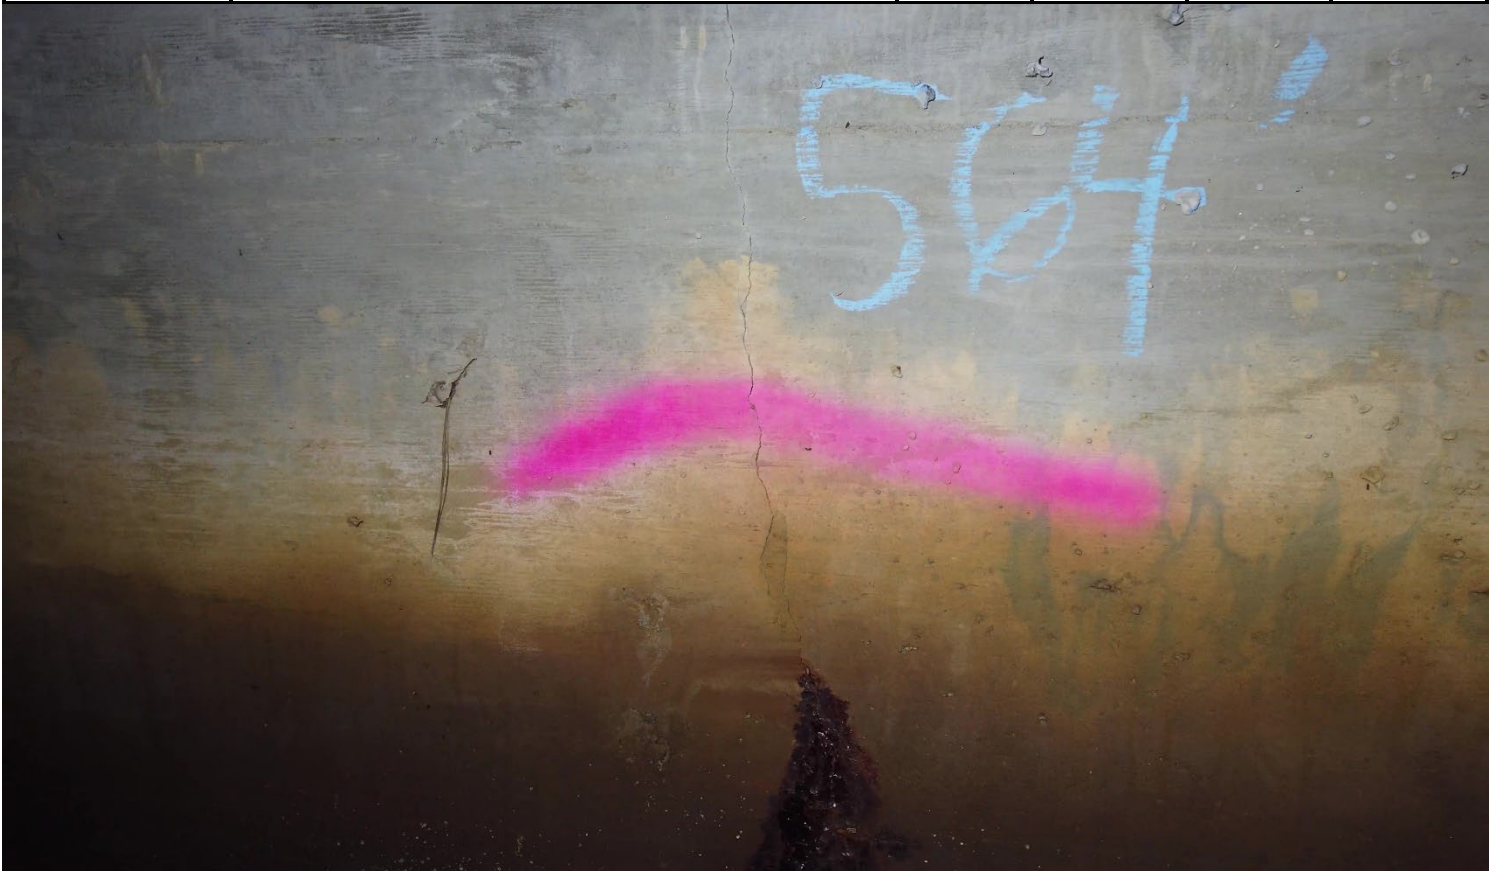
Footage	Defect Description	Top	Right	Left	Bottom
564 ft	Crack and Infiltration	Y	Y	Y
