I-26 & I-95 INTERCHANGE IMPROVEMENTS

June 29, 2023

PIPE INSPECTION REPORT

This report contains the results of the video pipe inspection and assessment of the existing storm water drainage pipes within the project area in Orangeburg and Dorchester Counties.

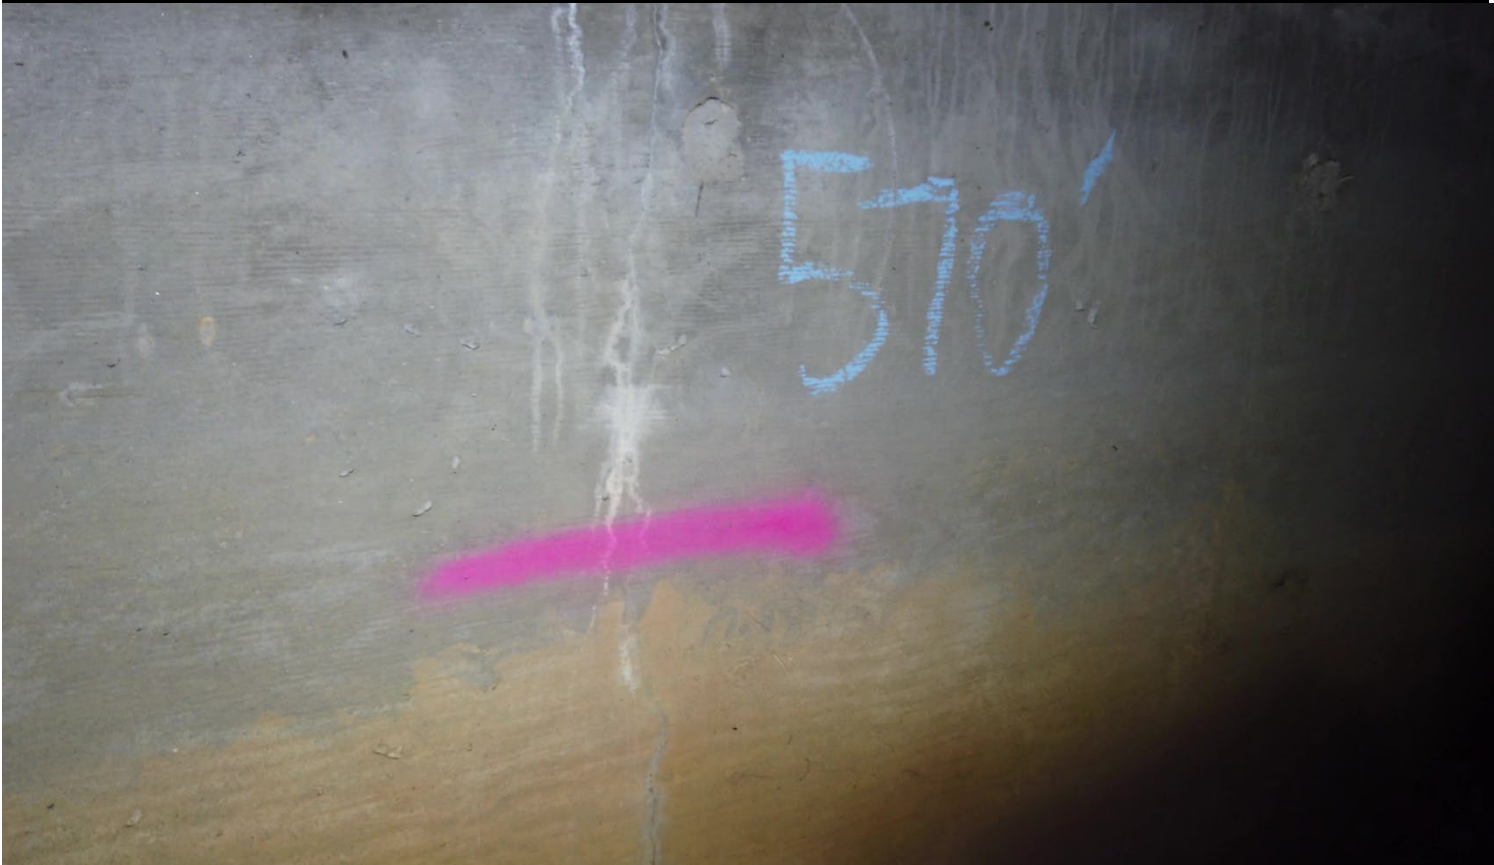
Footage	Defect Description	Top	Right	Left	Bottom
570 ft	Crack	Y		Y

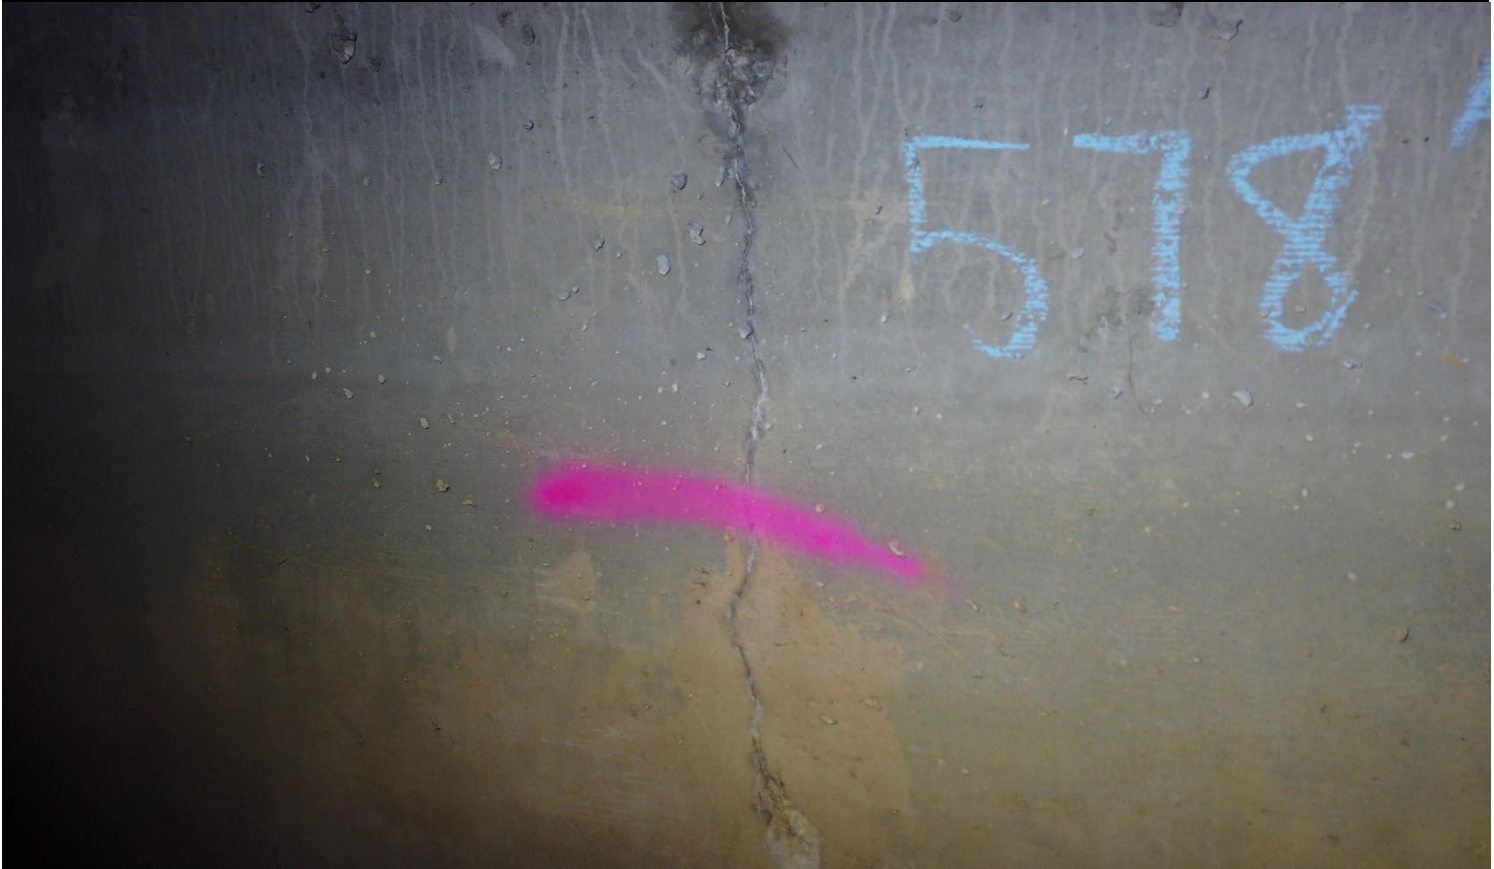
Footage	Defect Description	Top	Right	Left	Bottom
578 ft	Crack and Infiltration	Y	Y	Y

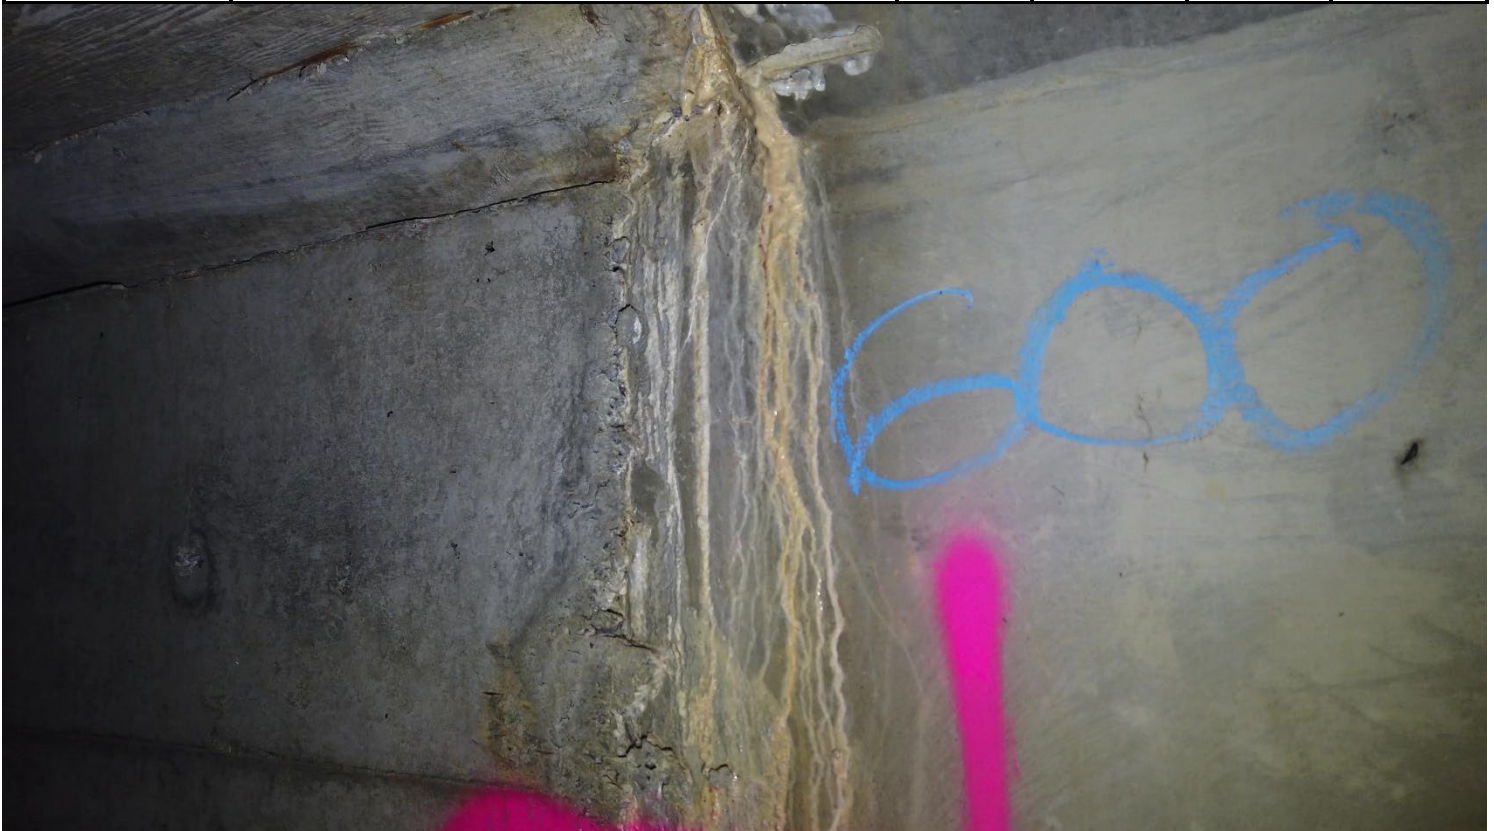
Footage	Defect Description	Top	Right	Left	Bottom
600 ft	Crack and Infiltration	Y	Y	Y

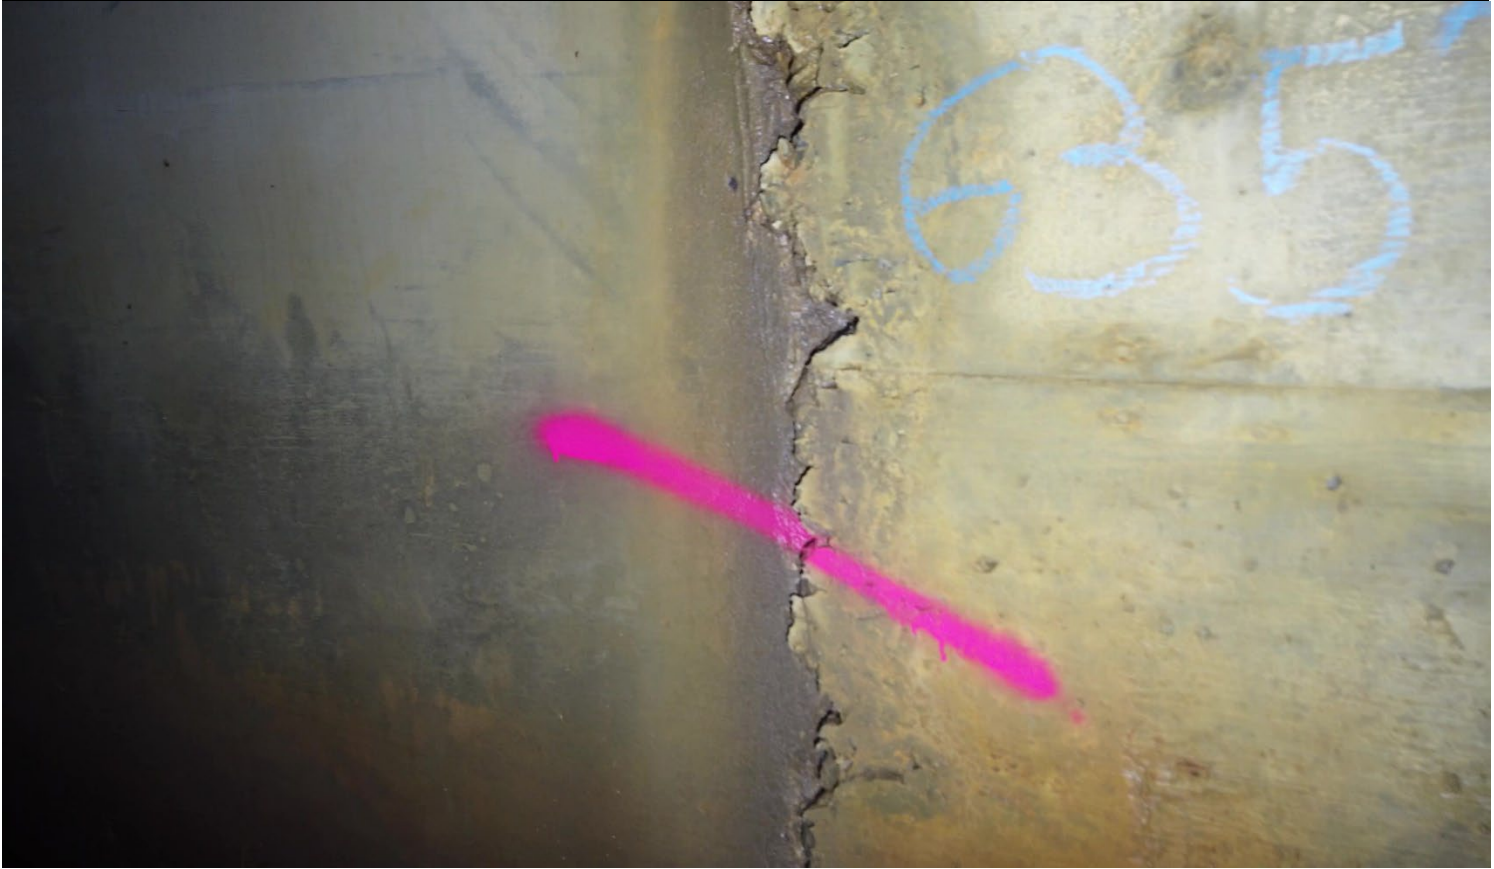
Footage	Defect Description	Top	Right	Left	Bottom
635 ft	Crack and Infiltration	Y	Y	Y

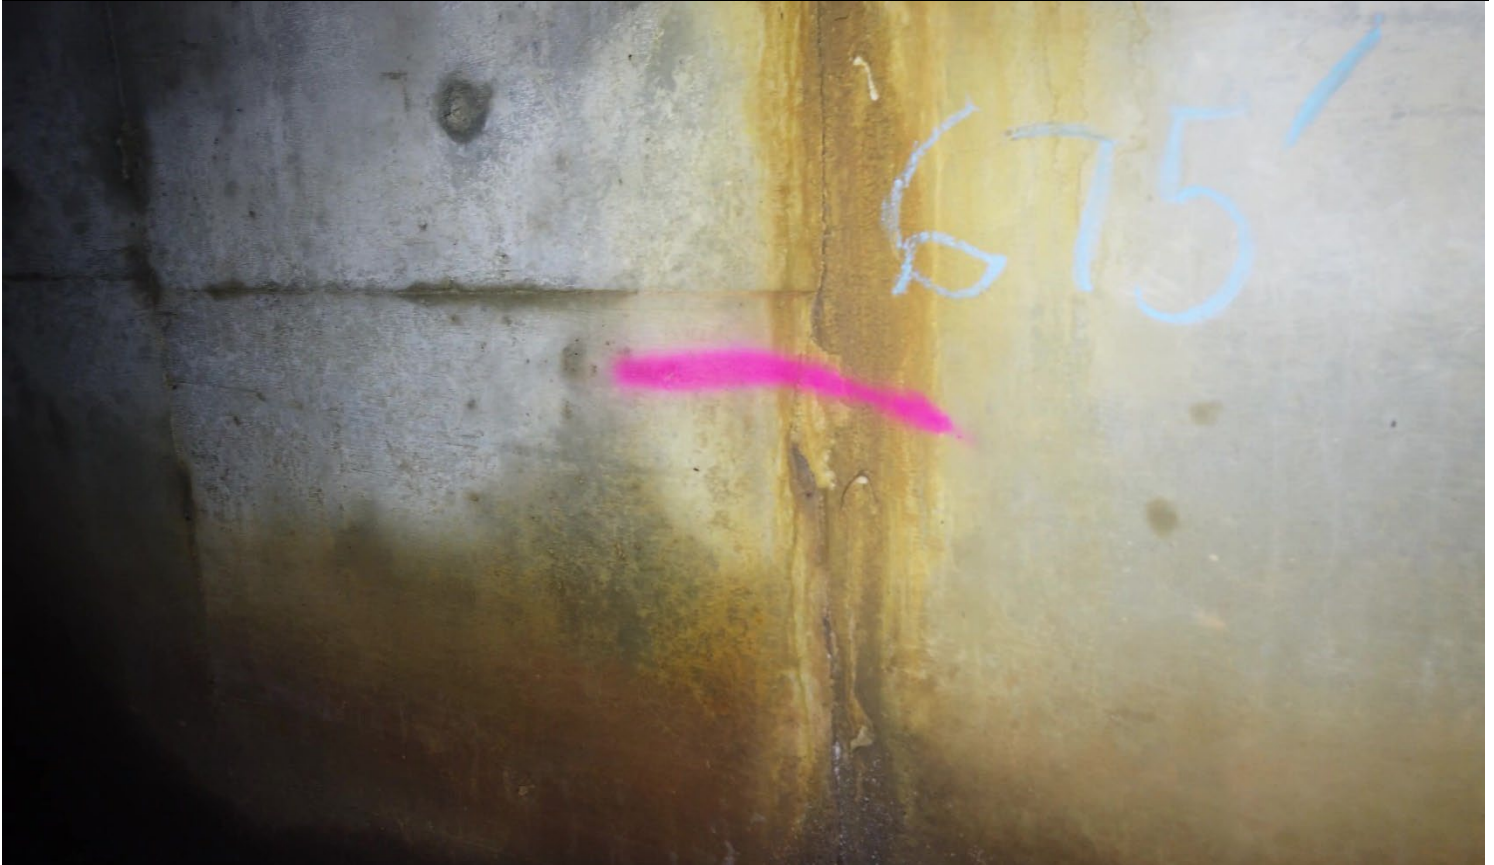
Footage	Defect Description	Top	Right	Left	Bottom
675 ft	Crack and Infiltration	Y	Y	Y

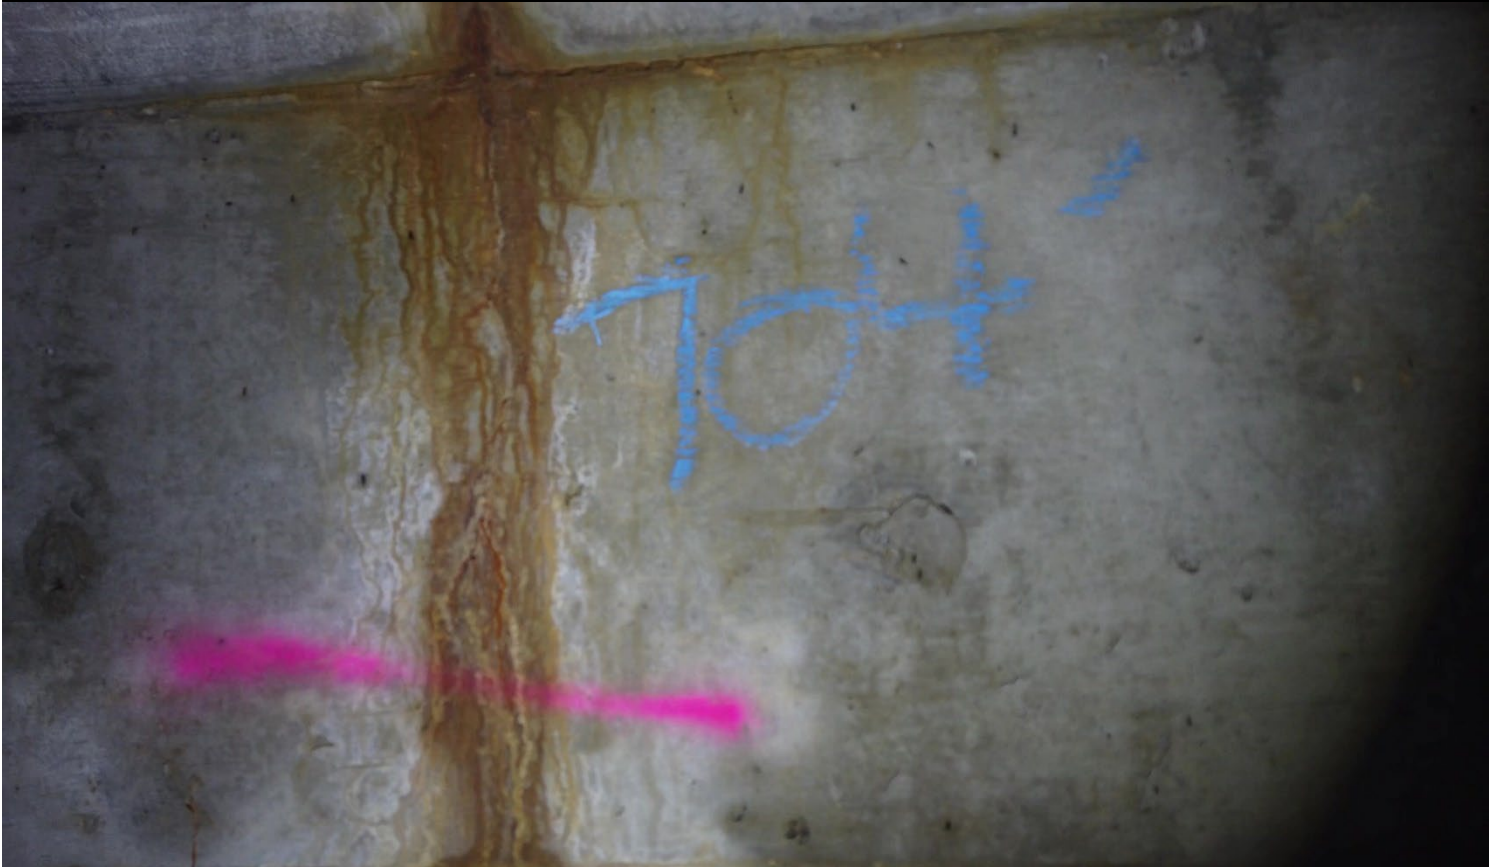
Footage	Defect Description	Top	Right	Left	Bottom
704 ft	Crack and Infiltration	Y	Y	Y

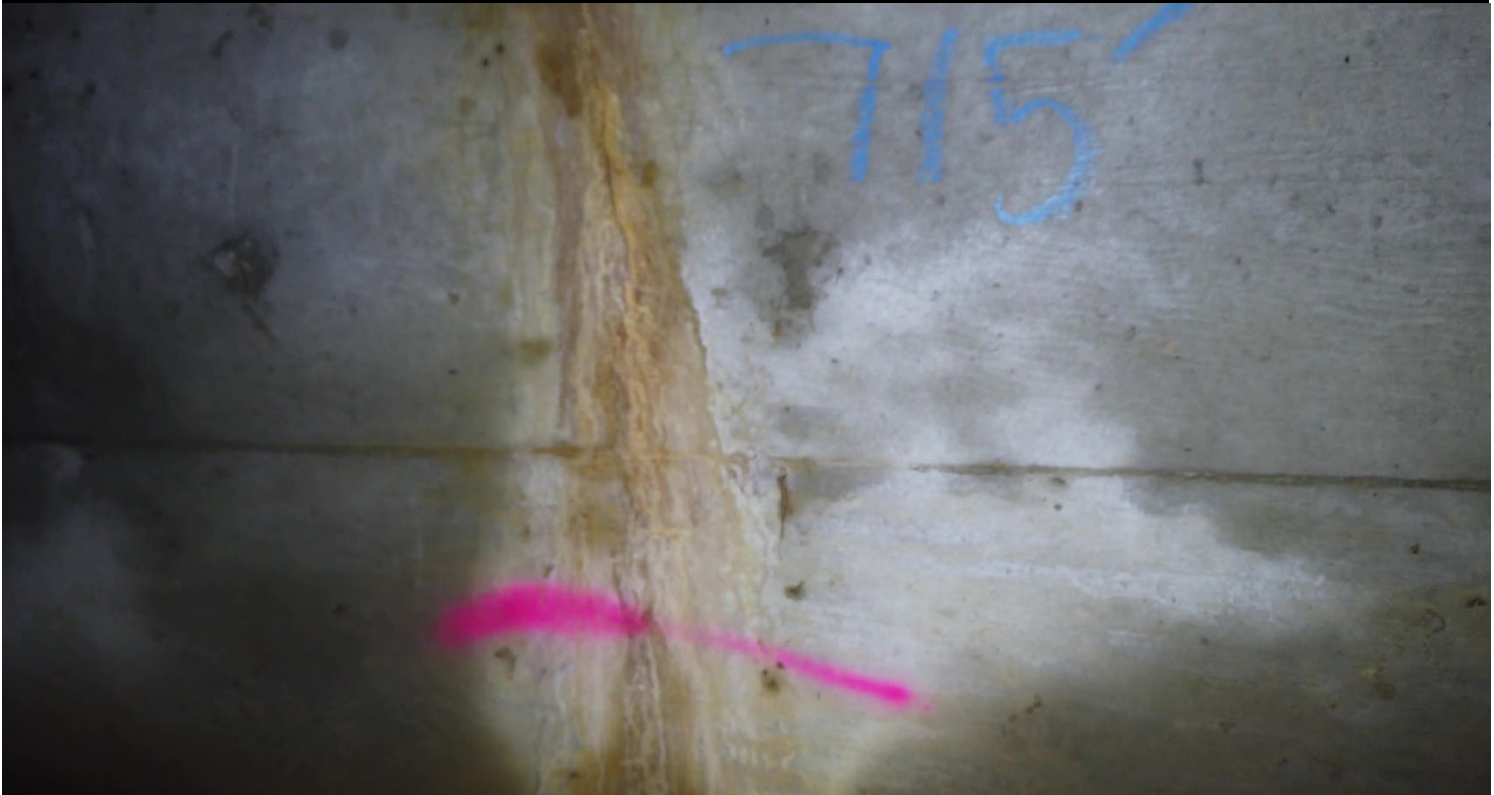
Footage	Defect Description	Top	Right	Left	Bottom
715 ft	Crack and Infiltration	Y	Y	Y

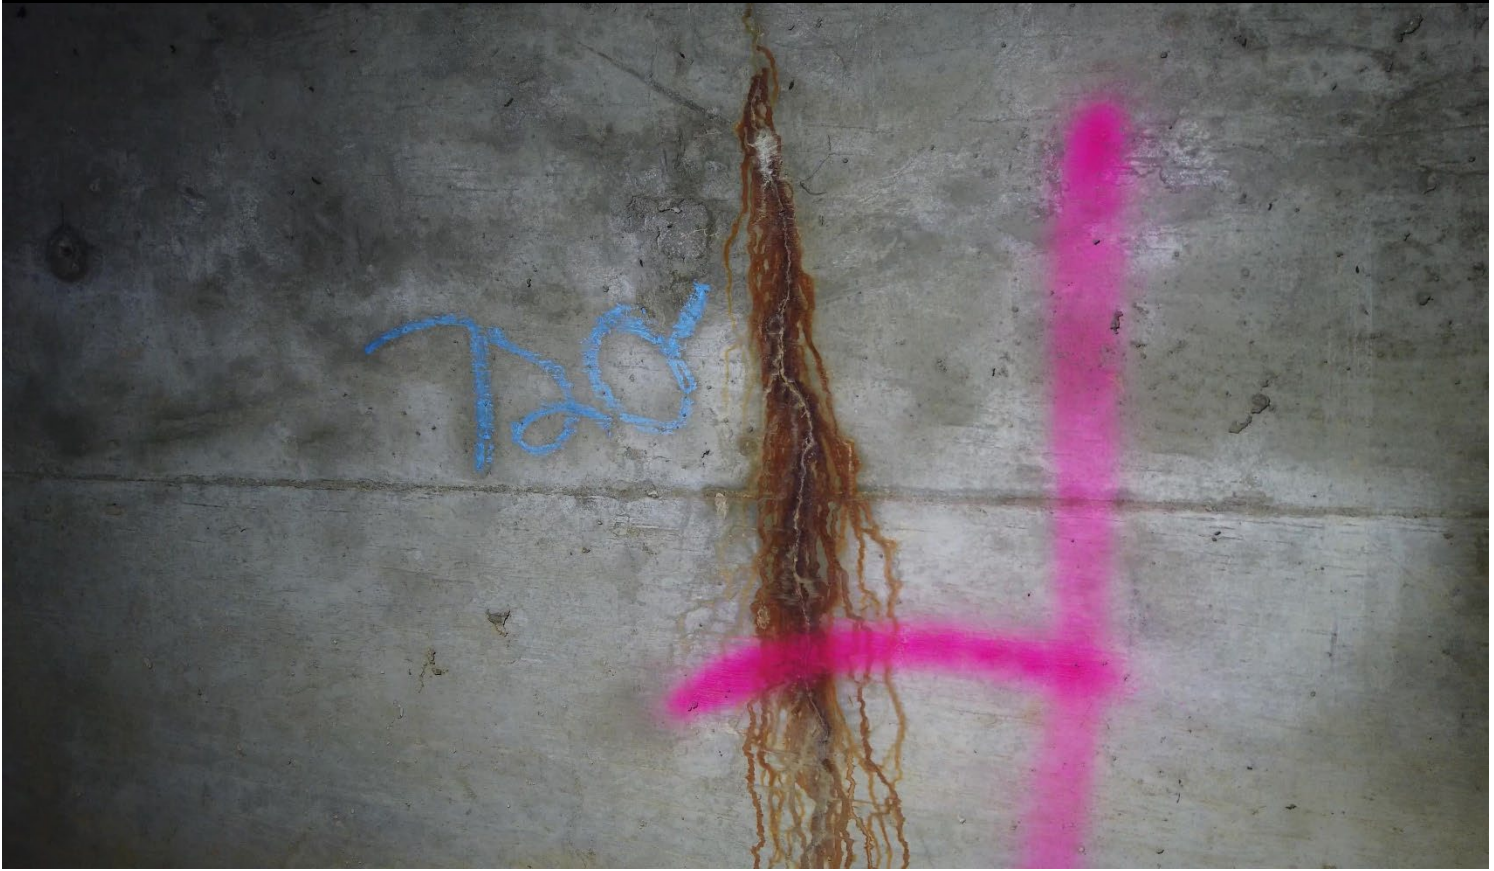
Footage	Defect Description	Top	Right	Left	Bottom
720 ft	Crack and Infiltration	Y	Y	Y

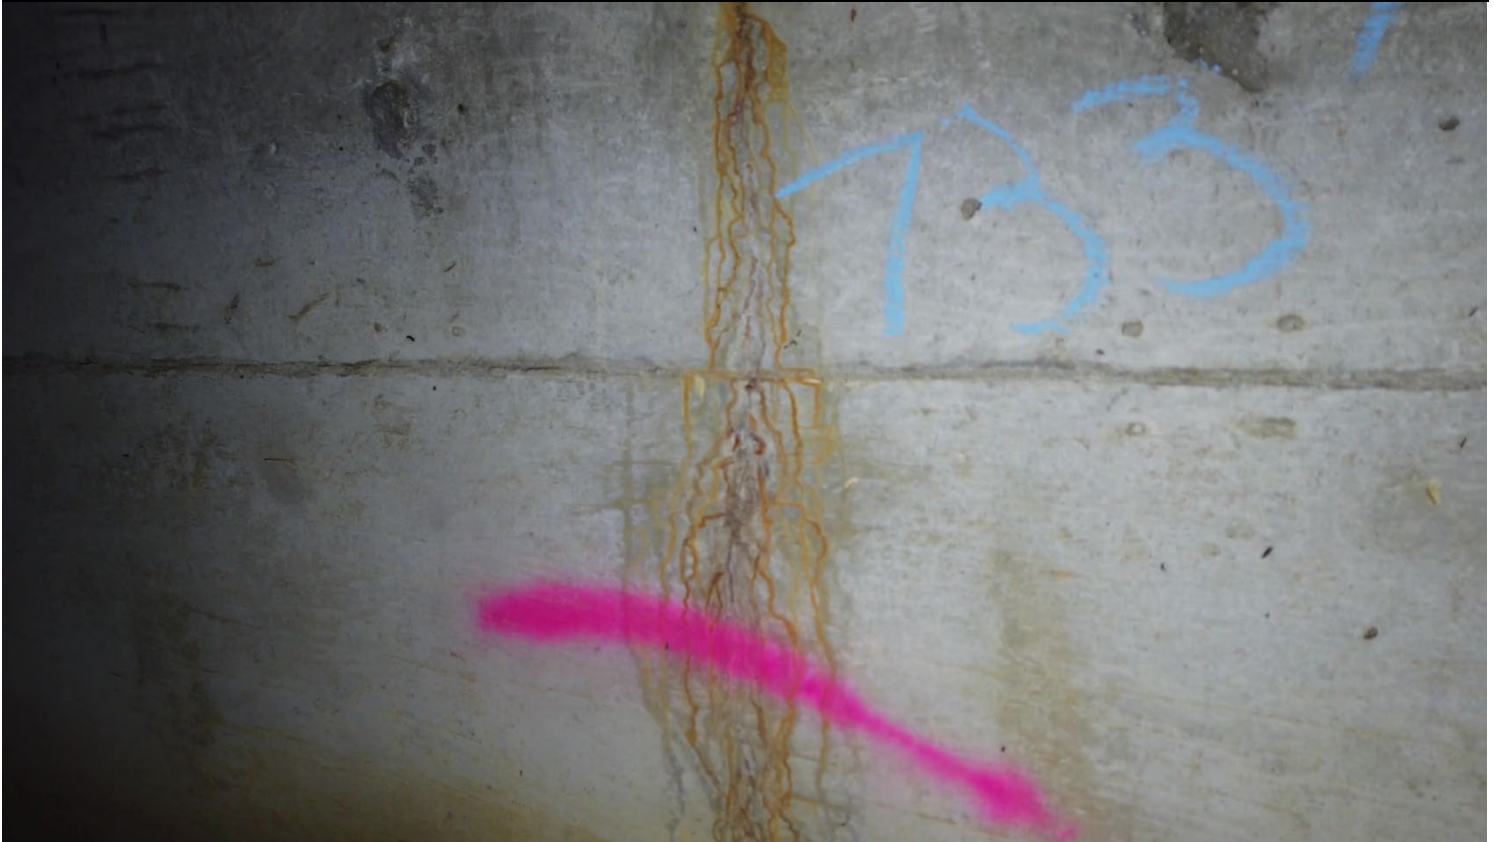
Footage	Defect Description	Top	Right	Left	Bottom
730 ft	Crack and Infiltration	Y	Y	Y

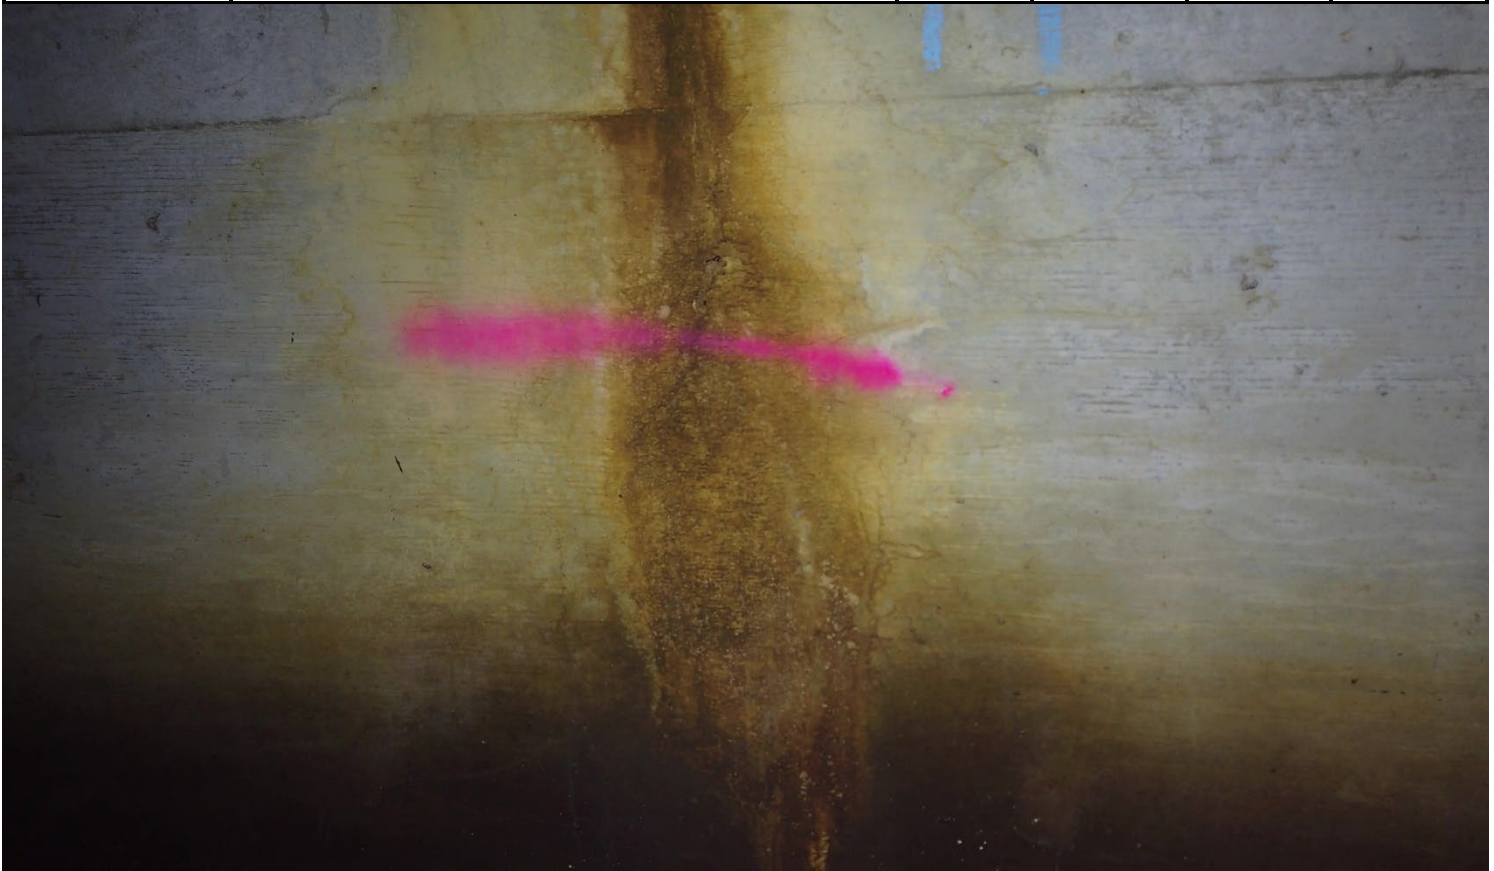
Footage	Defect Description	Top	Right	Left	Bottom
742 ft	Crack and Infiltration	Y	Y	Y

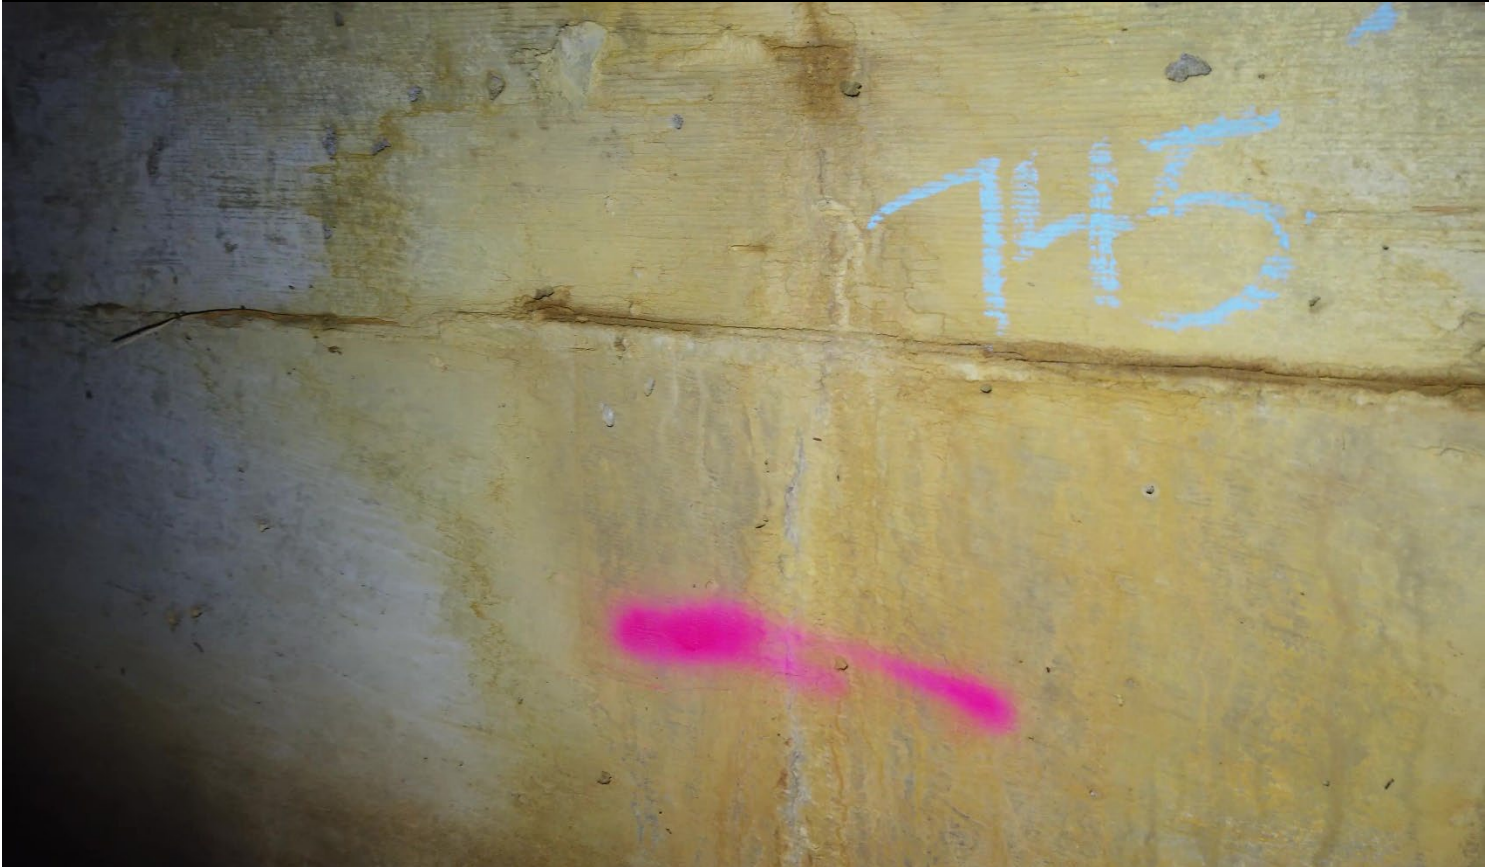
Footage	Defect Description	Top	Right	Left	Bottom
745 ft	Crack and Infiltration	Y	Y	Y

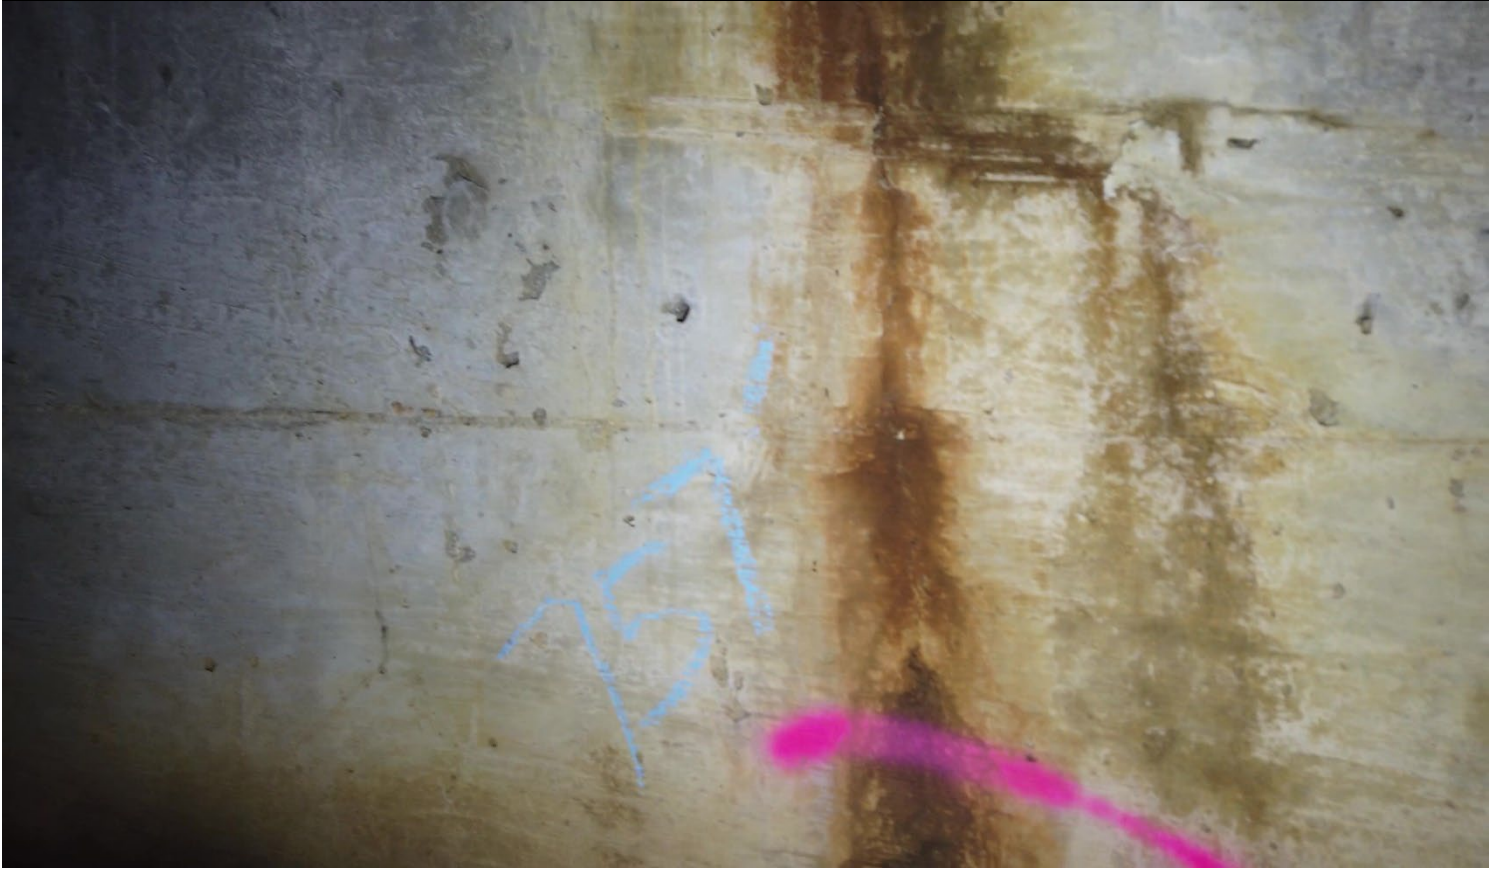
Footage	Defect Description	Top	Right	Left	Bottom
757 ft	Crack and Infiltration	Y	Y	Y

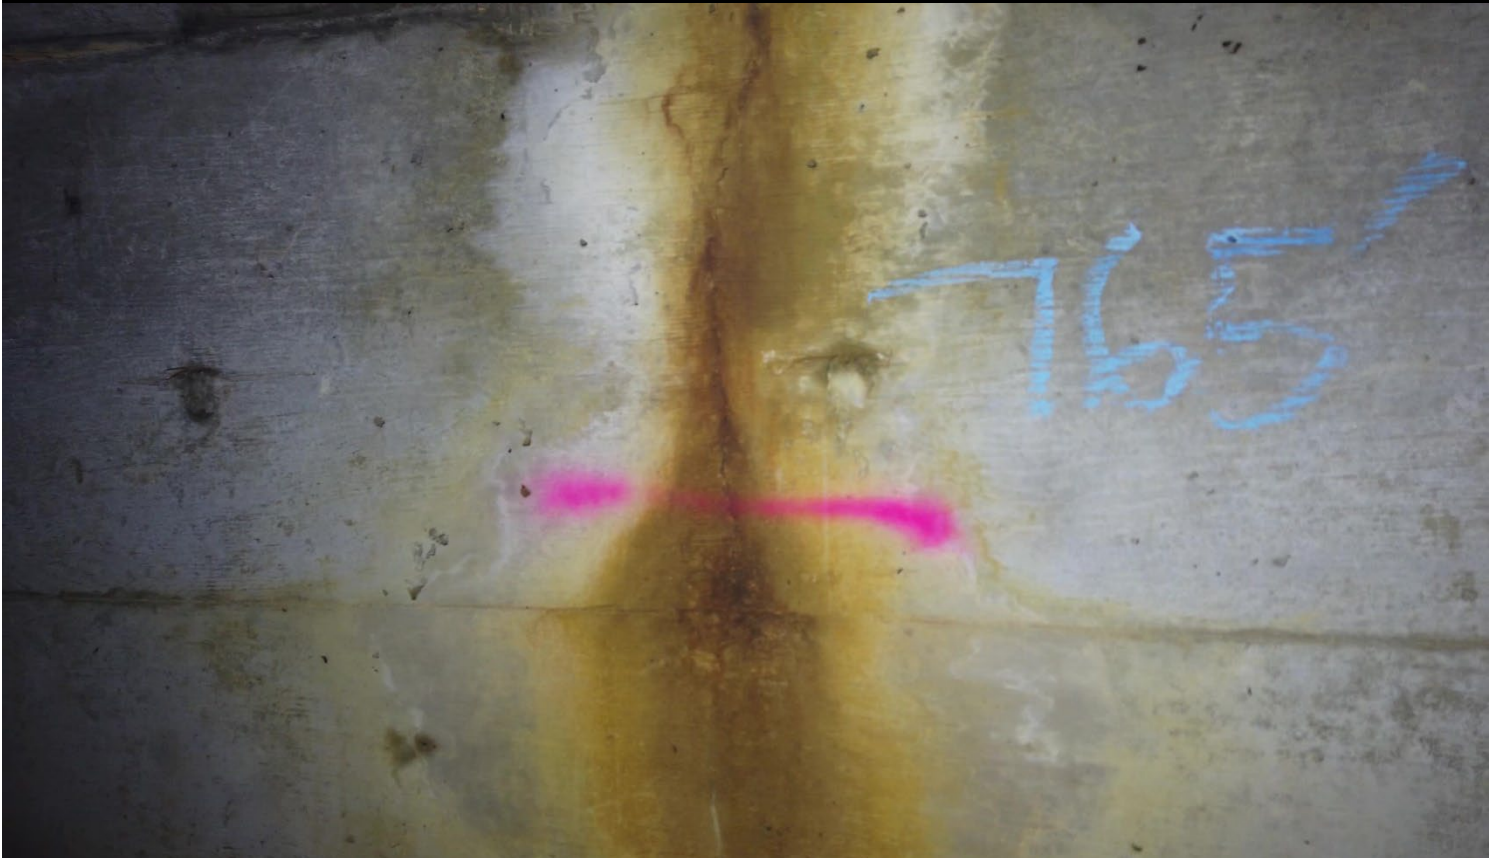
Footage	Defect Description	Top	Right	Left	Bottom
765 ft	Crack and Infiltration	Y	Y	Y

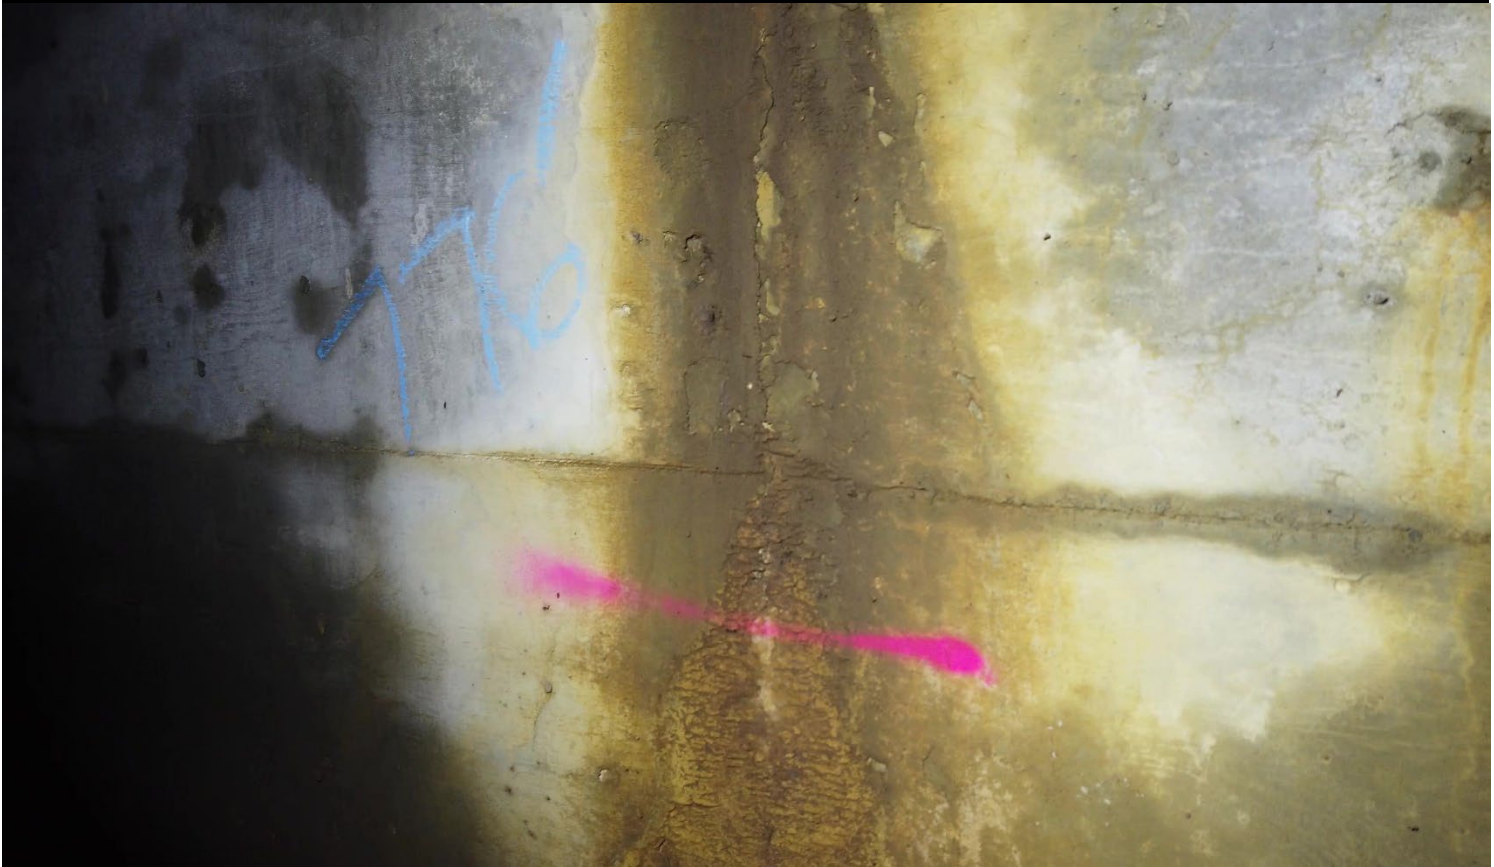
Footage	Defect Description	Top	Right	Left	Bottom
776 ft	Crack and Infiltration	Y	Y	Y

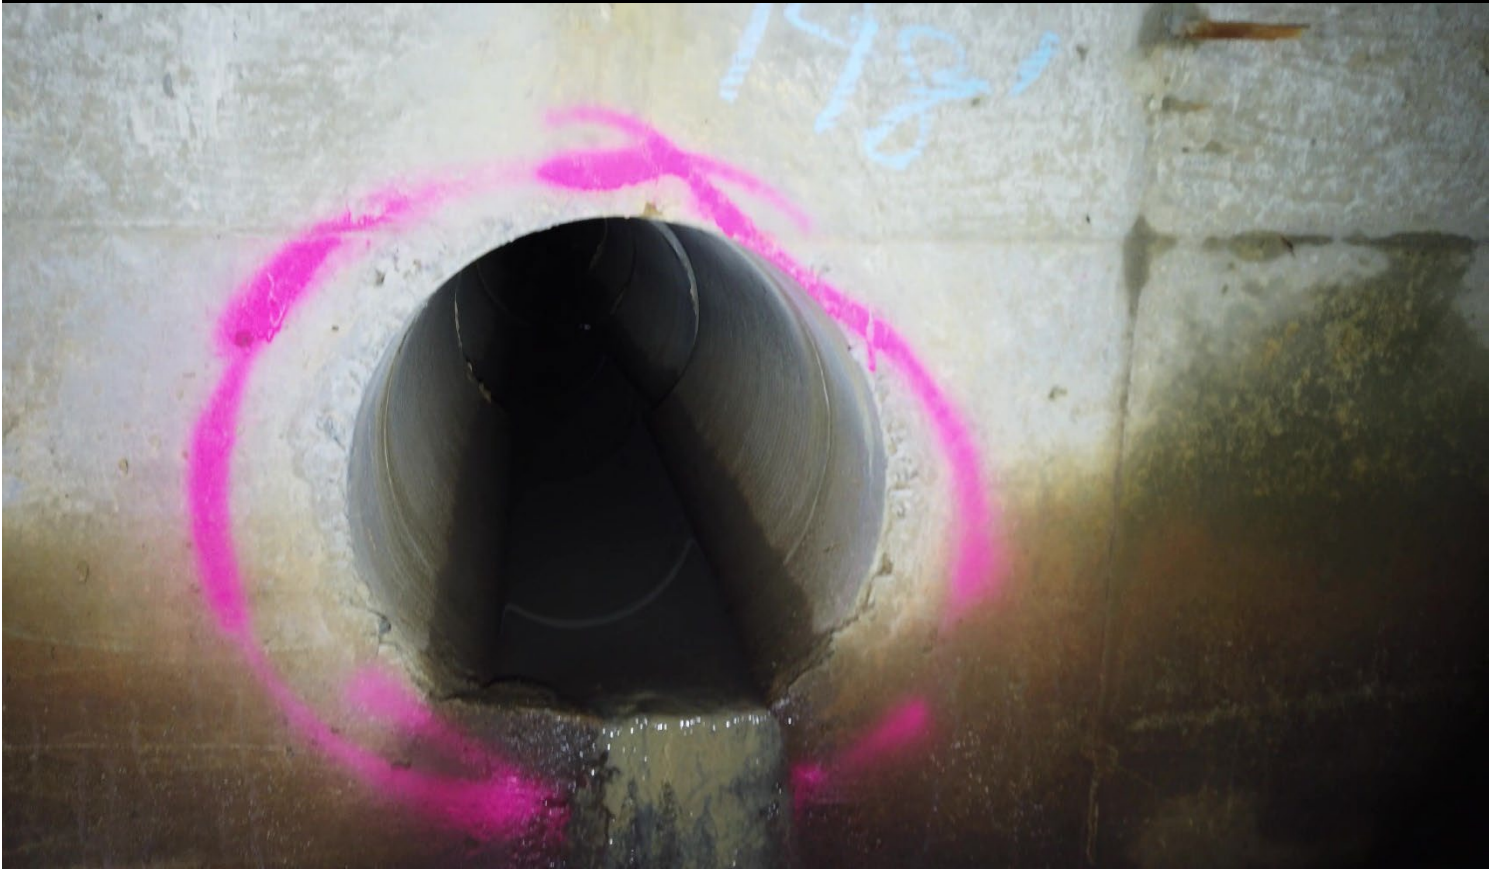
Footage	Defect Description	Top	Right	Left	Bottom
798 ft	Pipe Intersection			Y

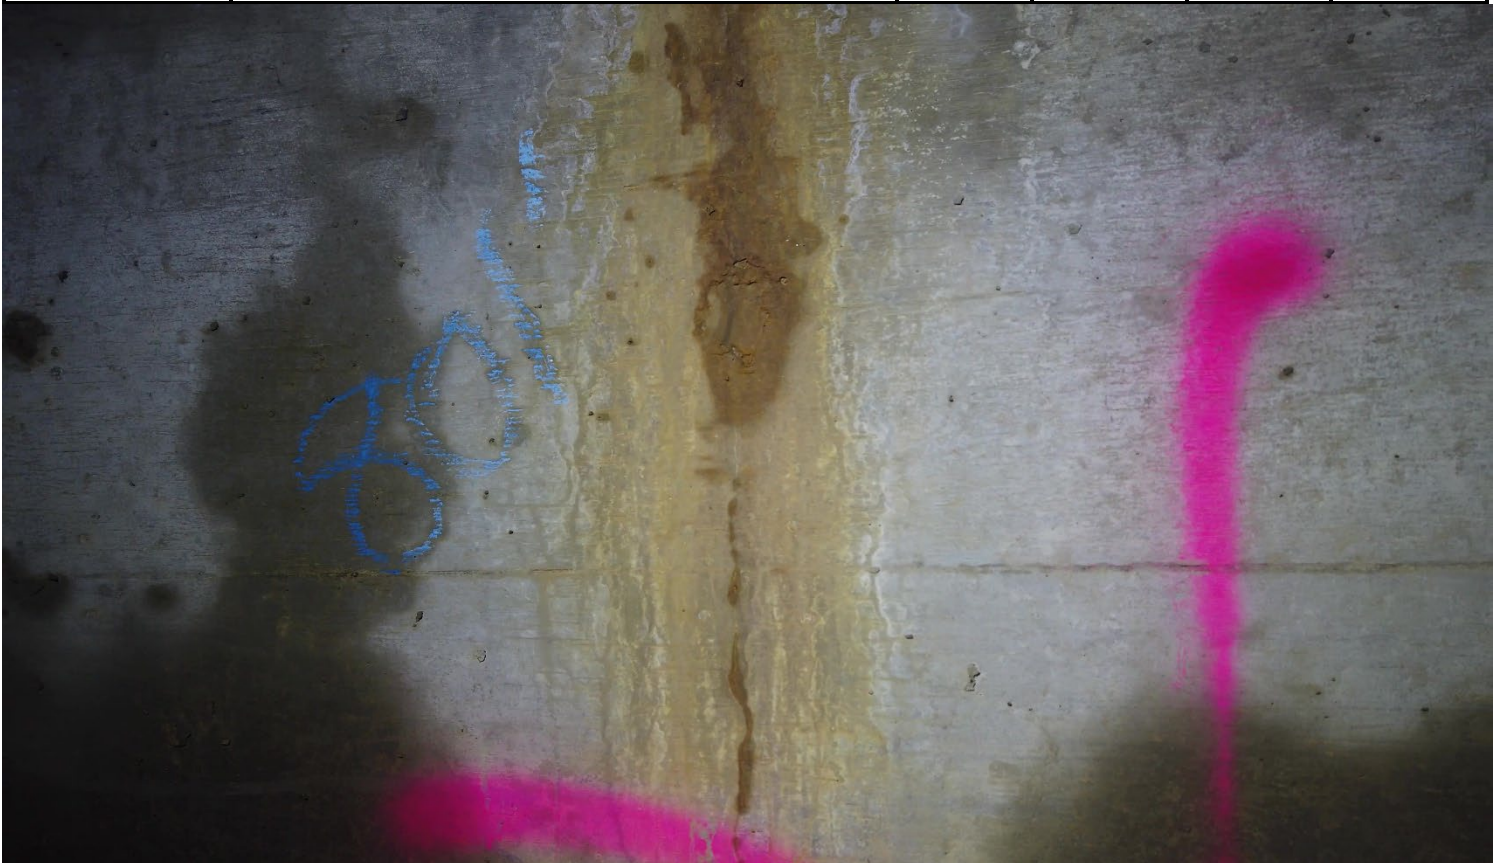
Footage	Defect Description	Top	Right	Left	Bottom
801 ft	Crack and Infiltration	Y	Y	Y

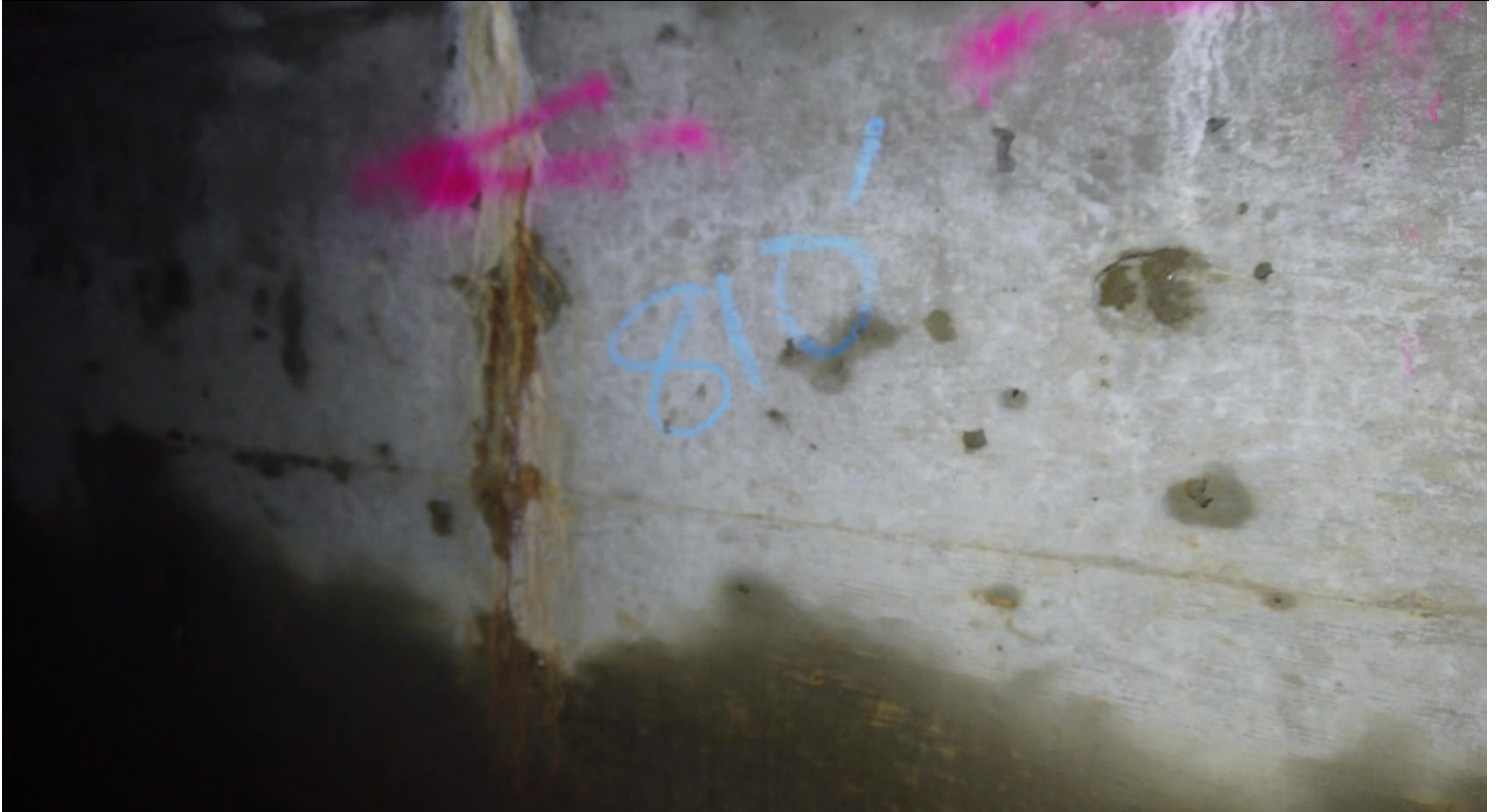
Footage	Defect Description	Top	Right	Left	Bottom
810 ft	Crack and Infiltration	Y	Y	Y
