I-26 & I-95 INTERCHANGE IMPROVEMENTS

June 29, 2023

PIPE INSPECTION REPORT

This report contains the results of the video pipe inspection and assessment of the existing storm water drainage pipes within the project area in Orangeburg and Dorchester Counties.

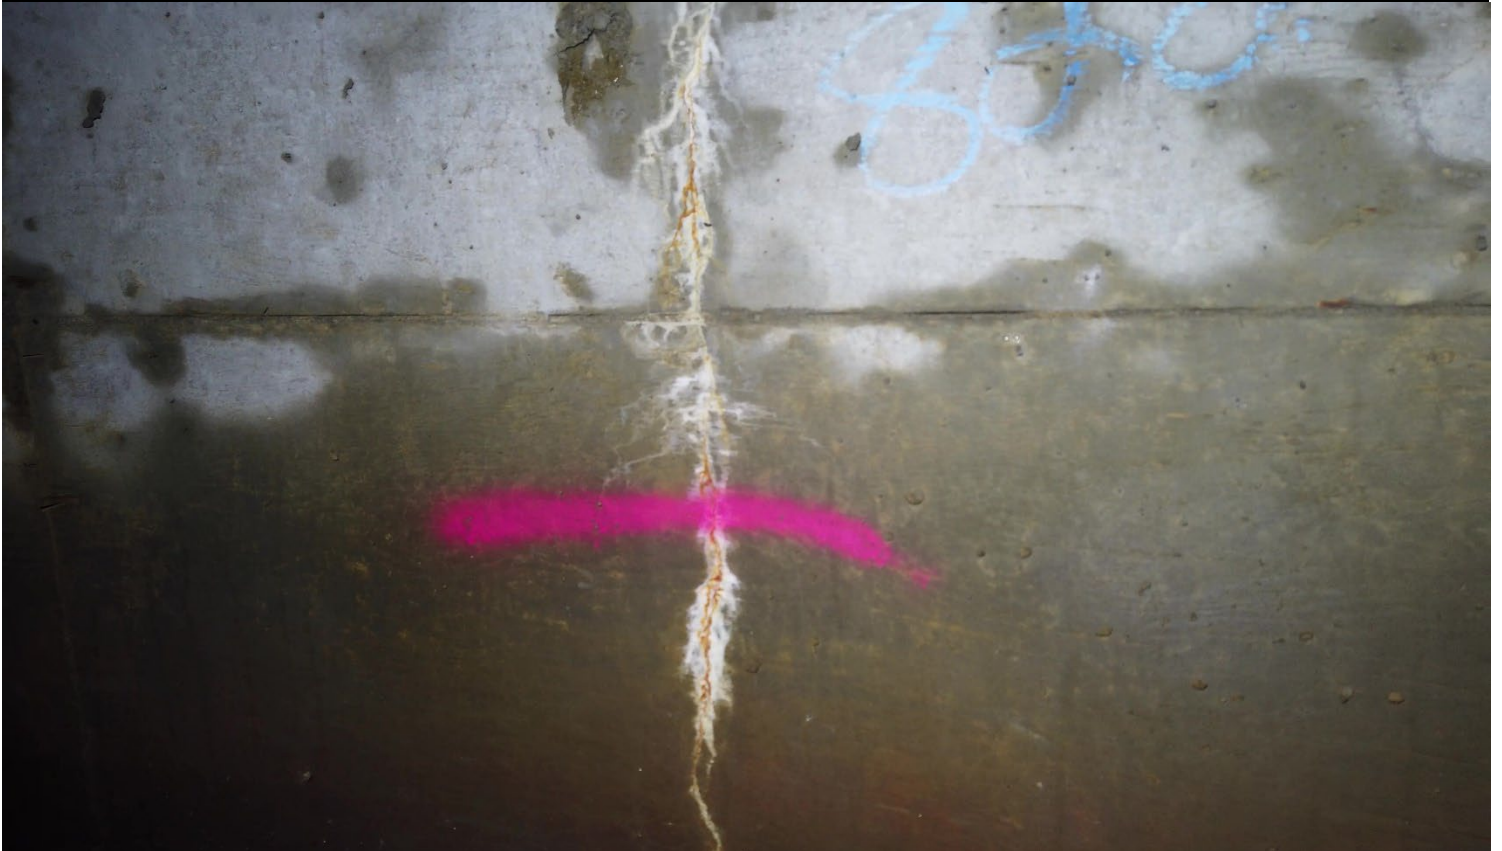
Footage	Defect Description	Top	Right	Left	Bottom
822 ft	Crack and Infiltration	Y	Y	Y

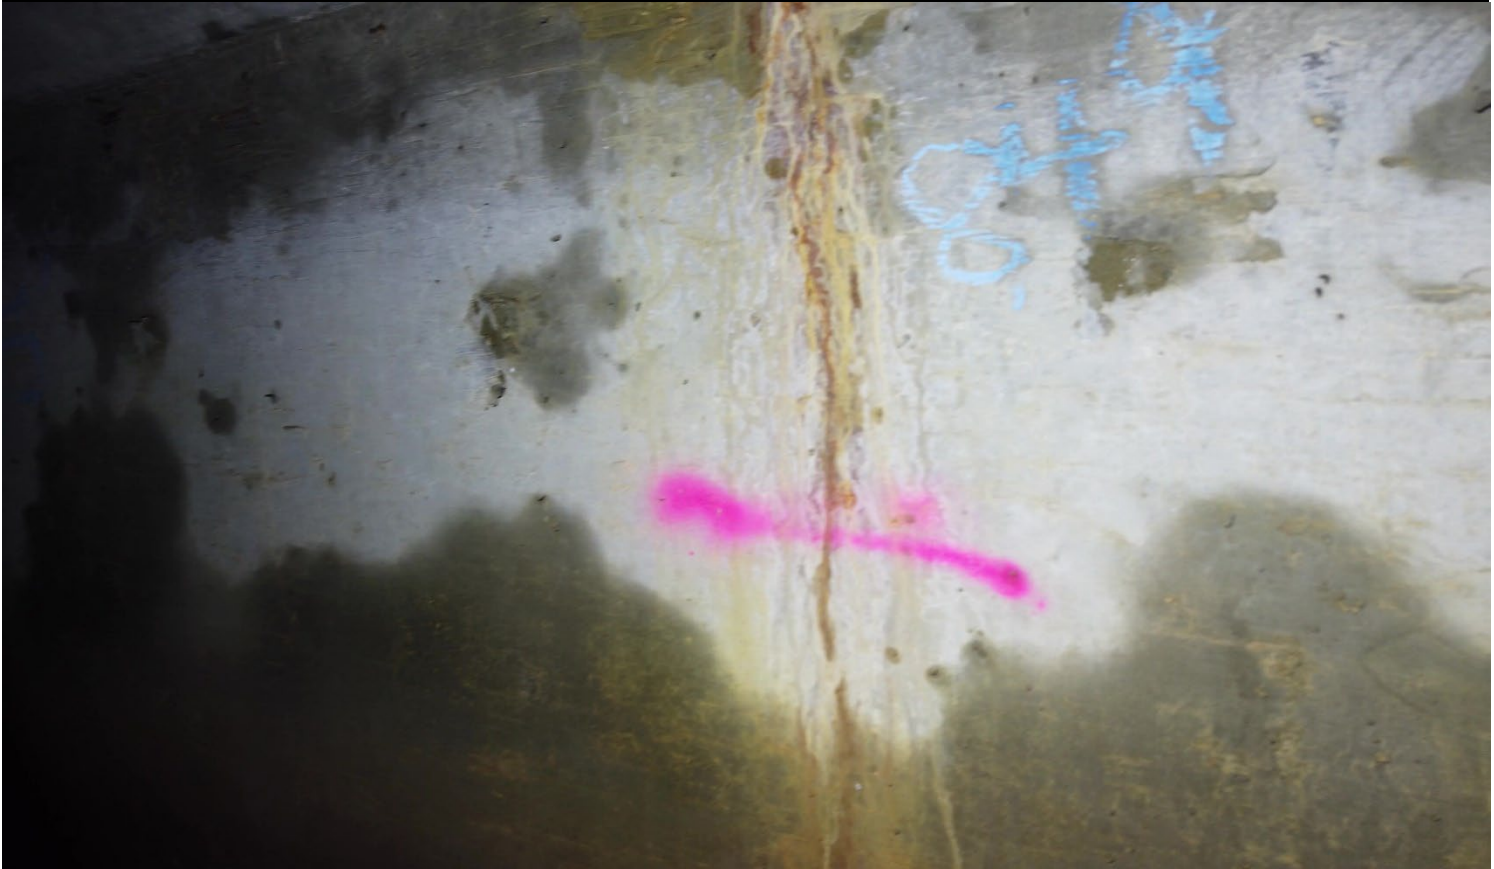
Footage	Defect Description	Top	Right	Left	Bottom
849 ft	Crack and Infiltration	Y	Y	Y

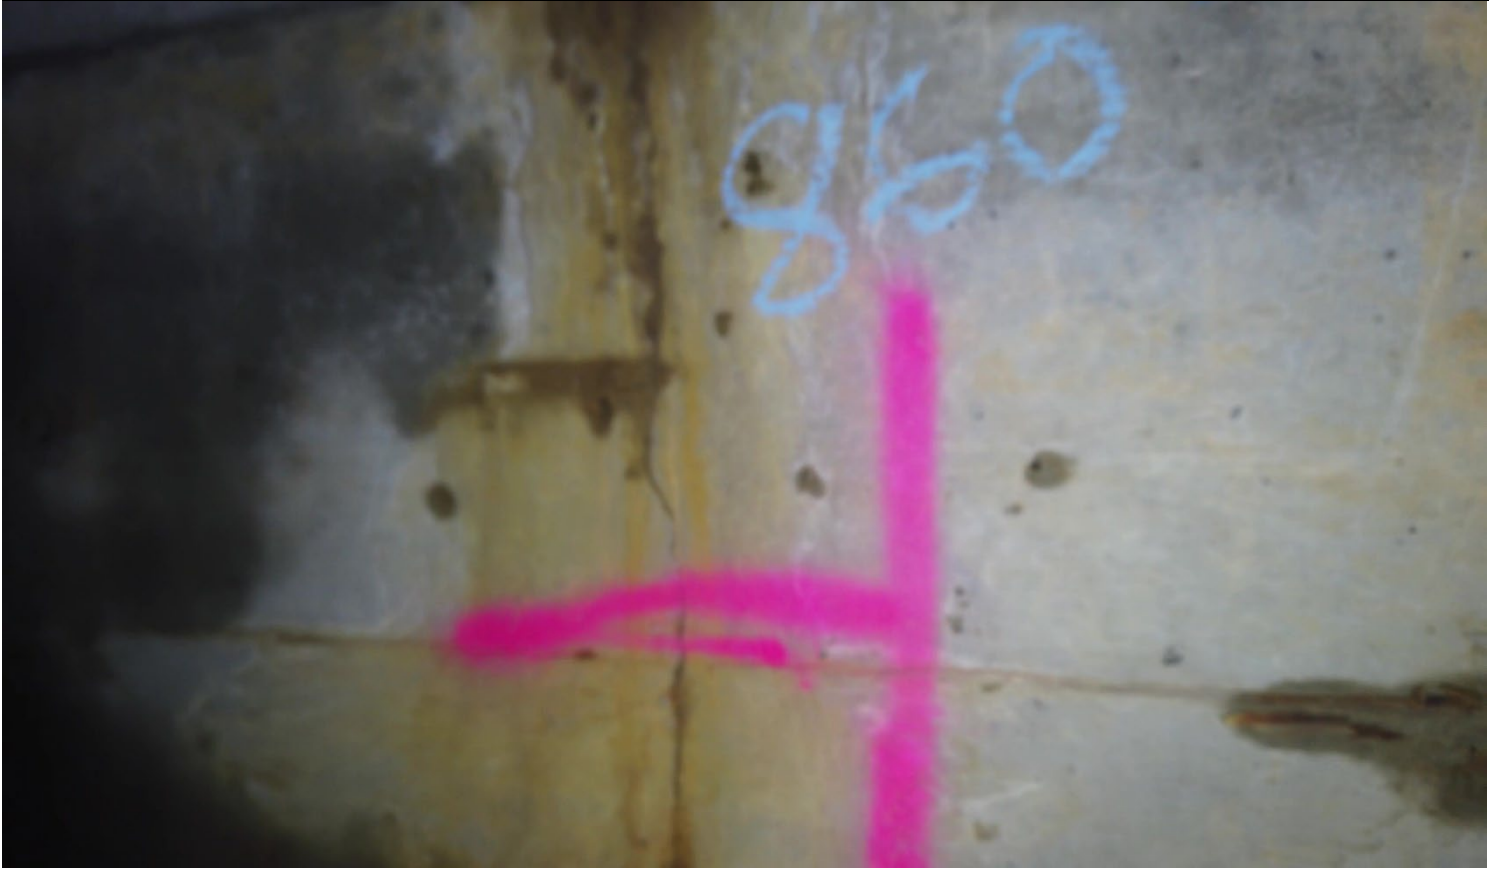
Footage	Defect Description	Top	Right	Left	Bottom
860 ft	Crack and Infiltration	Y	Y	Y

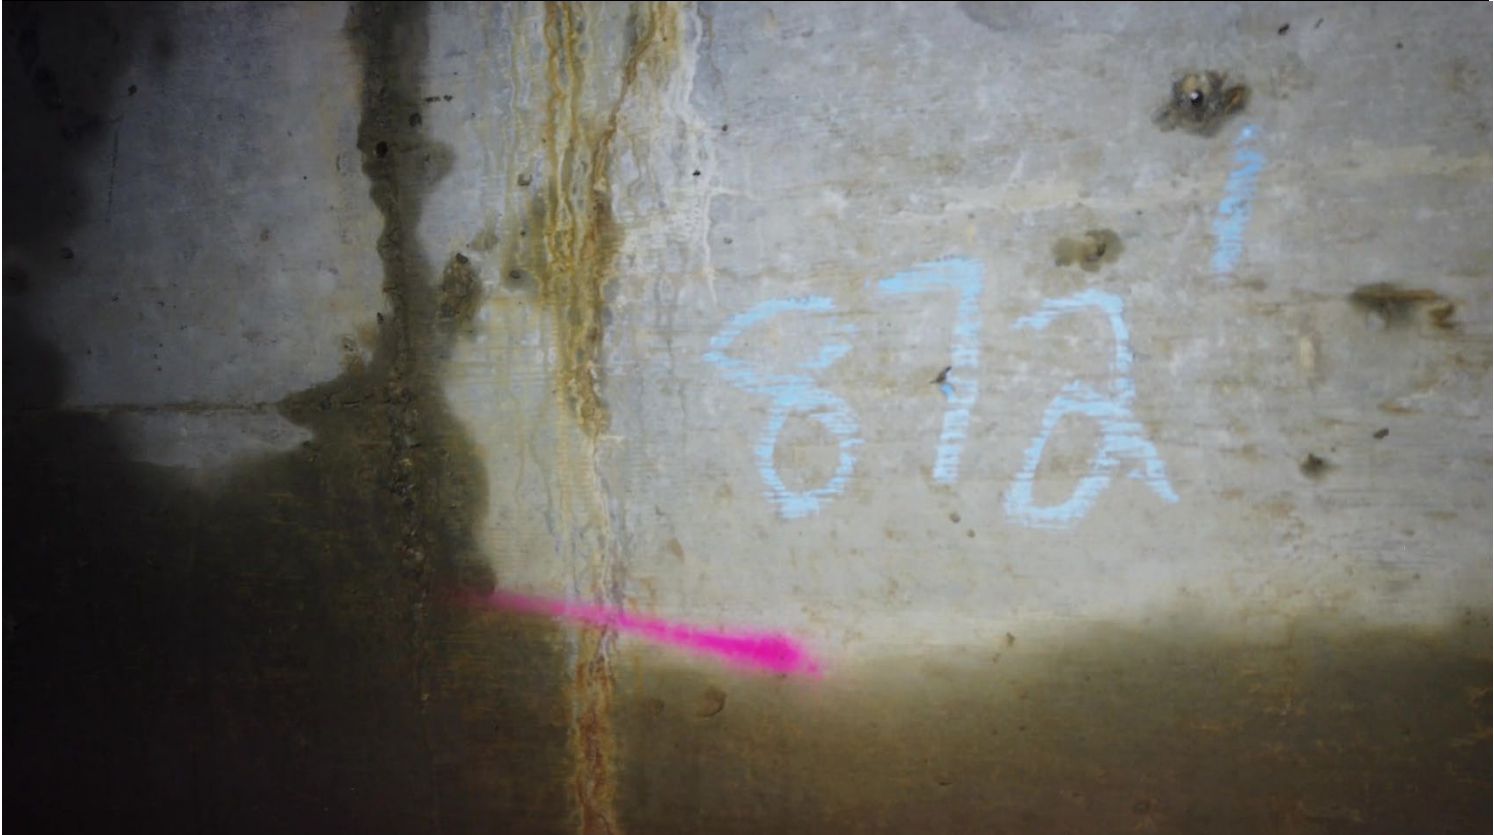
Footage	Defect Description	Top	Right	Left	Bottom
872 ft	Crack and Infiltration	Y	Y	Y

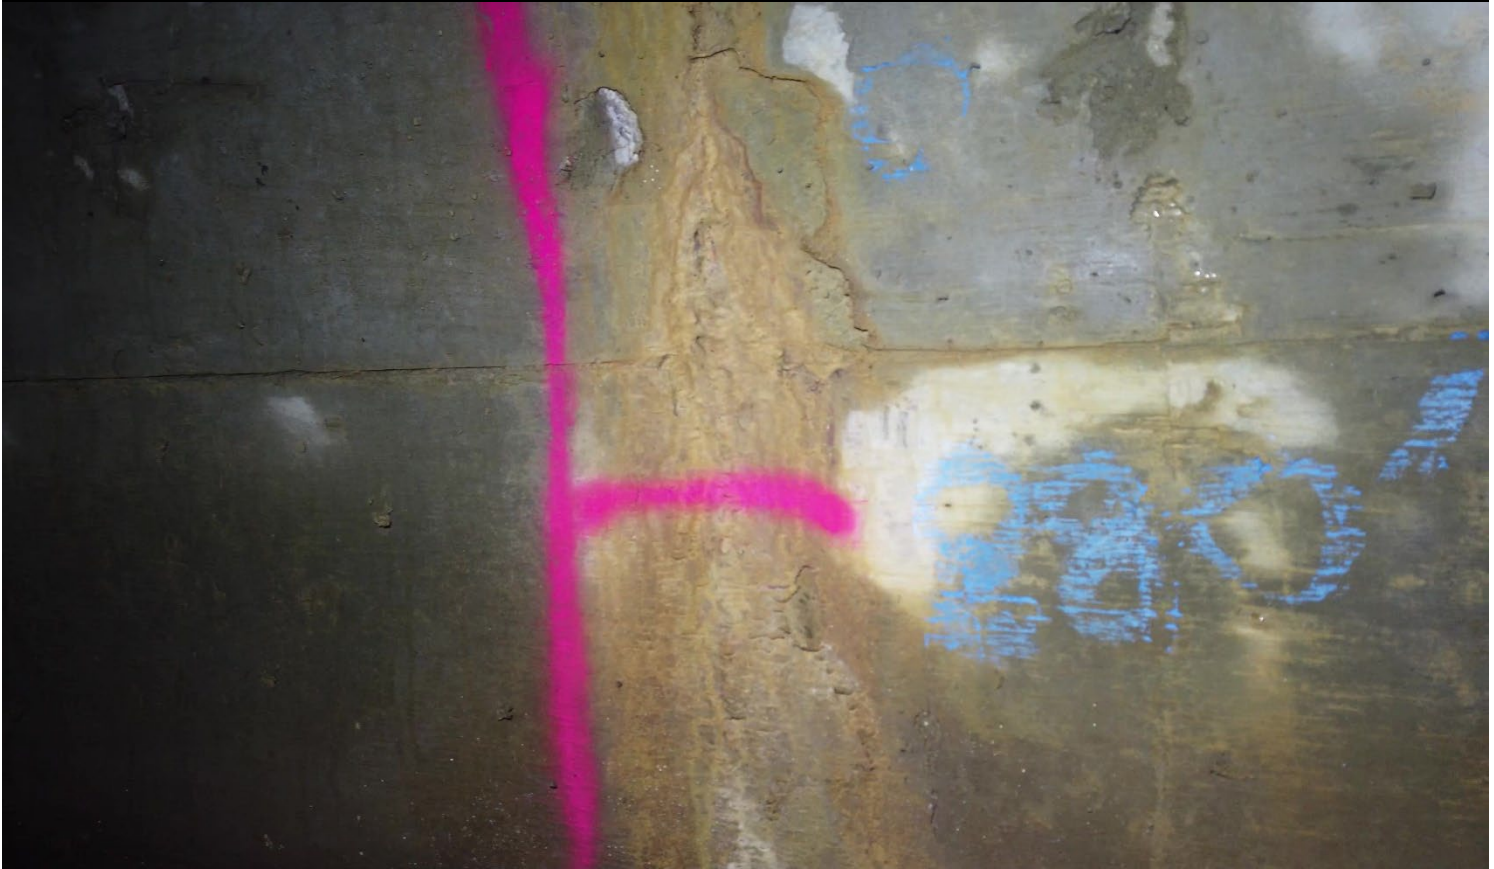
Footage	Defect Description	Top	Right	Left	Bottom
880 ft	Crack and Infiltration	Y	Y	Y

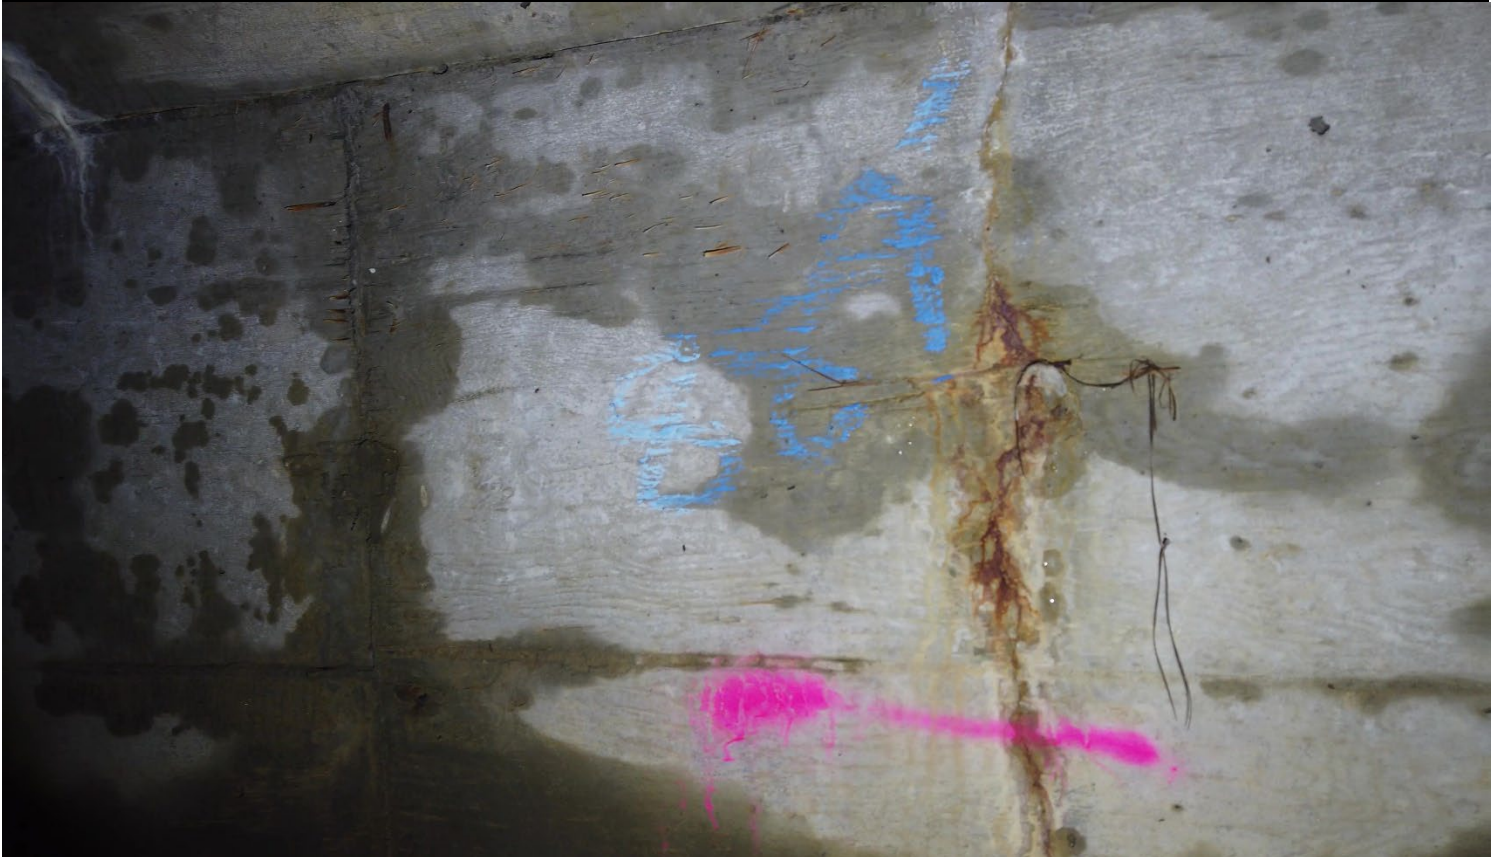
Footage	Defect Description	Top	Right	Left	Bottom
889 ft	Crack and Infiltration	Y	Y	Y

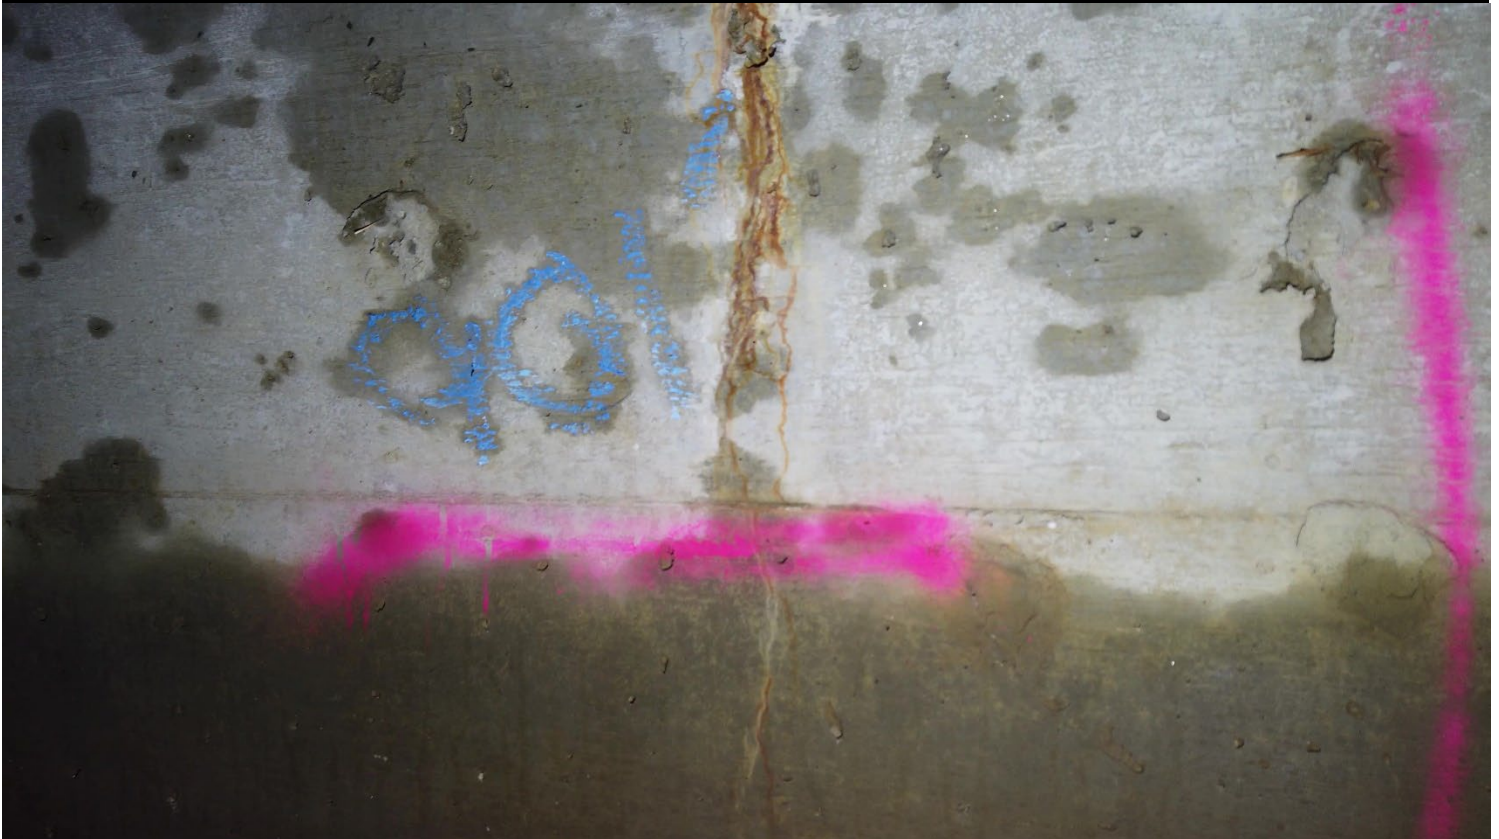
Footage	Defect Description	Top	Right	Left	Bottom
901 ft	Crack and Infiltration	Y	Y	Y

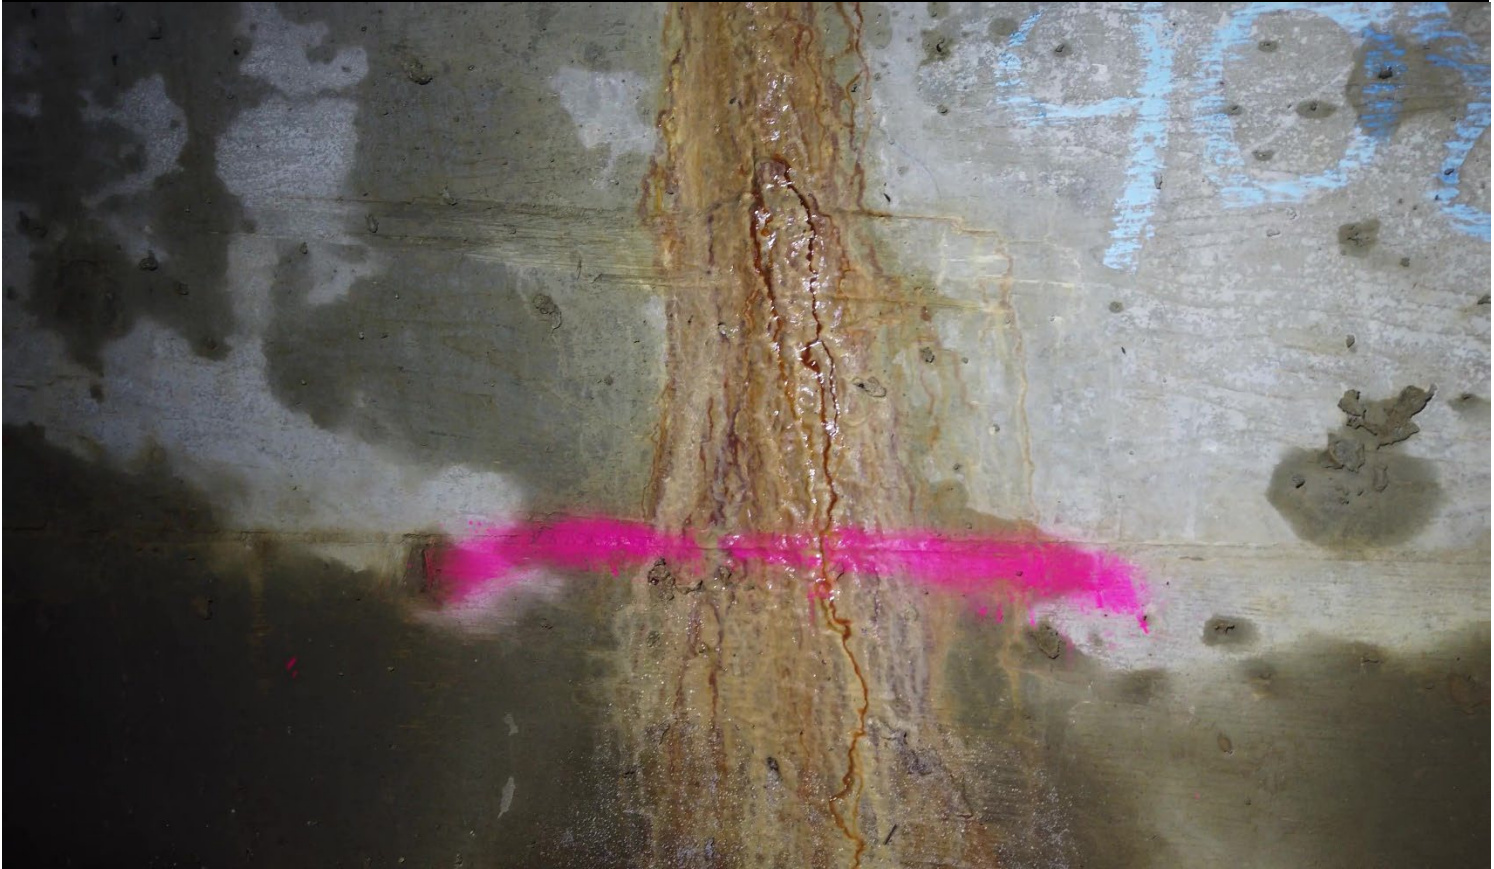
Footage	Defect Description	Top	Right	Left	Bottom
908 ft	Crack and Infiltration	Y	Y	Y

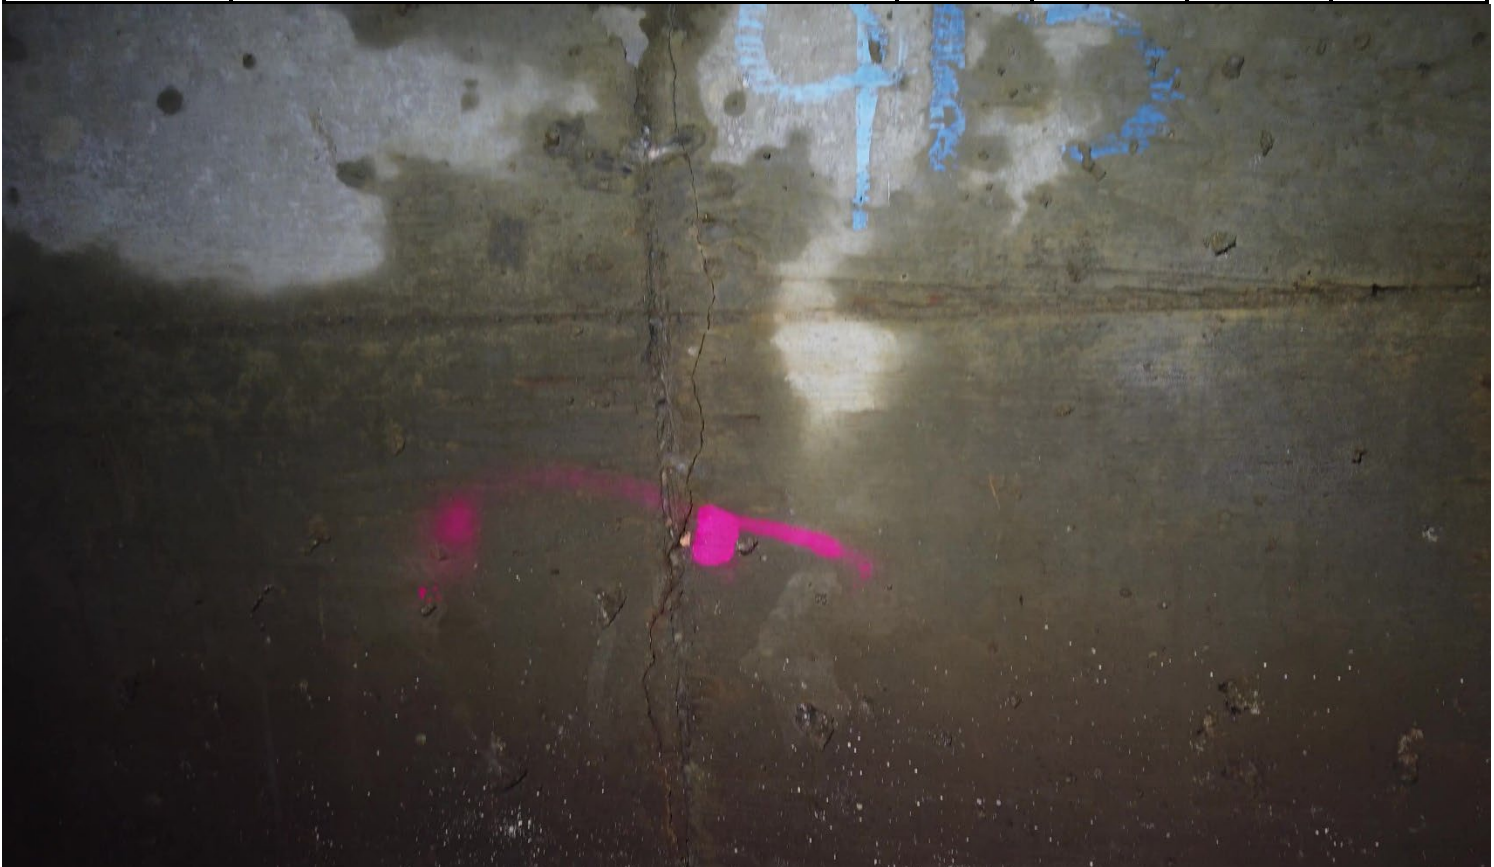
Footage	Defect Description	Top	Right	Left	Bottom
913 ft	Crack		Y

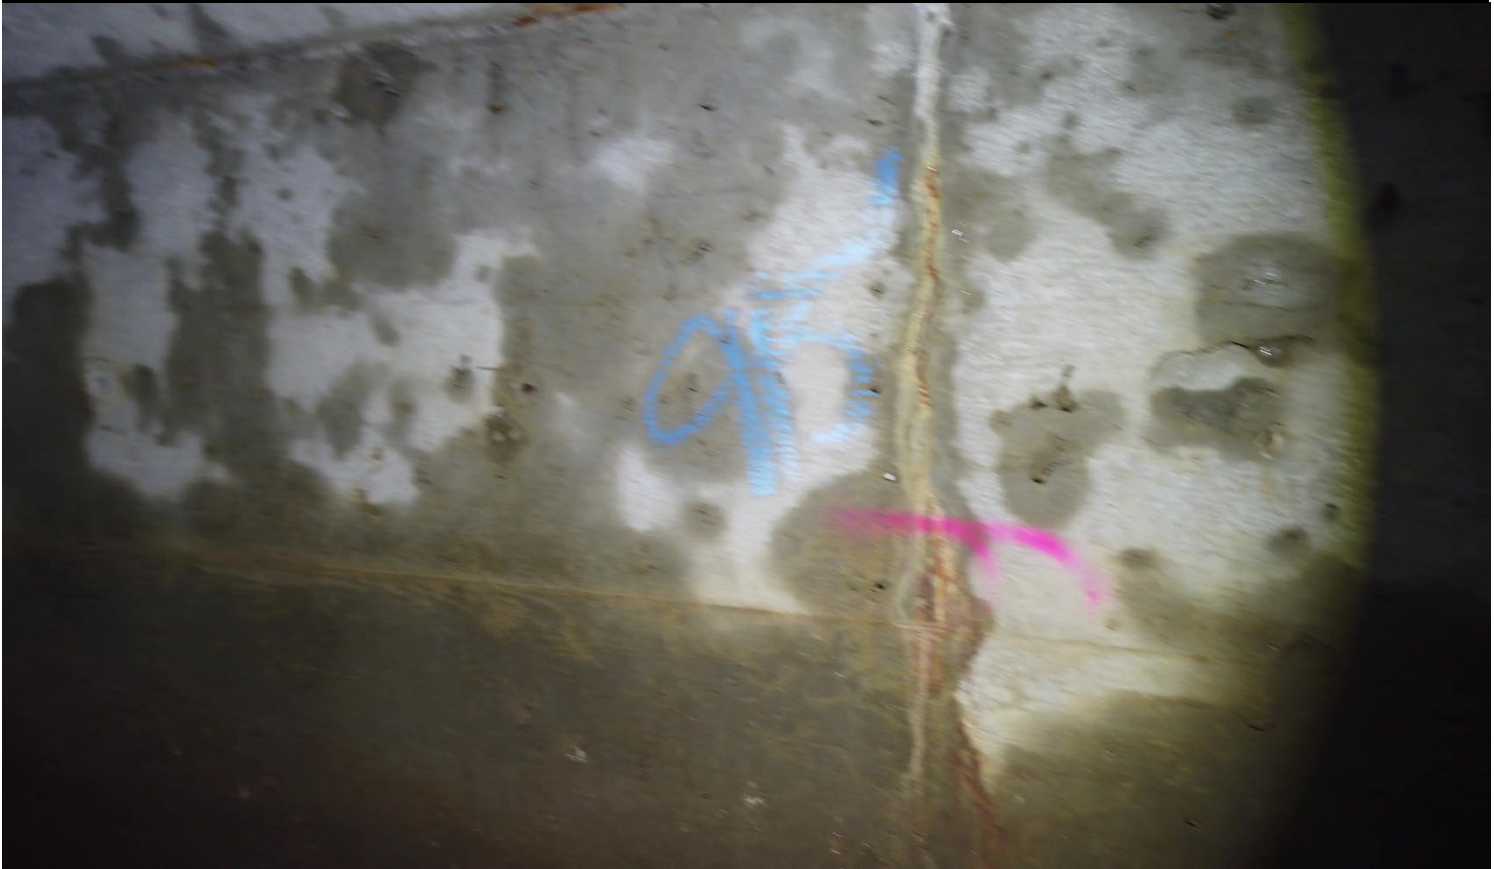
Footage	Defect Description	Top	Right	Left	Bottom
915 ft	Crack and Infiltration	Y	Y	Y

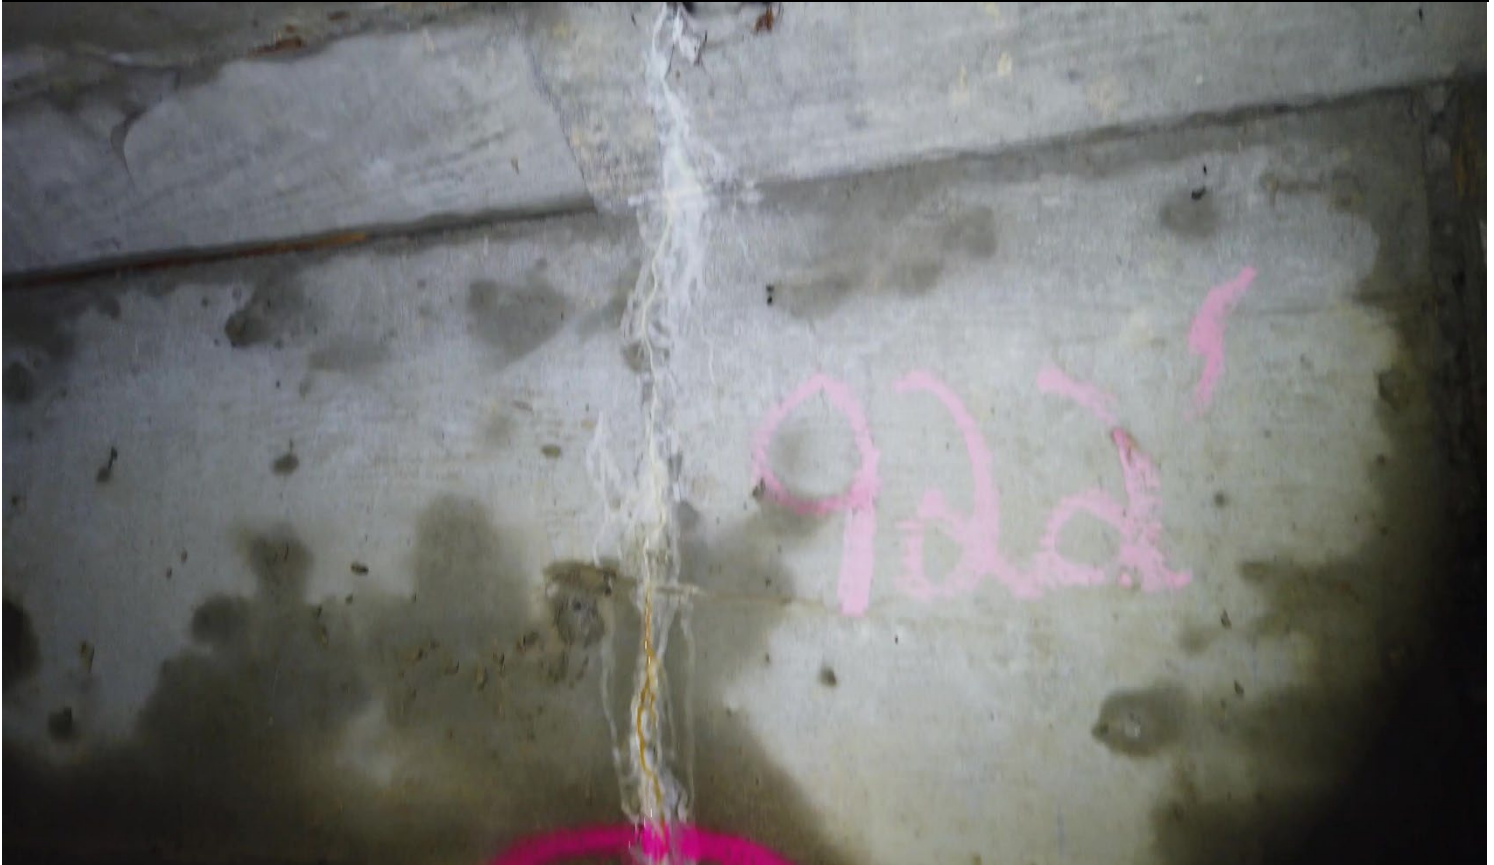
Footage	Defect Description	Top	Right	Left	Bottom
922 ft	Crack and Infiltration	Y	Y	Y

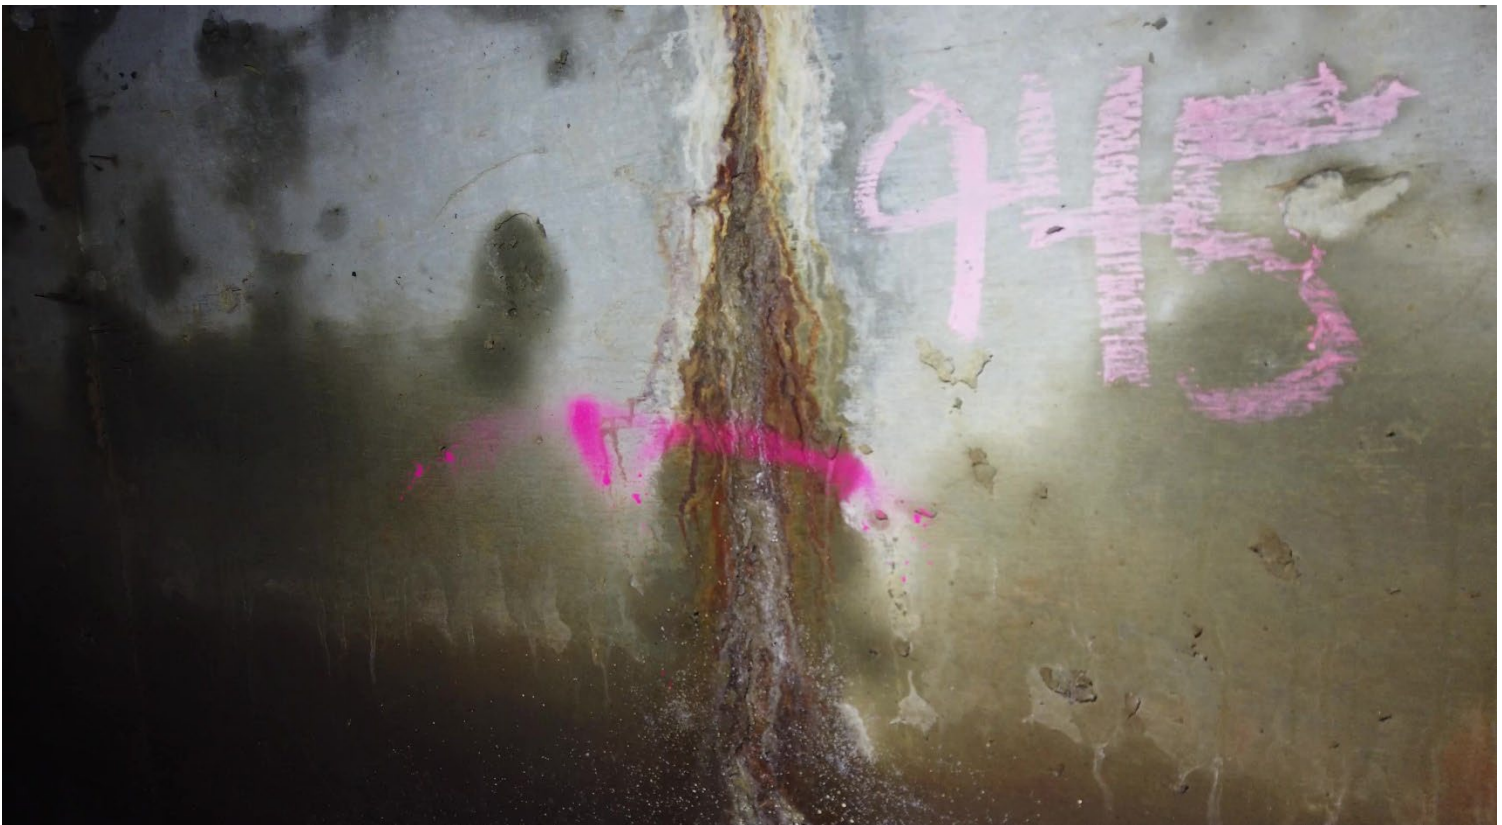
Footage	Defect Description	Top	Right	Left	Bottom
945 ft	Crack and Infiltration	Y	Y	Y

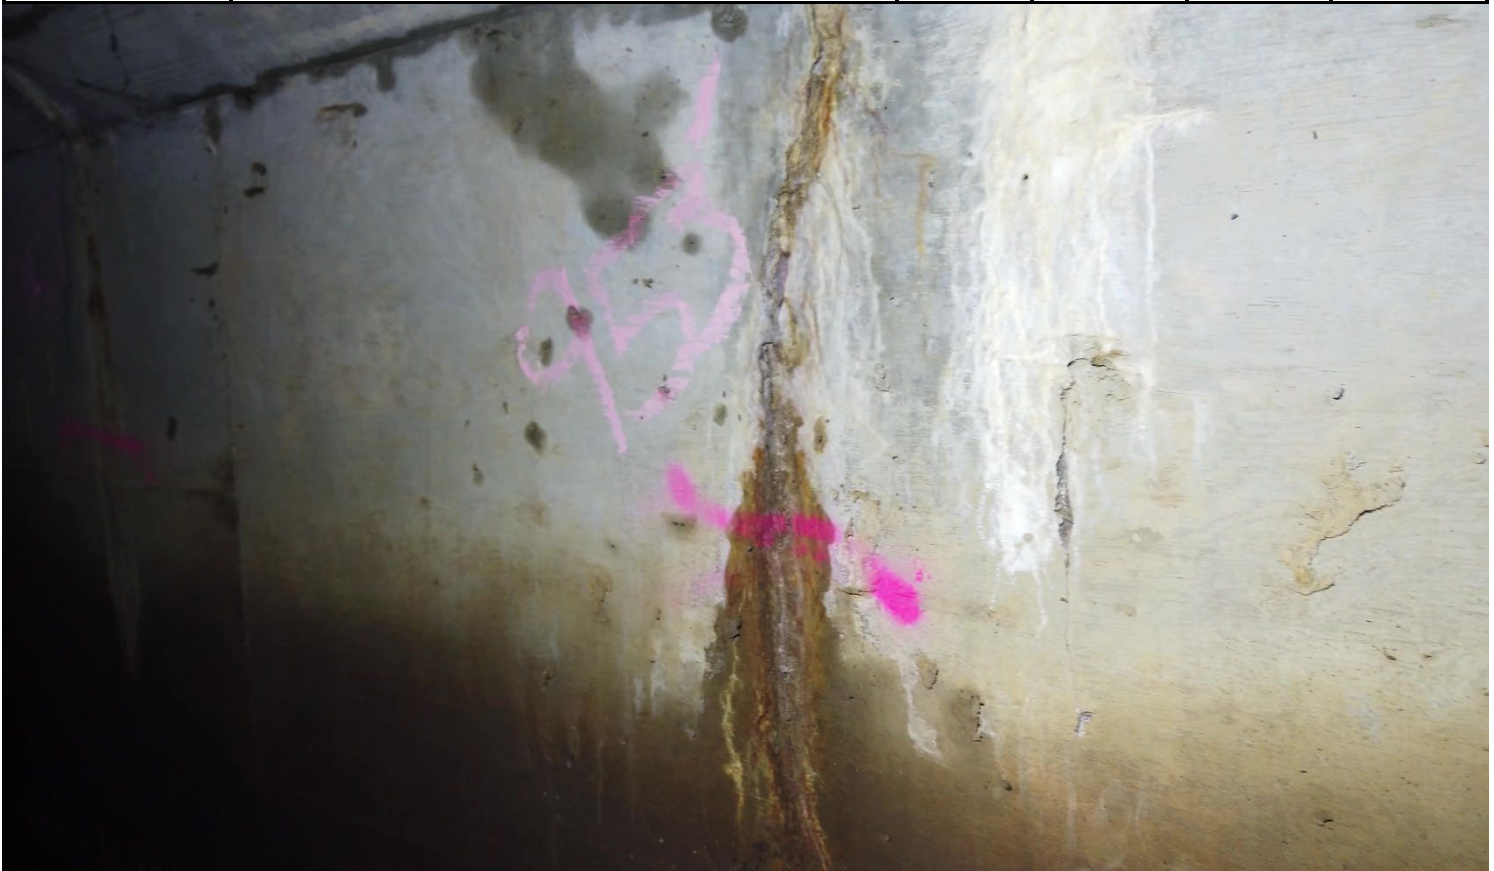
Footage	Defect Description	Top	Right	Left	Bottom
953 ft	Crack and Infiltration	Y	Y	Y

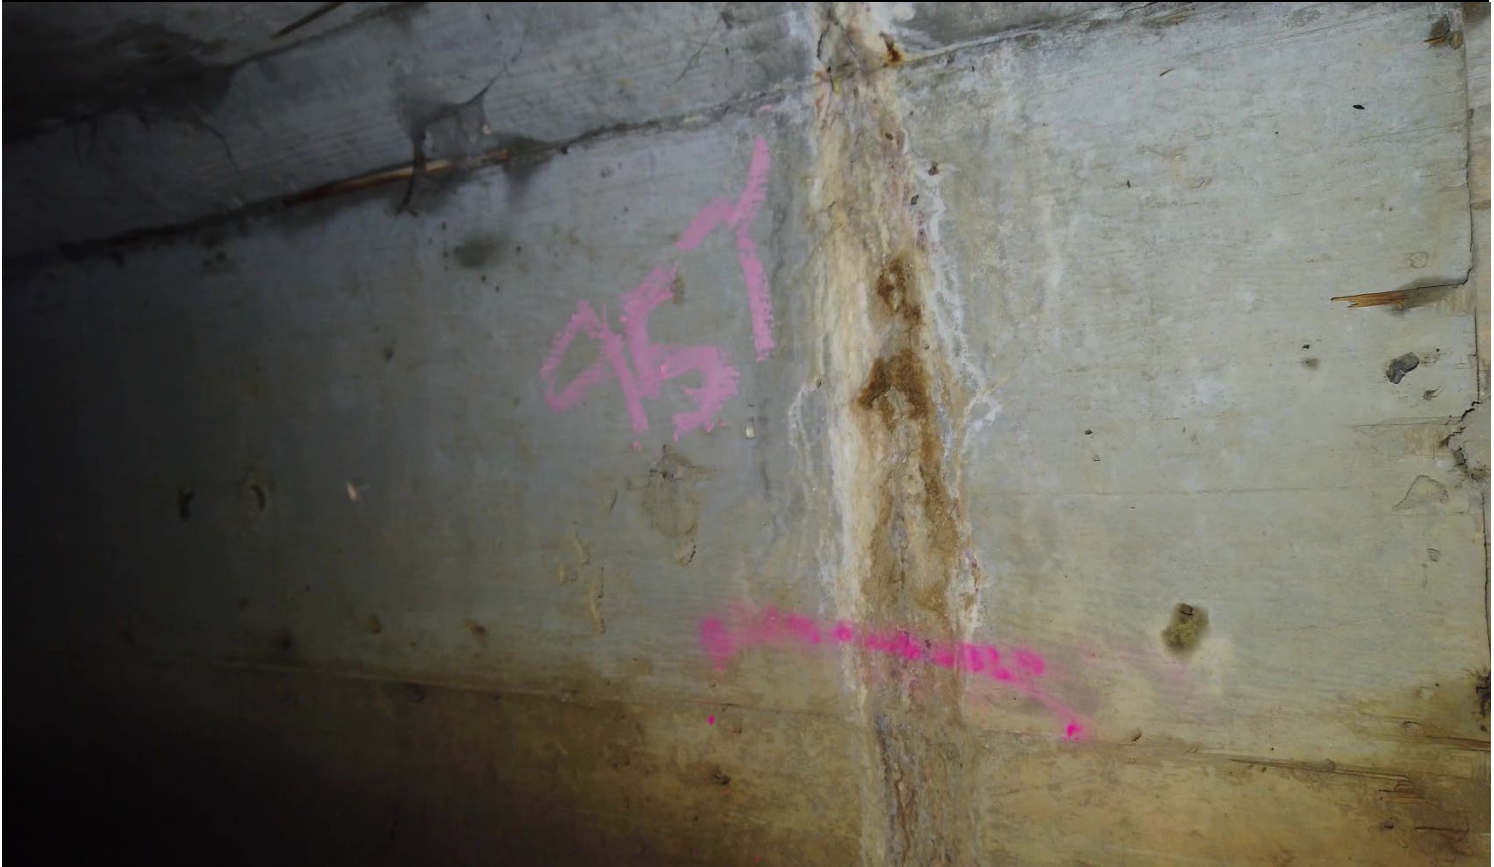
Footage	Defect Description	Top	Right	Left	Bottom
957 ft	Crack and Infiltration	Y	Y	Y

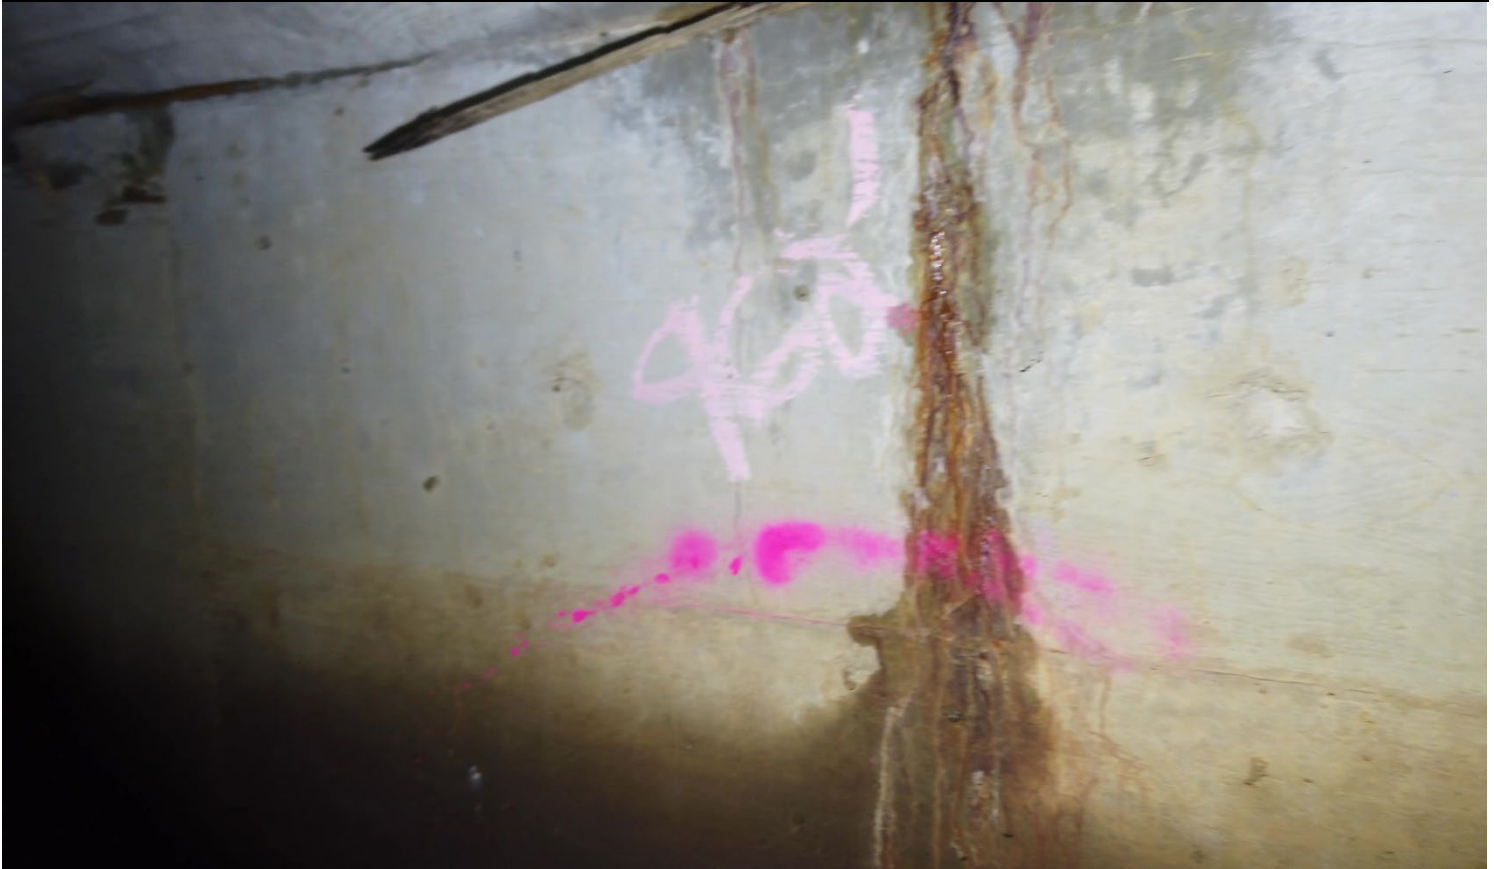
Footage	Defect Description	Top	Right	Left	Bottom
962 ft	Crack and Infiltration	Y	Y	Y

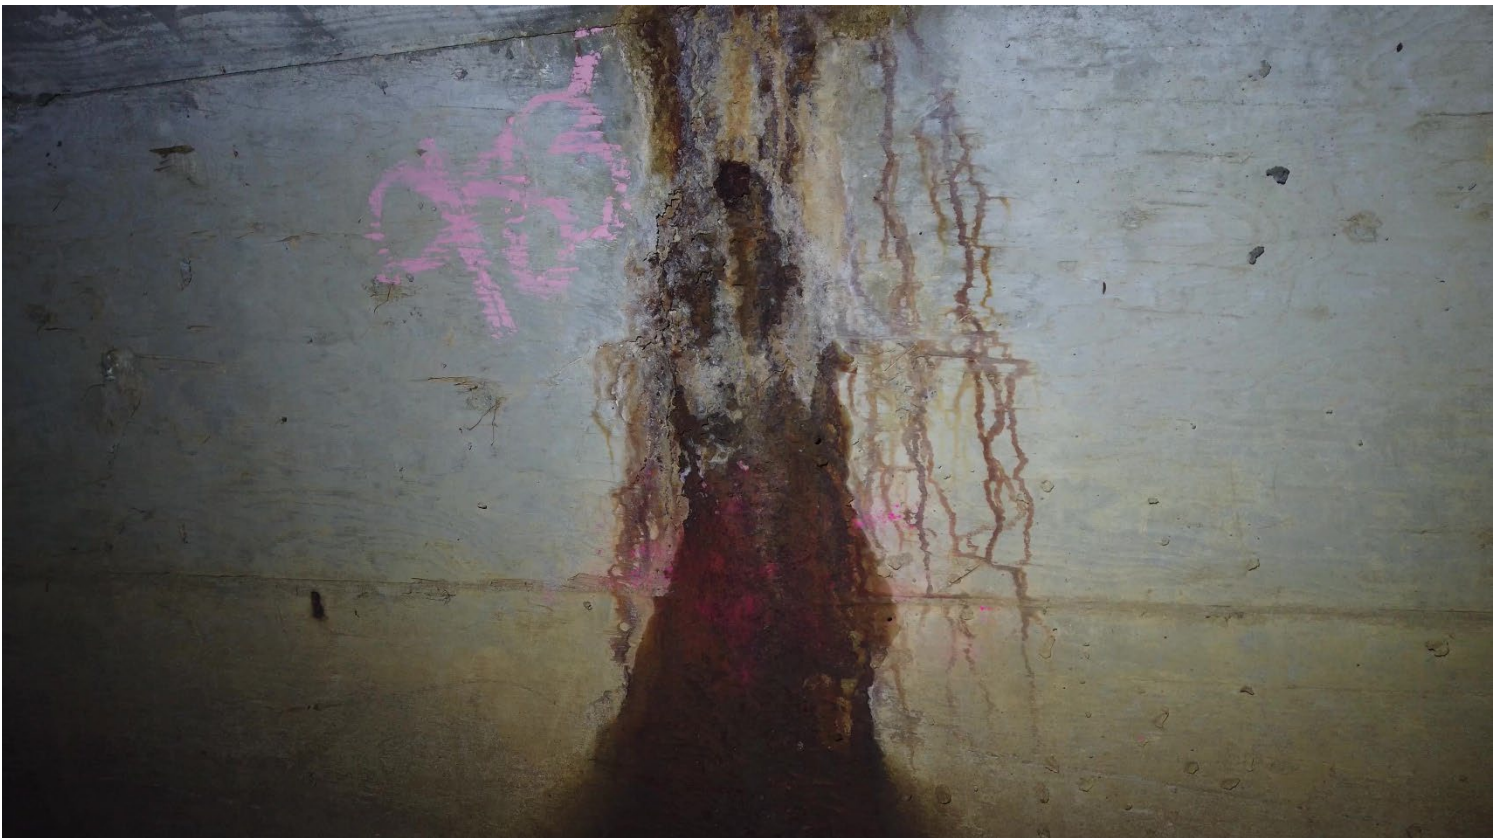
Footage	Defect Description	Top	Right	Left	Bottom
983 ft	Crack and Infiltration	Y	Y	Y

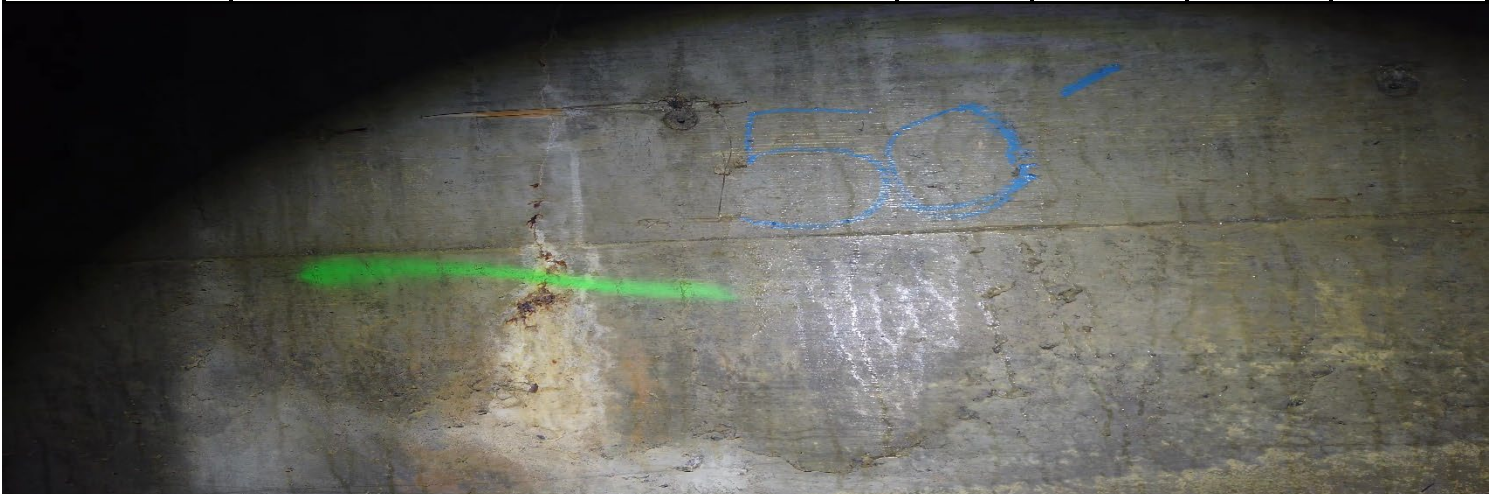
Footage	Defect Description	Top	Right	Left	Bottom
50 ft	Crack and Infiltration		Y

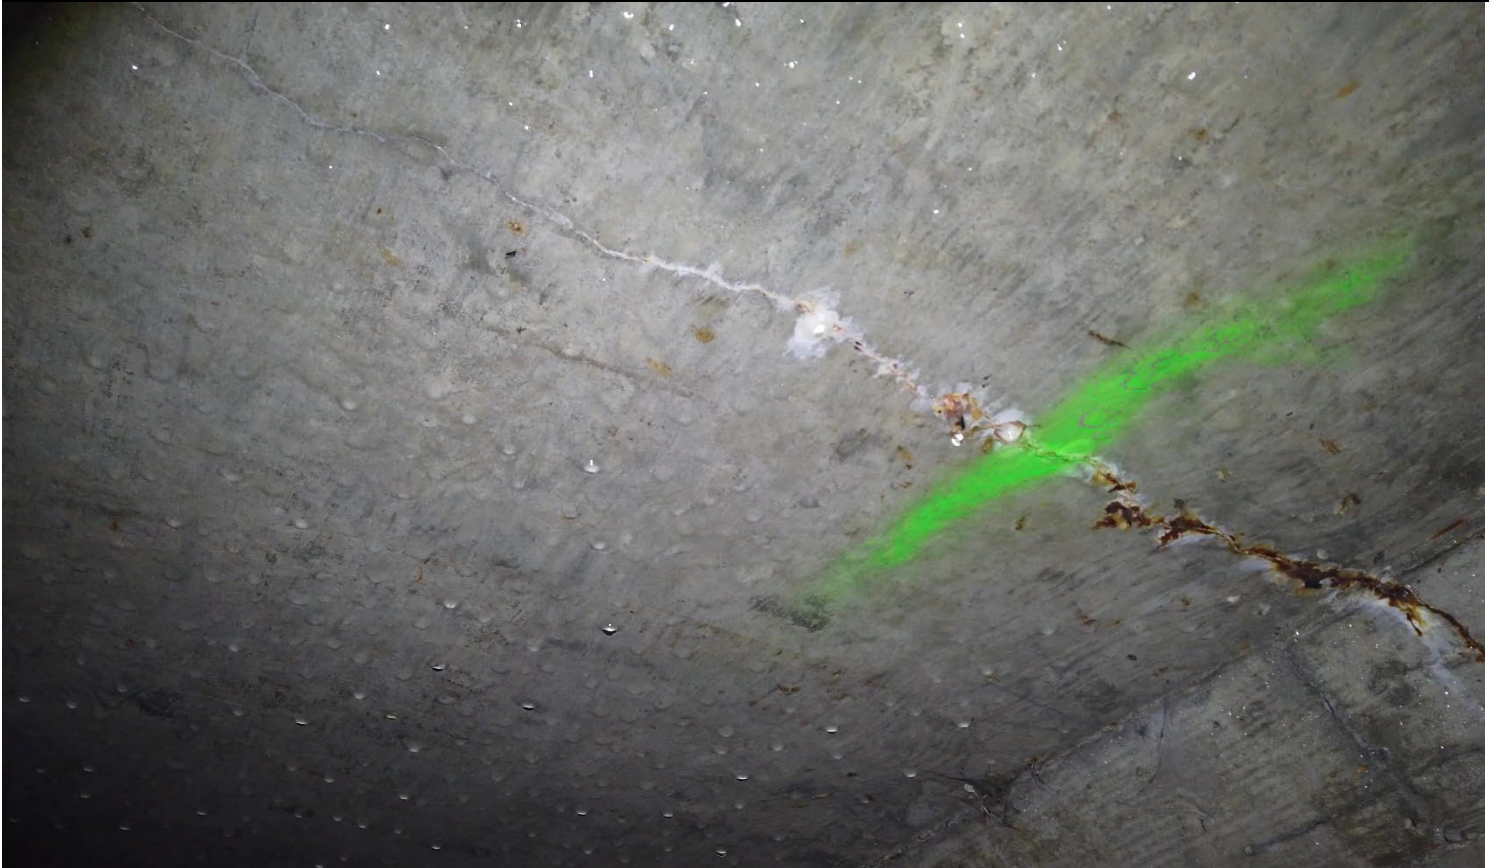
Footage	Defect Description	Top	Right	Left	Bottom
50 ft	Crack and Infiltration	Y
