I-26 & I-95 INTERCHANGE IMPROVEMENTS

June 29, 2023

PIPE INSPECTION REPORT

This report contains the results of the video pipe inspection and assessment of the existing storm water drainage pipes within the project area in Orangeburg and Dorchester Counties.

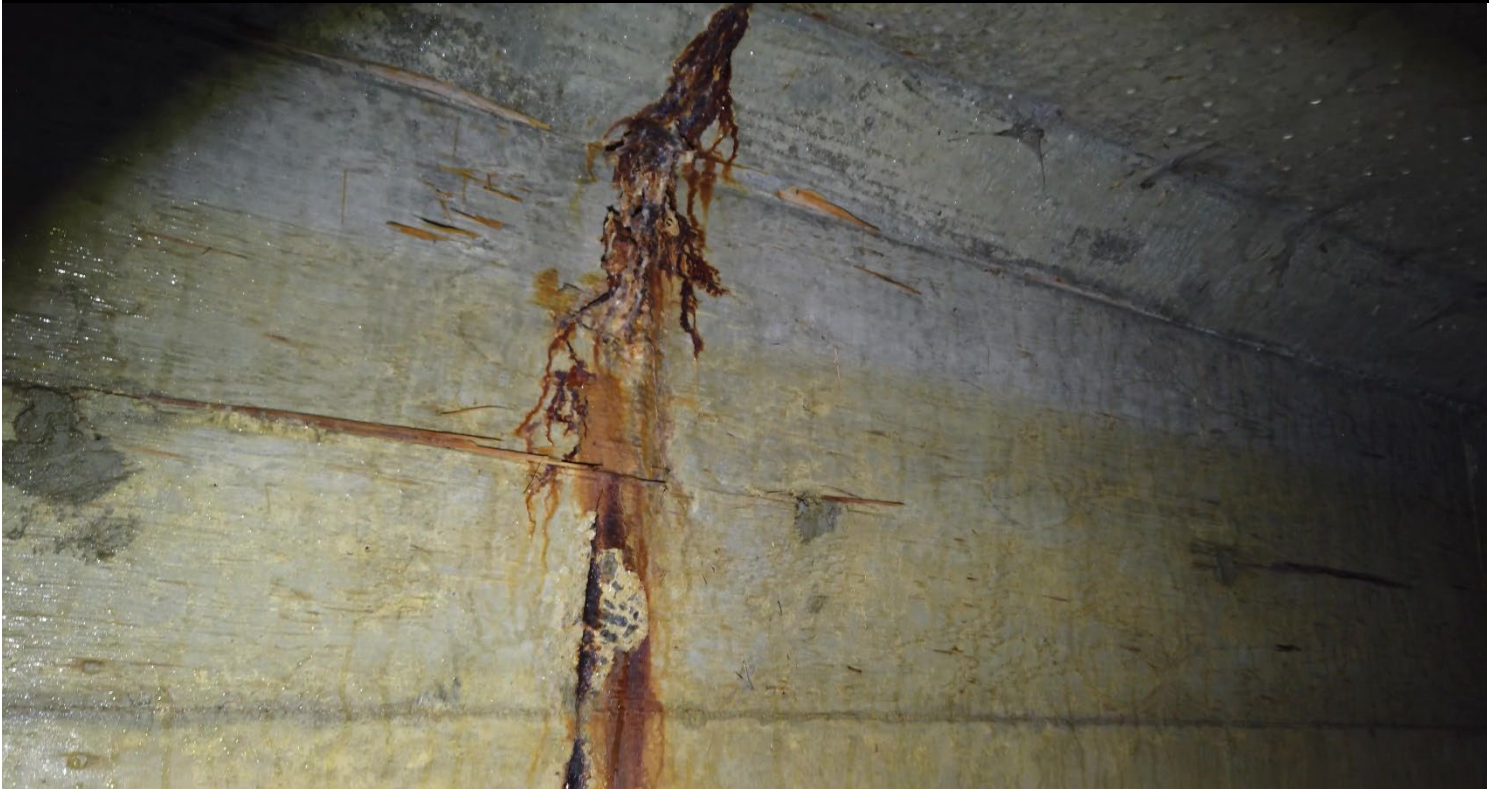
Footage	Defect Description	Top	Right	Left	Bottom
59 ft	Crack and Infiltration			Y

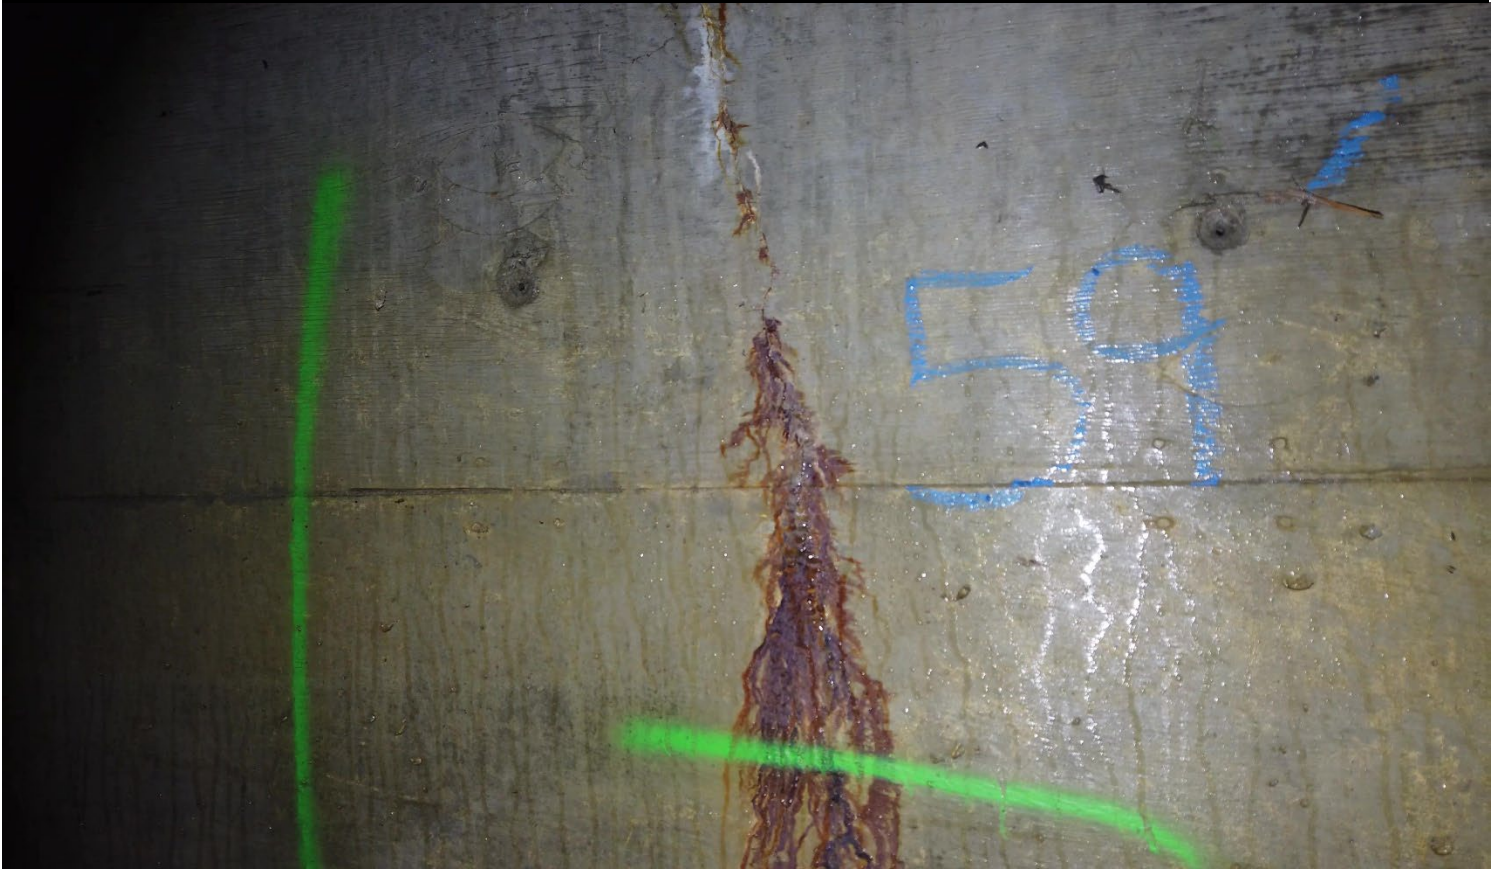
Footage	Defect Description	Top	Right	Left	Bottom
59 ft	Crack and Infiltration		Y

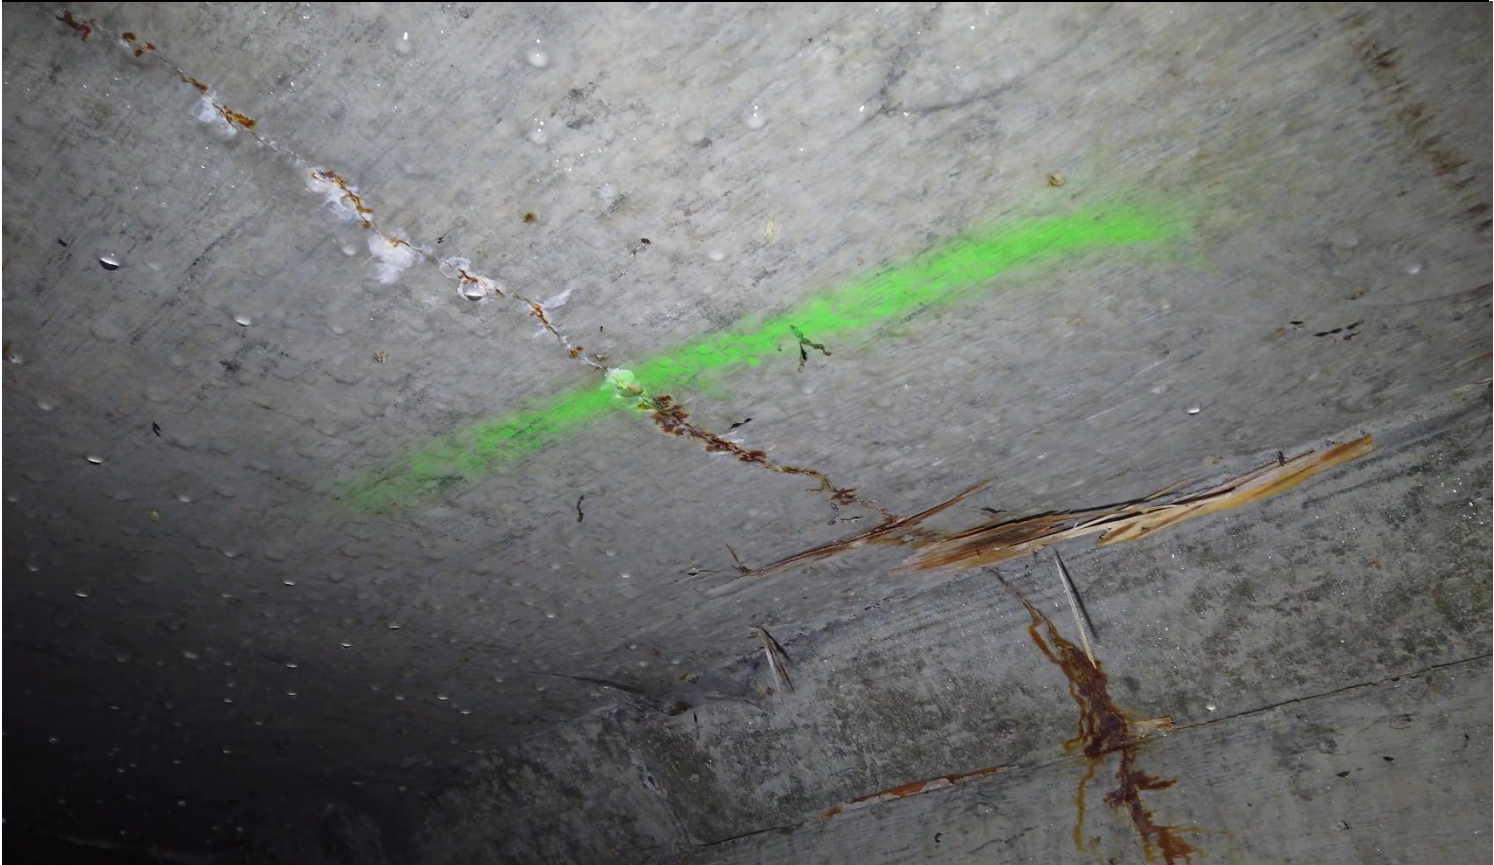
Footage	Defect Description	Top	Right	Left	Bottom
59 ft	Crack and Infiltration	Y

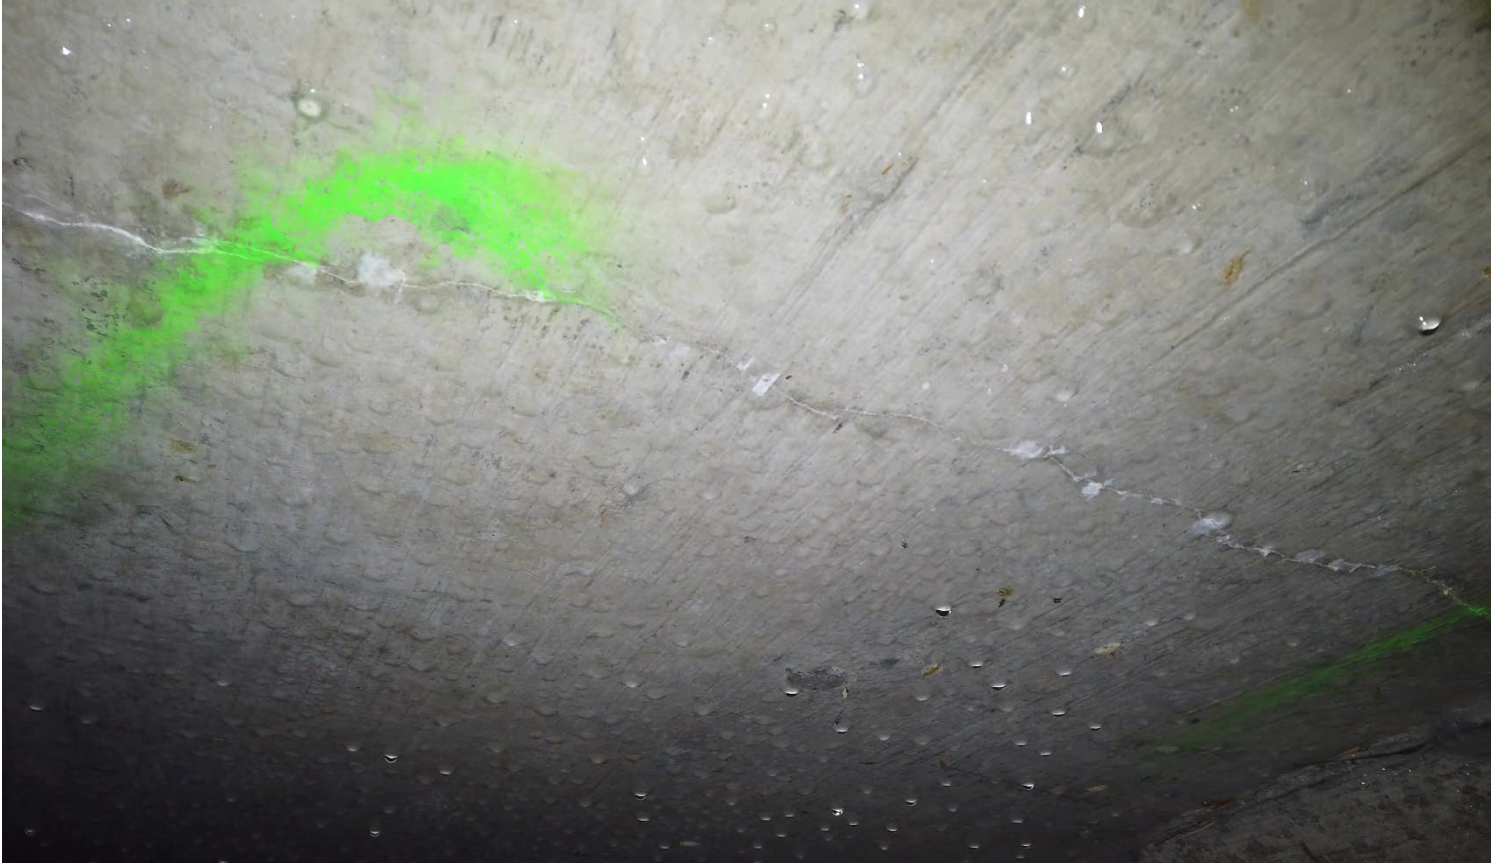
Footage	Defect Description	Top	Right	Left	Bottom
67 ft	Crack and Infiltration	Y

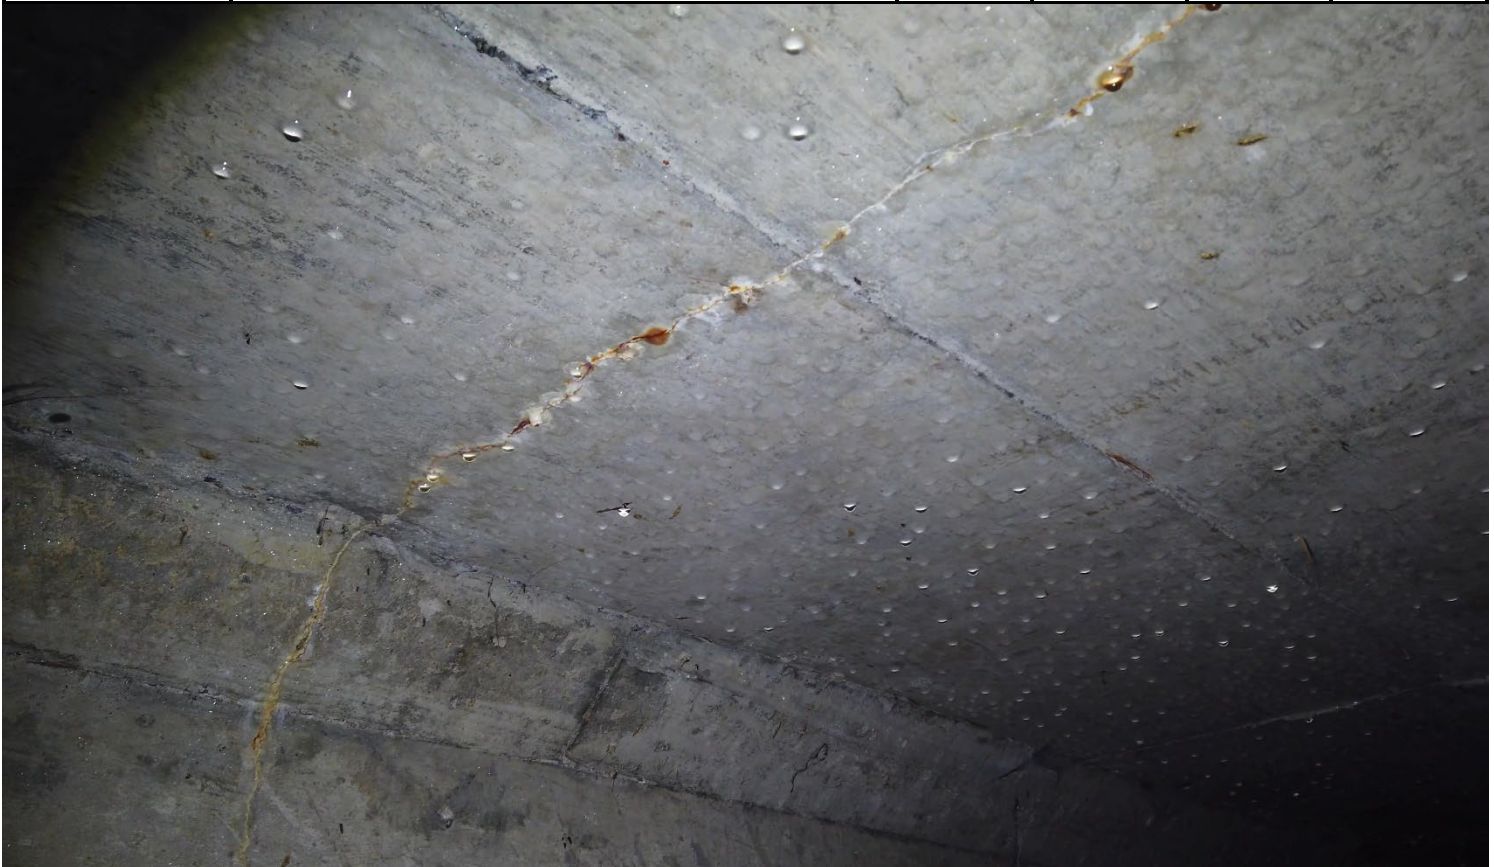
Footage	Defect Description	Top	Right	Left	Bottom
84 ft	Crack and Infiltration	Y

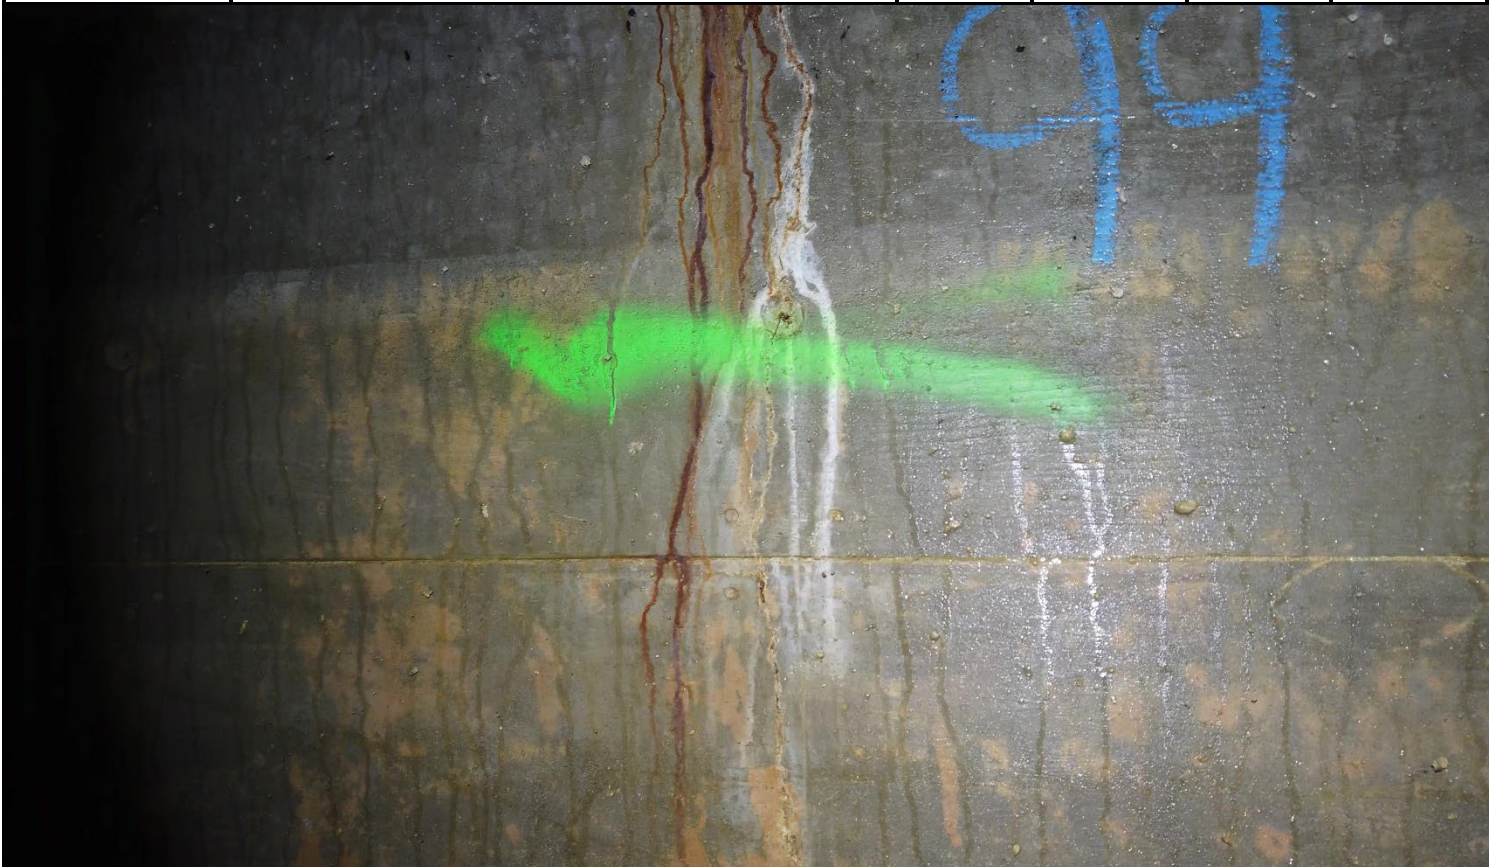
Footage	Defect Description	Top	Right	Left	Bottom
99 ft	Crack and Infiltration	Y		Y

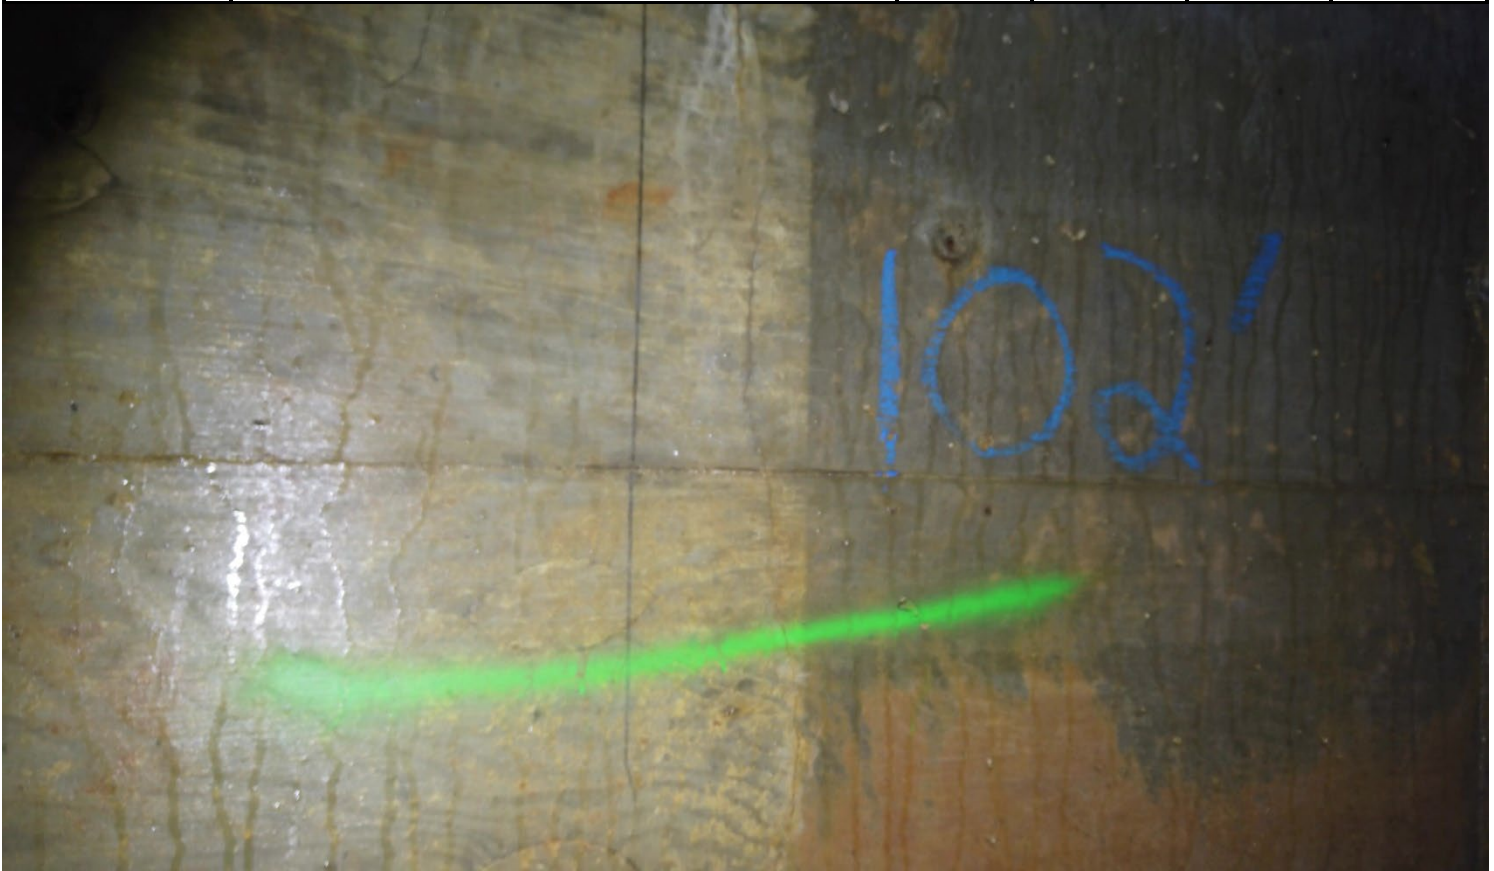
Footage	Defect Description	Top	Right	Left	Bottom
102 ft	Crack			Y

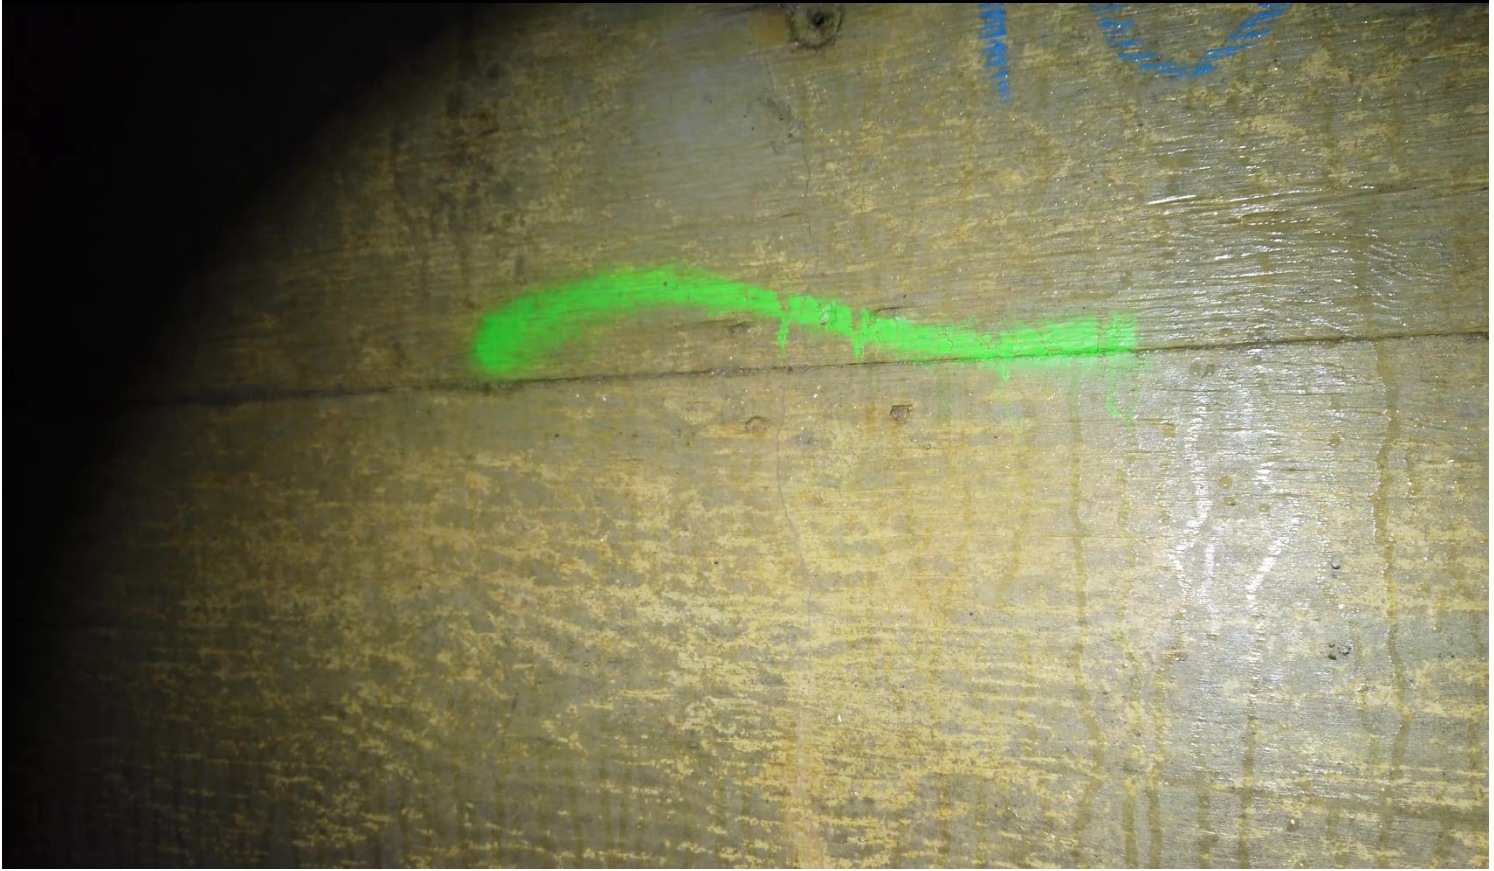
Footage	Defect Description	Top	Right	Left	Bottom
108 ft	Crack		Y

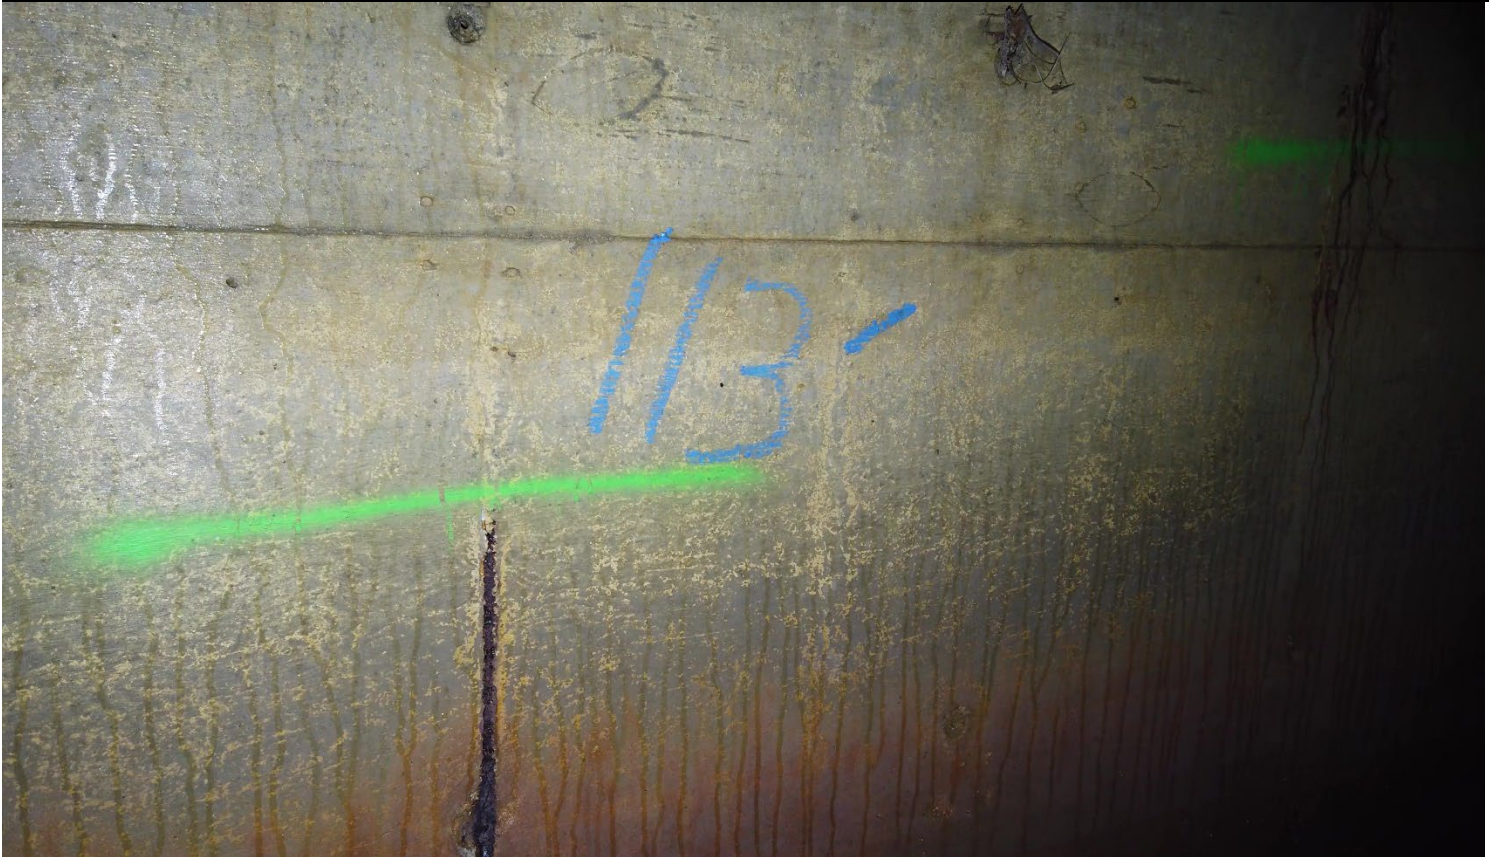
Footage	Defect Description	Top	Right	Left	Bottom
113 ft	Rebar Showing			Y

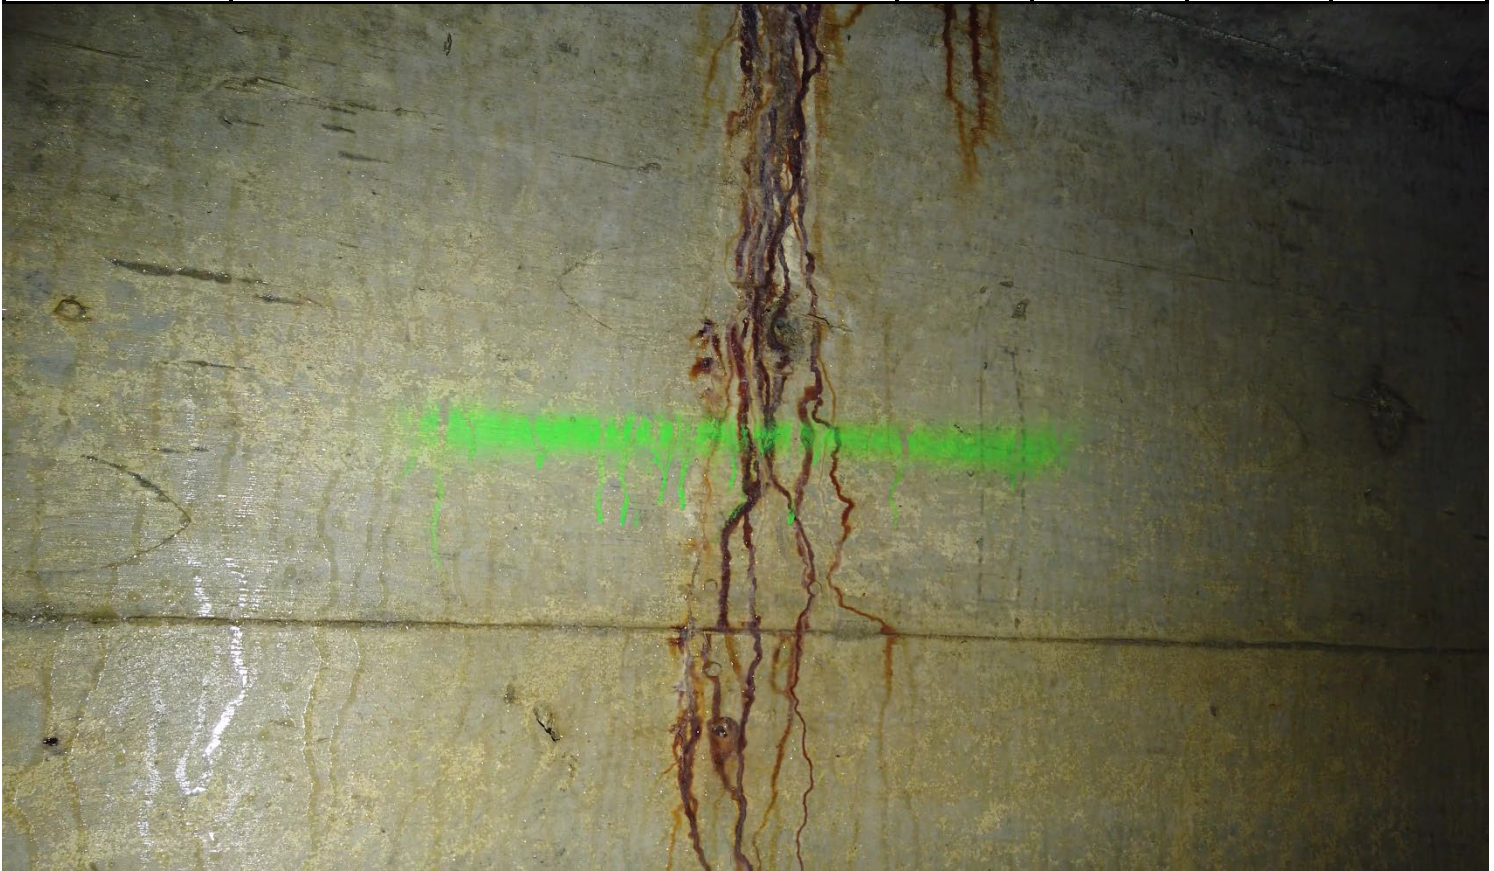
Footage	Defect Description	Top	Right	Left	Bottom
117 ft	Crack and Infiltration	Y	Y	Y

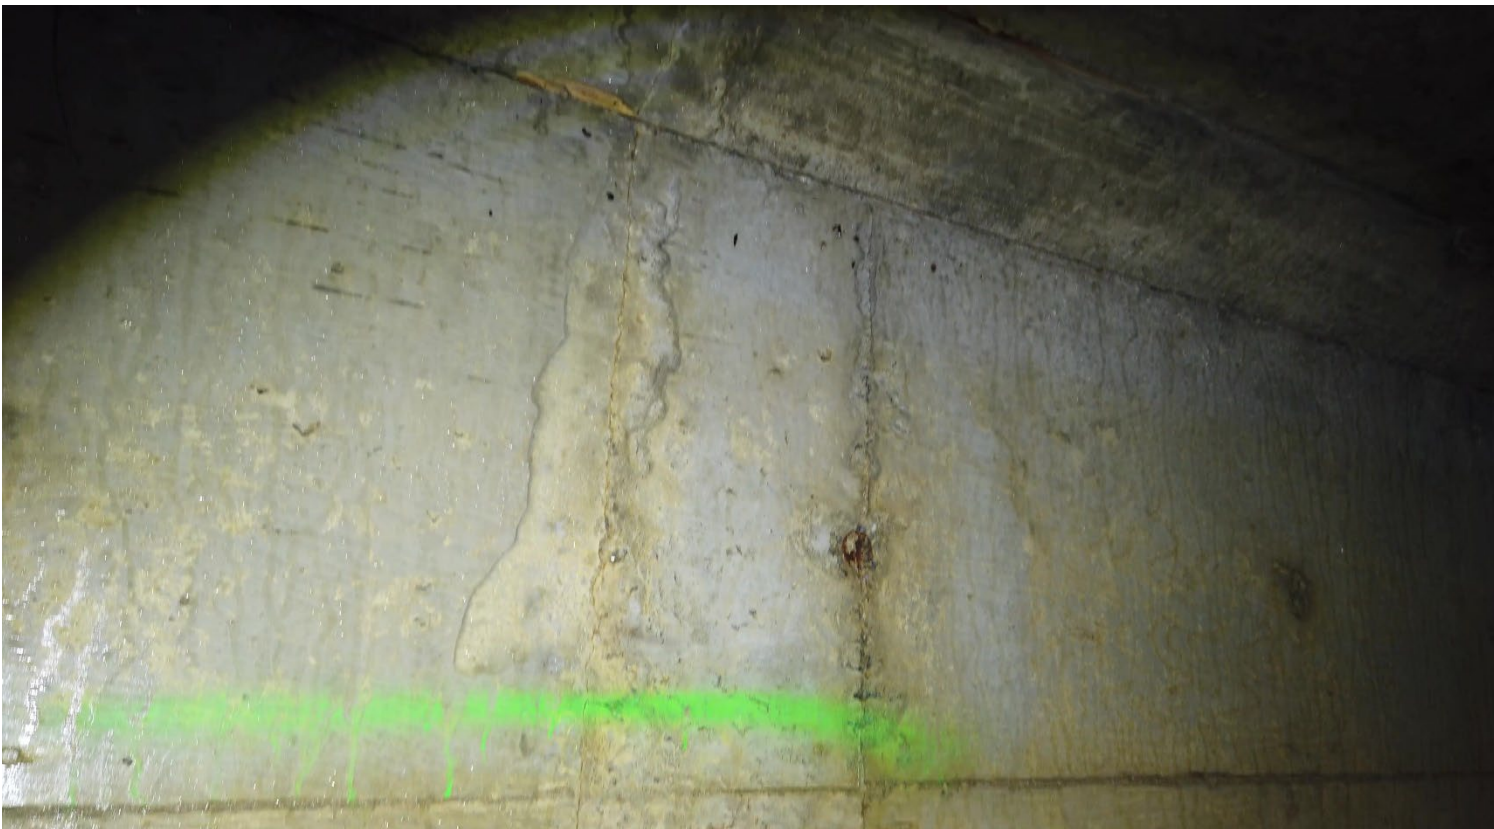
Footage	Defect Description	Top	Right	Left	Bottom
127 ft	Crack and Infiltration	Y	Y	Y

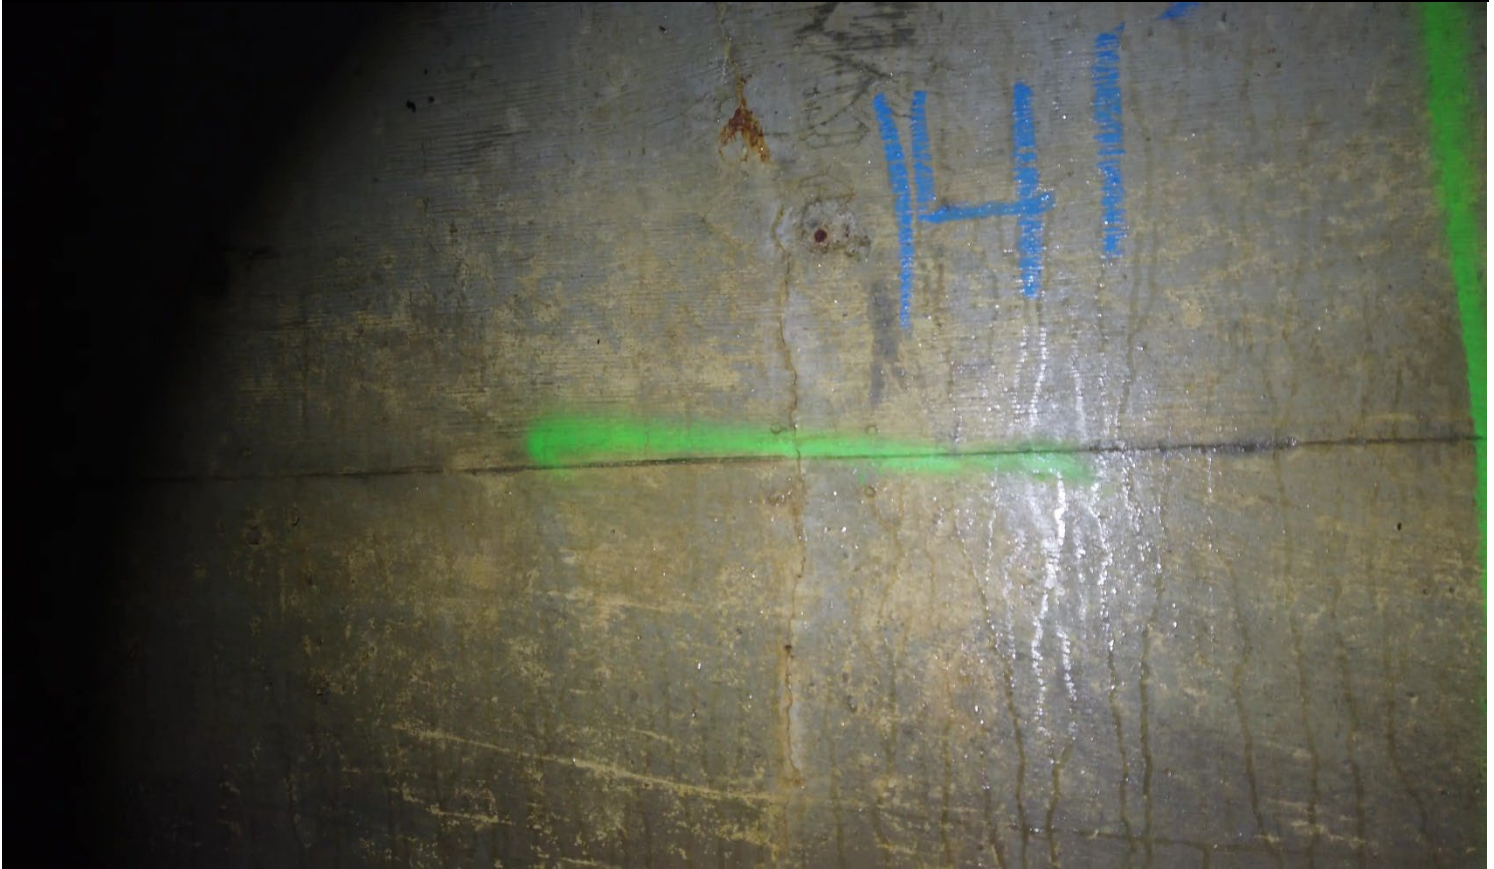
Footage	Defect Description	Top	Right	Left	Bottom
141 ft	Crack		Y

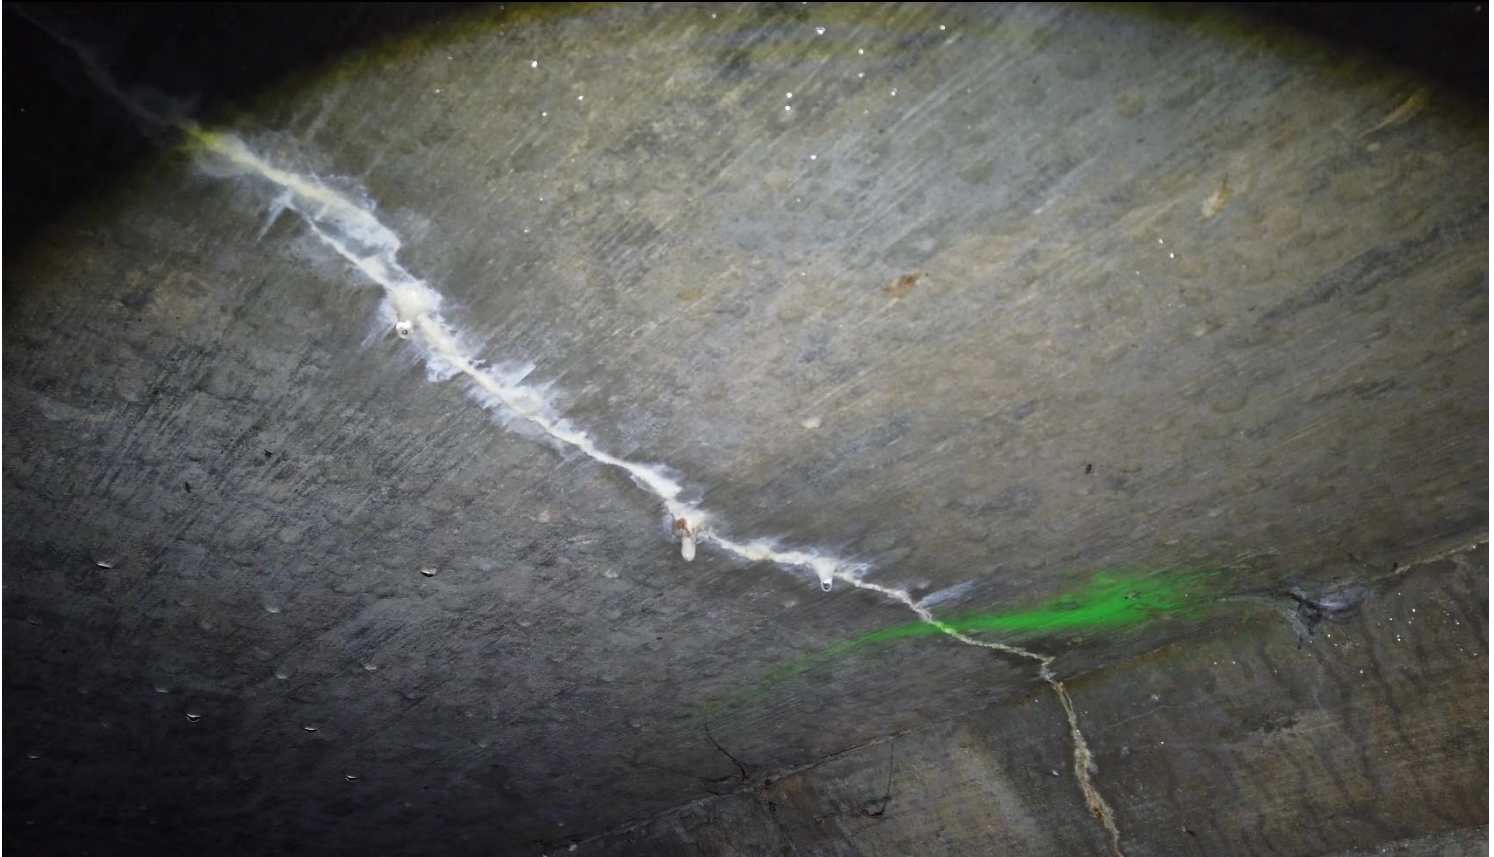
Footage	Defect Description	Top	Right	Left	Bottom
141 ft	Crack and Infiltration			Y

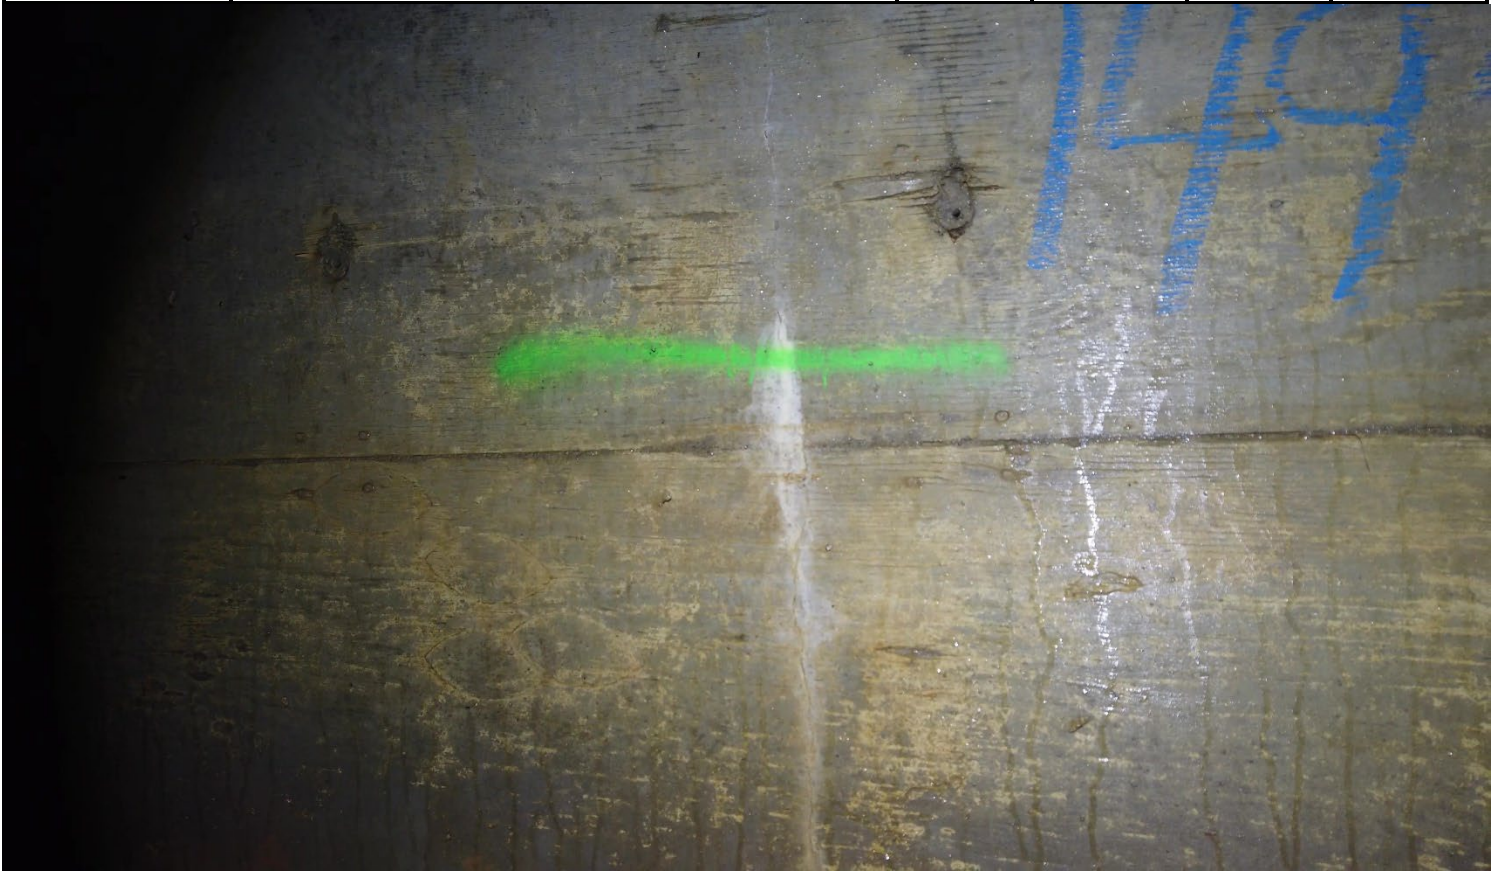
Footage	Defect Description	Top	Right	Left	Bottom
149 ft	Crack		Y

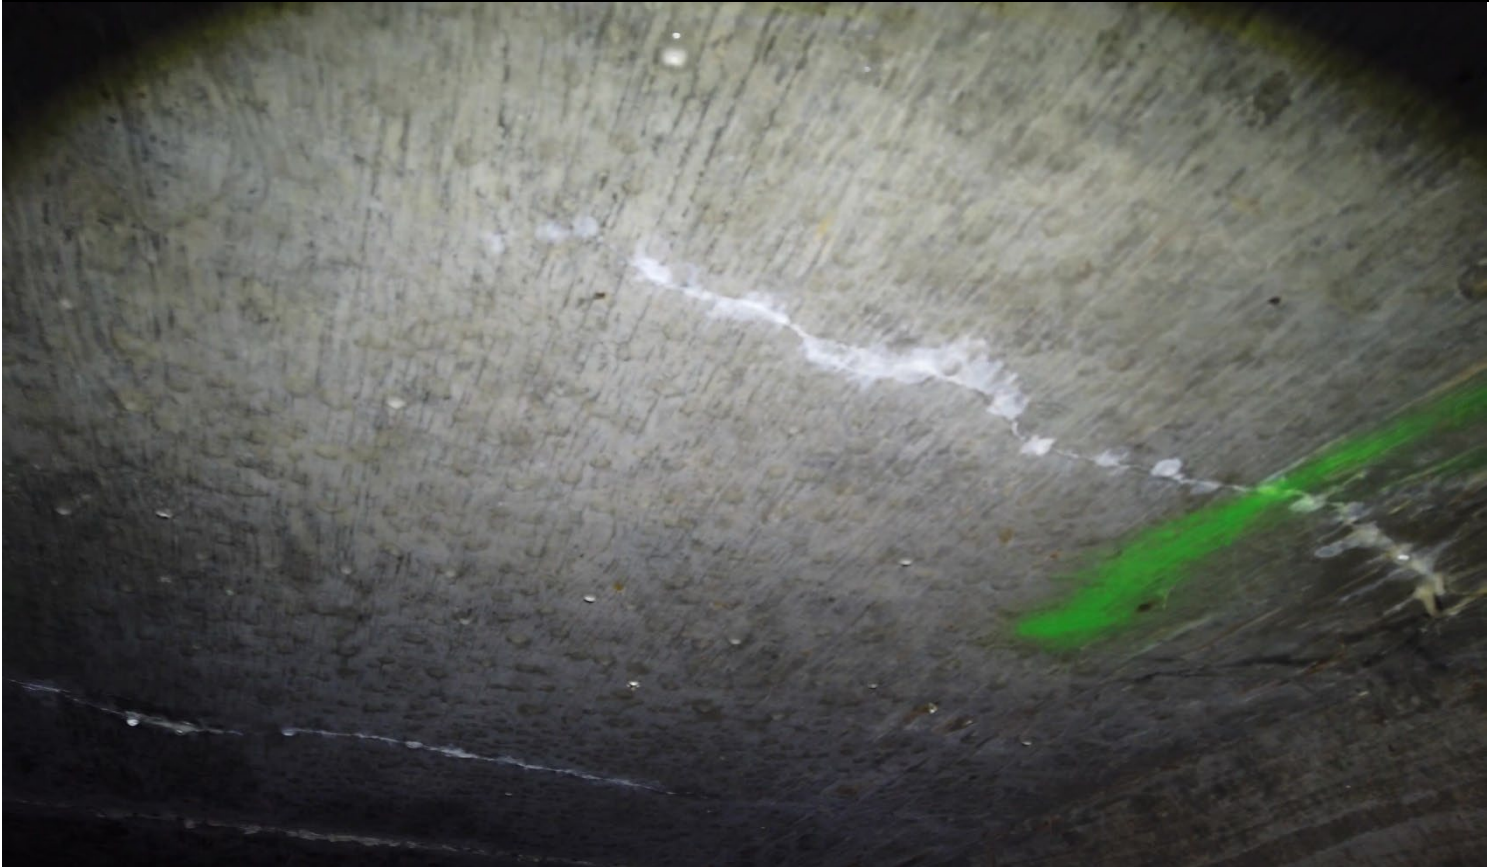
Footage	Defect Description	Top	Right	Left	Bottom
149 ft	Crack and Infiltration	Y

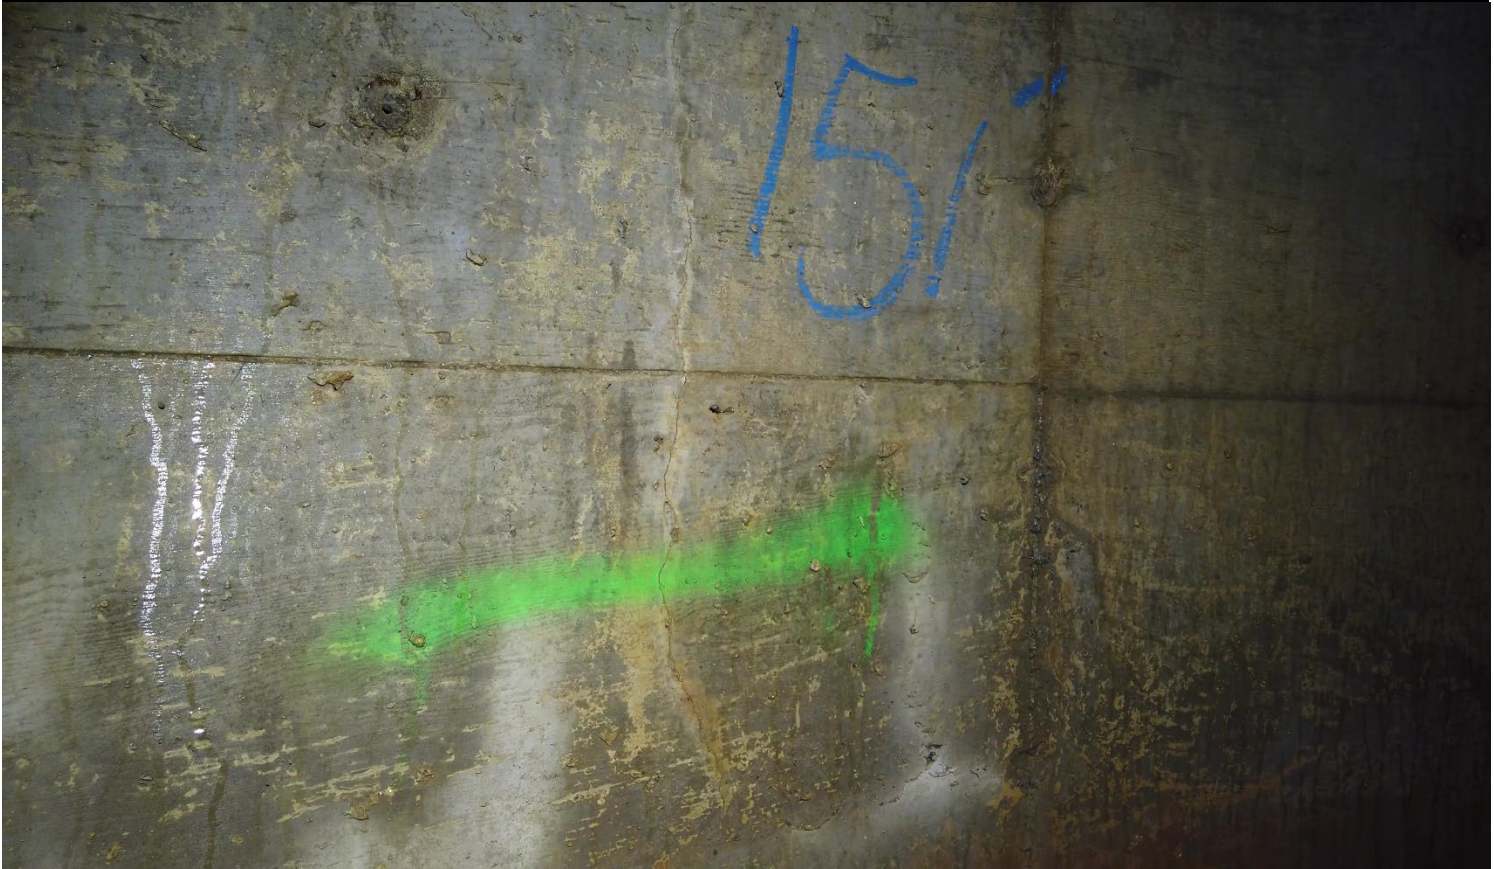
Footage	Defect Description	Top	Right	Left	Bottom
151 ft	Crack			Y

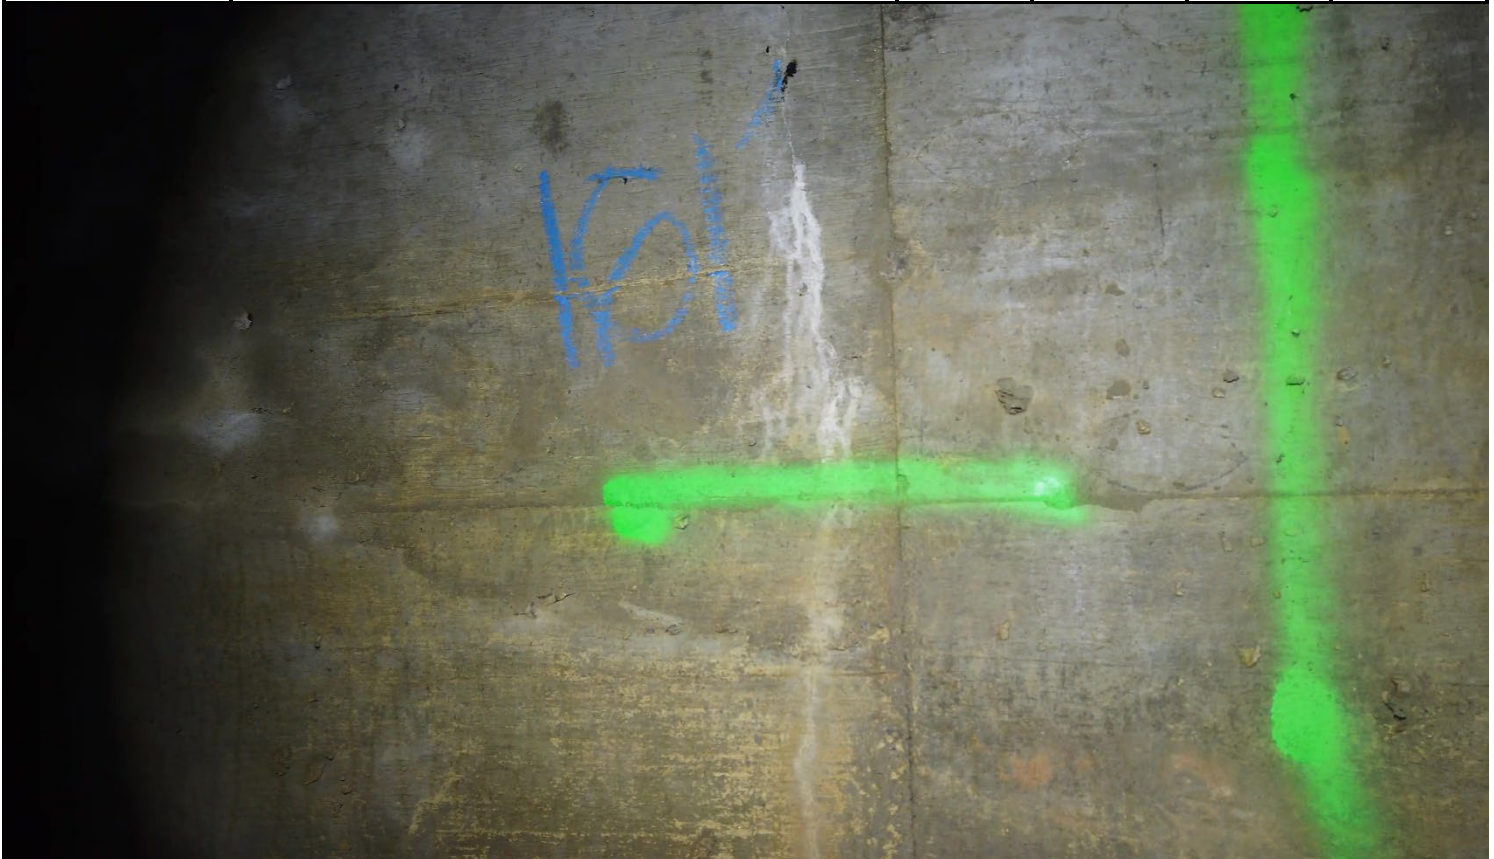
Footage	Defect Description	Top	Right	Left	Bottom
161 ft	Crack		Y
