I-26 & I-95 INTERCHANGE IMPROVEMENTS

June 29, 2023

PIPE INSPECTION REPORT

This report contains the results of the video pipe inspection and assessment of the existing storm water drainage pipes within the project area in Orangeburg and Dorchester Counties.

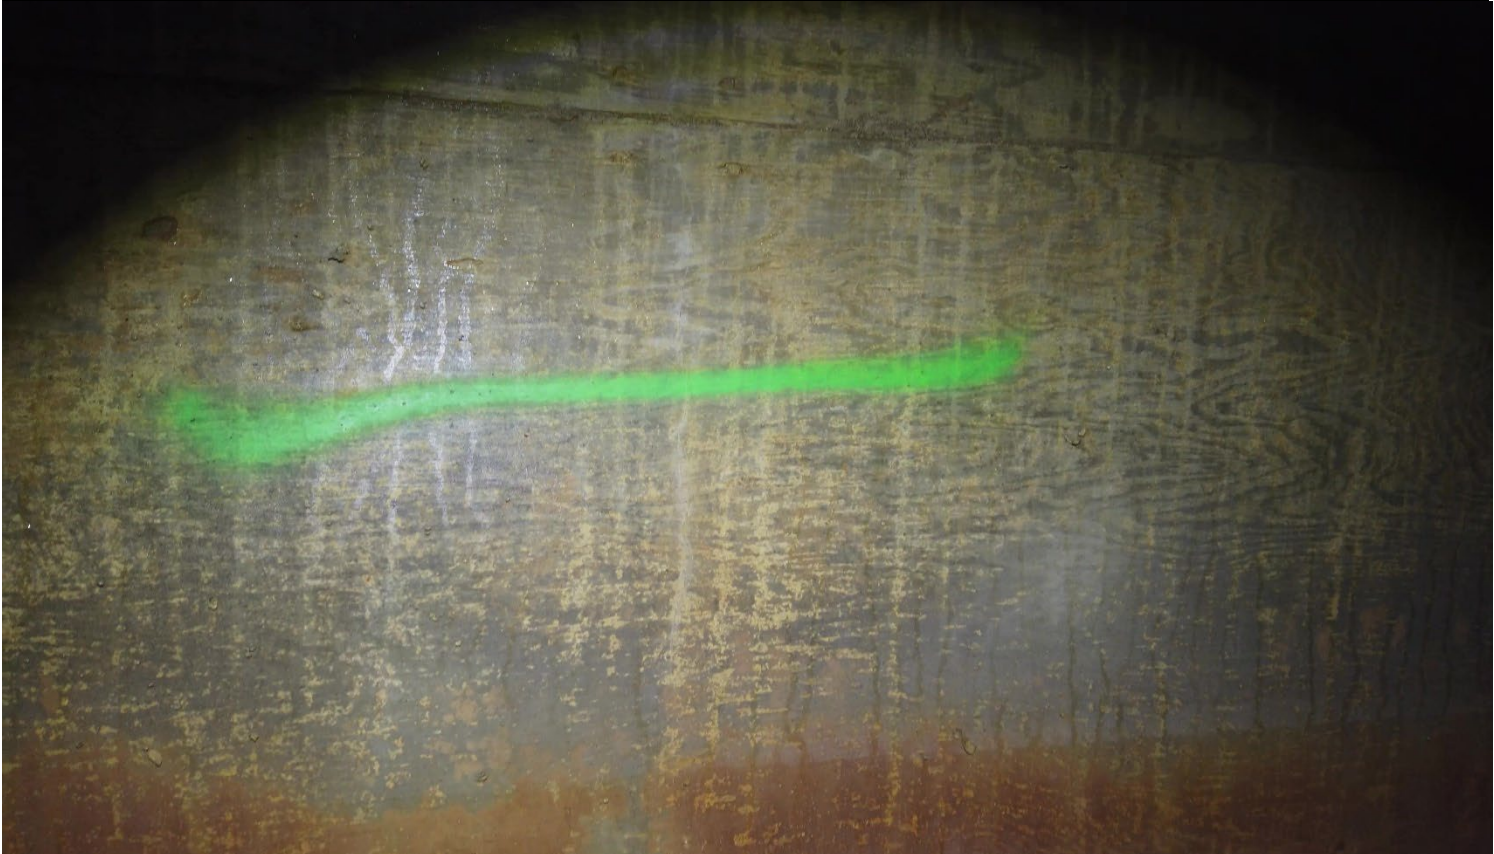
Footage	Defect Description	Top	Right	Left	Bottom
169 ft	Crack			Y

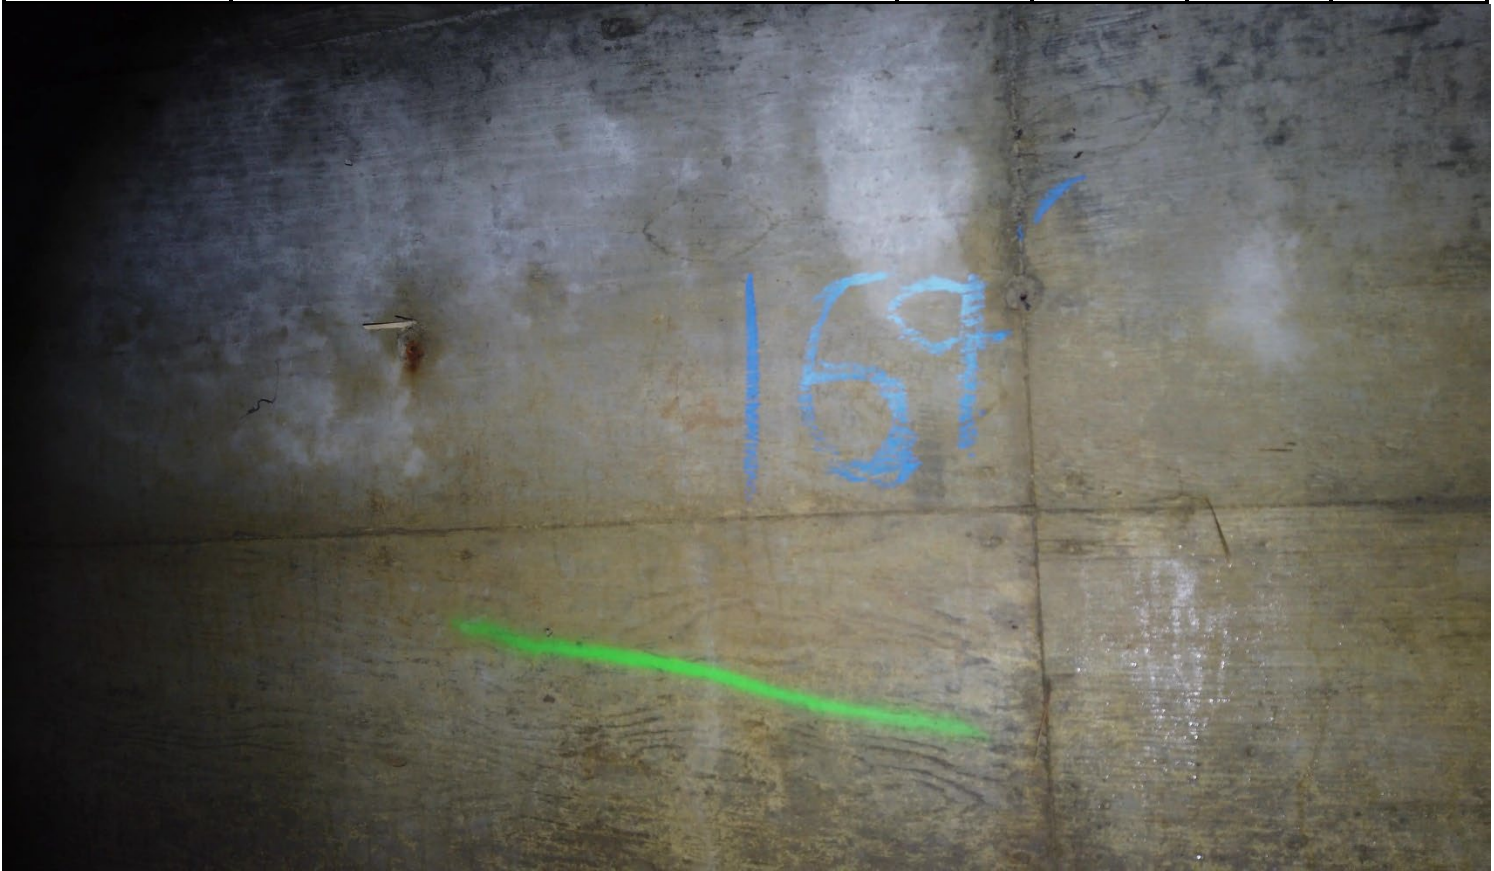
Footage	Defect Description	Top	Right	Left	Bottom
169 ft	Crack		Y

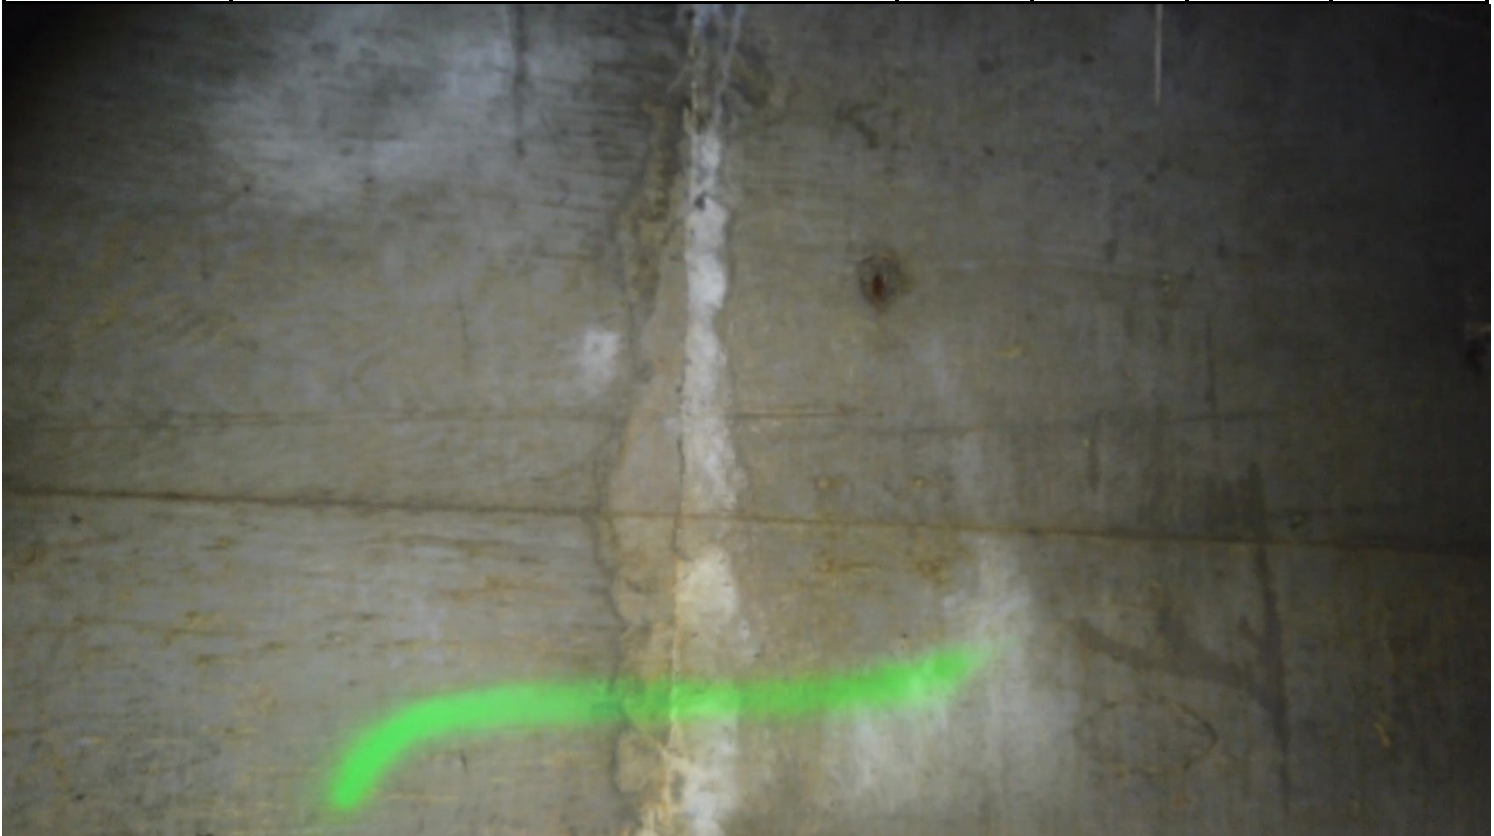
Footage	Defect Description	Top	Right	Left	Bottom
177 ft	Crack			Y

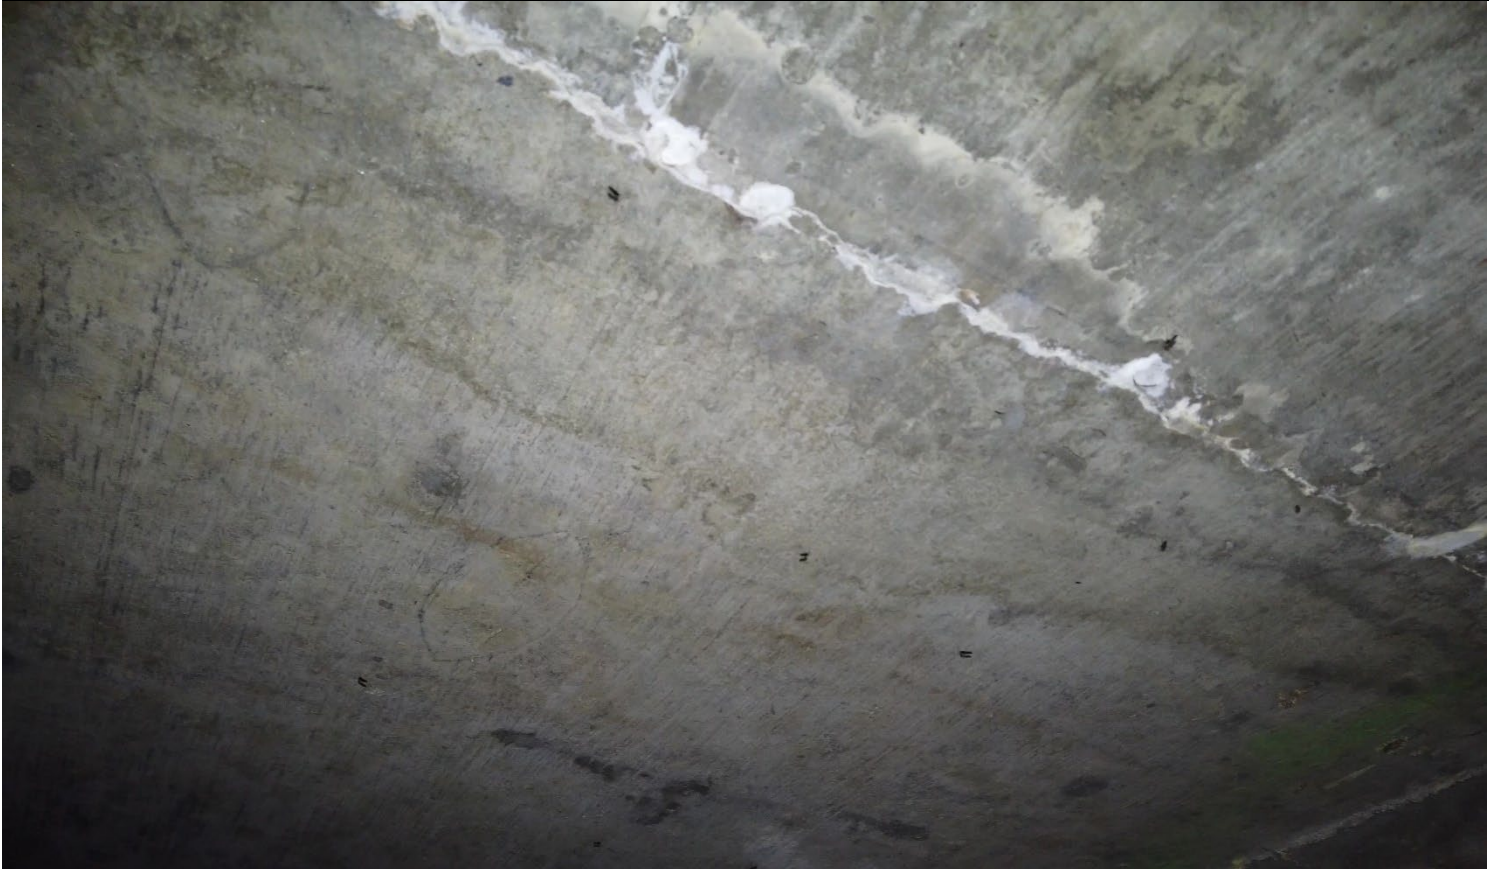
Footage	Defect Description	Top	Right	Left	Bottom
177 ft	Crack	Y

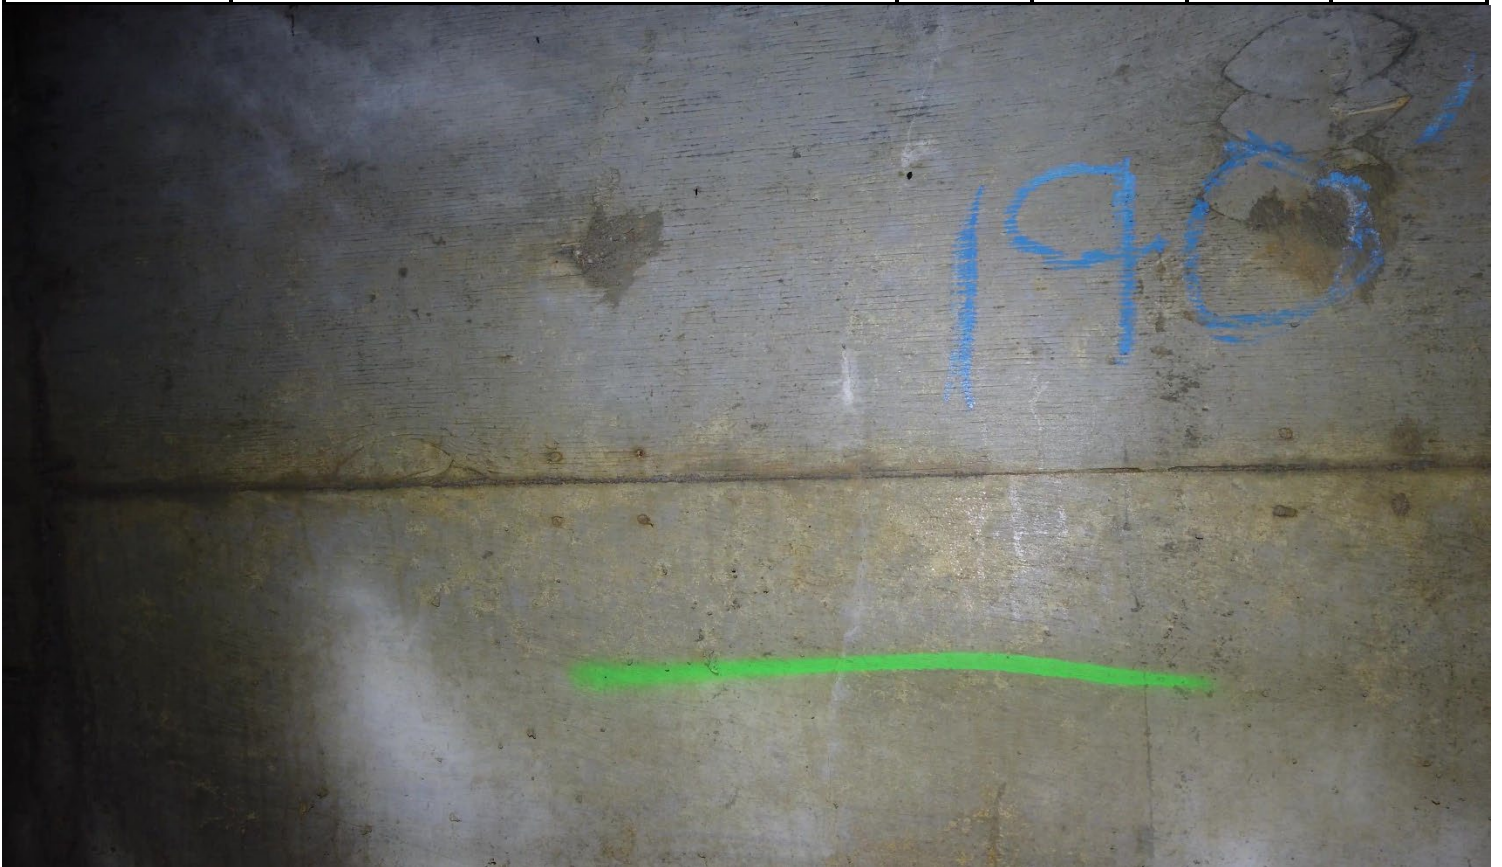
Footage	Defect Description	Top	Right	Left	Bottom
190 ft	Crack		Y

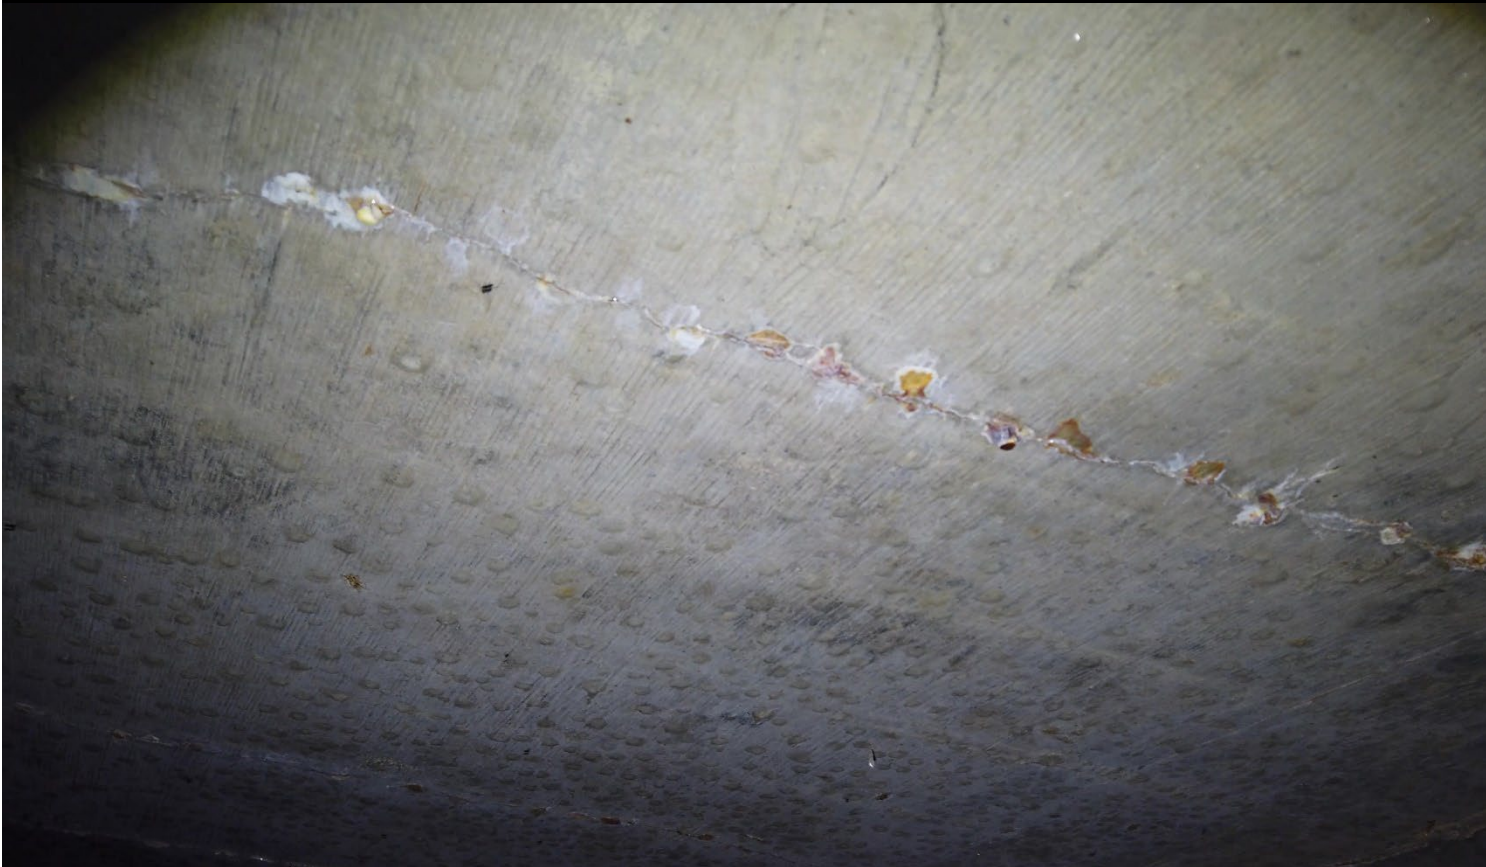
Footage	Defect Description	Top	Right	Left	Bottom
206 ft	Crack and Infiltration	Y

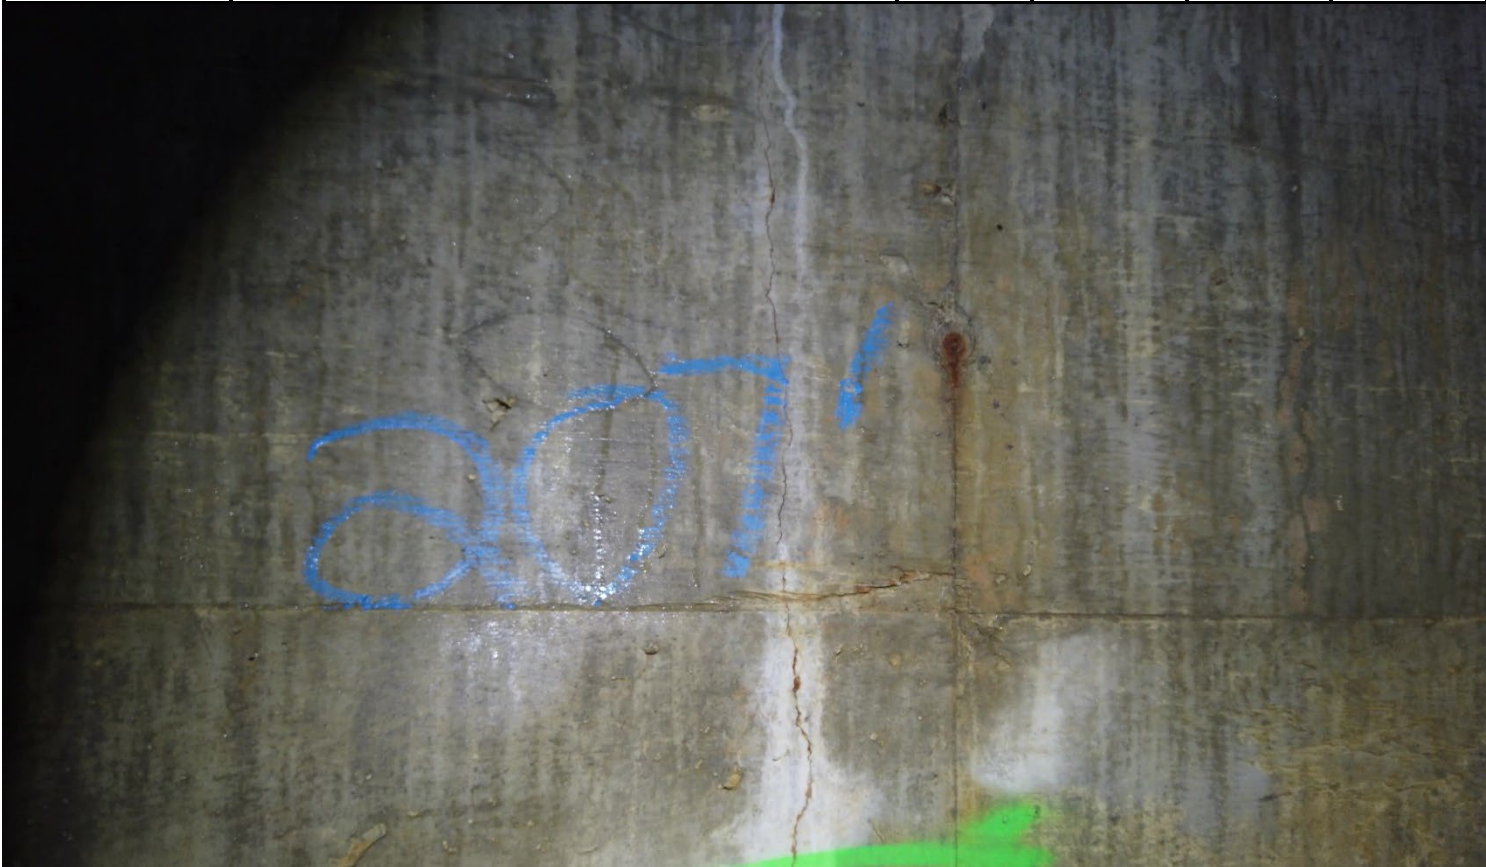
Footage	Defect Description	Top	Right	Left	Bottom
207 ft	Crack			Y

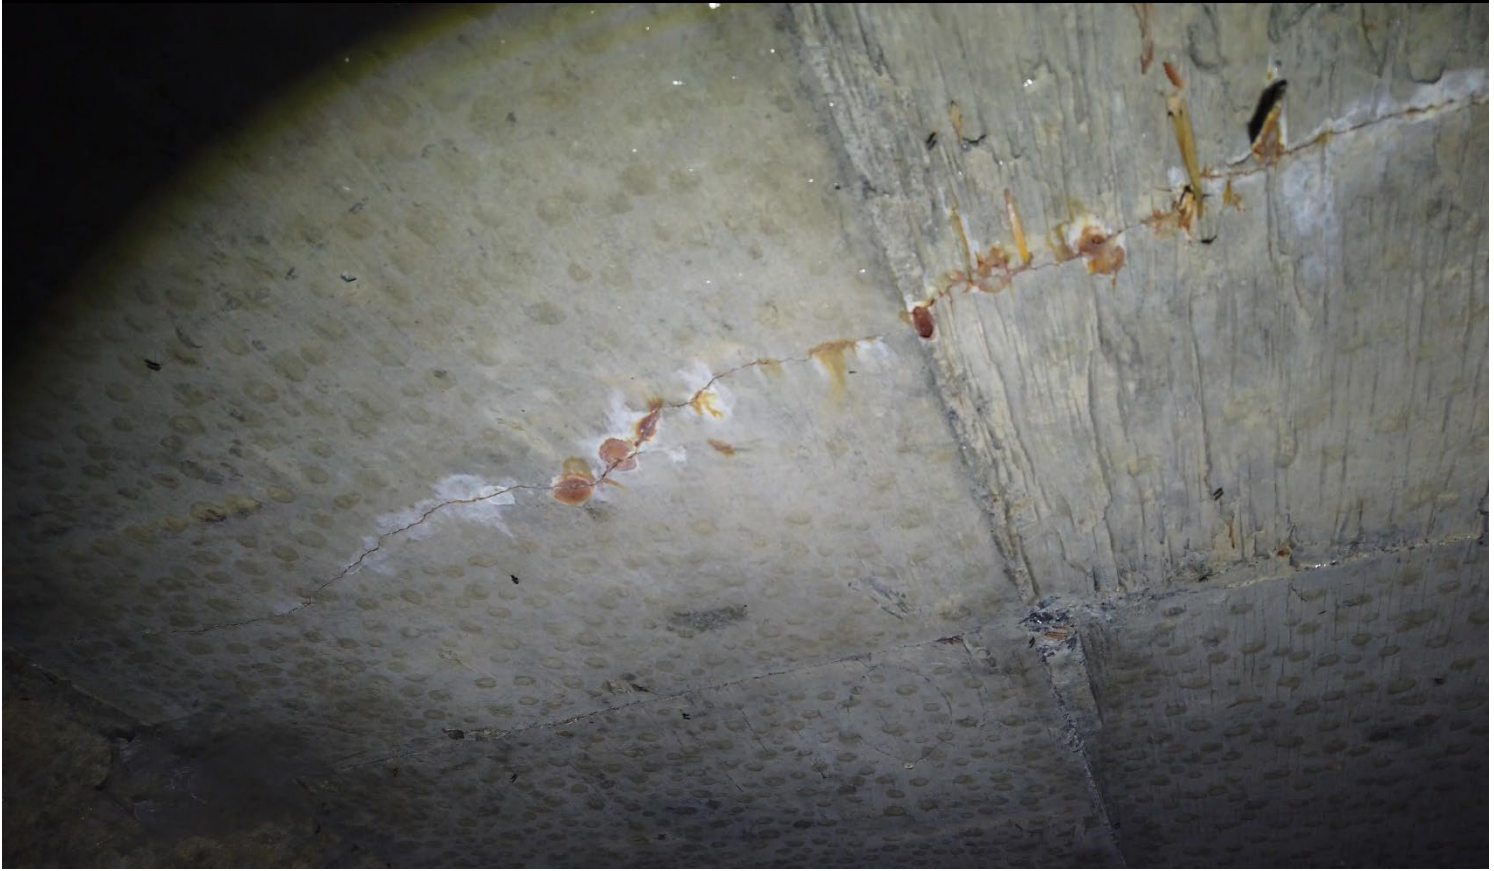
Footage	Defect Description	Top	Right	Left	Bottom
207 ft	Crack and Infiltration	Y

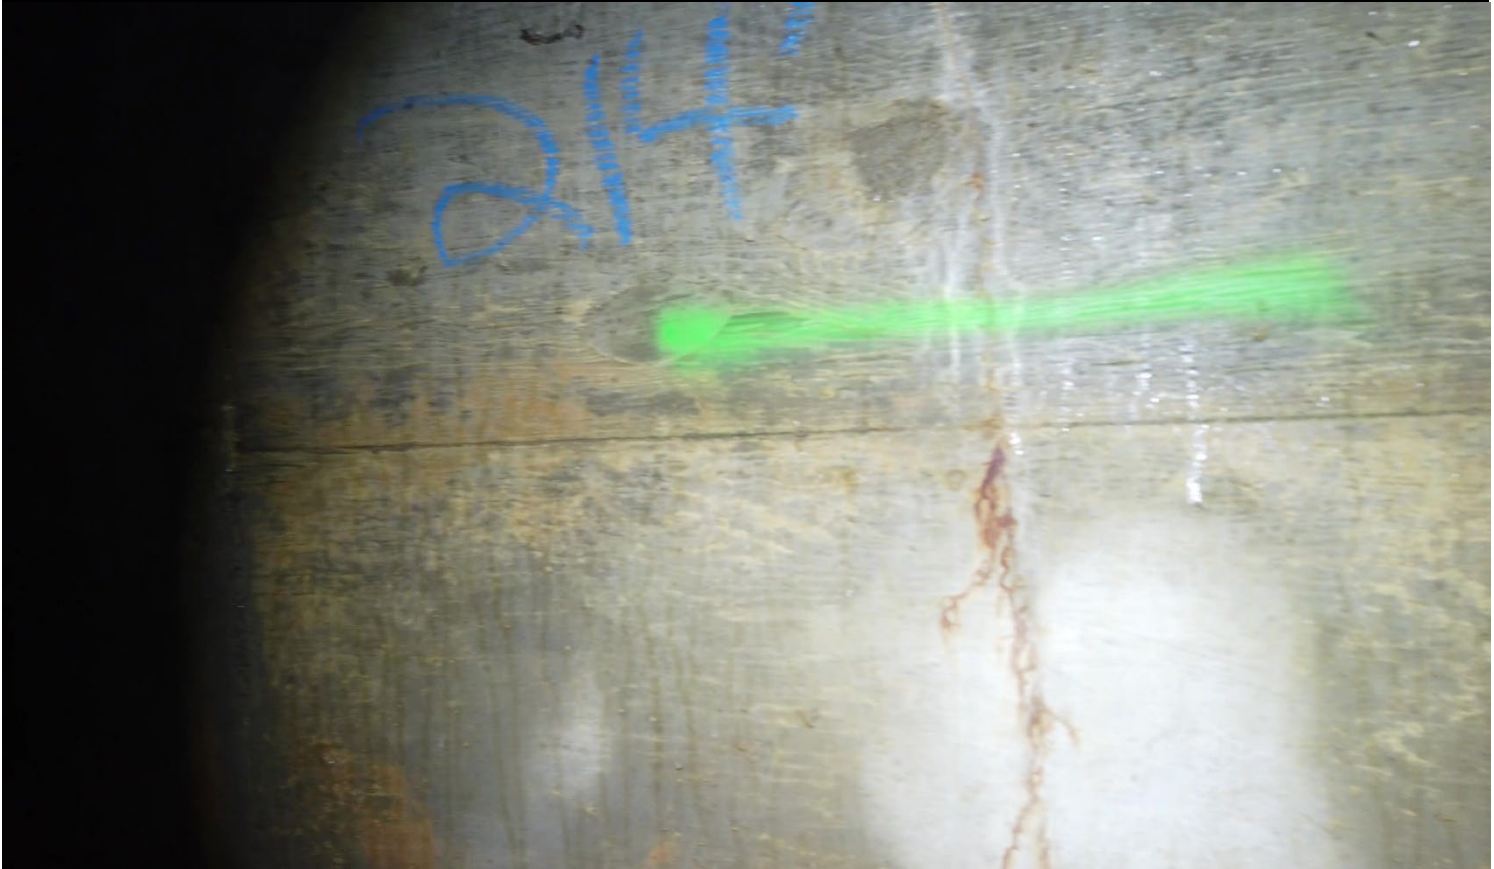
Footage	Defect Description	Top	Right	Left	Bottom
214 ft	Crack		Y

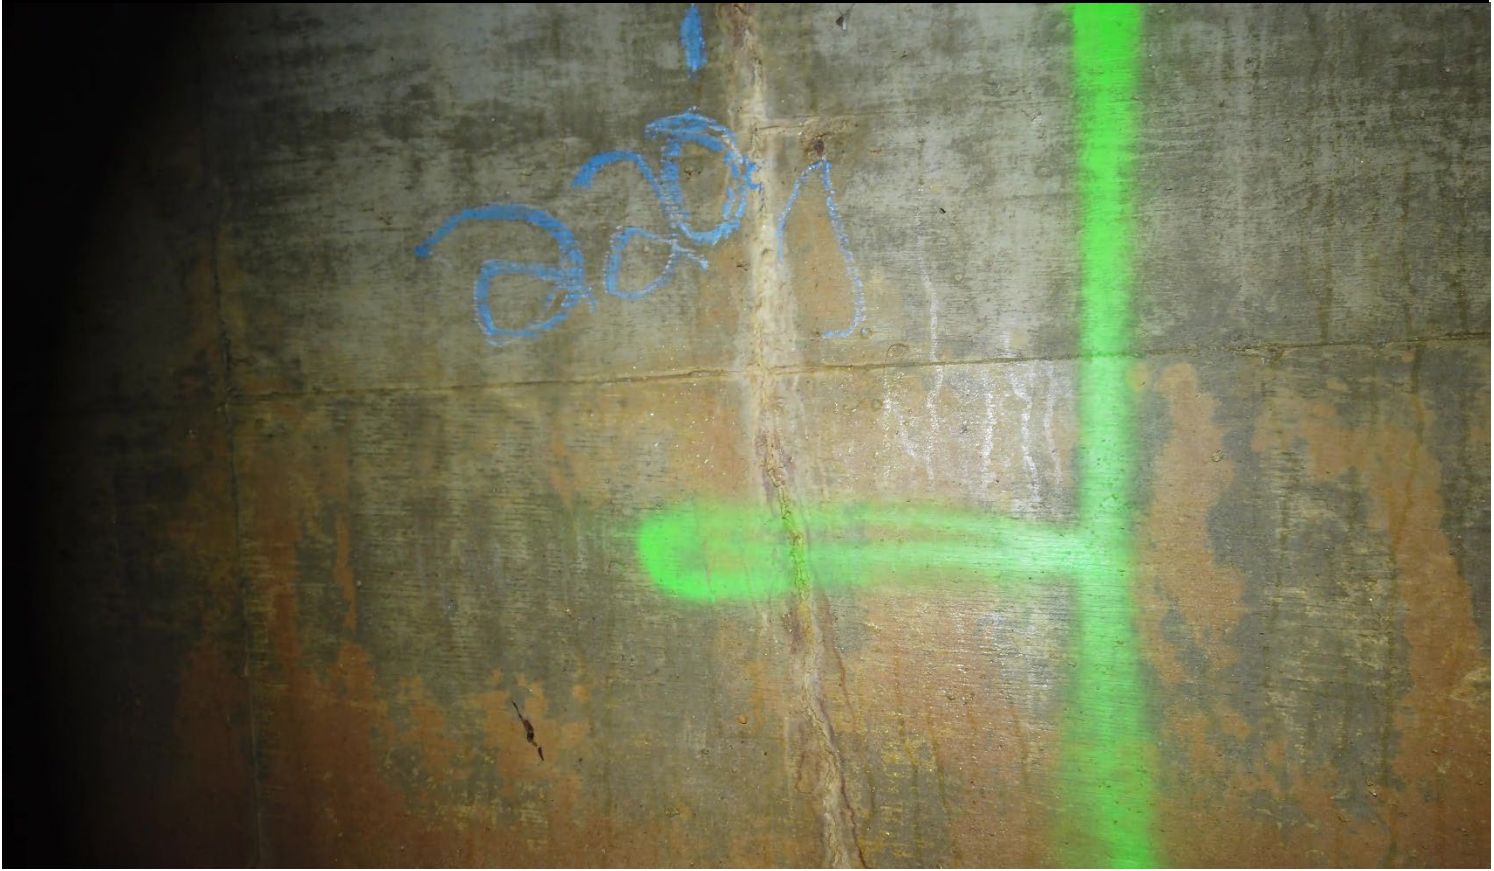
Footage	Defect Description	Top	Right	Left	Bottom
220 ft	Crack and Infiltration		Y

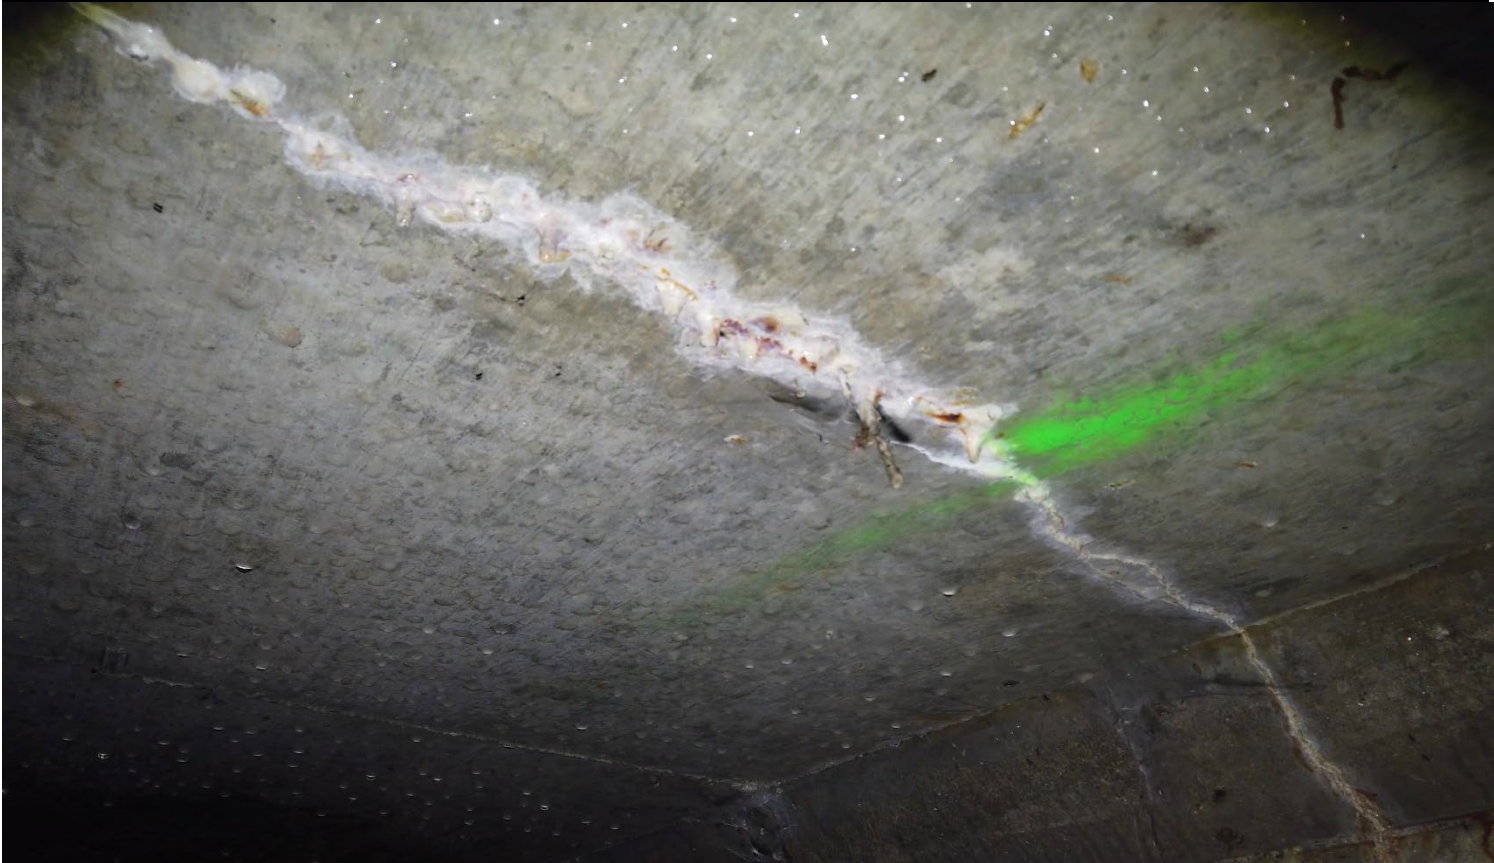
Footage	Defect Description	Top	Right	Left	Bottom
220 ft	Cracks and Infiltration	Y

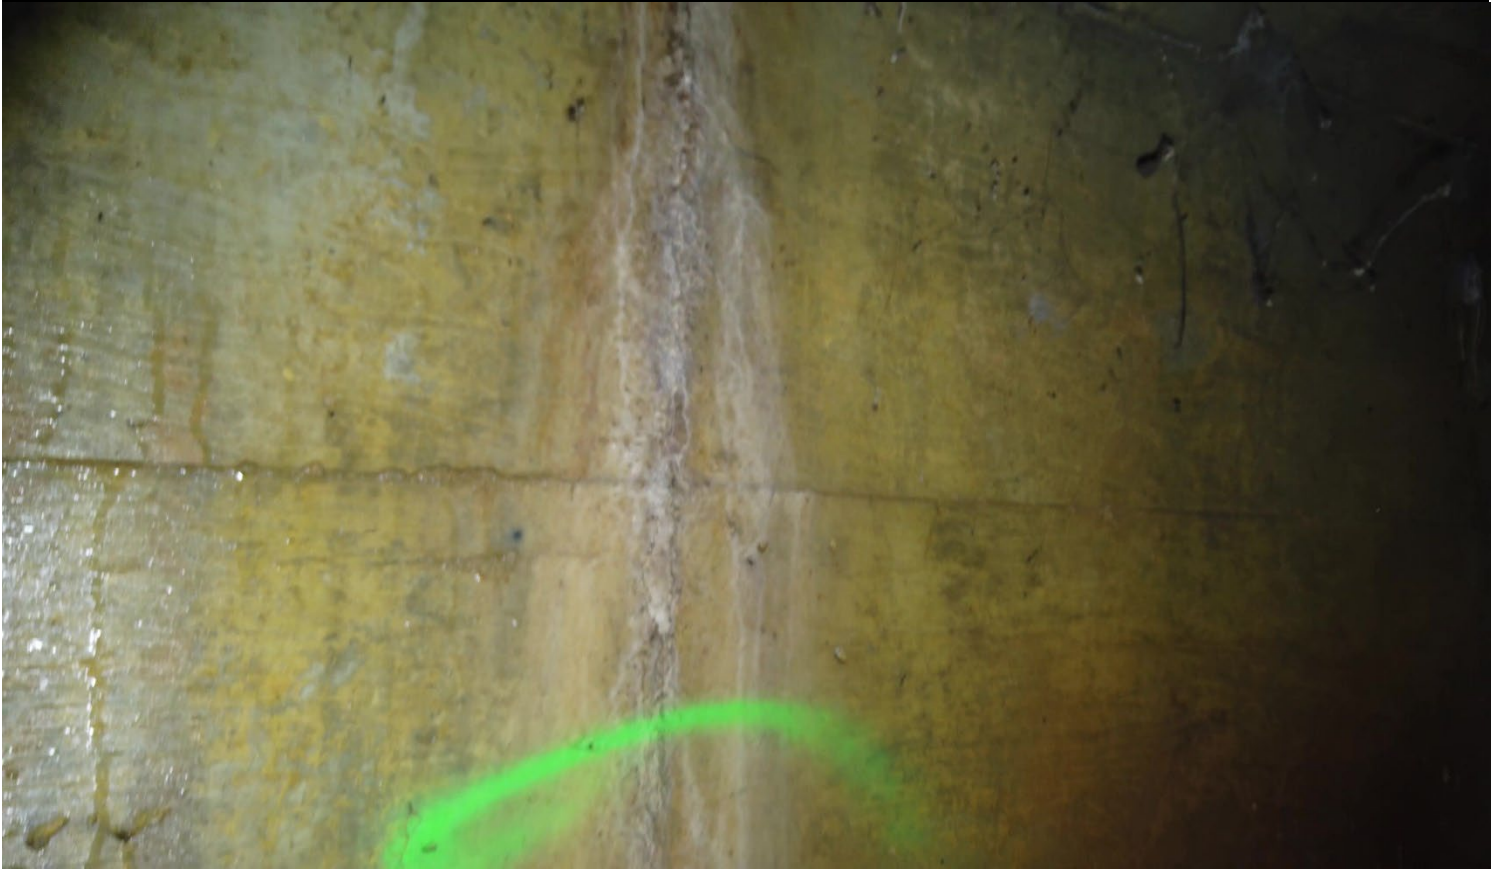
Footage	Defect Description	Top	Right	Left	Bottom
225 ft	Cracks and Infiltration	Y	Y	Y

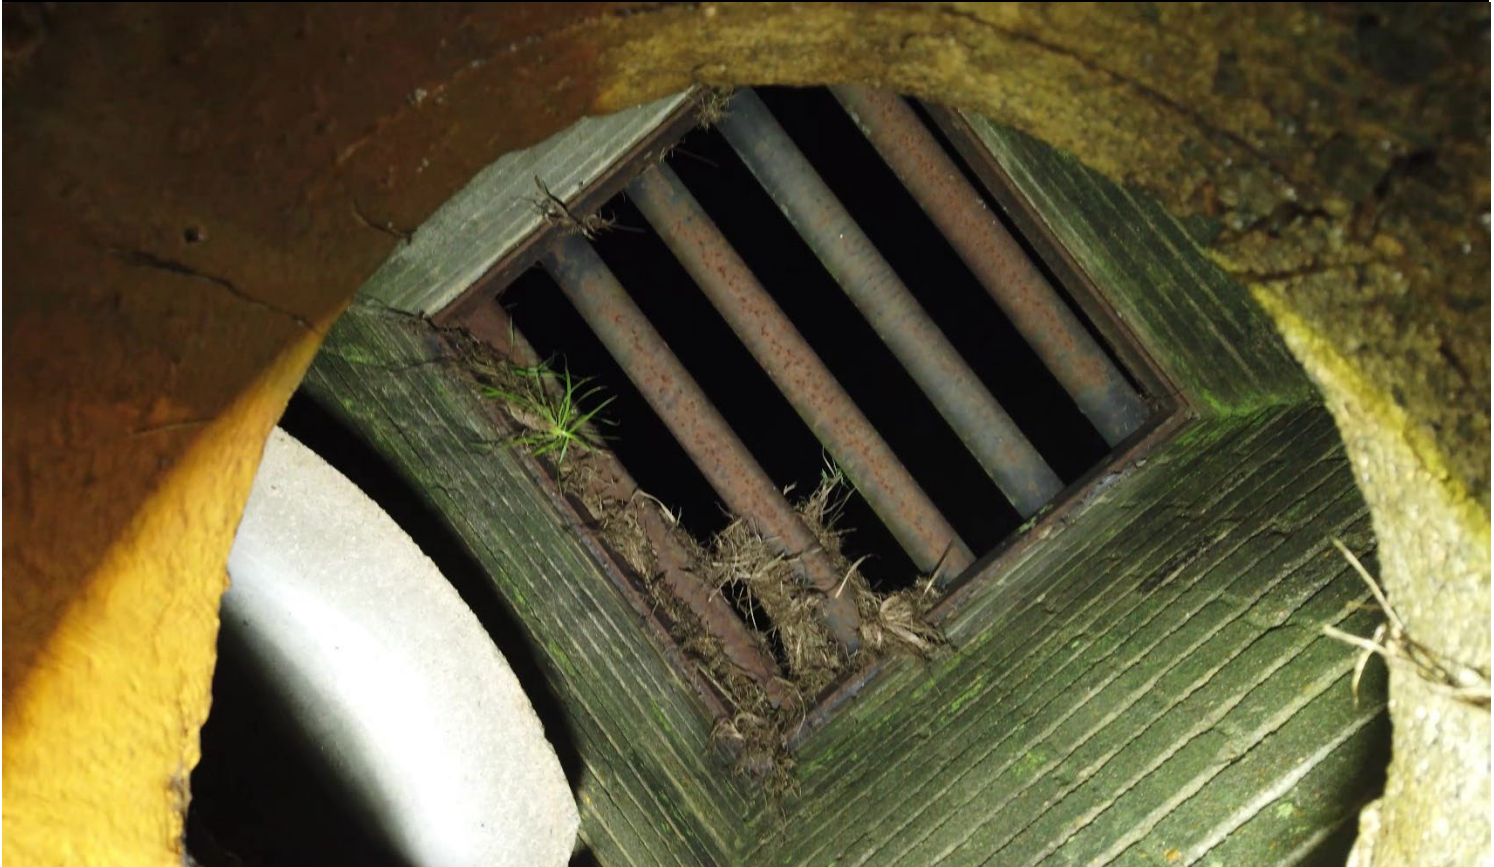
Footage	Defect Description	Top	Right	Left	Bottom
230 ft	Junction Box	Y

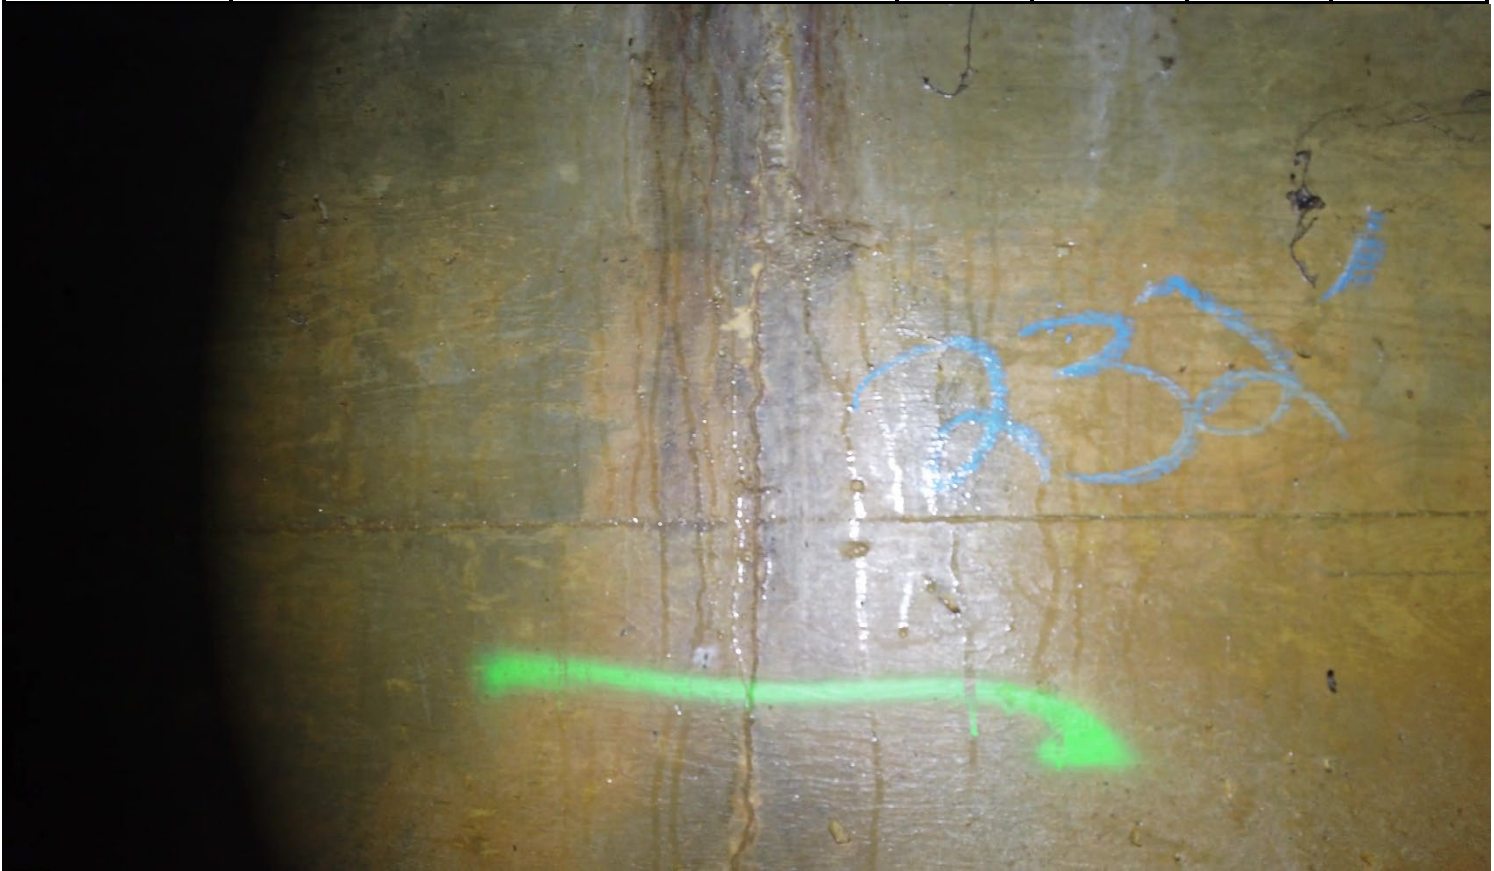
Footage	Defect Description	Top	Right	Left	Bottom
232 ft	Crack		Y

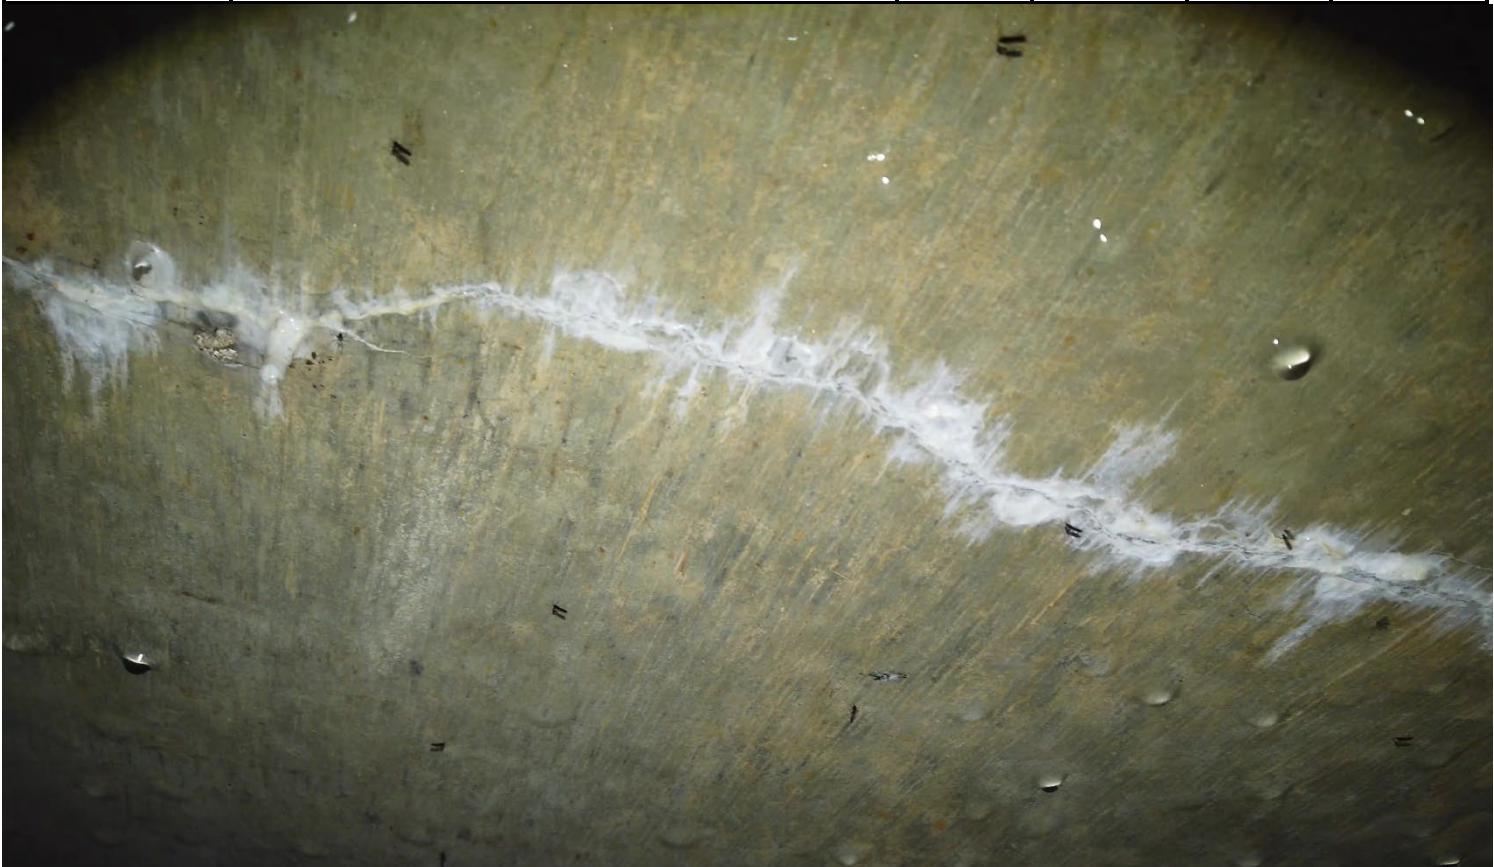
Footage	Defect Description	Top	Right	Left	Bottom
232 ft	Crack and Infiltration	Y

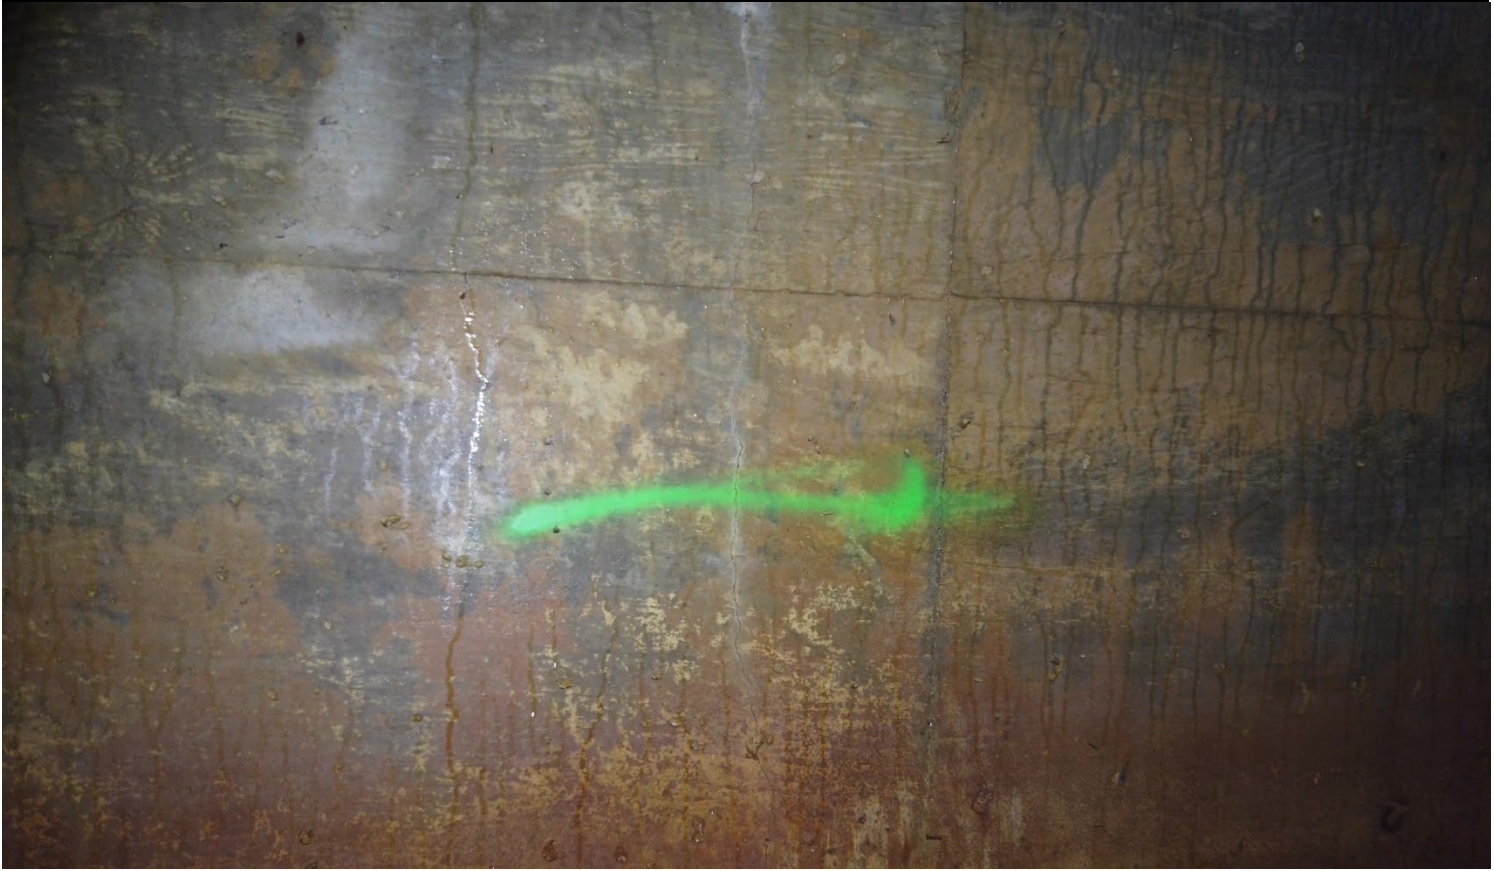
Footage	Defect Description	Top	Right	Left	Bottom
254 ft	Crack			Y

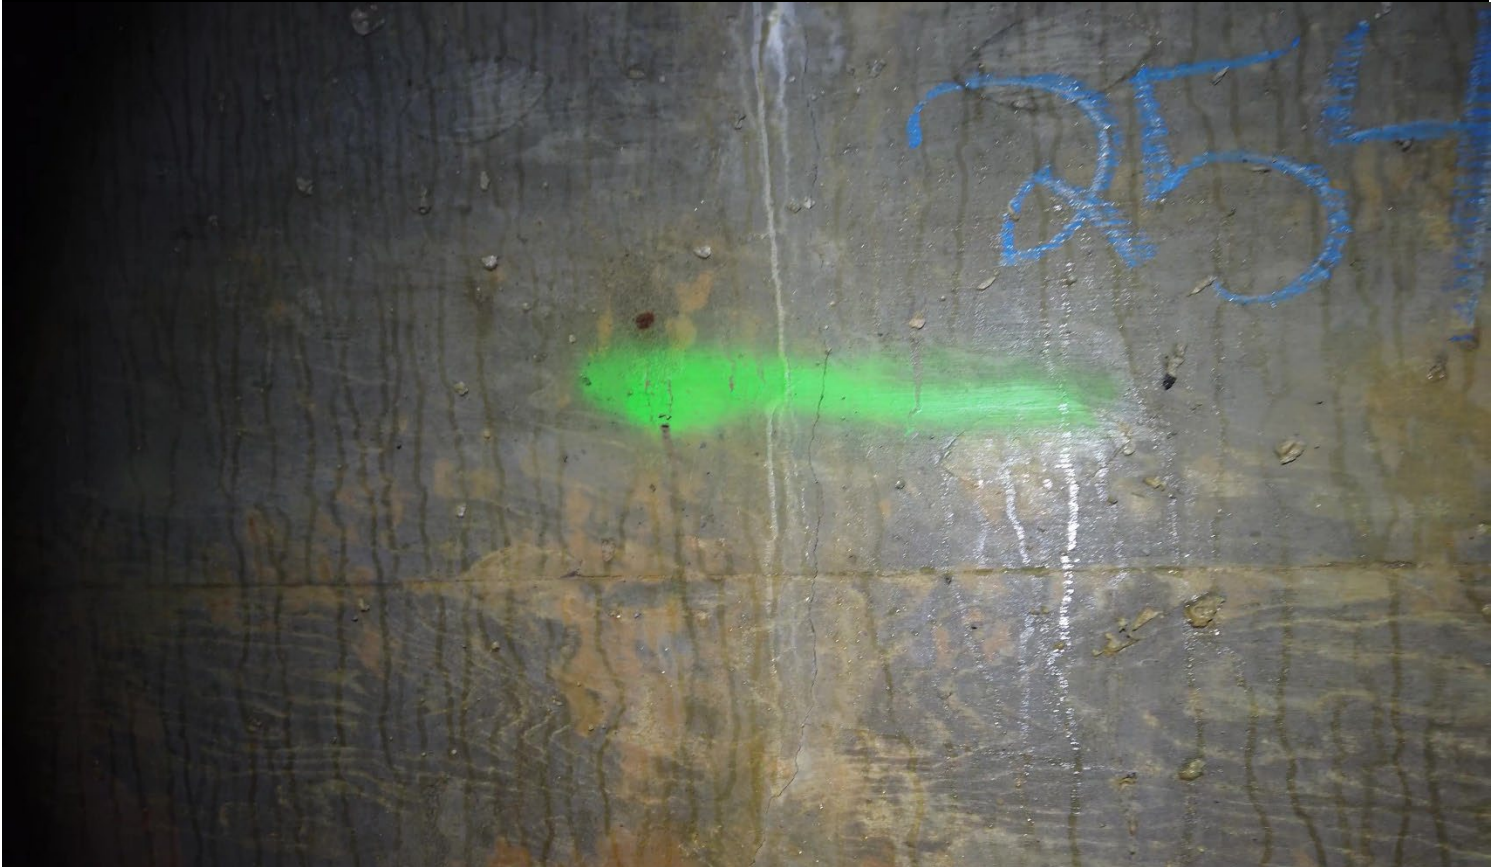
Footage	Defect Description	Top	Right	Left	Bottom
254 ft	Crack		Y
