I-26 & I-95 INTERCHANGE IMPROVEMENTS

June 29, 2023

PIPE INSPECTION REPORT

This report contains the results of the video pipe inspection and assessment of the existing storm water drainage pipes within the project area in Orangeburg and Dorchester Counties.

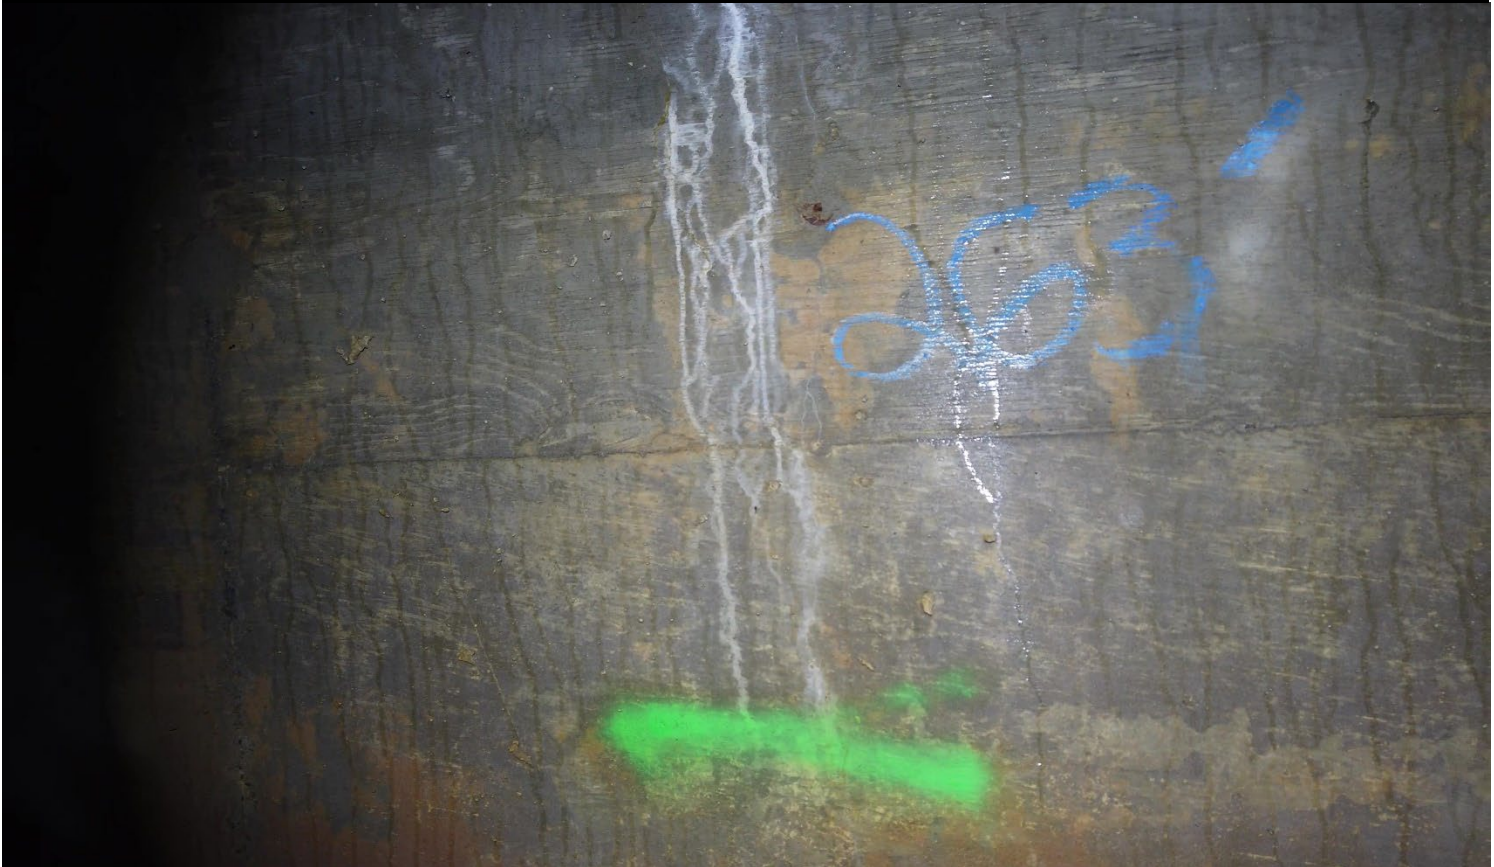
Footage	Defect Description	Top	Right	Left	Bottom
263 ft	Crack and Infiltration		Y

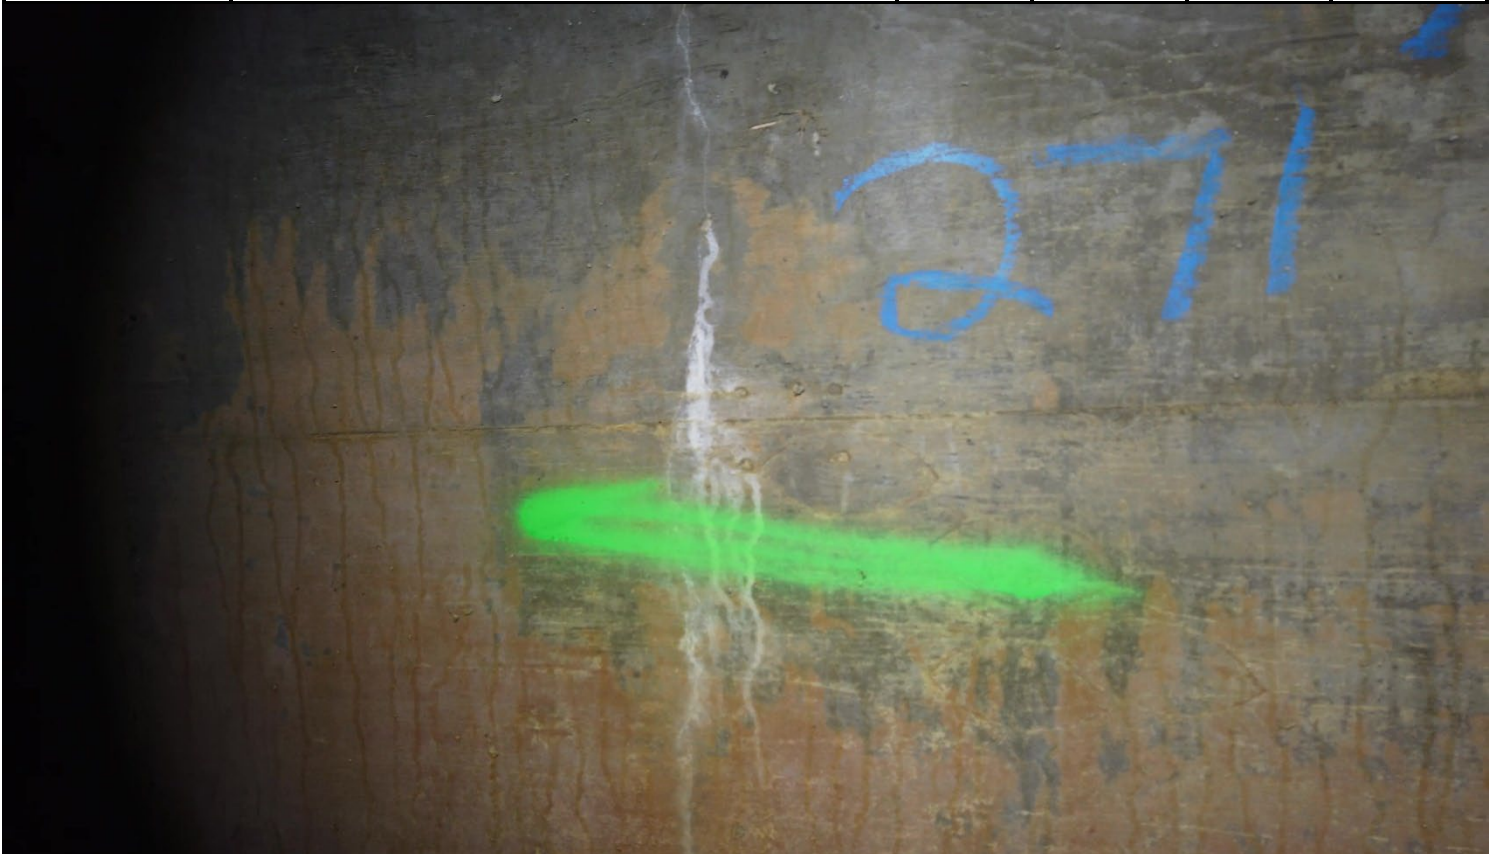
Footage	Defect Description	Top	Right	Left	Bottom
271 ft	Crack		Y

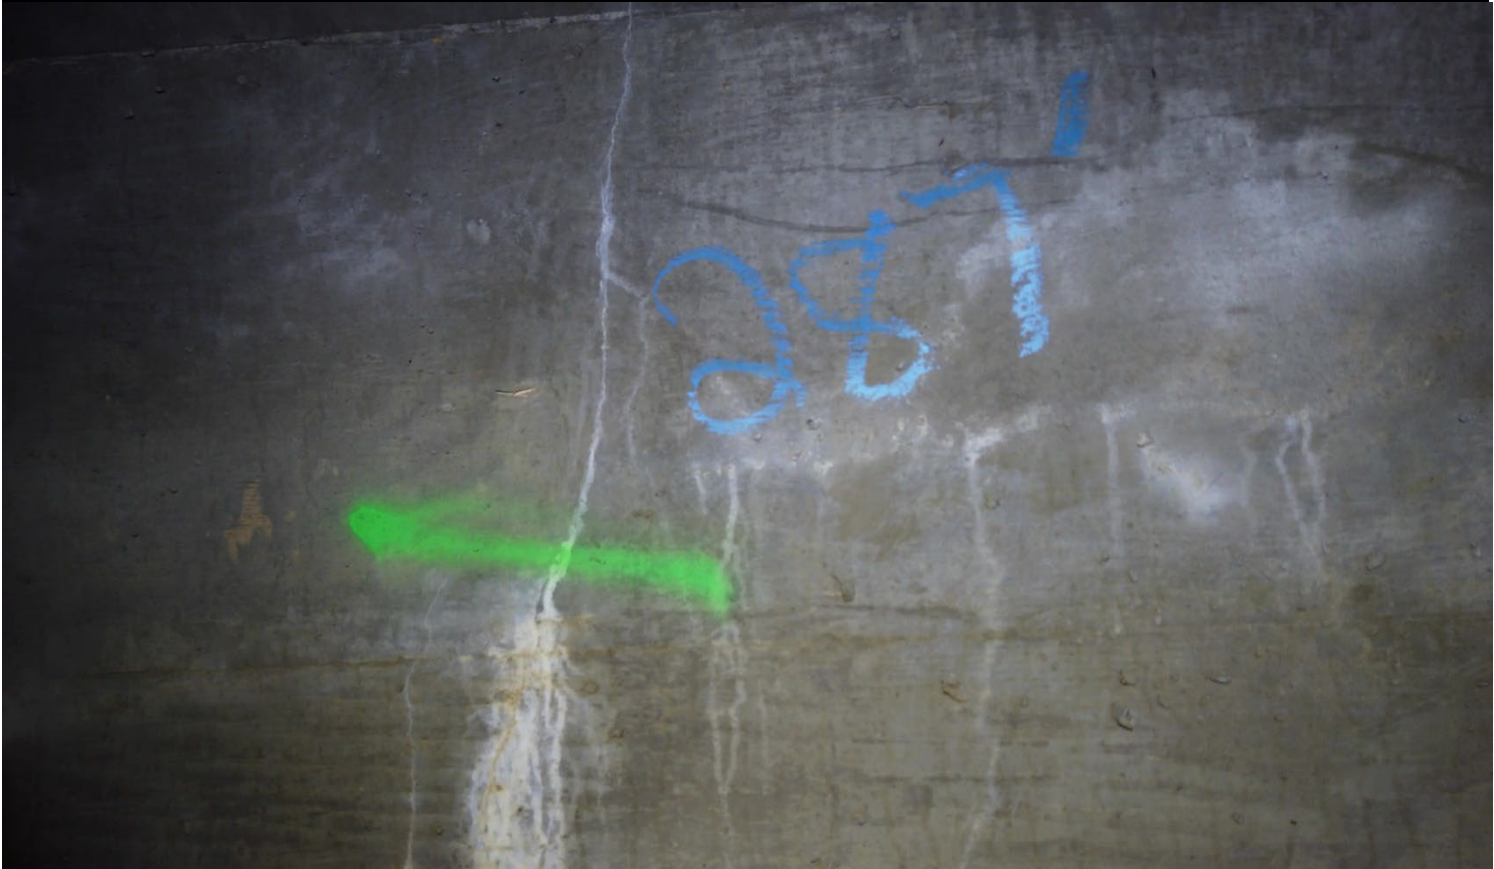
Footage	Defect Description	Top	Right	Left	Bottom
287 ft	Crack and Infiltration		Y

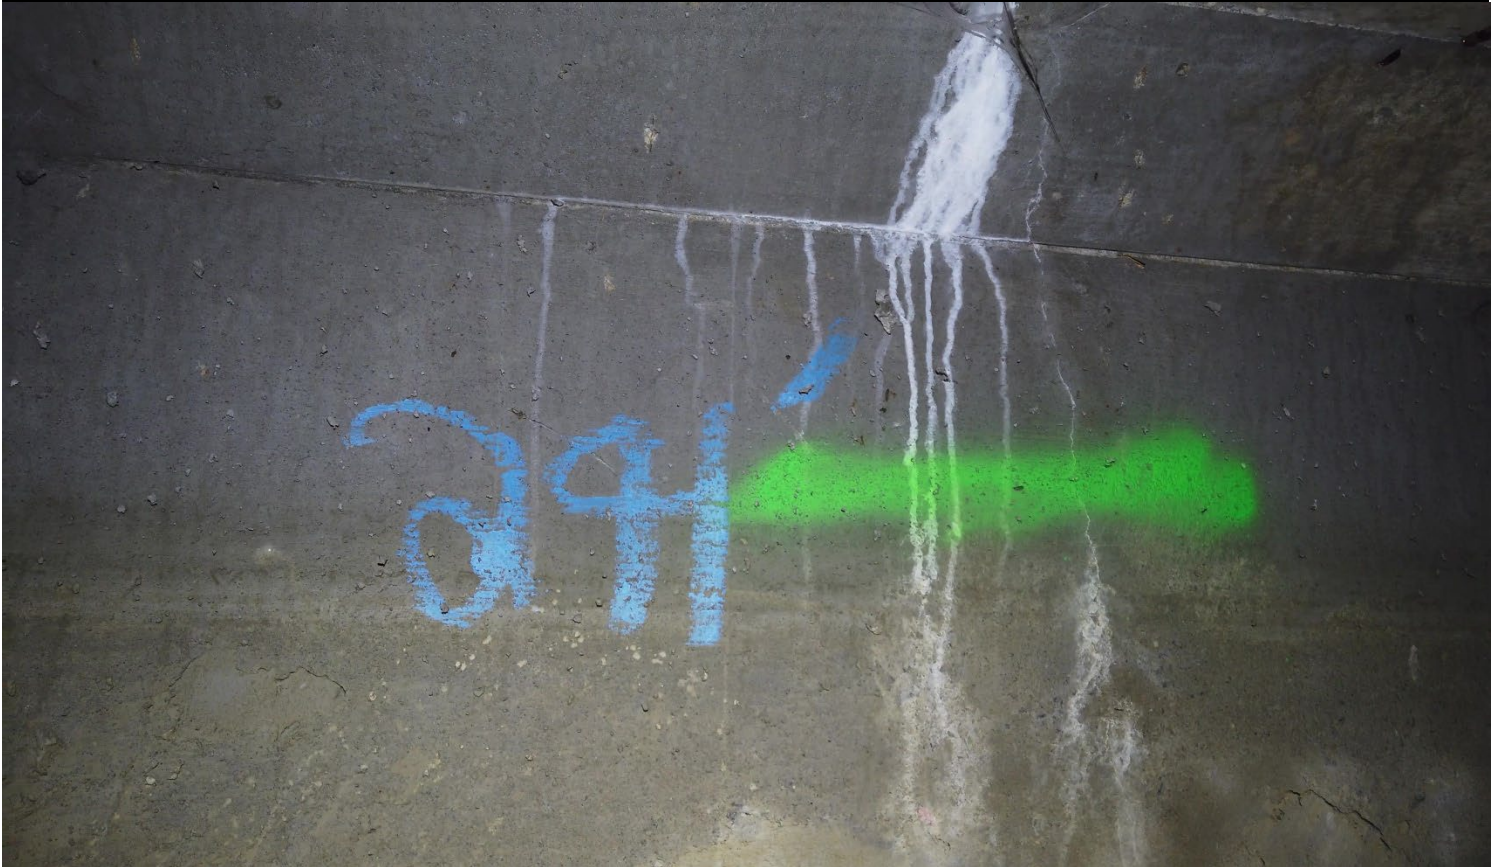
Footage	Defect Description	Top	Right	Left	Bottom
291 ft	Crack and Infiltration			Y

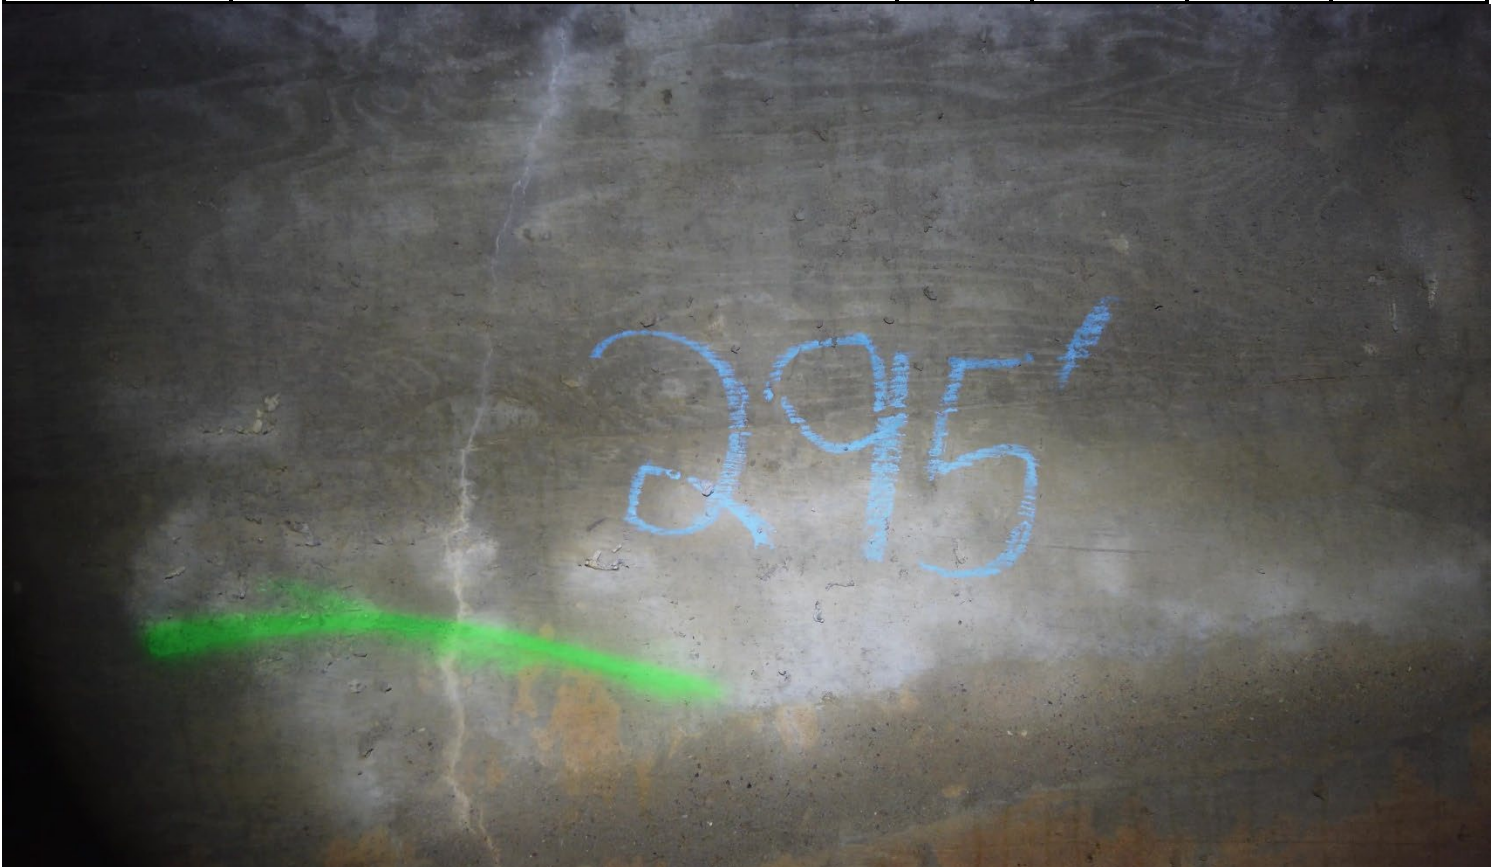
Footage	Defect Description	Top	Right	Left	Bottom
295 ft	Crack		Y

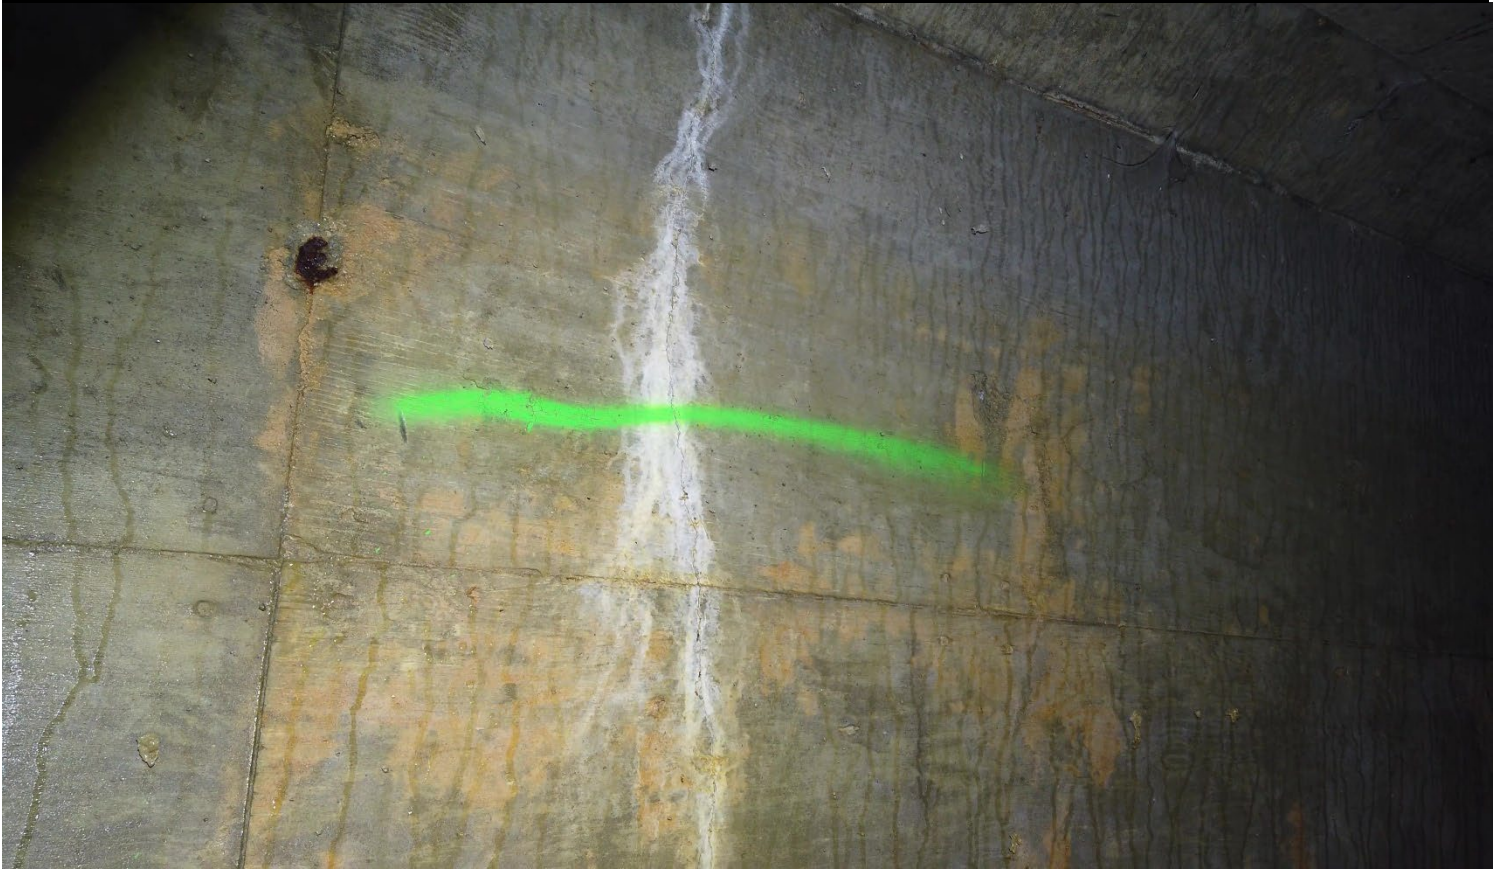
Footage	Defect Description	Top	Right	Left	Bottom
313 ft	Crack and Infiltration			Y

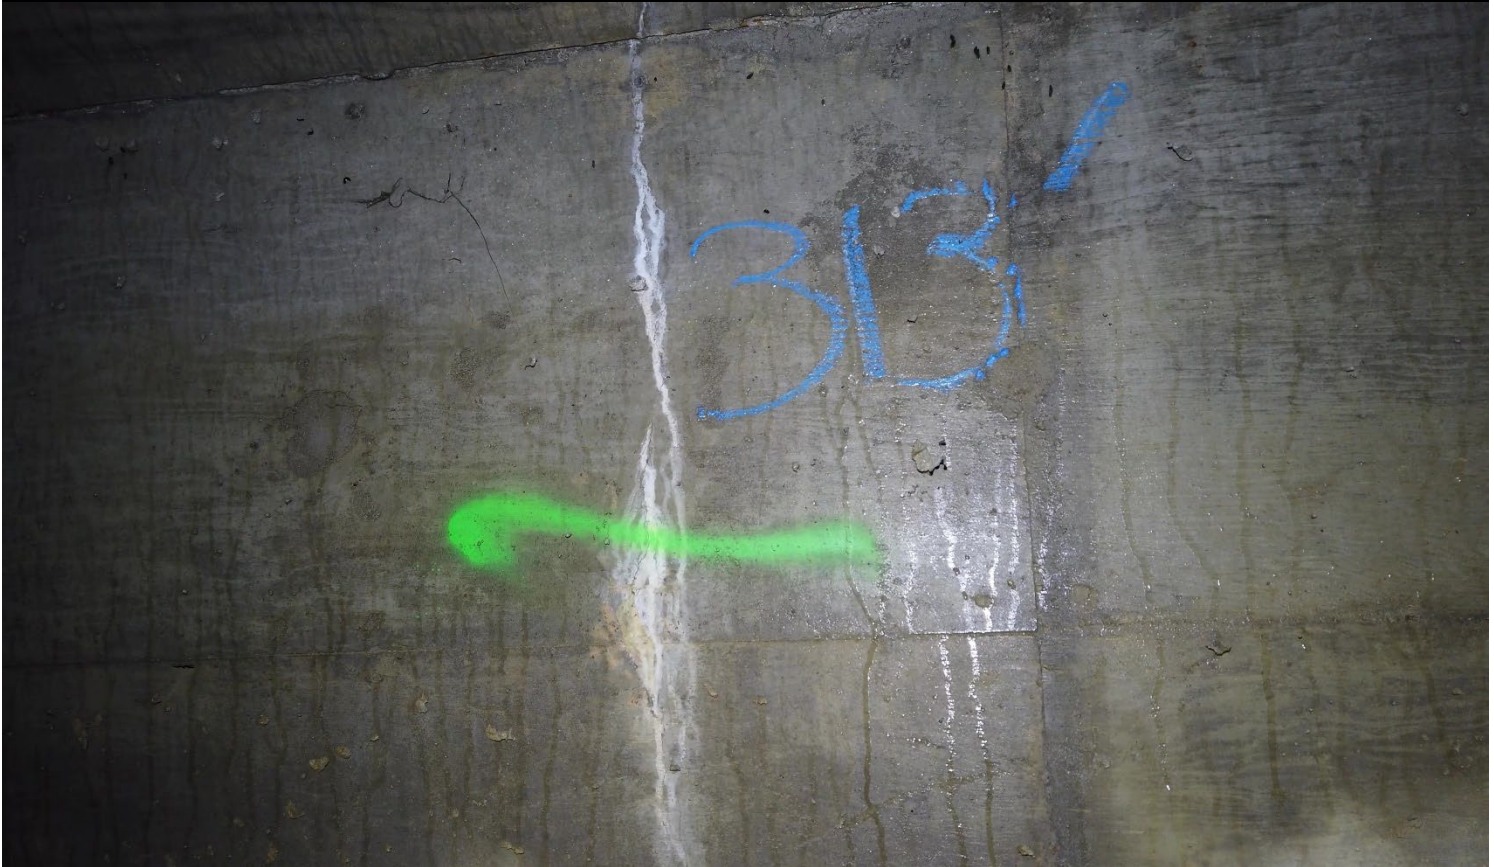
Footage	Defect Description	Top	Right	Left	Bottom
313 ft	Crack and Infiltration		Y

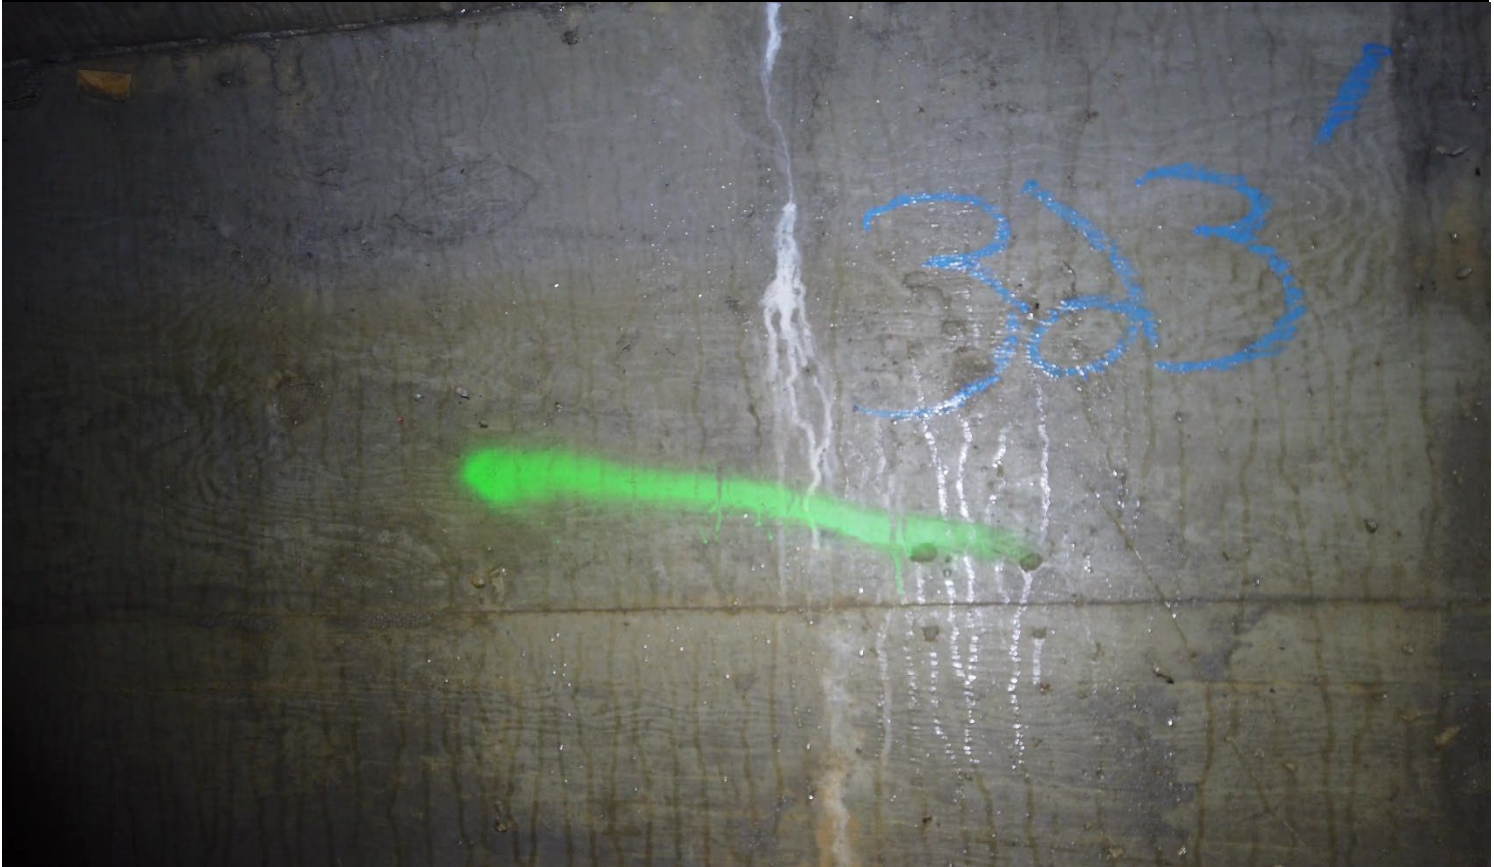
Footage	Defect Description	Top	Right	Left	Bottom
323 ft	Crack and Infiltration		Y

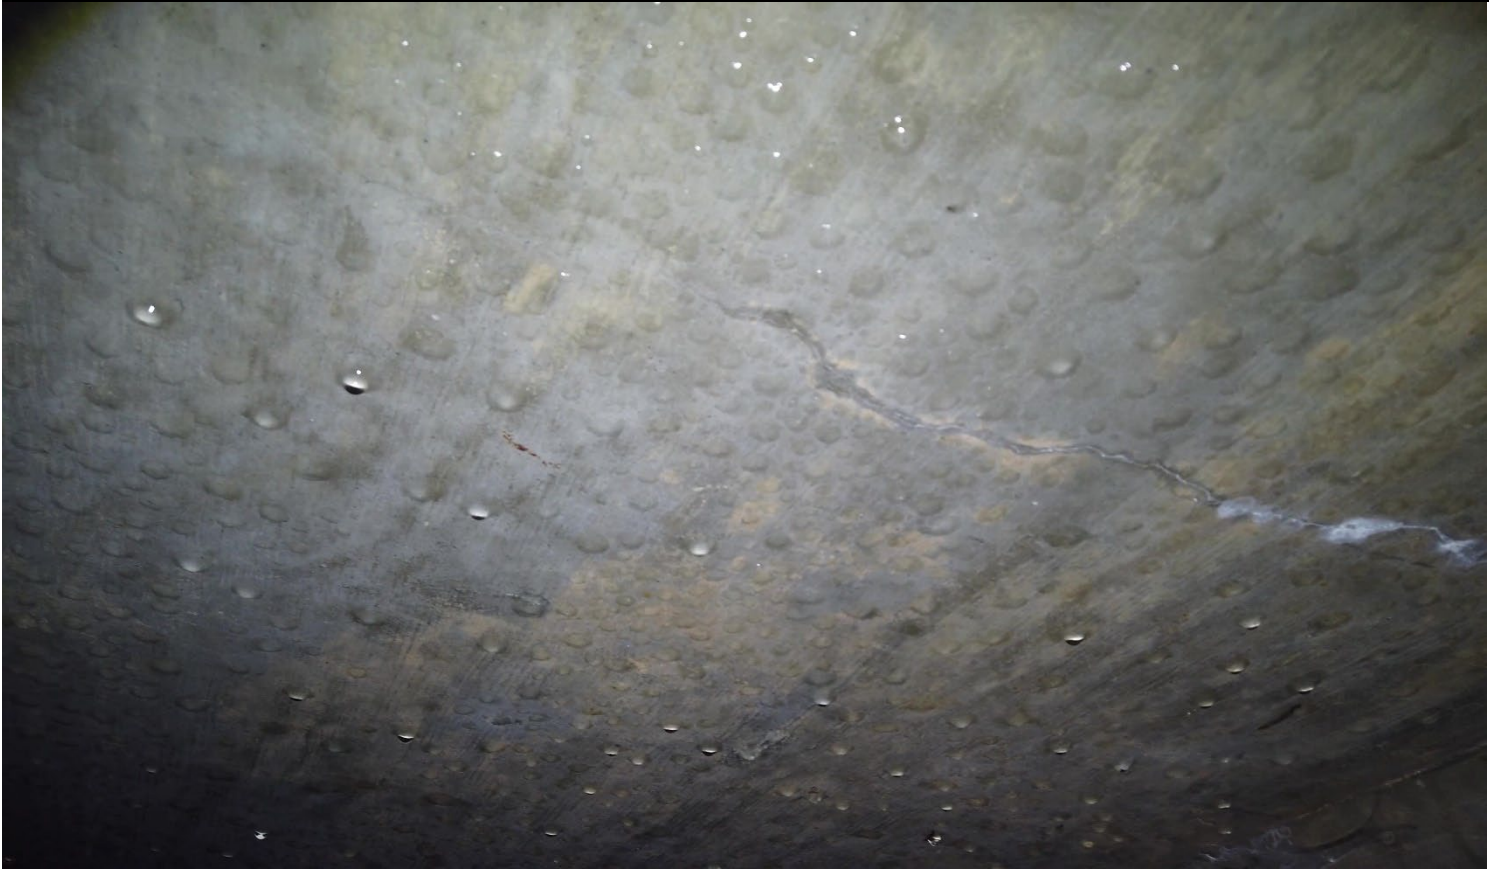
Footage	Defect Description	Top	Right	Left	Bottom
323 ft	Crack	Y

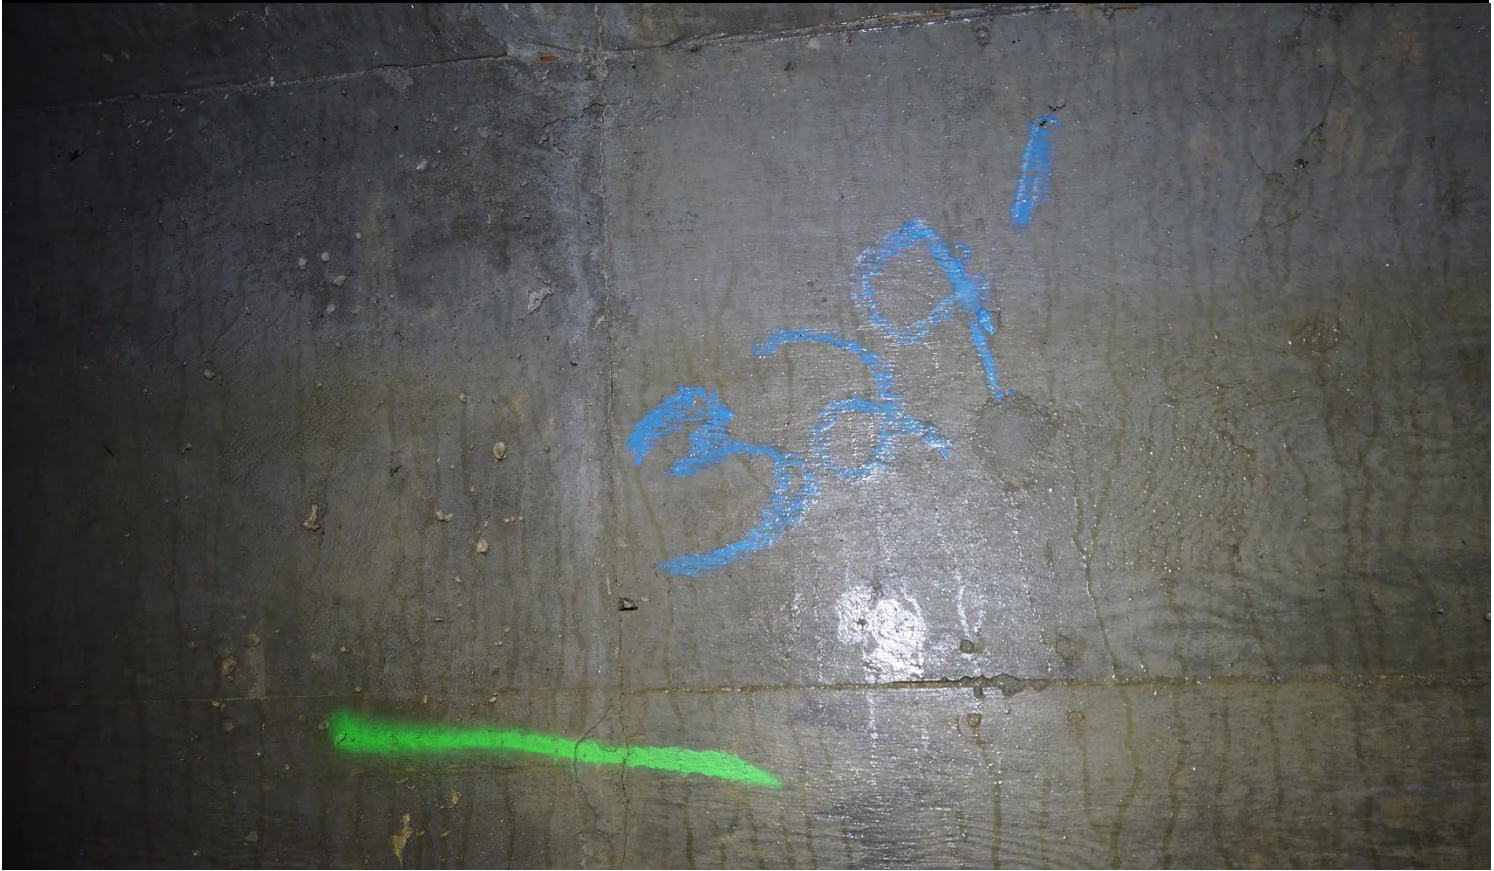
Footage	Defect Description	Top	Right	Left	Bottom
329 ft	Crack		Y

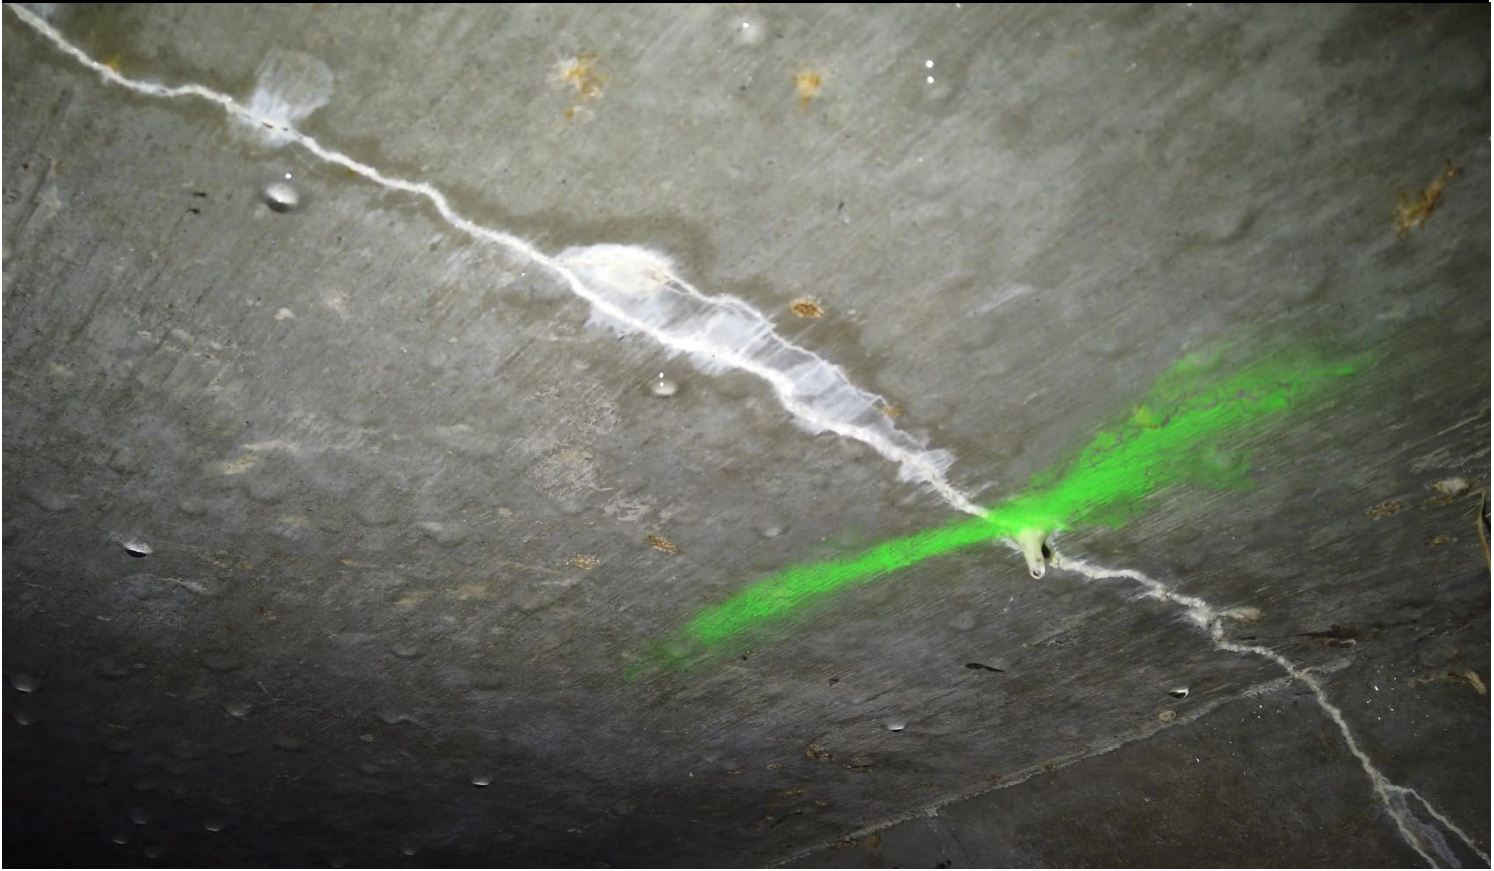
Footage	Defect Description	Top	Right	Left	Bottom
354 ft	Crack and Infiltration	Y

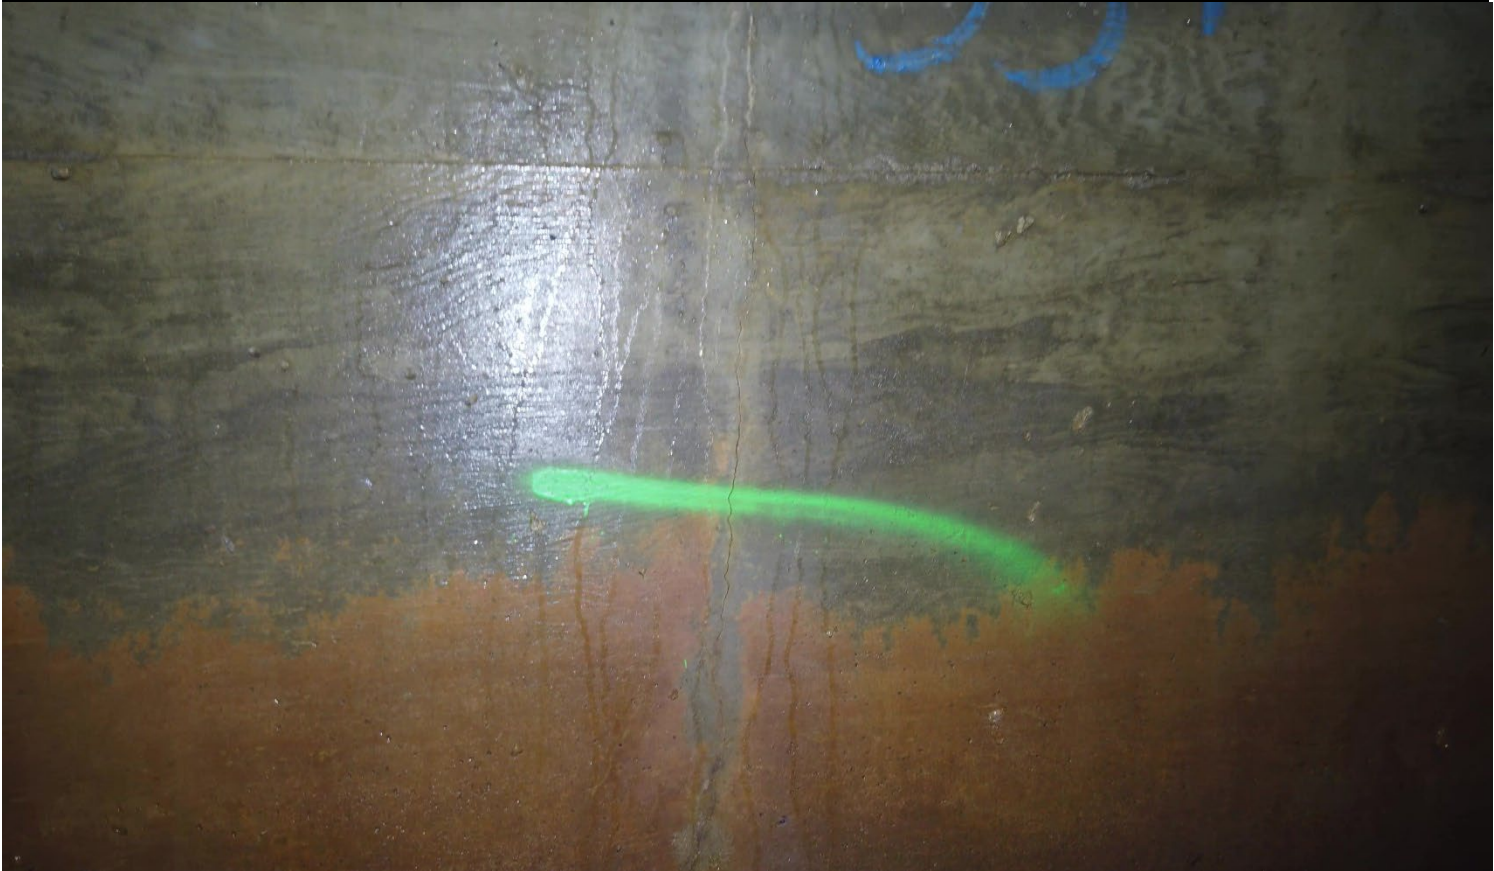
Footage	Defect Description	Top	Right	Left	Bottom
357 ft	Crack			Y

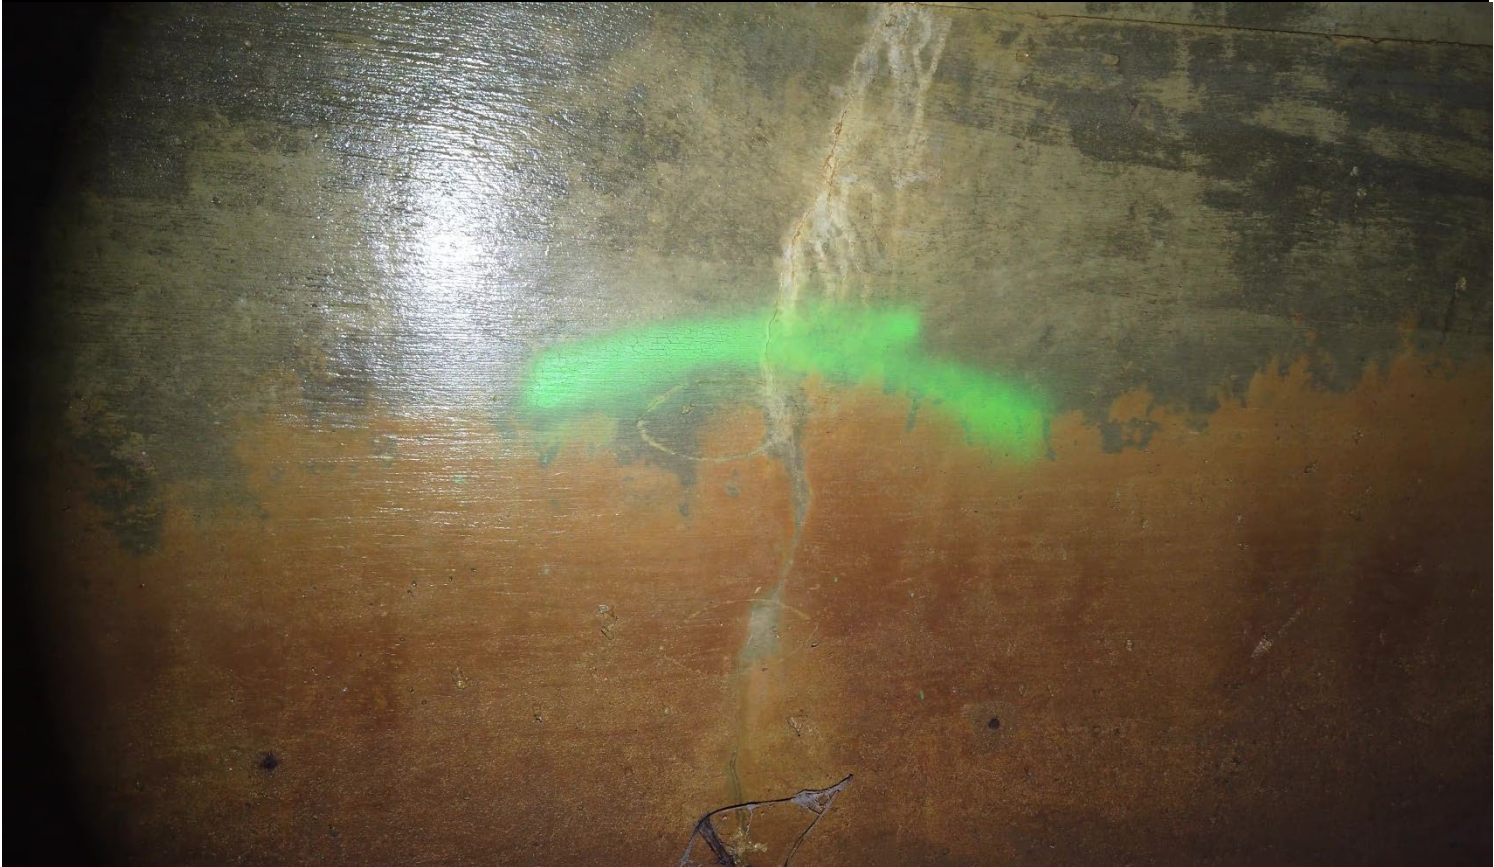
Footage	Defect Description	Top	Right	Left	Bottom
362 ft	Crack			Y

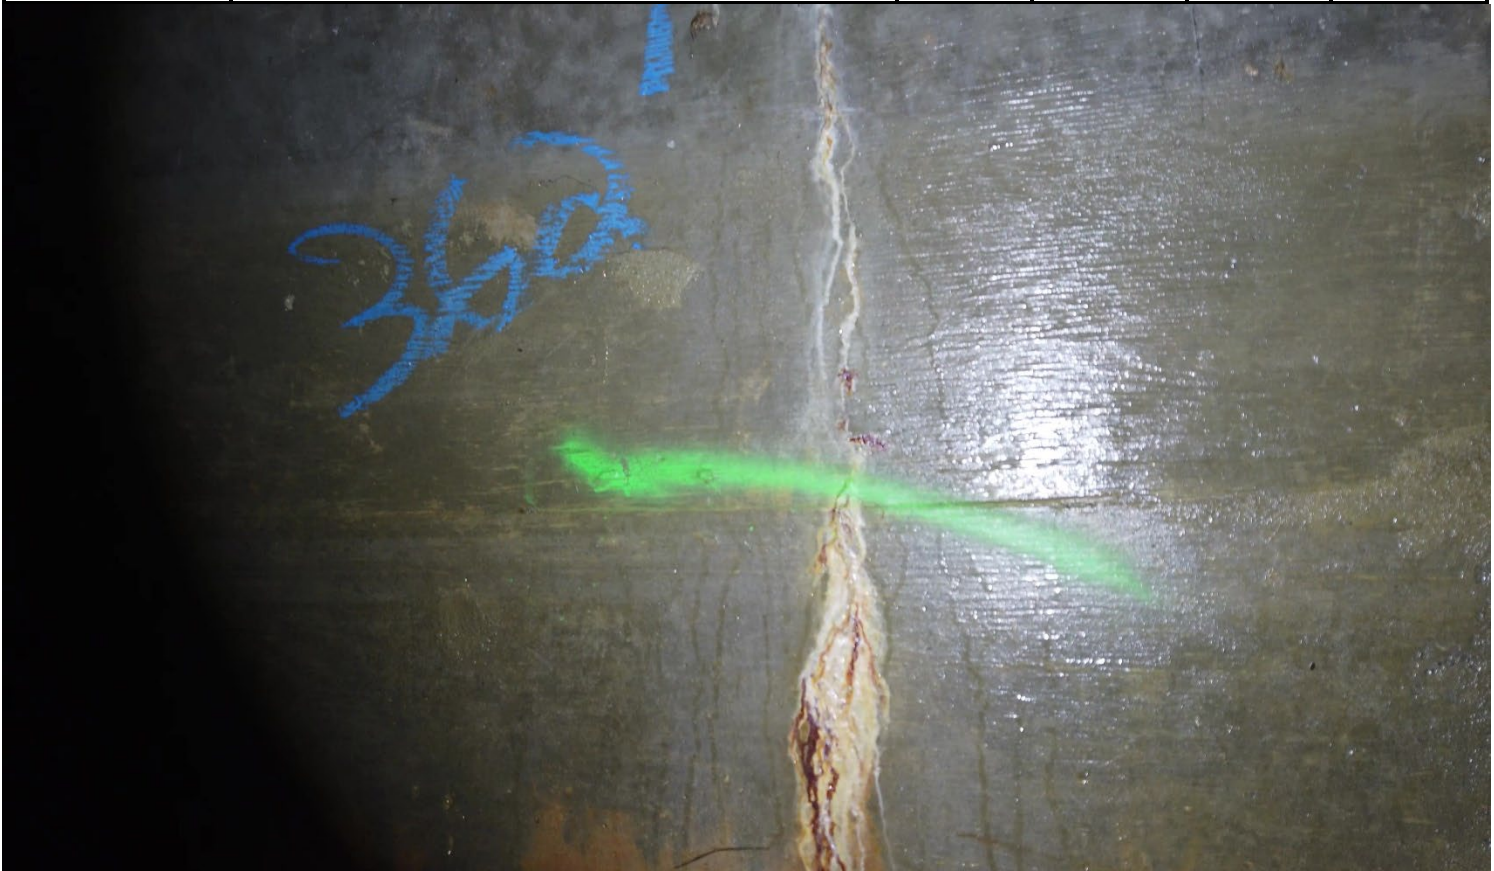
Footage	Defect Description	Top	Right	Left	Bottom
362 ft	Crack and Infiltration		Y

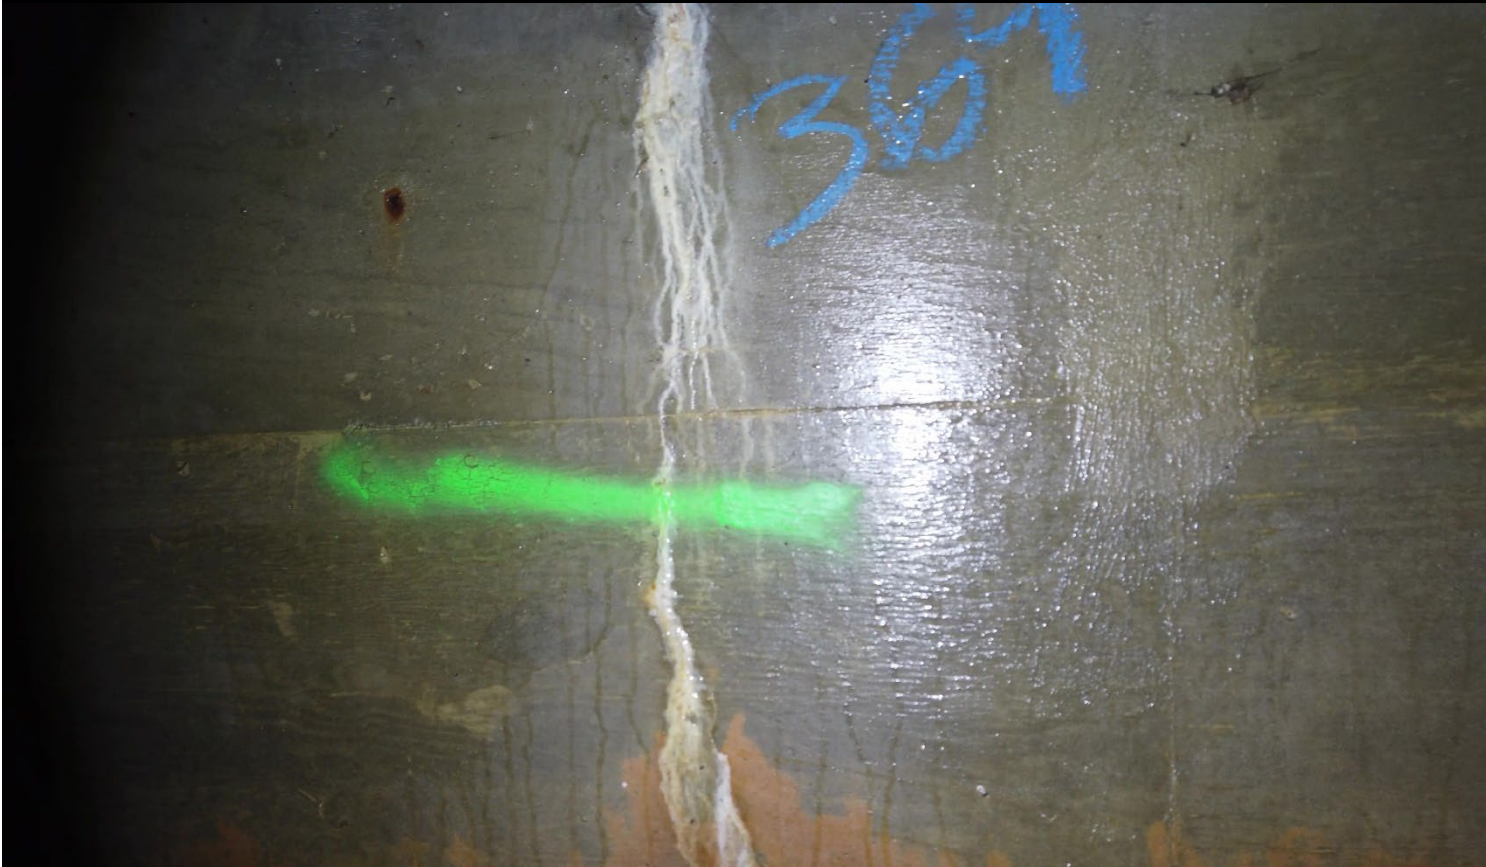
Footage	Defect Description	Top	Right	Left	Bottom
369 ft	Crack and Infiltration		Y

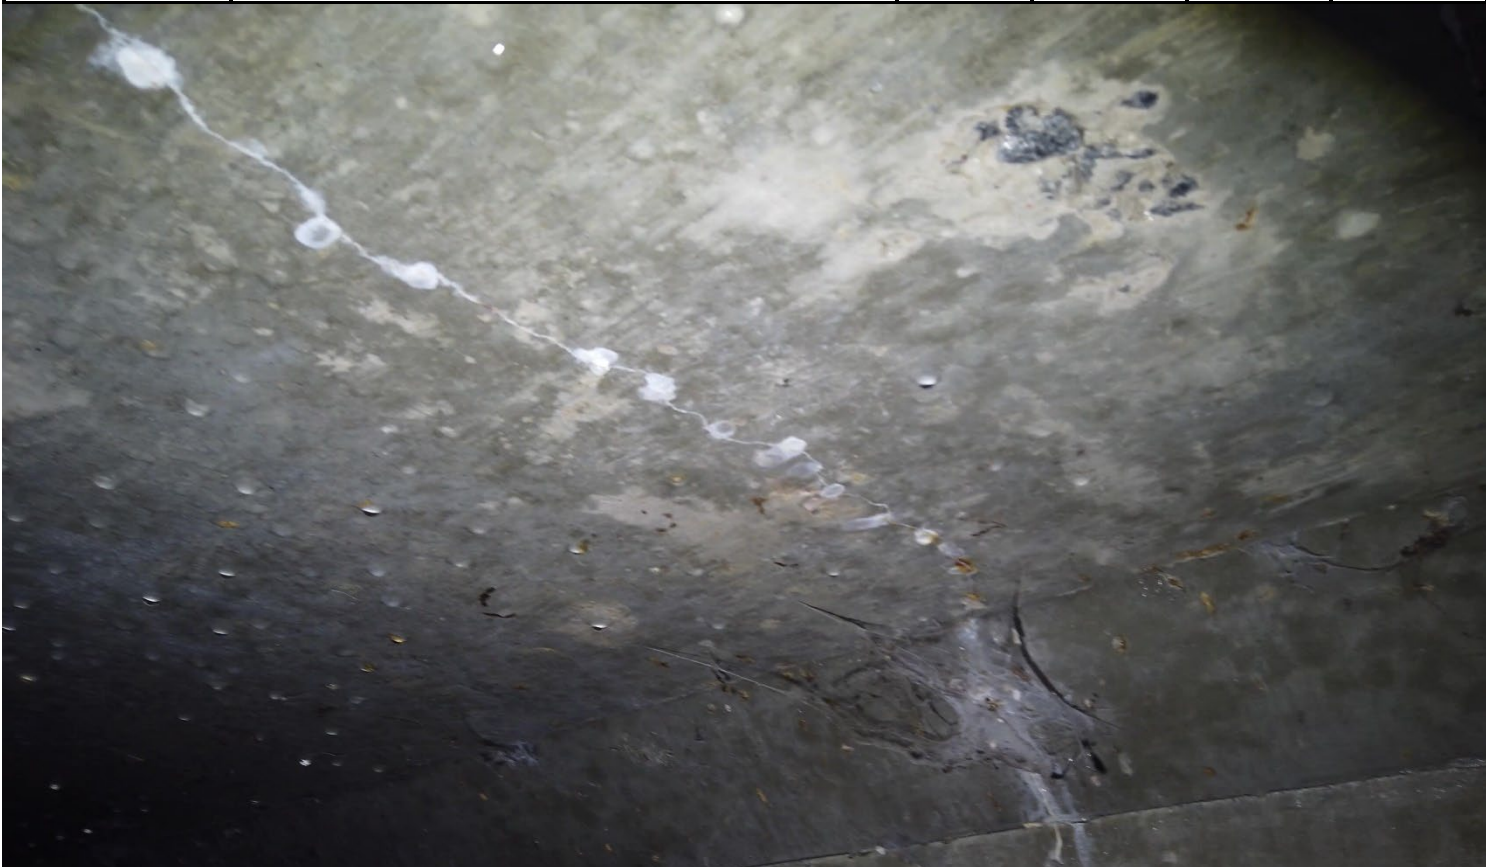
Footage	Defect Description	Top	Right	Left	Bottom
369 ft	Crack and Infiltration	Y

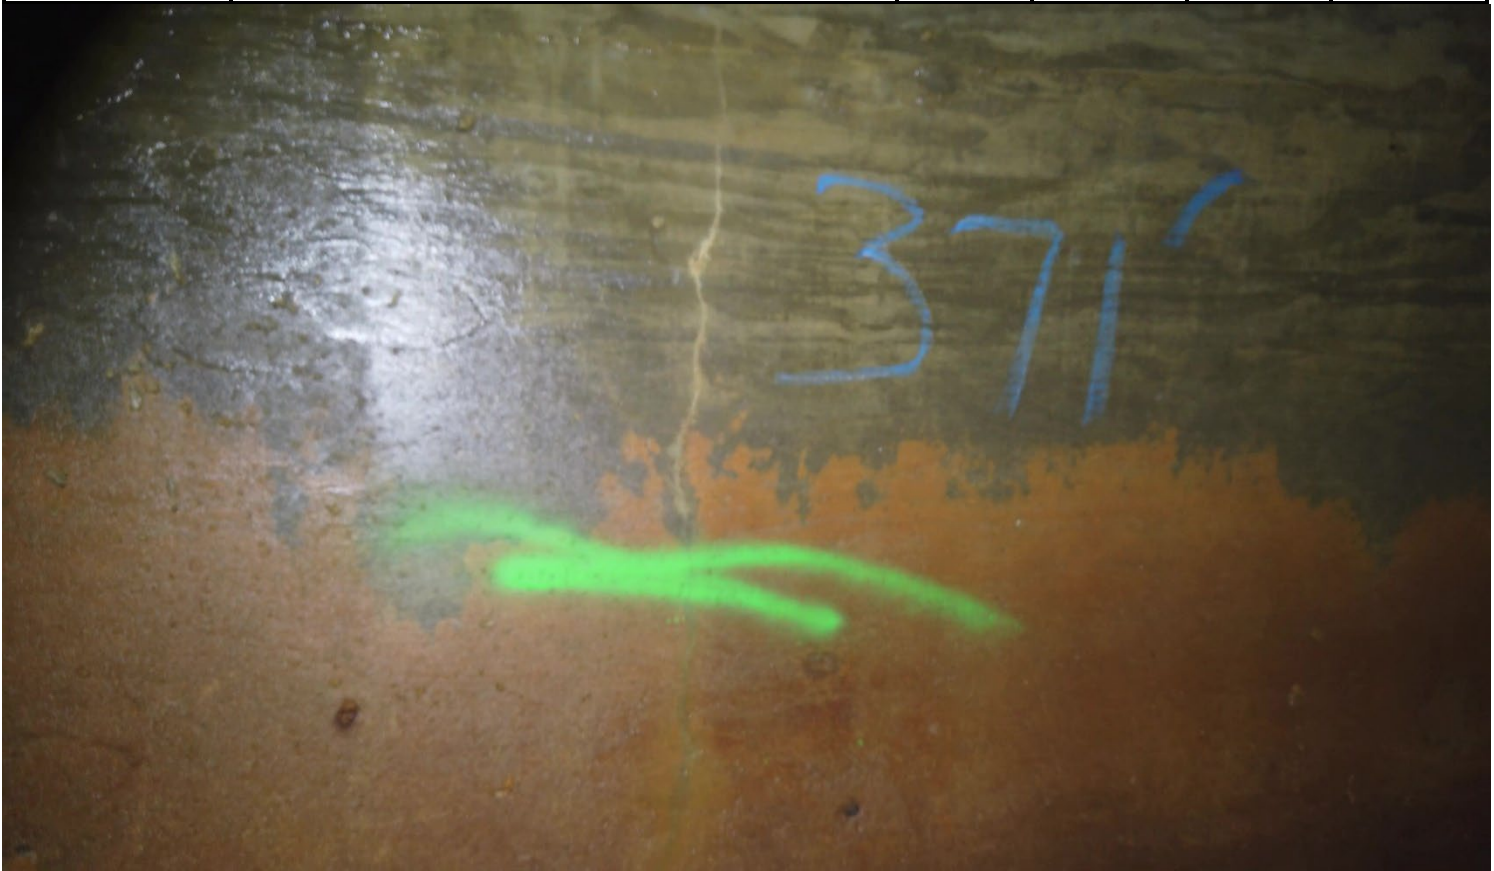
Footage	Defect Description	Top	Right	Left	Bottom
371 ft	Crack			Y
