I-26 & I-95 INTERCHANGE IMPROVEMENTS

June 29, 2023

PIPE INSPECTION REPORT

This report contains the results of the video pipe inspection and assessment of the existing storm water drainage pipes within the project area in Orangeburg and Dorchester Counties.

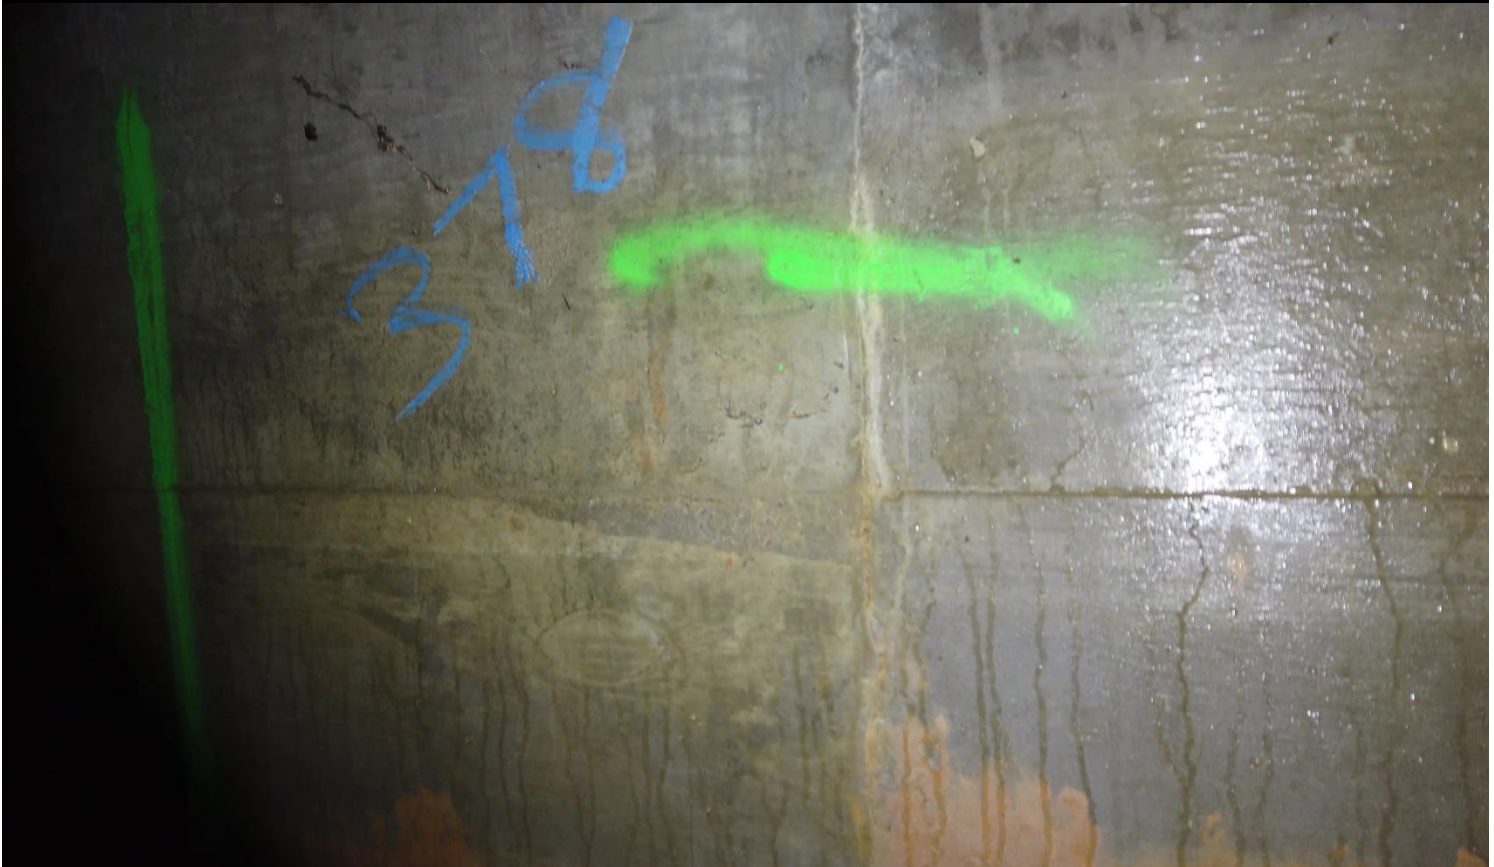
Footage	Defect Description	Top	Right	Left	Bottom
378 ft	Crack		Y

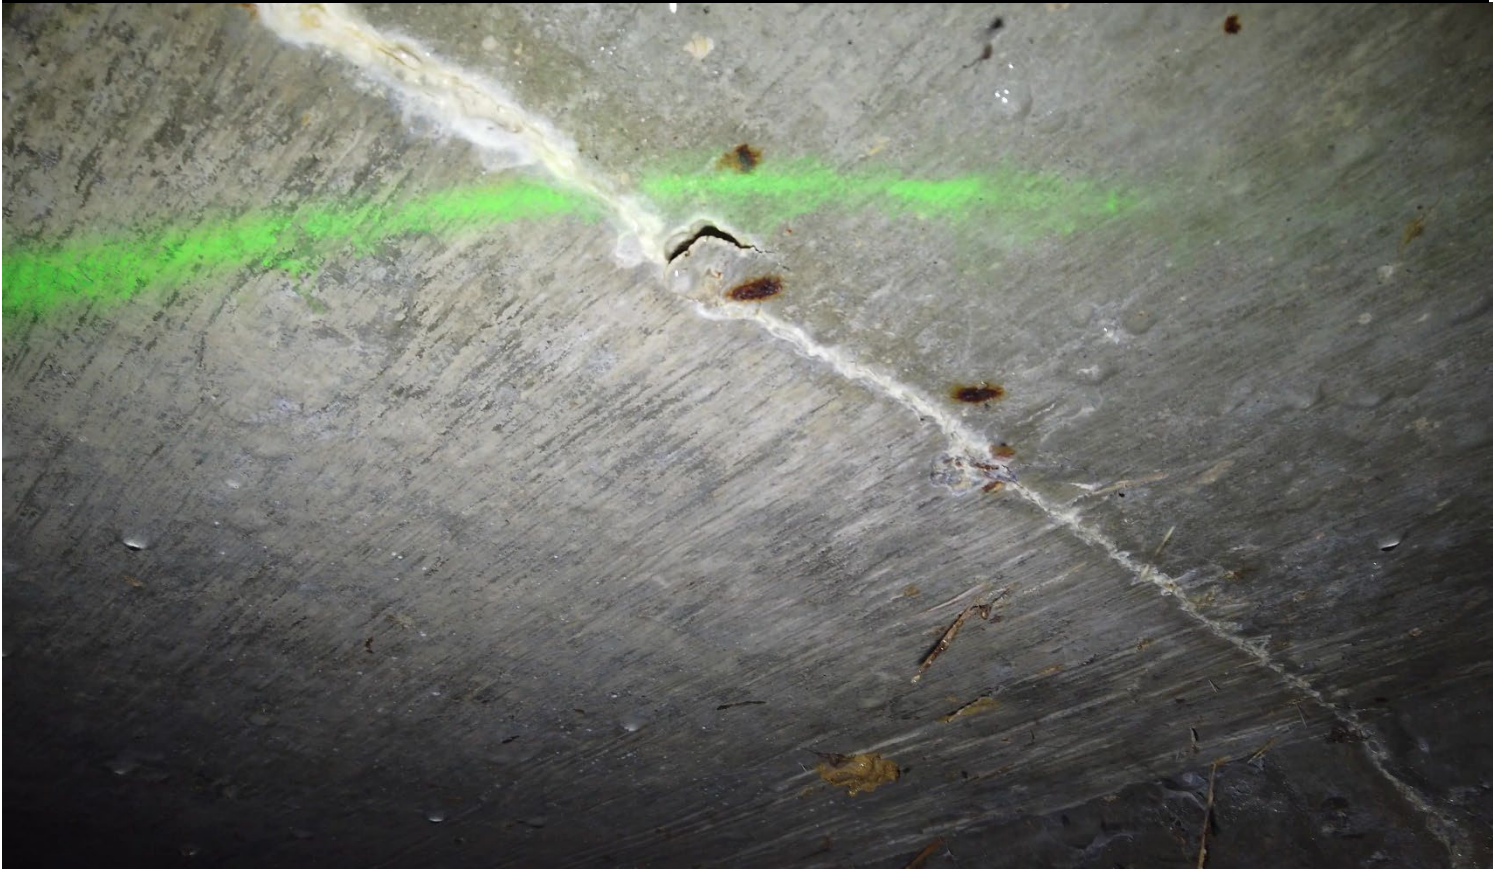
Footage	Defect Description	Top	Right	Left	Bottom
378 ft	Crack and Infiltration	Y

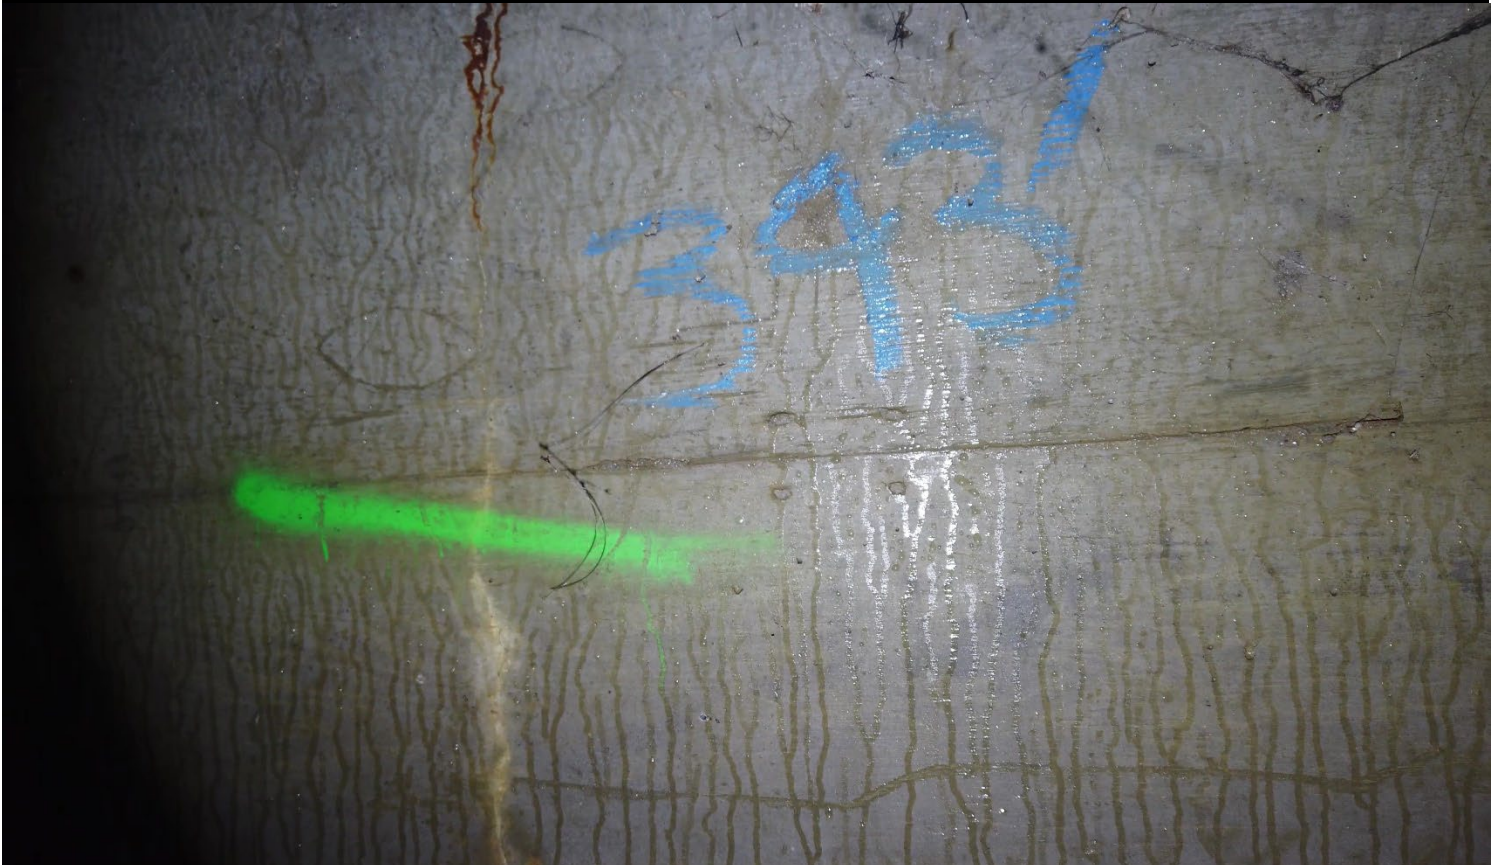
Footage	Defect Description	Top	Right	Left	Bottom
393 ft	Crack and Infiltration		Y

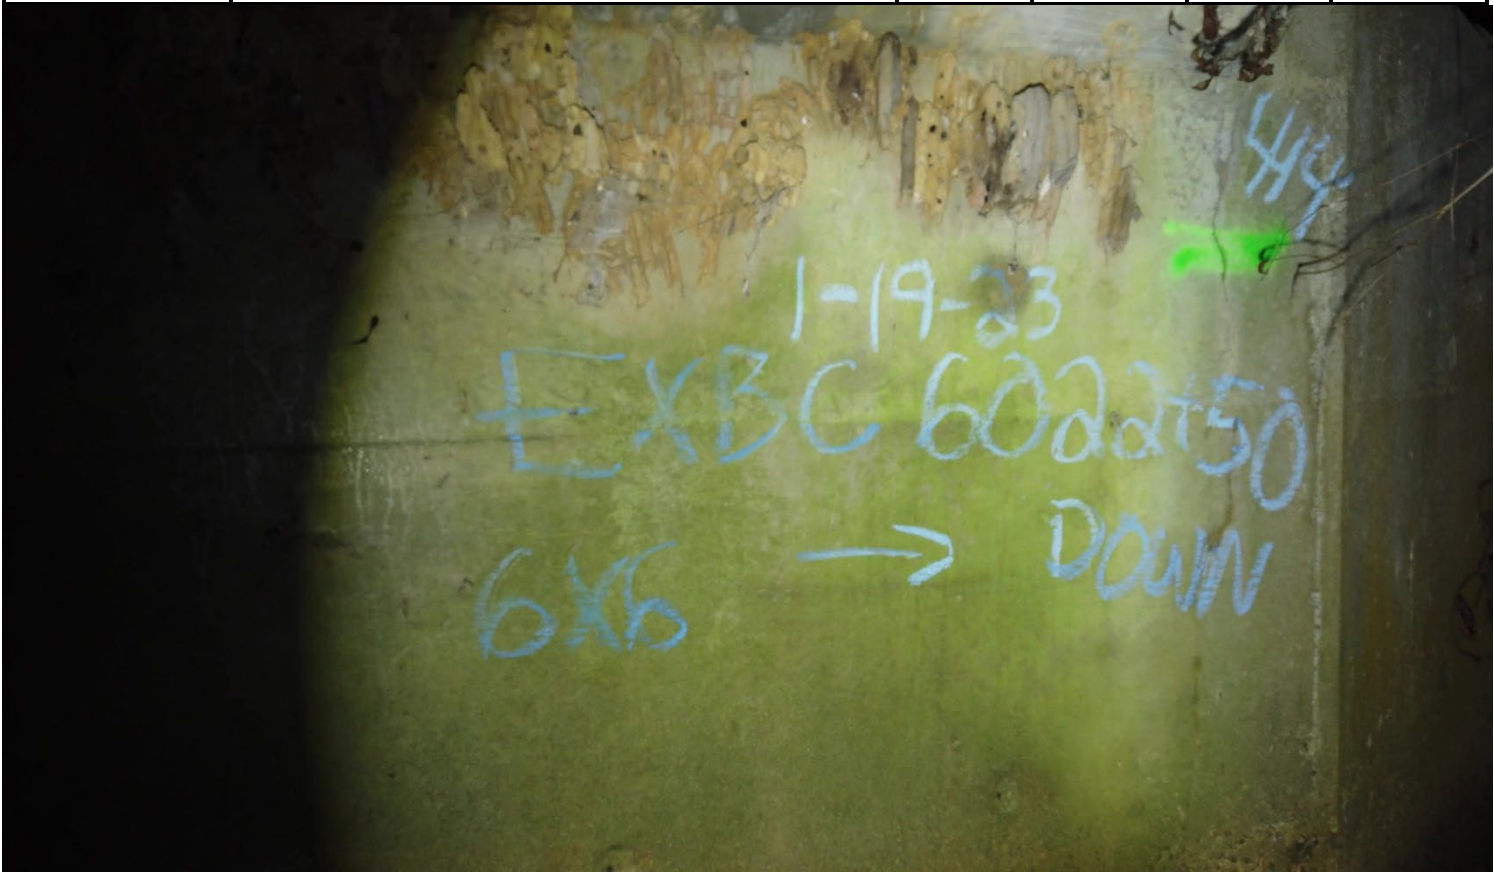
Footage	Defect Description	Top	Right	Left	Bottom
444 ft	End of Culvert			Y
